Columbia Crew Survival Investigation Report

NASA/SP-2008-565

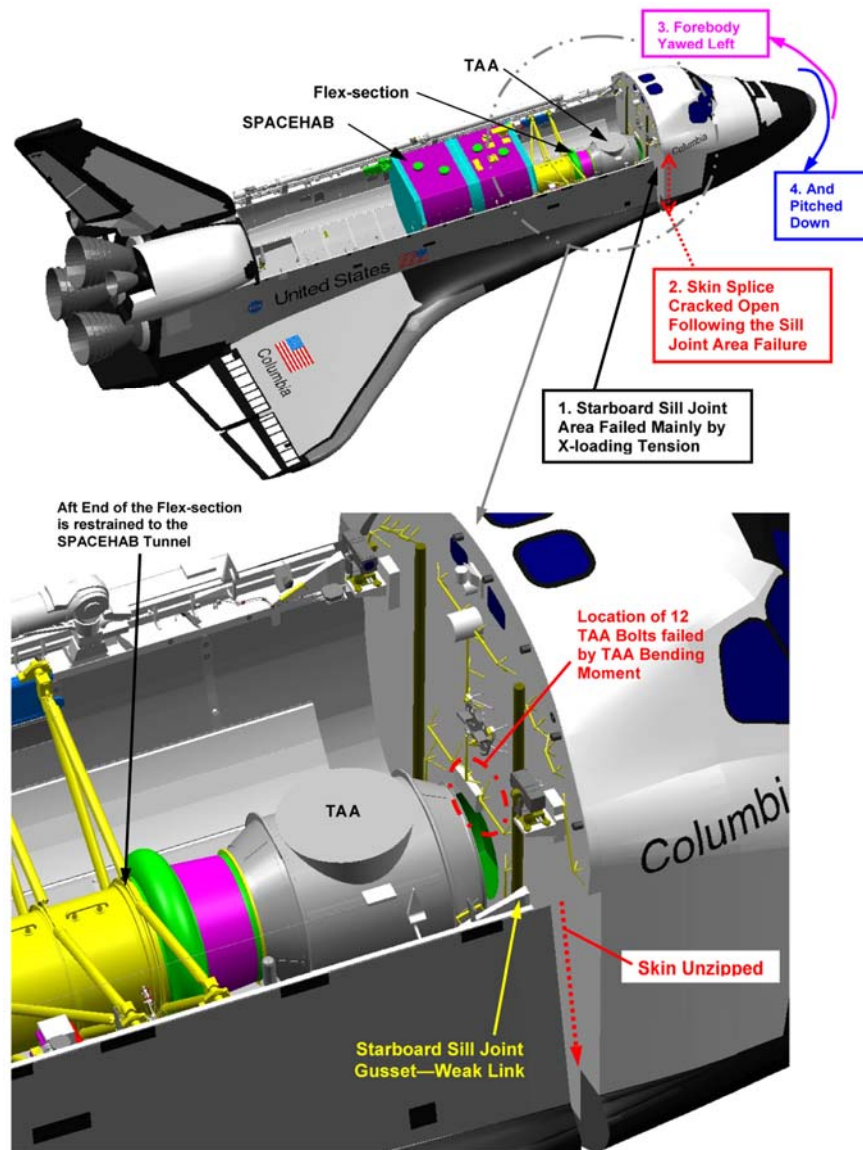
Figure 2.2-44. Forebody departed the midbody at the Catastrophic Event.
