Report of Findings

X-43A Mishap

By the
X-43A
Mishap Investigation Board

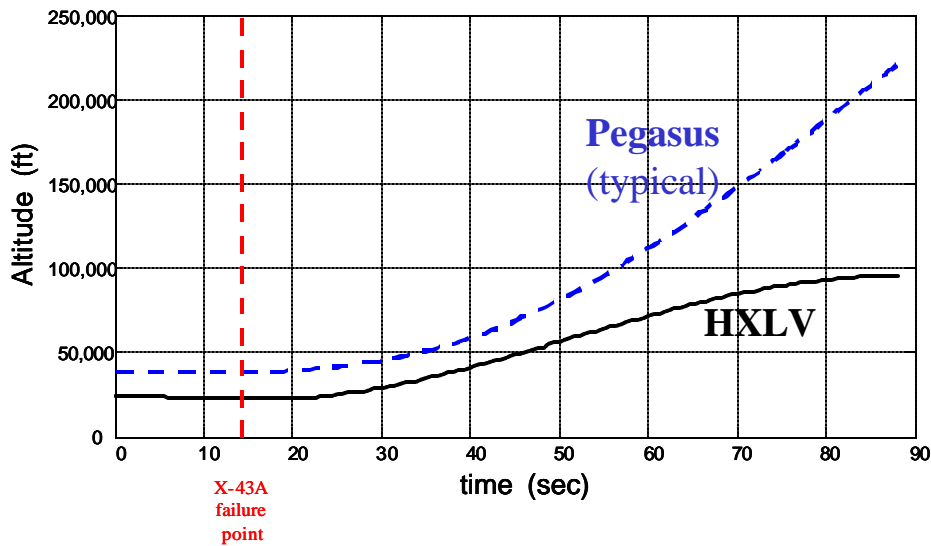
Figure 6-4. Altitude vs. Time

The HXLV was launched and flown in an environment that was significantly different from previous Pegasus experience. At the time of failure, 13.5 seconds, the HXLV altitude was 22,244 feet, whereas a typical Pegasus altitude for the same flight duration would have been approximately 40,000 feet. In addition, at Mach 1, near the failure point, the HXLV dynamic pressure was 650 psf whereas a typical Pegasus dynamic pressure for the same Mach number would have been approximately 300 psf. This increase in dynamic pressure at transonic conditions was a major factor in the mishap.

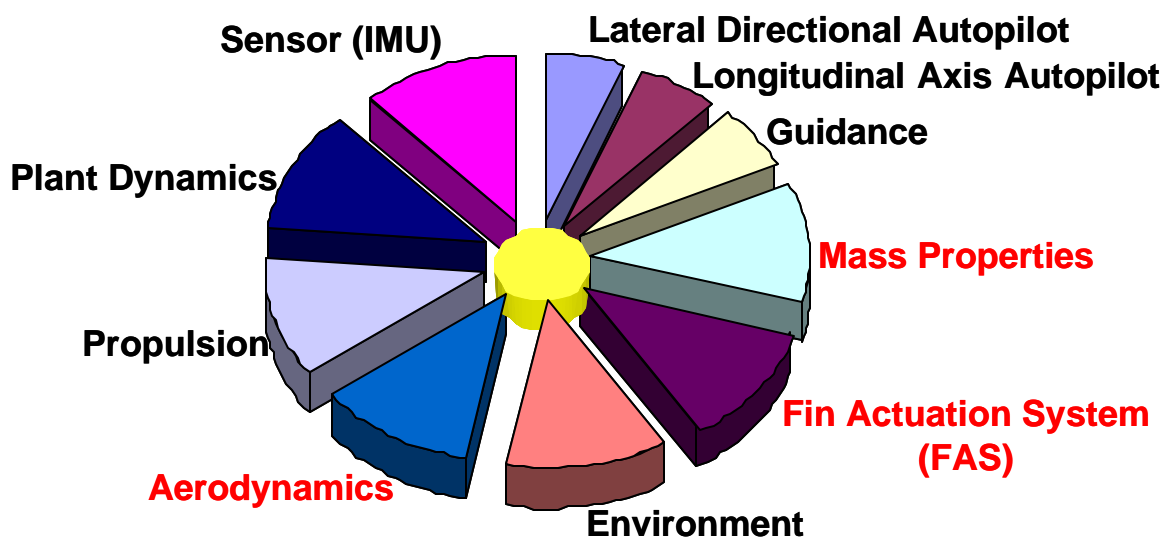
Figure 6-7. Subsystem Models Comprising the System Level Models

These systems level models were developed from multiple supporting models (Figure 6-7). Three of the supporting models (FAS, aerodynamics, mass properties) were determined to be contributors to the mishap.

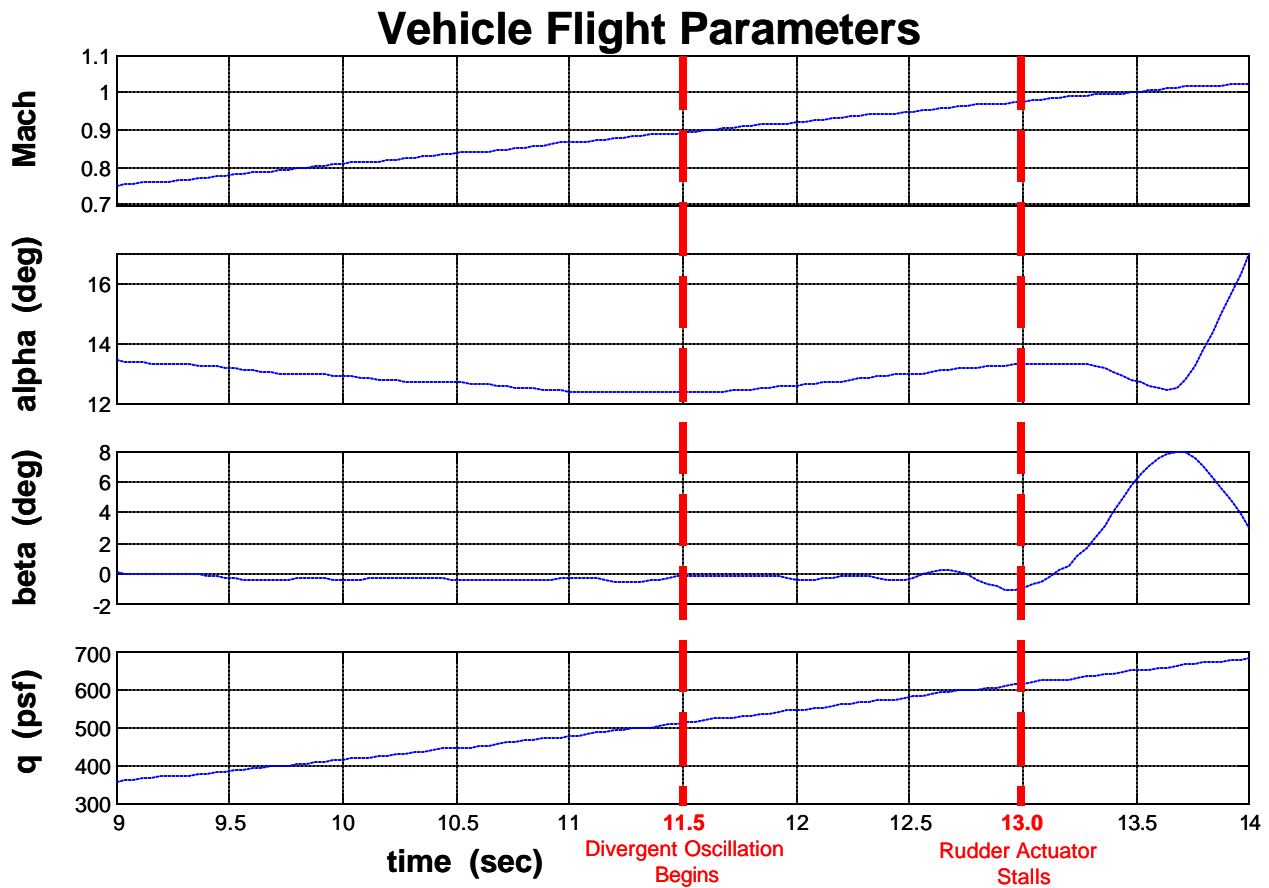
Figure 7-1. Vehicle Flight Parameters

Figure 7-1 shows vehicle flight parameters [Mach, angle of attack (alpha), sideslip (beta) and dynamic pressure (q)] for the time period between 9 and 14 seconds. Also denoted on this figure are the key phenomena that triggered this mishap. The first phenomenon was the divergent roll oscillatory motion that started at approximately 11.5 seconds. The second phenomenon was the rudder actuator stall at approximately 13 seconds. Data shown in Figure 7-1 for Mach, angle of attack (alpha) and dynamic pressure (q) indicate that these parameters remained nominal until after the rudder actuator stalled at 13 seconds. Sideslip (beta) was within the expected range until 12.5 seconds but began a rapid divergence at 13 seconds when rudder actuator stall occurred.

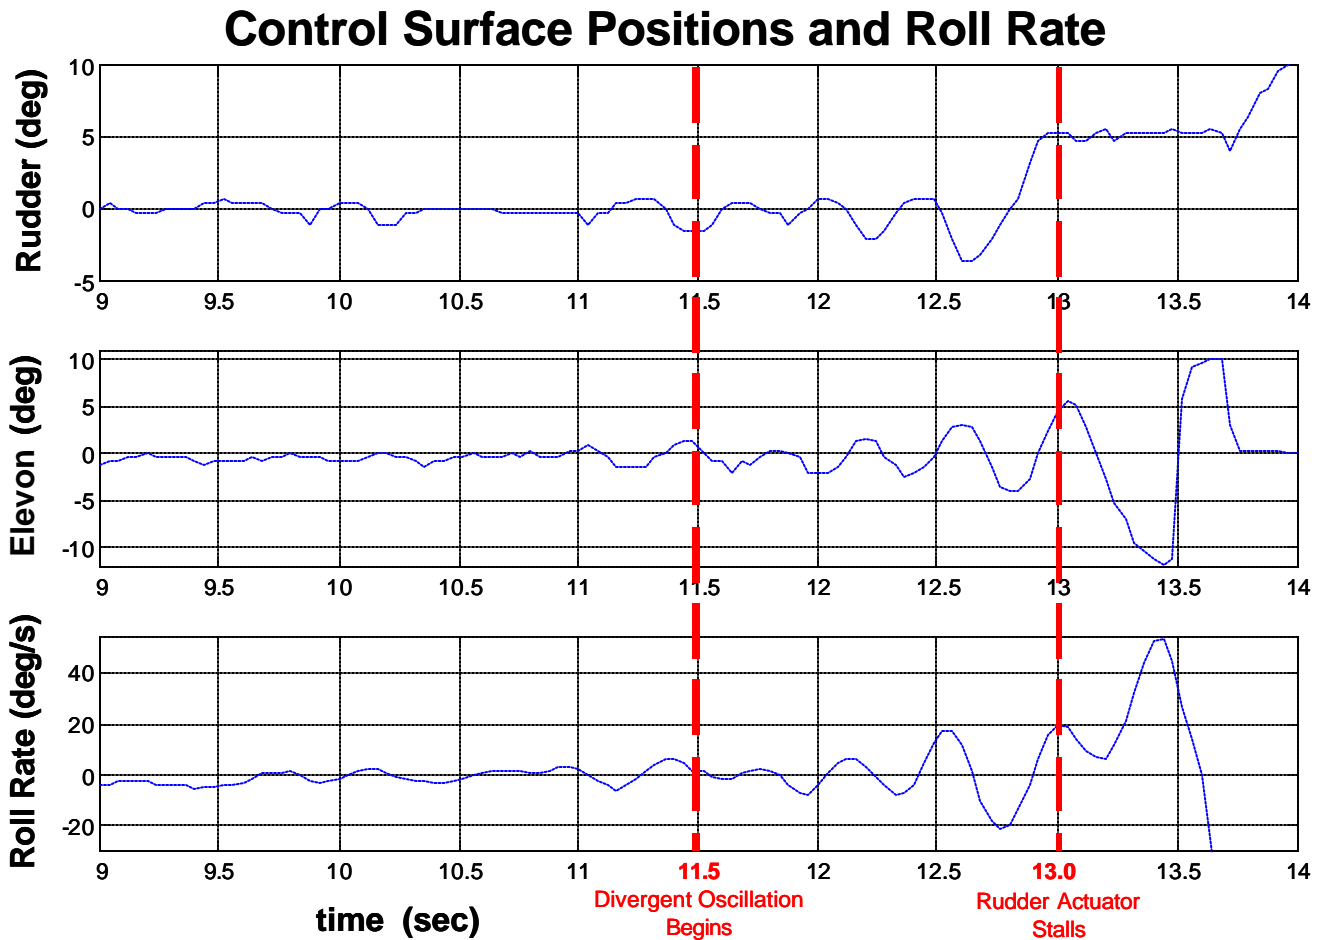
Figure 7-2. Control Surface Positions and Roll Rate

Figure 7-2 shows the control surface positions (rudder and elevon) and vehicle roll rate for the time period between 9 and 14 seconds. The data for rudder deflection (rudder), and differential elevon deflection (elevon) and roll rate remained within the expected range until 11.5 seconds when the divergent oscillation began. At that point, rudder deflection, differential elevon deflection and roll rate began an oscillatory increase at 2.5 Hz. At approximately 13 seconds, rudder actuator stall occurred and differential elevon and roll rate increased dramatically. At approximately 13.5 seconds the starboard elevon departed from the vehicle.

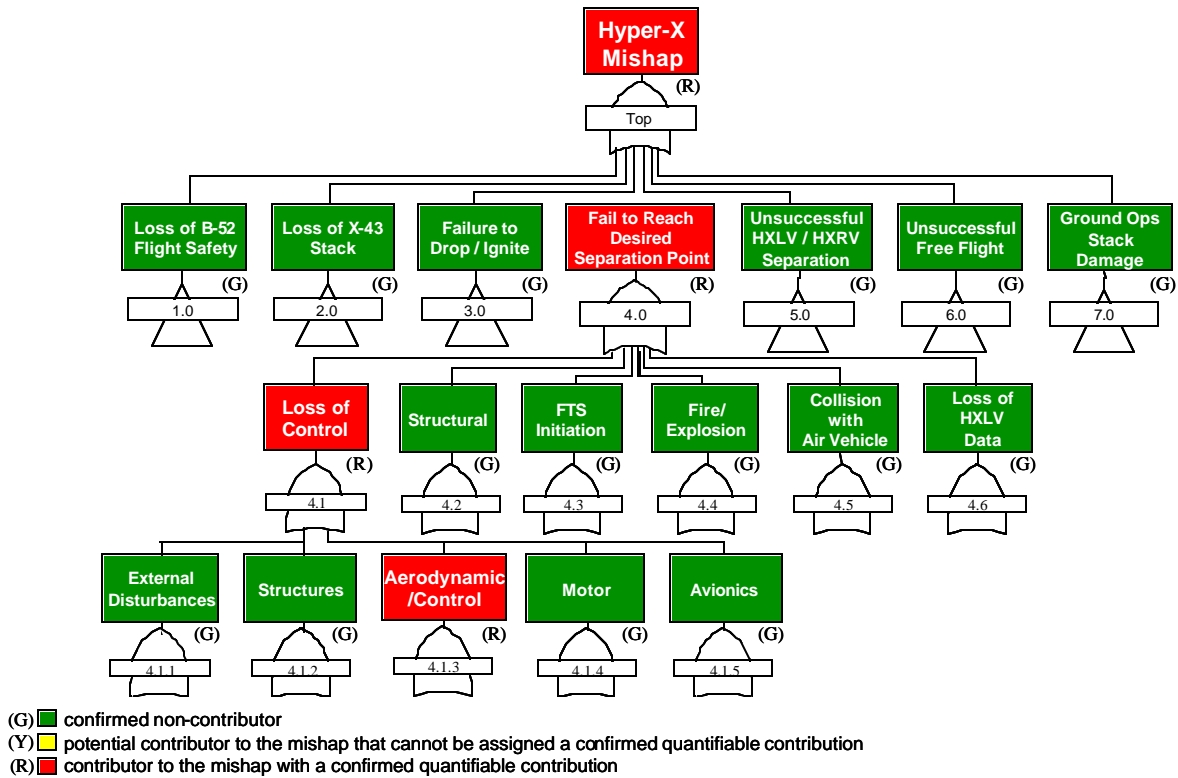
Figure 8-2. Top Level Fault Tree

The top level fault tree developed for the X-43A mishap is shown in Figure 8-2. A total of 613 faults were evaluated. Of these, eleven were determined to be direct contributors to the mishap and three were determined to be potential contributors. The entire fault tree used in this investigation is shown in Volume II Appendix A.
