Condition Assessment and Rehabilitation Plan Hangar One

for NASA Headquarters and
Ames Research Center, California

Volume 1
Condition Assessment

1.0 Executive Summary – Condition Assessment and Rehabilitation Plan

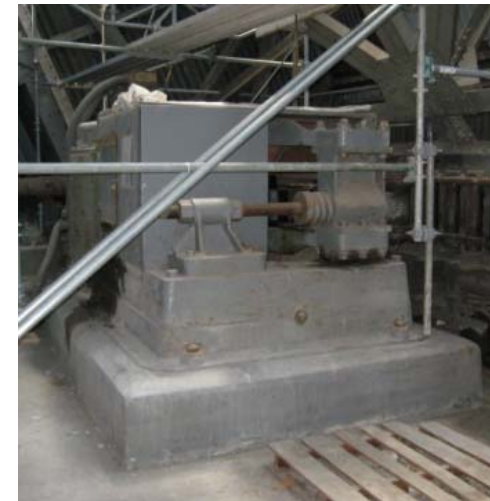
Figure 2.12

There are four individual motors that operate the hangar doors – one motor for each door leaf. The south hangar doors were last known to be operational in 2001 according to the Page & Turnbull Condition Matrix (see Appendix B) but have not been operated since. Additionally, at this time only three of the four motors are known to be operational. The non-working motor is located on the north hangar door. The last known operational date for the north hangar doors is not known. Each motor is located on top of a concrete curb, inside the hangar. They are located on either side of the hangar door openings. Of the three remaining operational hangar door motors it is expected that each will require maintenance and cleaning in order to become fully functional in the future. The missing motor will need to be replaced, or located, refurbished, and re-installed.

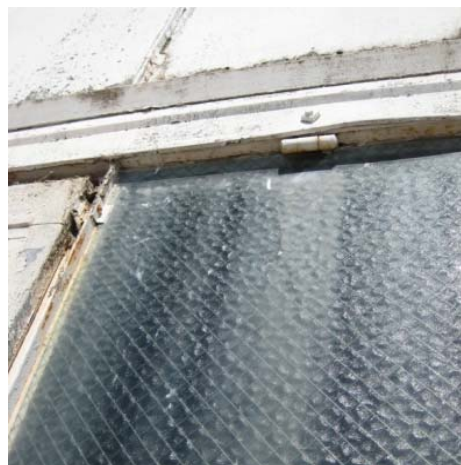
Figure 2.19

The existing windows are mostly intact but are in fairly poor condition. Many of the lowest sets of windows are damaged and have been broken over time. The corrugated glass is also cracked and broken in many places. It was the original intent to salvage and re-install the windows as part of the rehabilitation of the hangar. However, the full extent of window damage is too great to support salvage and repair of the existing window systems (frames and glazing). Therefore, the Rehabilitation Plan calls for all windows and frames to be replaced as part of the rehabilitation process.

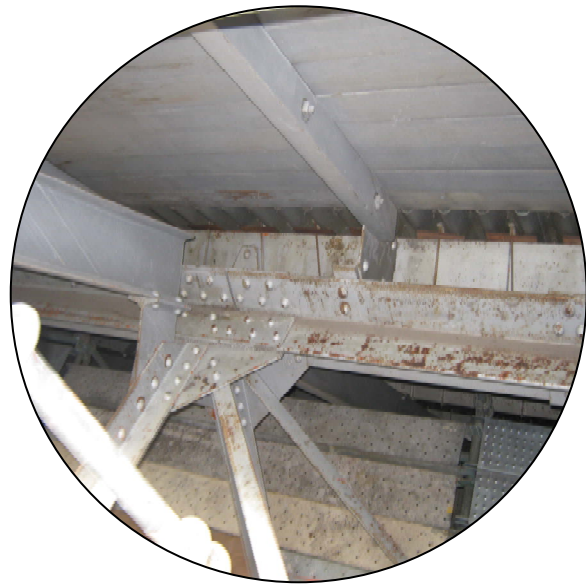
Figure 3-14: Corrosion at Gabled Frame Framing Below Window.

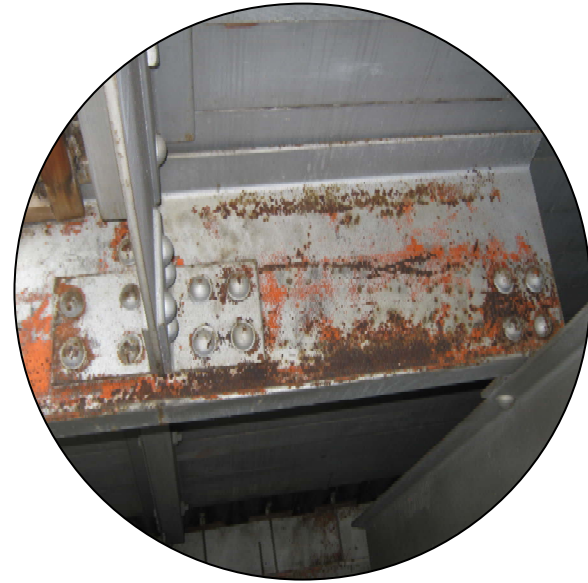
Figure 3-15: Corrosion at Wind Girt Below Window

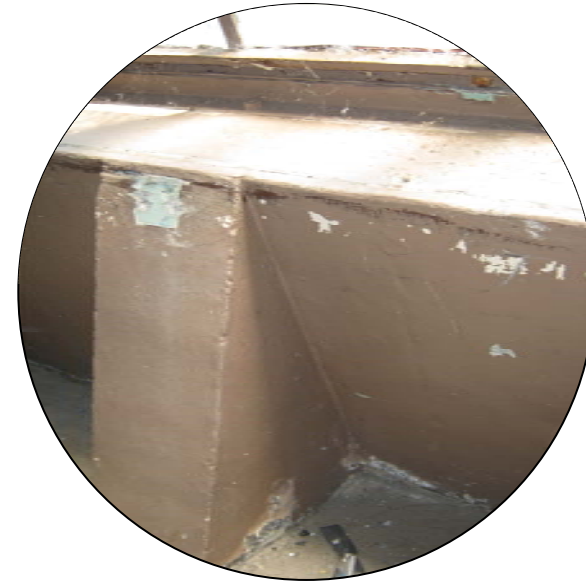
Figure 3-16: Concrete Wall at Hangar Perimeter, From Inside

The concrete perimeter walls also appear to be in good condition. No concrete decay was noted during the site visit. The new doors in the hangar wall were saw cut through the concrete. The saw cut portion may need to be replaced for historical reasons.

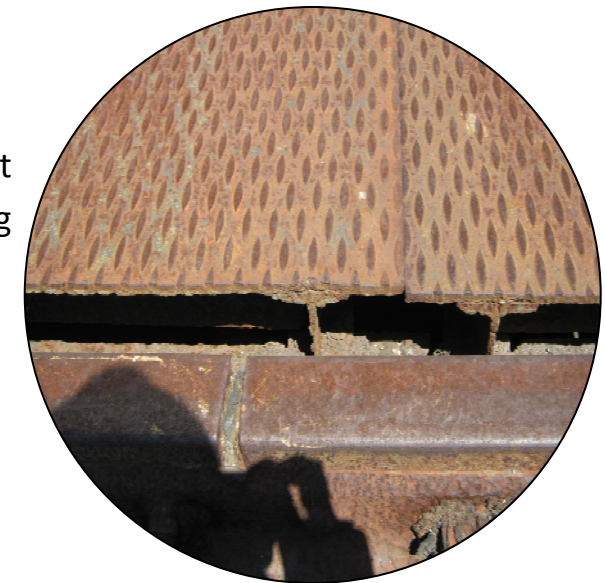
Figure 3-28: Repair Pit at Hangar Exterior Showing Corrosion
