# Space Shuttle External Tank ET-120, STS-120

ET-120, which will fly on the STS-120 mission, was the first Return to Flight tank — the first

# NASAfacts

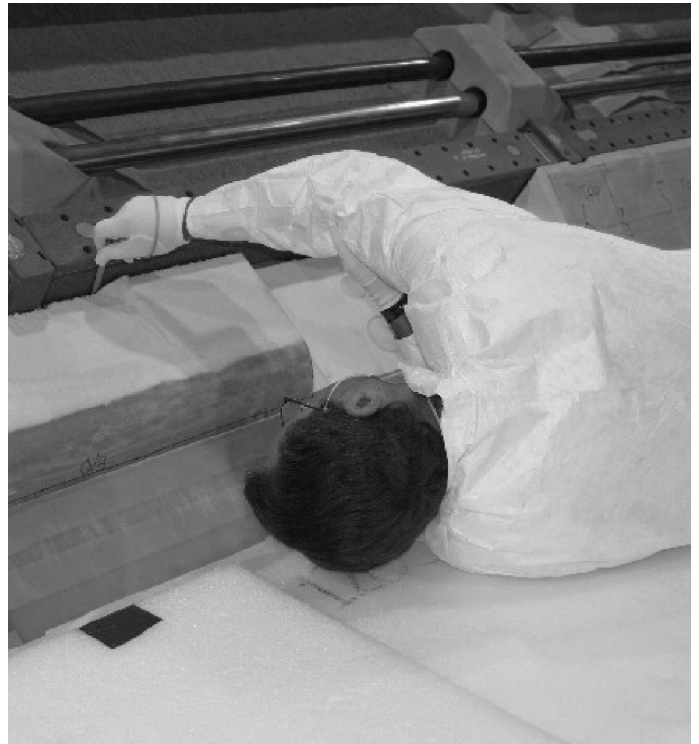
**A technician measures foam prior to removing it from ET-120's liquid hydrogen tank protuberance airloads (PAL) ramp in November 2005. Following STS-114, studies and testing determined that both the liquid oxygen and the liquid hydrogen PAL ramps could be removed from the external tank to minimize potential foam loss. The two PAL ramps, made entirely of foam, weighed almost 37 pounds. ET-119 was the first tank to fly without PAL ramps. (Photo credit: Lockheed Martin)**

- Liquid Oxygen and Liquid Hydrogen PAL Ramps have been removed.
- Bipod Harness Modifications — Wire harness sealing/ bonding, flown as a Return to Flight modification on ET-119/STS-121 (second RTF flight), was performed to preclude a debris event similar to the one observed on STS-114. Voids within cabling and underneath the harnesses have the potential to cause cryoingestion and cryopumping failure. A process was developed to seal cables and bond harnesses with minimal defects.

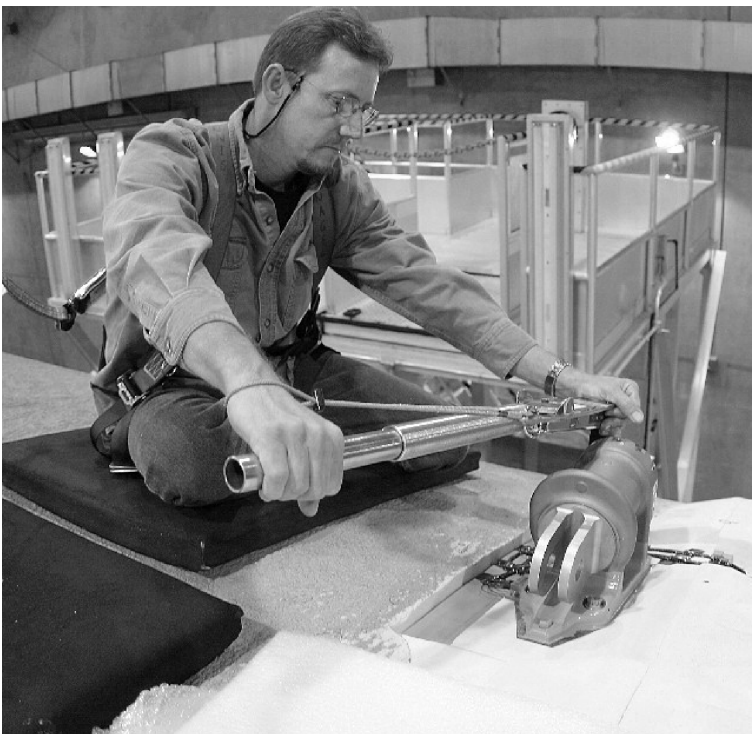
**A technician torques bolt fasteners on the redesigned -Y bipod fitting on ET-120 at NASA's Michoud Assembly Facility in New Orleans in November 2004. The bipod redesign was one of the Return to Flight changes to the external tank to minimize potential debris by eliminating the large insulating foam covering the bipod area in favor of electric heaters. (Photo credit: Lockheed Martin)**

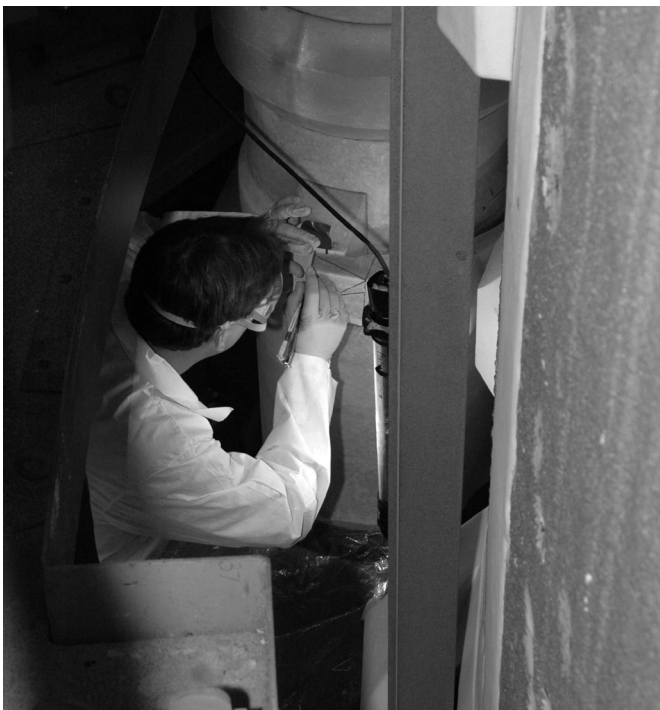
A technician at the Kennedy Space Center maps out the cutting area of the liquid oxygen (LO2) feedline bracket where foam insulation and super lightweight ablator, or SLA, cork insulation were removed. Foam insulation was then reapplied without the SLA. (Photo credit: NASA/KSC)

- The Liquid Oxygen Feedline Brackets — As an interim measure before the new titanium bracket design flies on ET-128, four feedline brackets (stations 1129, 1623, 1377, and 1871) have been modified with a different foam configuration. BX foam and SLA were removed from the upper portion of the four brackets and resprayed with BX foam only and restored to approximately the original mold line. Bracket BX foam is about one-inch thick and the underlying SLA is about one-half-inch thick, but the SLA is denser, or heavier than the BX foam. Approximately five inches of TPS has been removed — about .12 pounds of TPS mass each bracket. Less foam on the brackets is acceptable for the shuttle's ascent; it is now known that SLA is not required on the brackets.

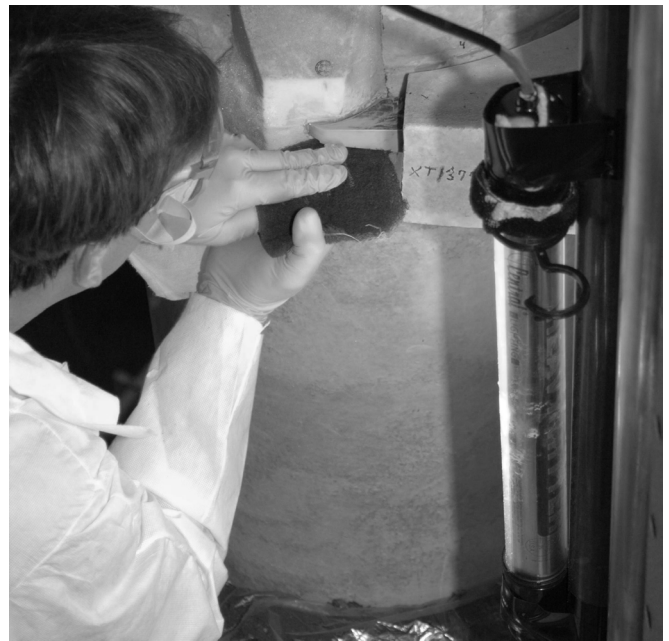
As an interim measure before the new titanium liquid oxygen (LO2) feedline bracket redesign flies on ET-128, four feedline brackets (stations 1129, 1623, 1377, and 1871) on ET-120 were modified with a different foam configuration at the Kennedy Space Center. (Photo credit: NASA/KSC)
