International Space Station (ISS) EVA Suit Water Intrusion

High Visibility Close Call

IRIS Case Number: S-2013-199-00005

Date of Mishap: July 16, 2013

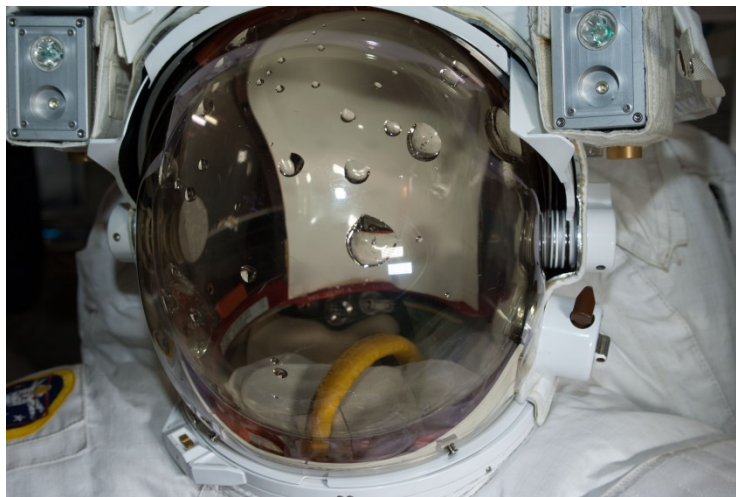
Figure 1-1. Extravehicular Mobility Unit (EMU) With Water in Helmet During Post-EVA 23 Screening Test

In summary, the causes for this mishap evolved from (1) inorganic materials causing blockage of the drum holes in the EMU water separator resulting in water spilling into the vent loop; (2) the NASA team's lack of knowledge regarding this particular failure mode; and (3) misdiagnosis of this suit failure when it initially occurred on EVA 22.

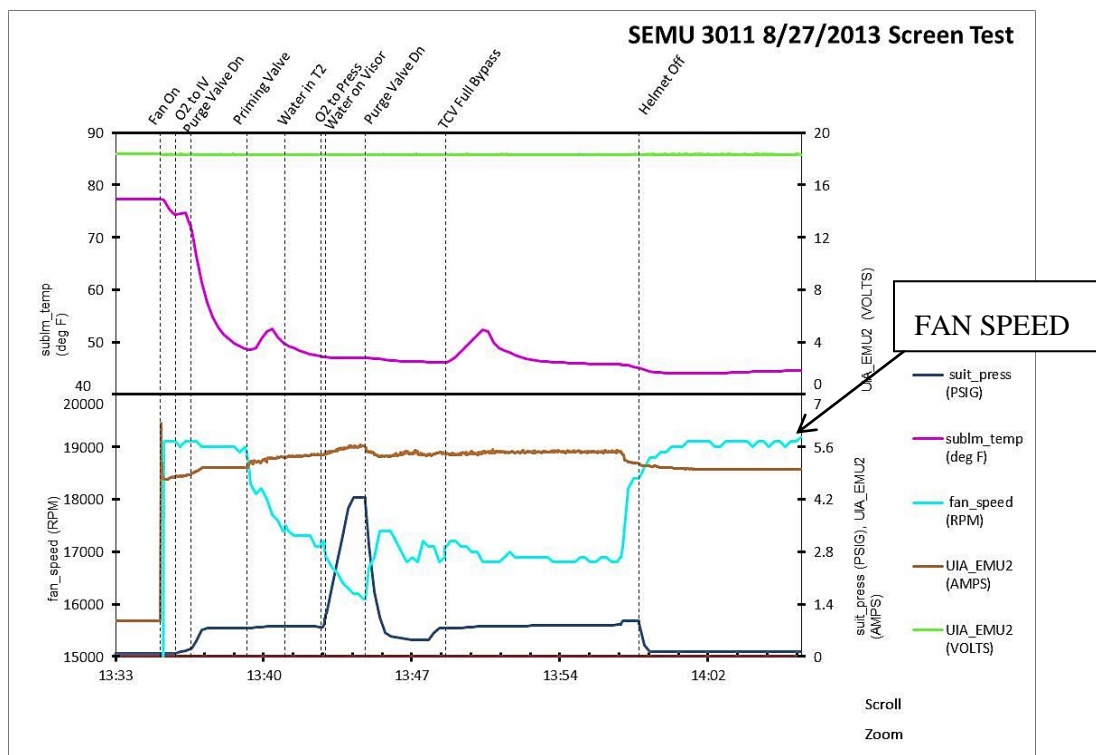
Figure 3-23. EMU 3011 Screening Test Data

Accordingly, on 8-27-13, a screening testing similar to that carried out on EMU’s 3005 and 3010 was performed. A chart of results is presented as Figure 3-23.

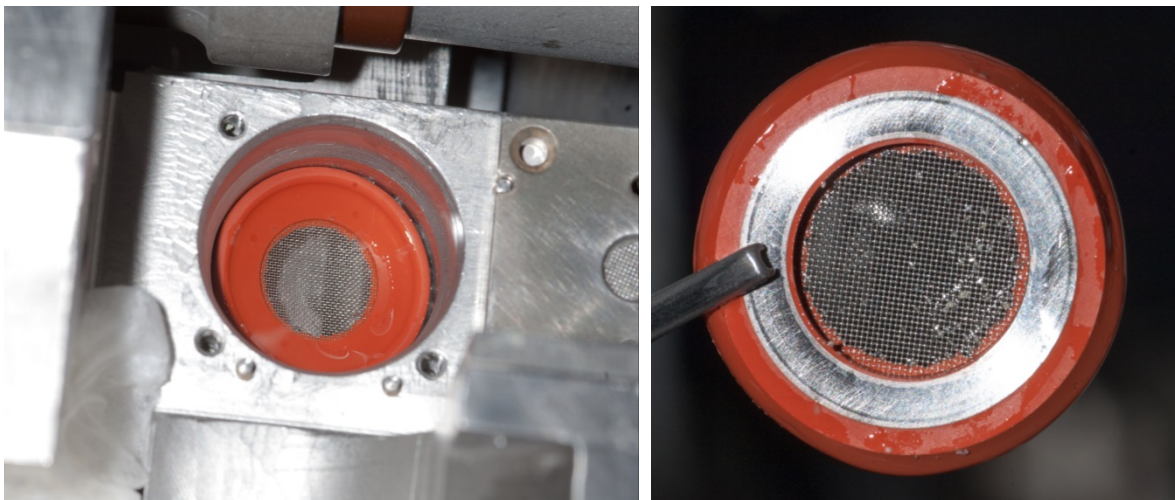
Figure 3-24. Item 134 Valve and Filter from EMU 3011 Post-Anomaly

Detailed procedures for on-orbit removal and replacement of the Item 134 valve and filter had been developed by NASA and ground processing contractor Stinger Ghaffarian Technologies (SGT). Engineering and technician personnel working at the SGT facility in Houston coordinated with UTAS in Windsor Locks, CT. Along with the replacement Item 134 valve and filter, special tools had been placed aboard Progress flight 52P, and received aboard the ISS. On 8-31-13, the Item 134 valve and filter were removed. The condition of the filter is shown in Figure 3-24. As may be seen in the photo, small amounts of gray and white material are present, but not in sufficient quantities to block flow and cause the leakage into the suit loop. (A discussion of the makeup of the contamination found in these items is presented in Section 3.5.7 below.)

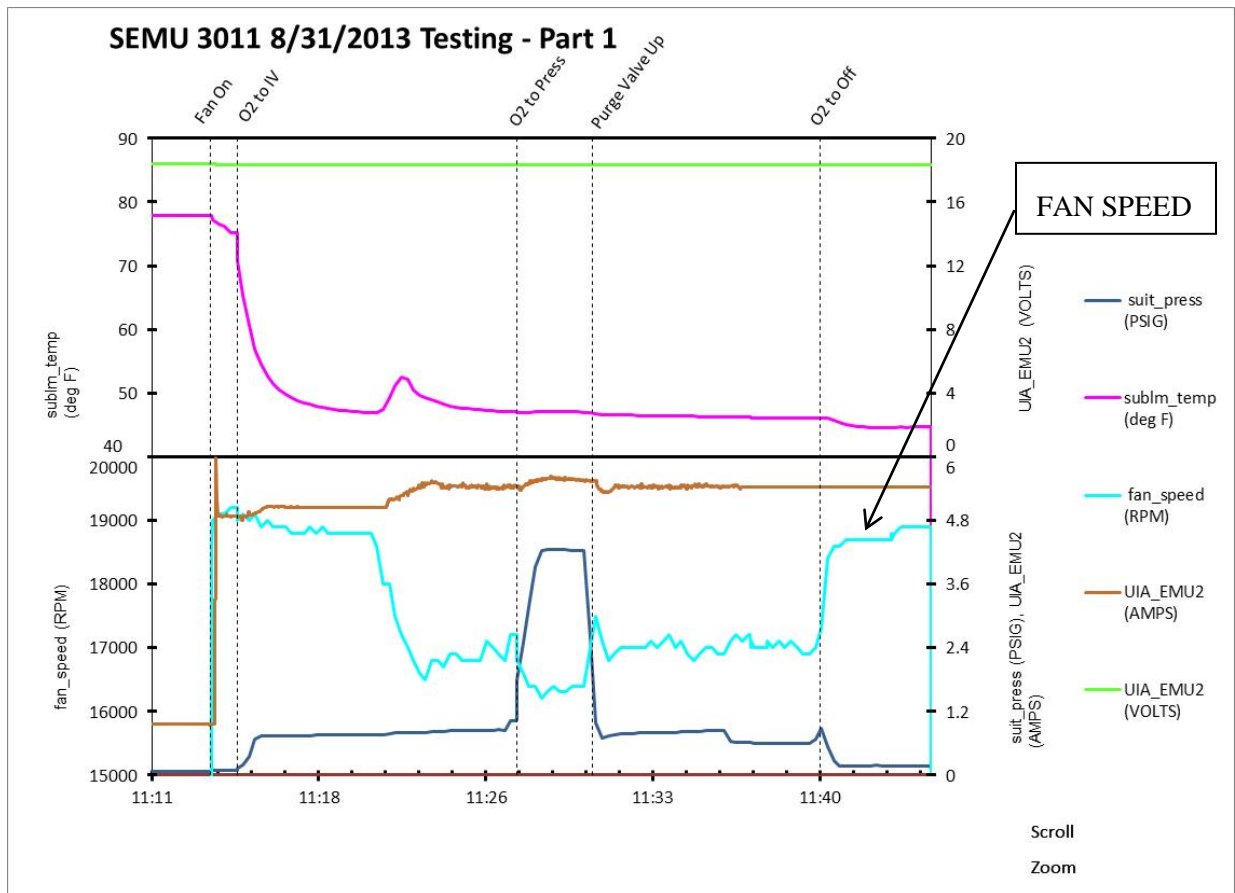
Figure 3-25. EMU 3011 Screening Test Data Post I-134 R&R

Following replacement of the valve and filter with the new items, a repeat of the screening test was performed, and results are shown in Figure 3-25. Although specific annotation is lacking, it has been verified that the Item 125 pump priming valve was manually actuated at about 11:20, and from there forward, the fan speed trace is similar to that produced in the preceding test, indicating that the problem still existed.

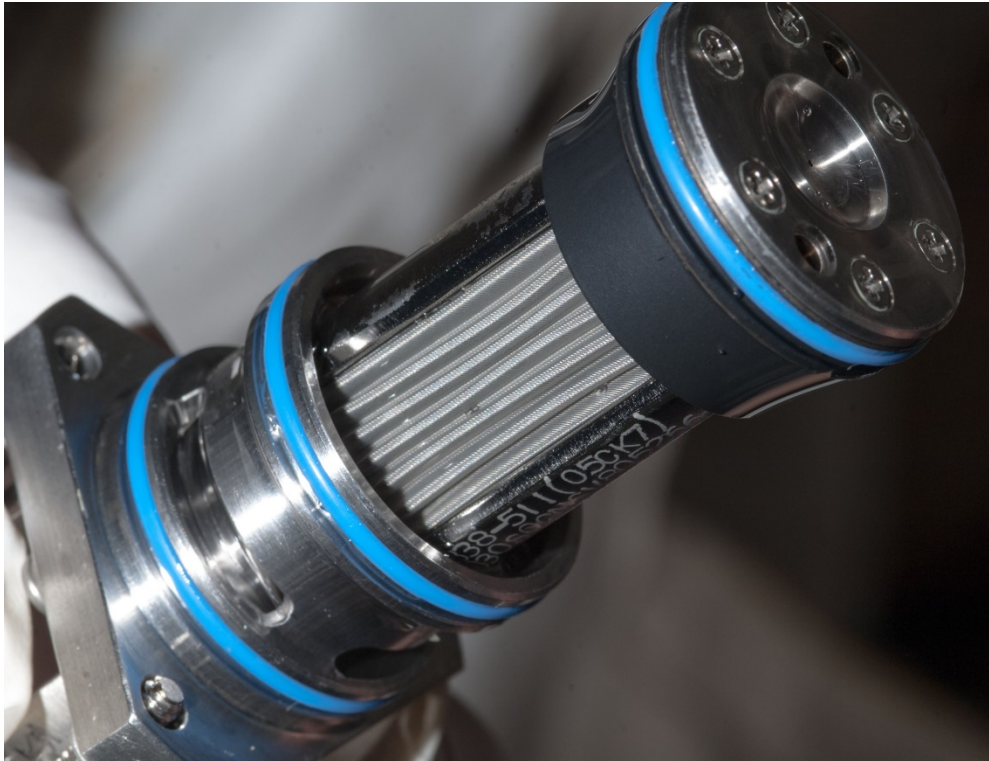
Figure 3-26. Item 141 Gas Trap from EMU 3011 Post-Anomaly

The next step taken was the removal and replacement of the Item 141 gas trap cartridge. This item is meant to be replaced on-orbit, so no special procedure development was required. Rationale for removal of this item for return to earth was based on two desires: first and foremost to capture any water residing in the filter for analysis; second, to analyze any residue on the 20 micron filter screen (Figure 3-27). Since a missing or damaged O-ring could cause leakage through the gas trap, the condition of these seals was of interest. Examination of the seals on the gas trap revealed no O-rings missing or damaged (blue O-rings in Figure 3-26).

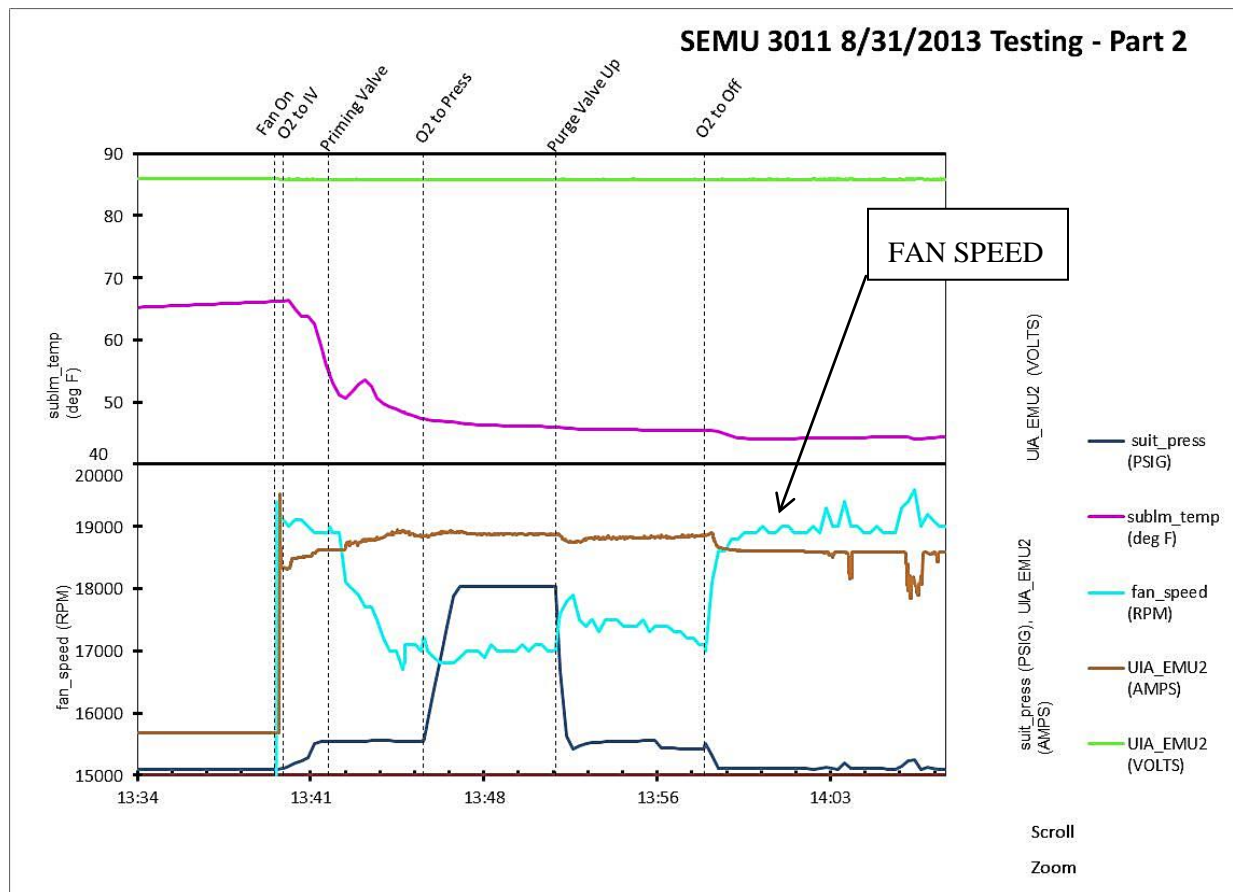
Figure 3-28. EMU 3011 Screening Test Data Post I-141 R&R

Following the replacement of the cartridge, the screening test was repeated, with results as shown in Figure 3-28. Lack of annotation notwithstanding, it may be seen that the results are similar to the other two tests. Thus, the gas trap was removed from consideration as a cause or contributor to the leakage condition.

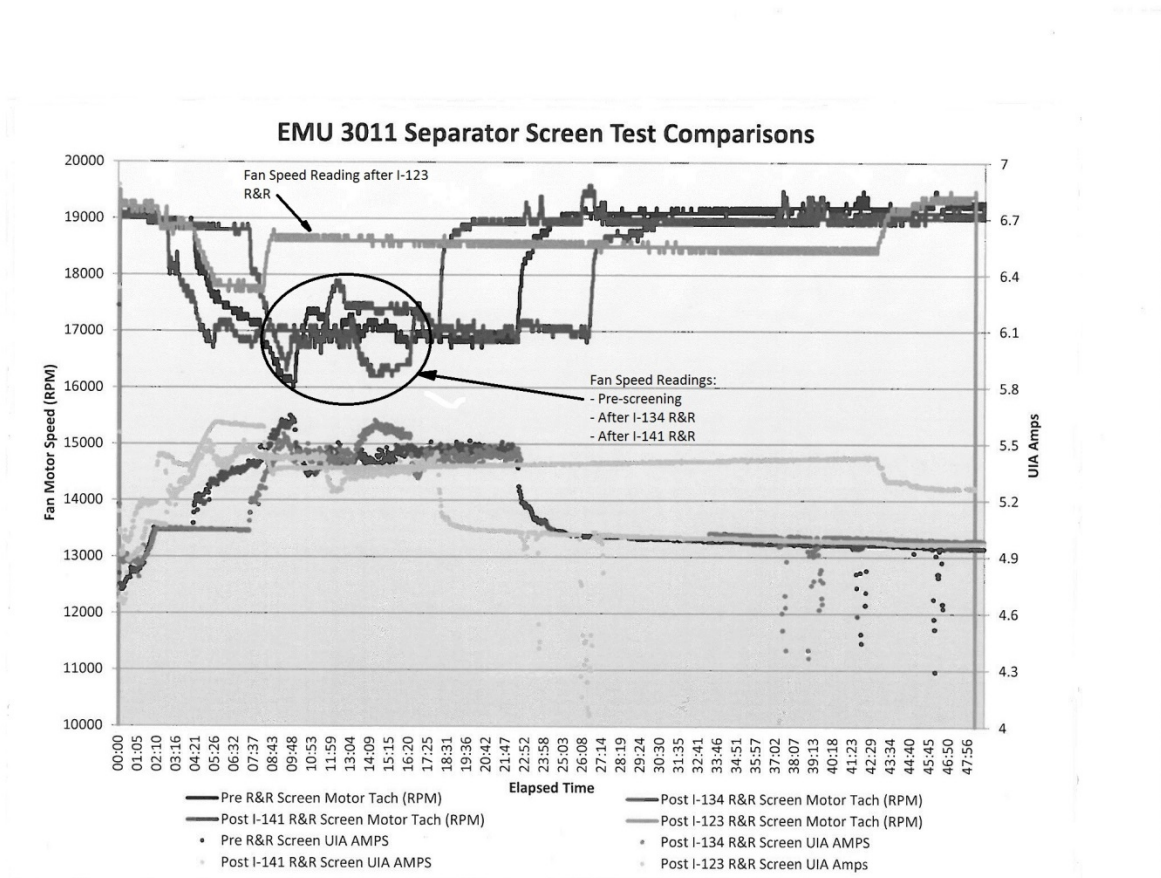
Figure 3-34. Comparison of Fan Motor Speed and UIA Current Before and After I-134, I-141, and I-123 Replacement

The conclusion drawn was that the leakage problem encountered during EVA 23 was caused by a failure condition residing somewhere in the FPS water separator components. Figure 3-34 presents a comparison of fan speed before any of the replacement activities, and after the I-134, I-141 and I-123 replacements. This figure graphically illustrates the effect of water carryover on fan speed. The constant fan speed observed after the I-123 R&R is in stark contrast to the decrease in speed experienced while the failure condition was still present.
