REPORT OF APOLLO 13 REVIEW BOARD

NATIONAL AERONAUTICS AND SPACE ADMINISTRATION

APOLLO 13 REVIEW BOARD

June 15, 1970

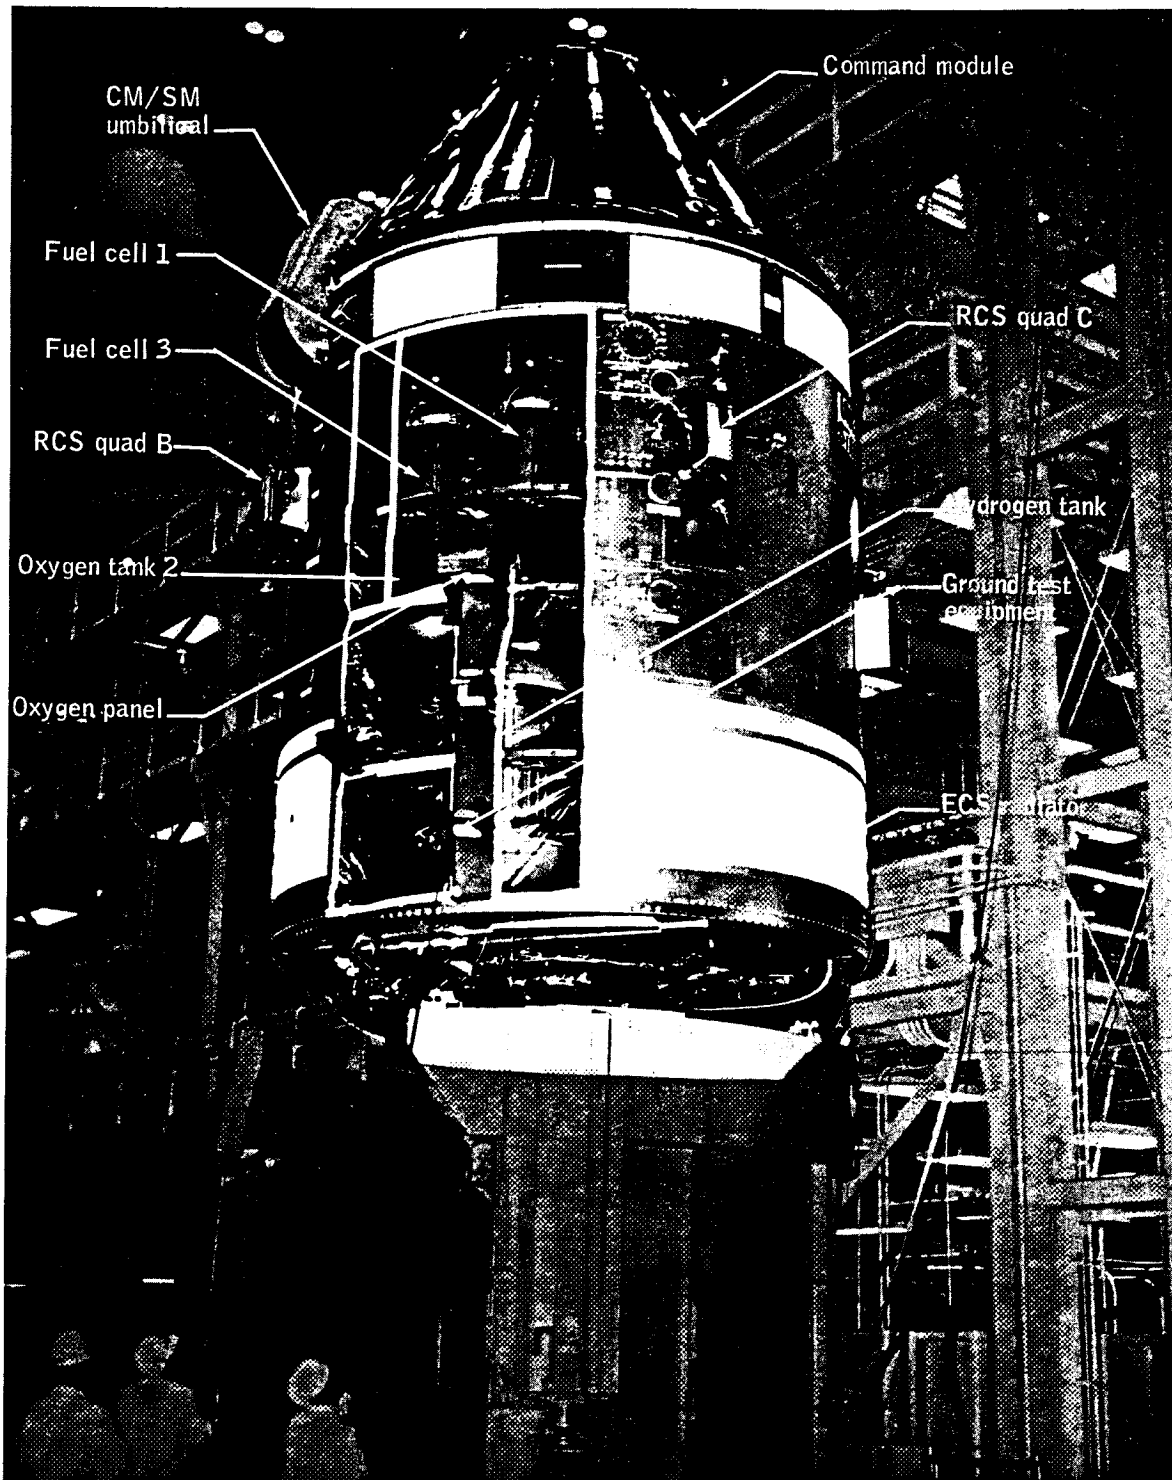
CSM in ground test with bay 4 panel removed.

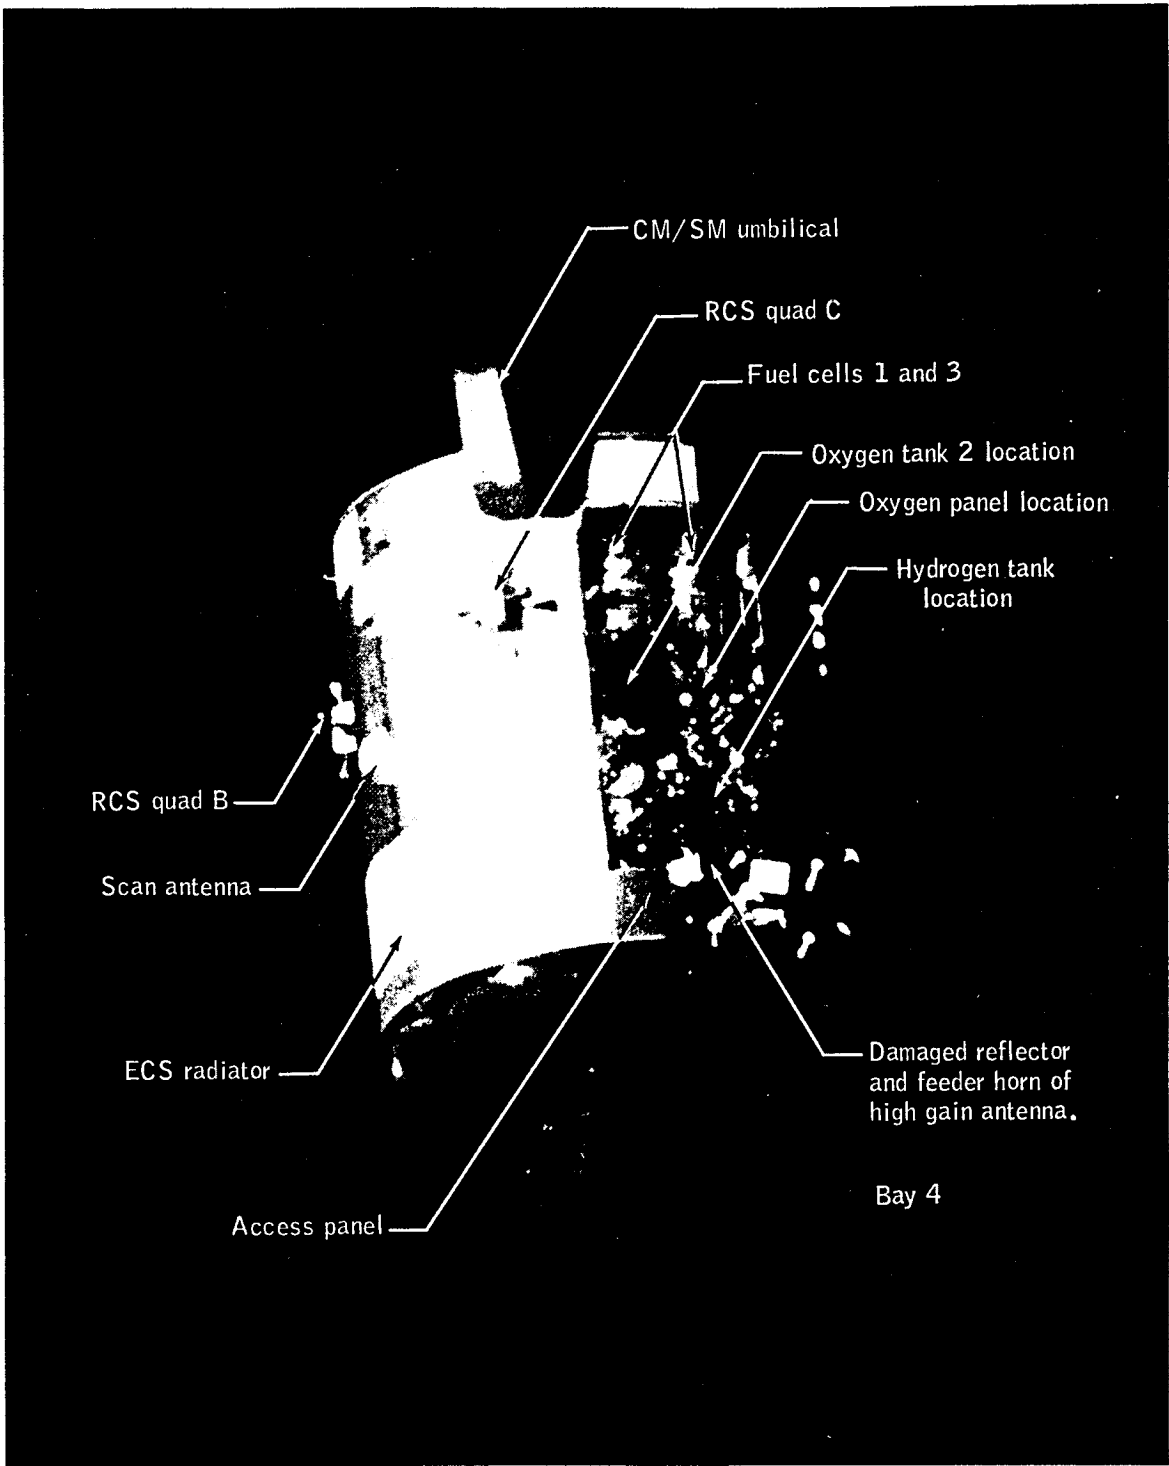
Inflight photograph of service module showing damage to bay 4.

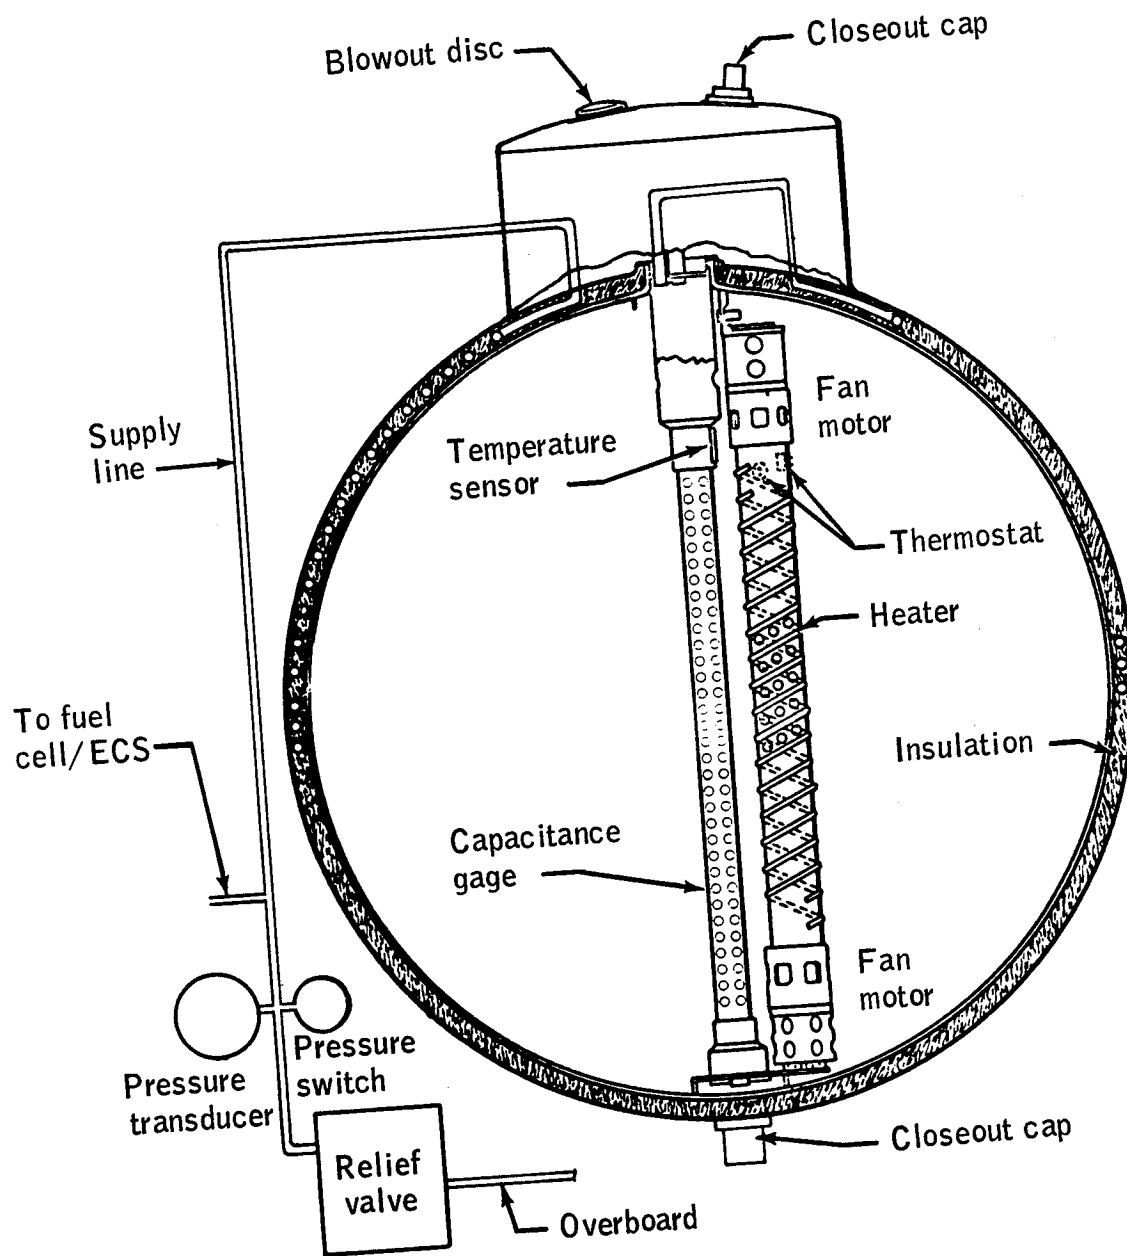
Figure 4-1.- Oxygen tank no. 2 internal components.

The supply line from the tank leads from the head of the quantity probe to the dome and thence, after passing around the tank between the inner and outer shells, exits through the dome to supply oxygen to the fuel cells in the service module (SM) and the environmental control system (ECS) in the command module (CM). The supply line also connects

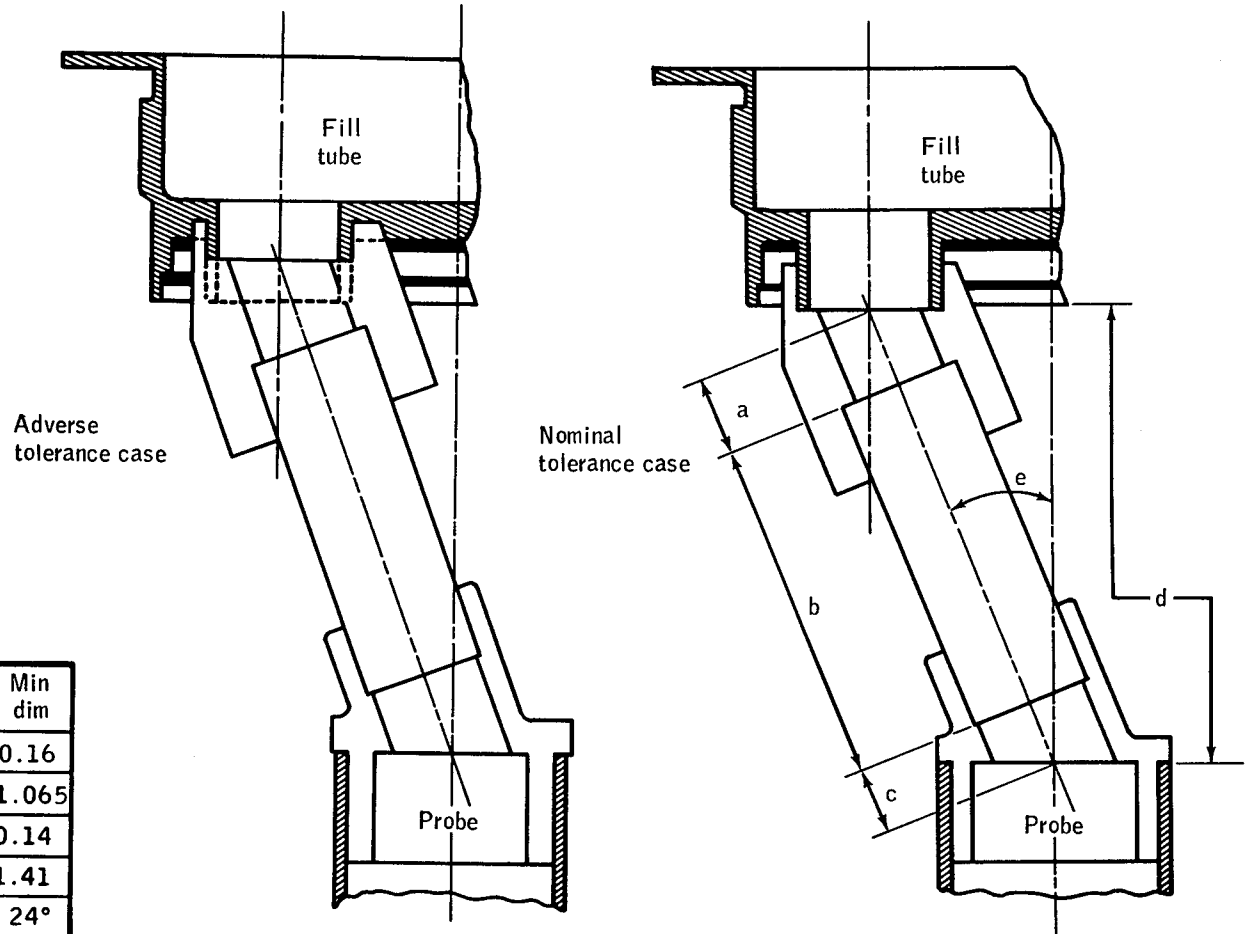
Figure 4-3.- Nominal and adverse tolerance cases.

Part	Max dim	Nom dim	Min dim
a *	0.28	0.24	0.16
b	1.095	1.080	1.065
c	0.26	0.20	0.14
d	1.45	1.43	1.41
e	18°	21°	24°
