MSC-00171

APOLLO 11 MISSION REPORT

MANNED SPACECRAFT CENTER
HOUSTON, TEXAS
NOVEMBER 1969

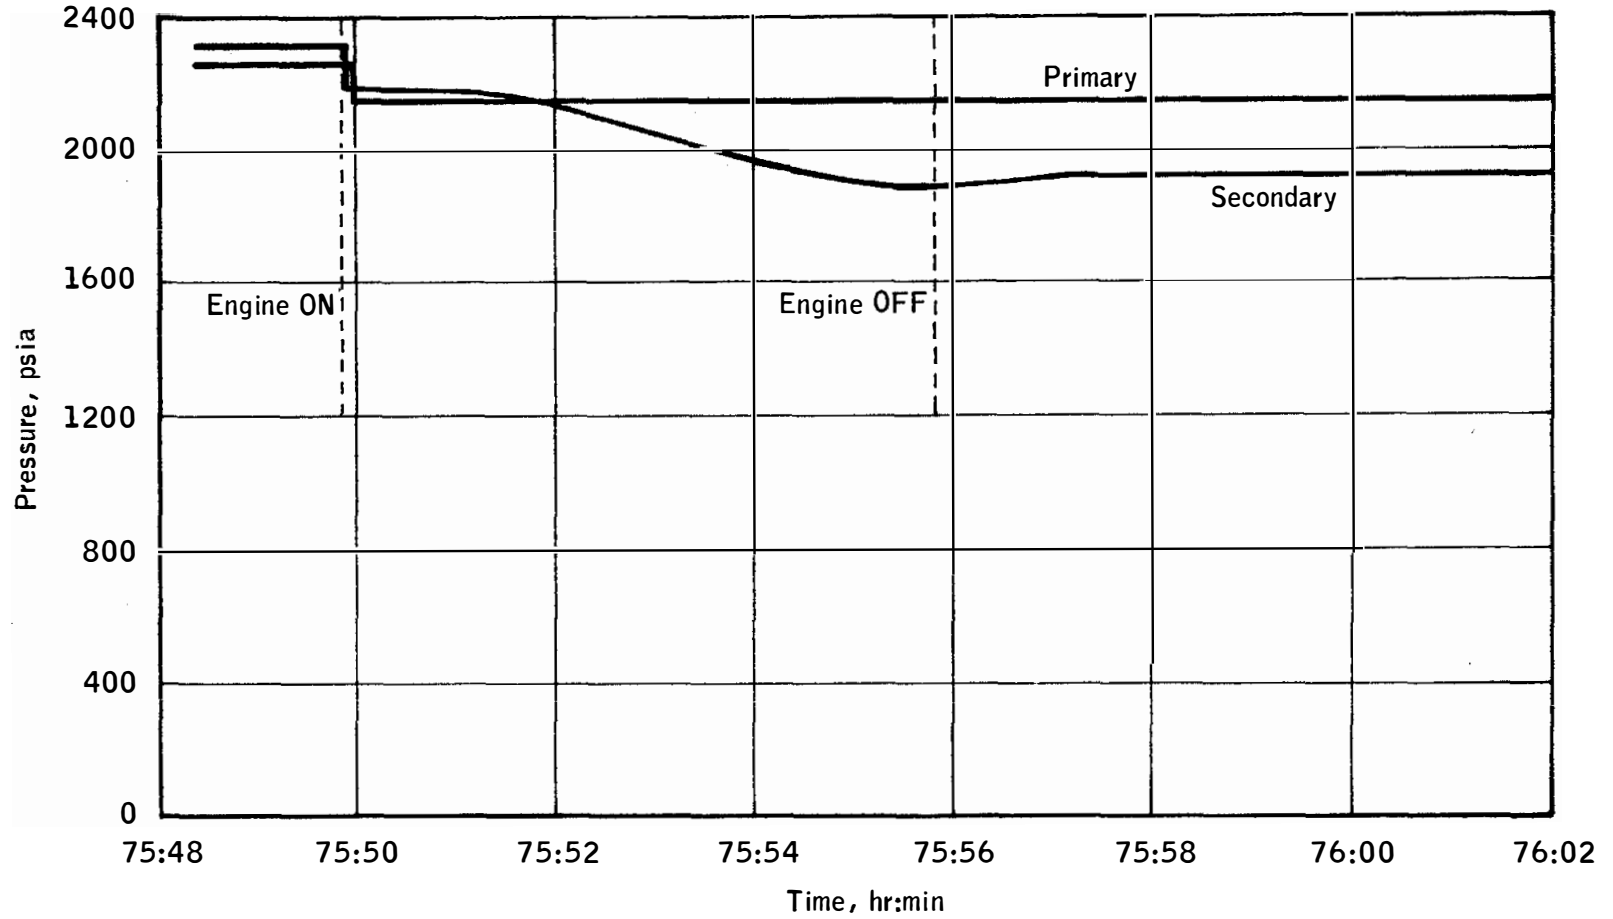
Figure 16-1.- Nitrogen pressure during initial lunar orbit insertion firing.

An abnormal decay in the secondary (system B) nitrogen pressure was observed during the lunar orbit insertion service propulsion firing, indicating a leak in the system which operates the engine upper bipropellant valve bank. No further leakage was indicated during the remainder of the mission. This anomaly is discussed in greater detail in section 16.1.1.
