### **APOLLO SPACECRAFT**

### **TEST IN PROGRESS AT TIME OF ACCIDENT**

Spacecraft 012 was undergoing a "Plugs Out Integrated Test" at the time of the accident on January 27, 1967. Operational Checkout Procedure, designated OCP FO-K-0021-1 applied to this test. Within this report this procedure is often referred to as OCP-0021.

**REPORT  
OF  
APOLLO 204 REVIEW BOARD**

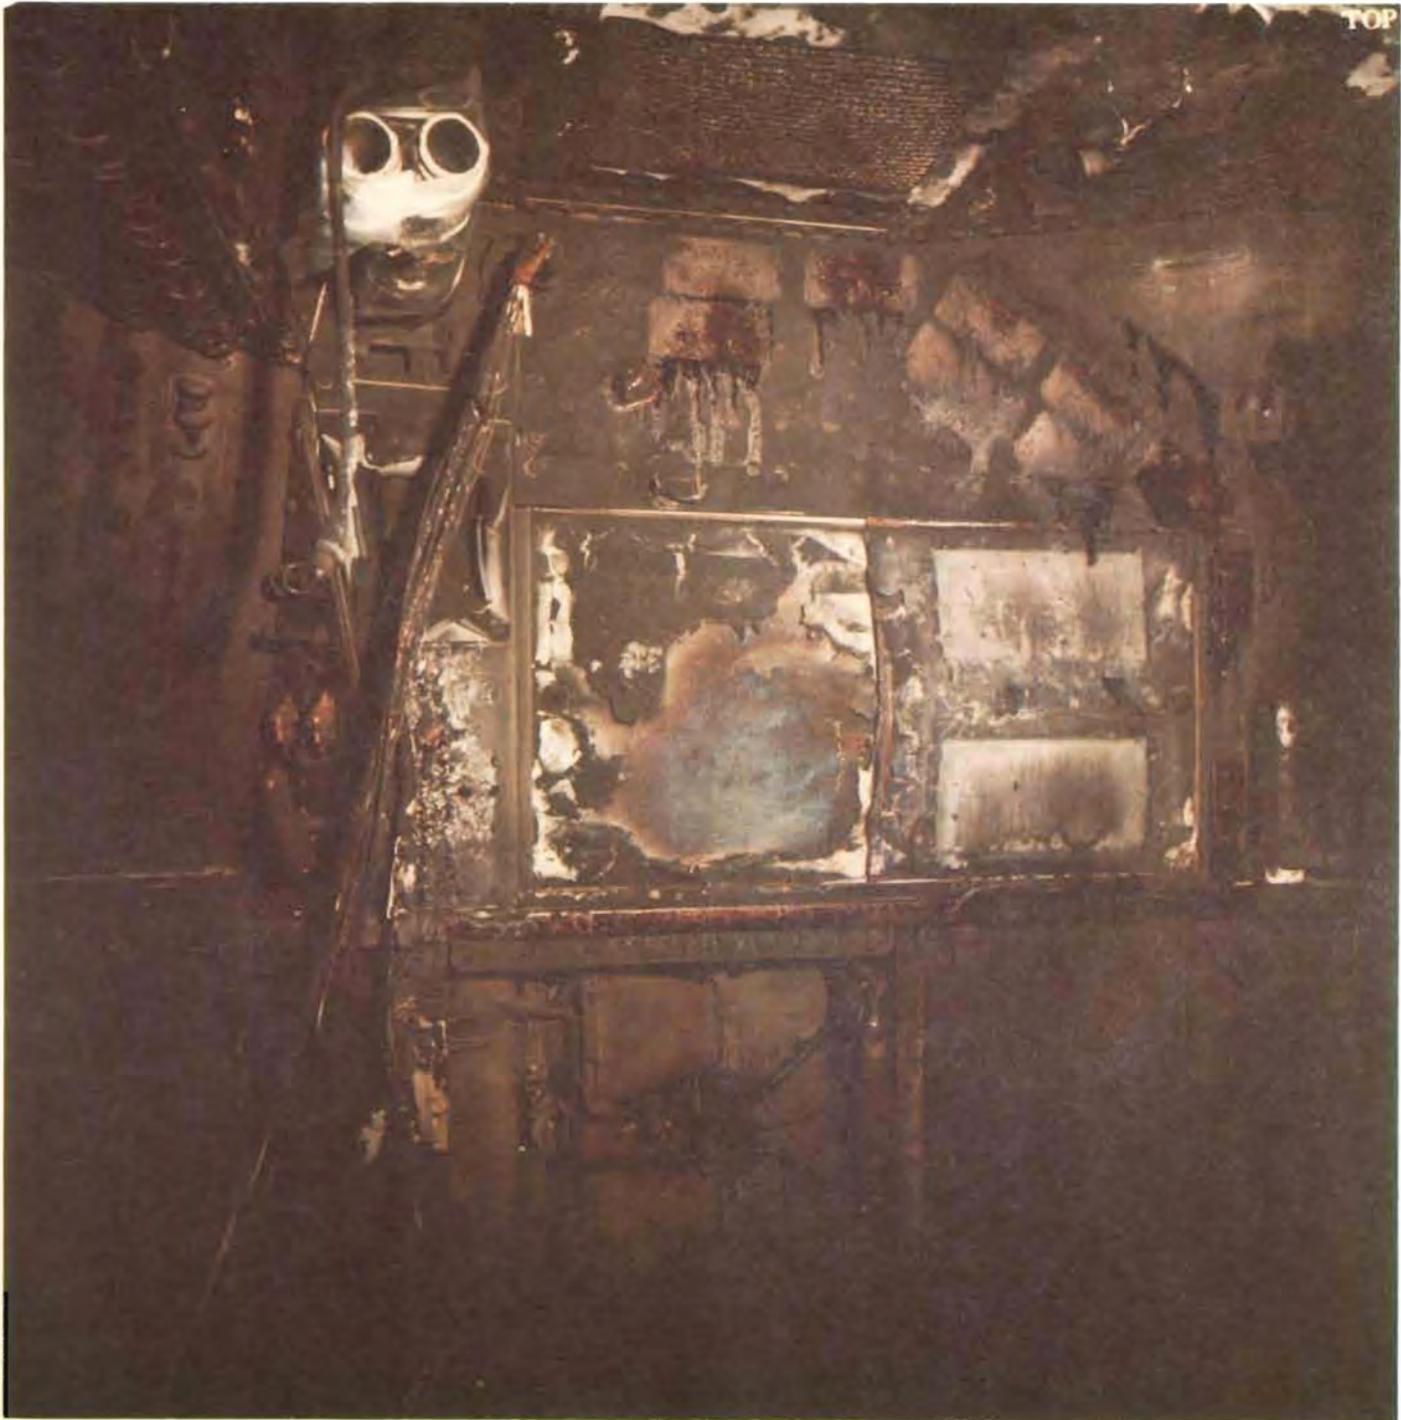
ENCLOSURE V - I

LEFT HAND FORWARD EQUIPMENT BAY

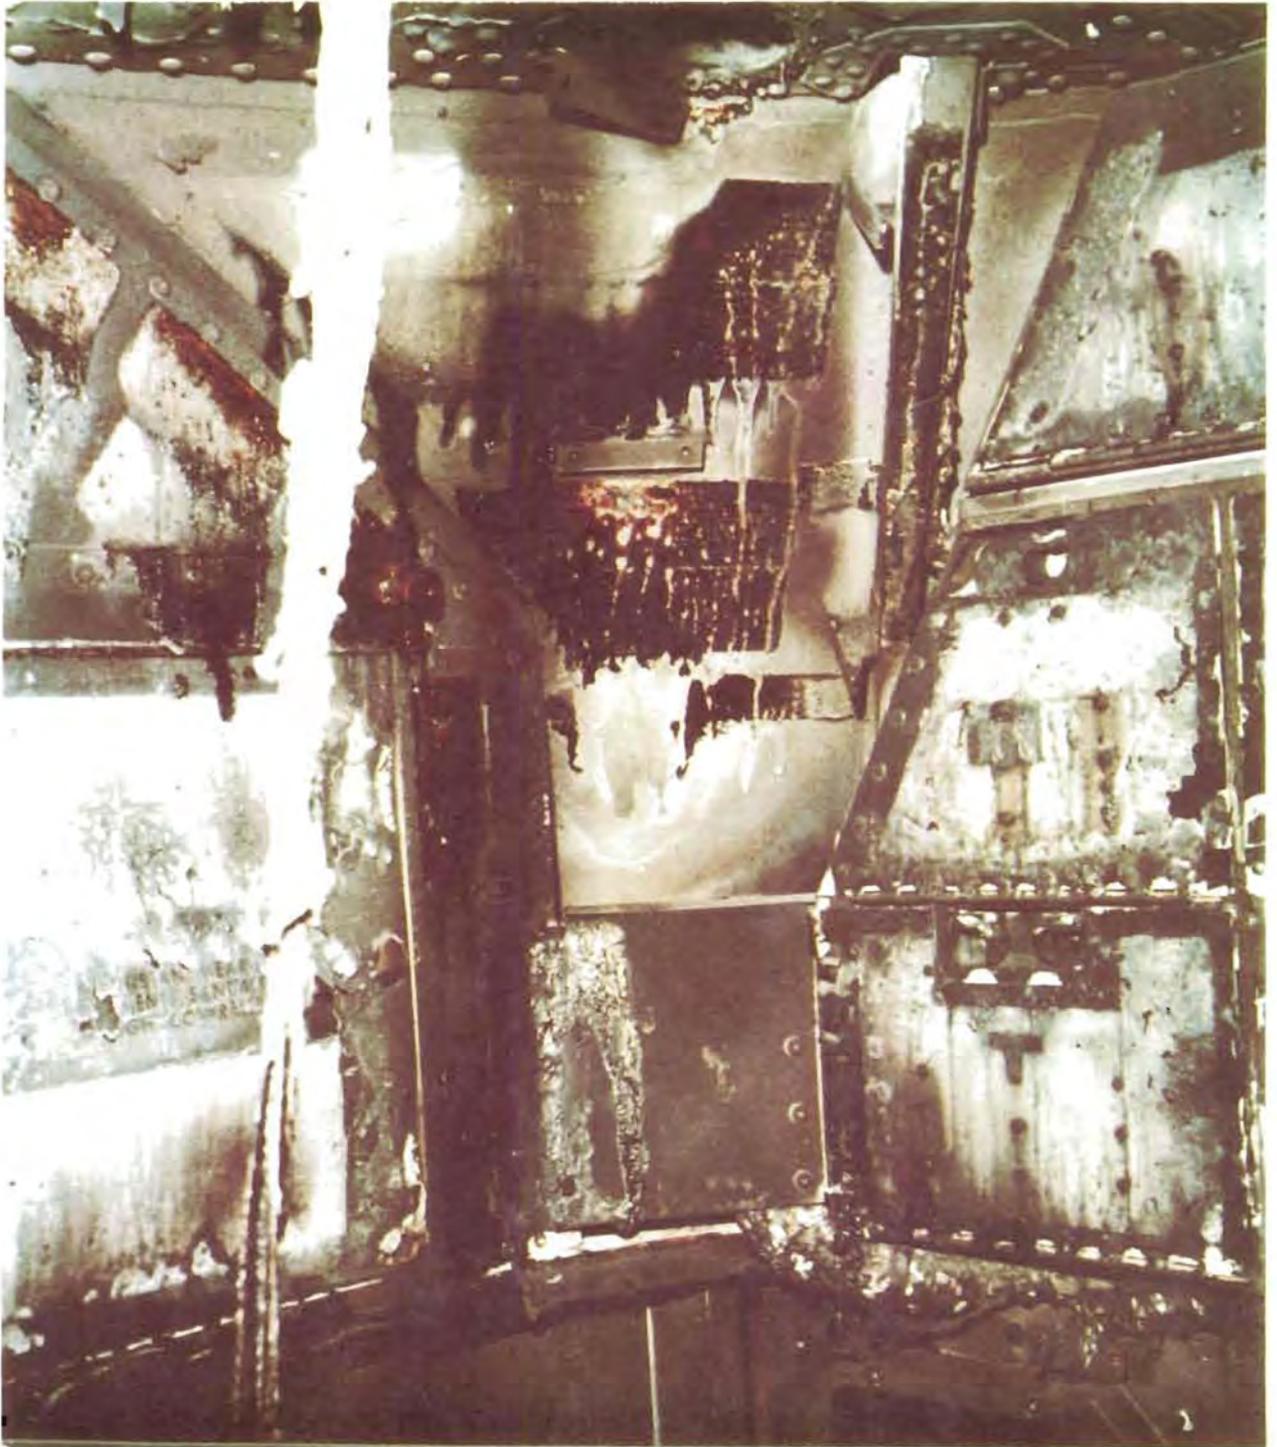
EXTREME UPPER LEFT HAND CORNER BETWEEN LOWER EQUIPMENT BAY  
AND LEFT HAND EQUIPMENT BAY

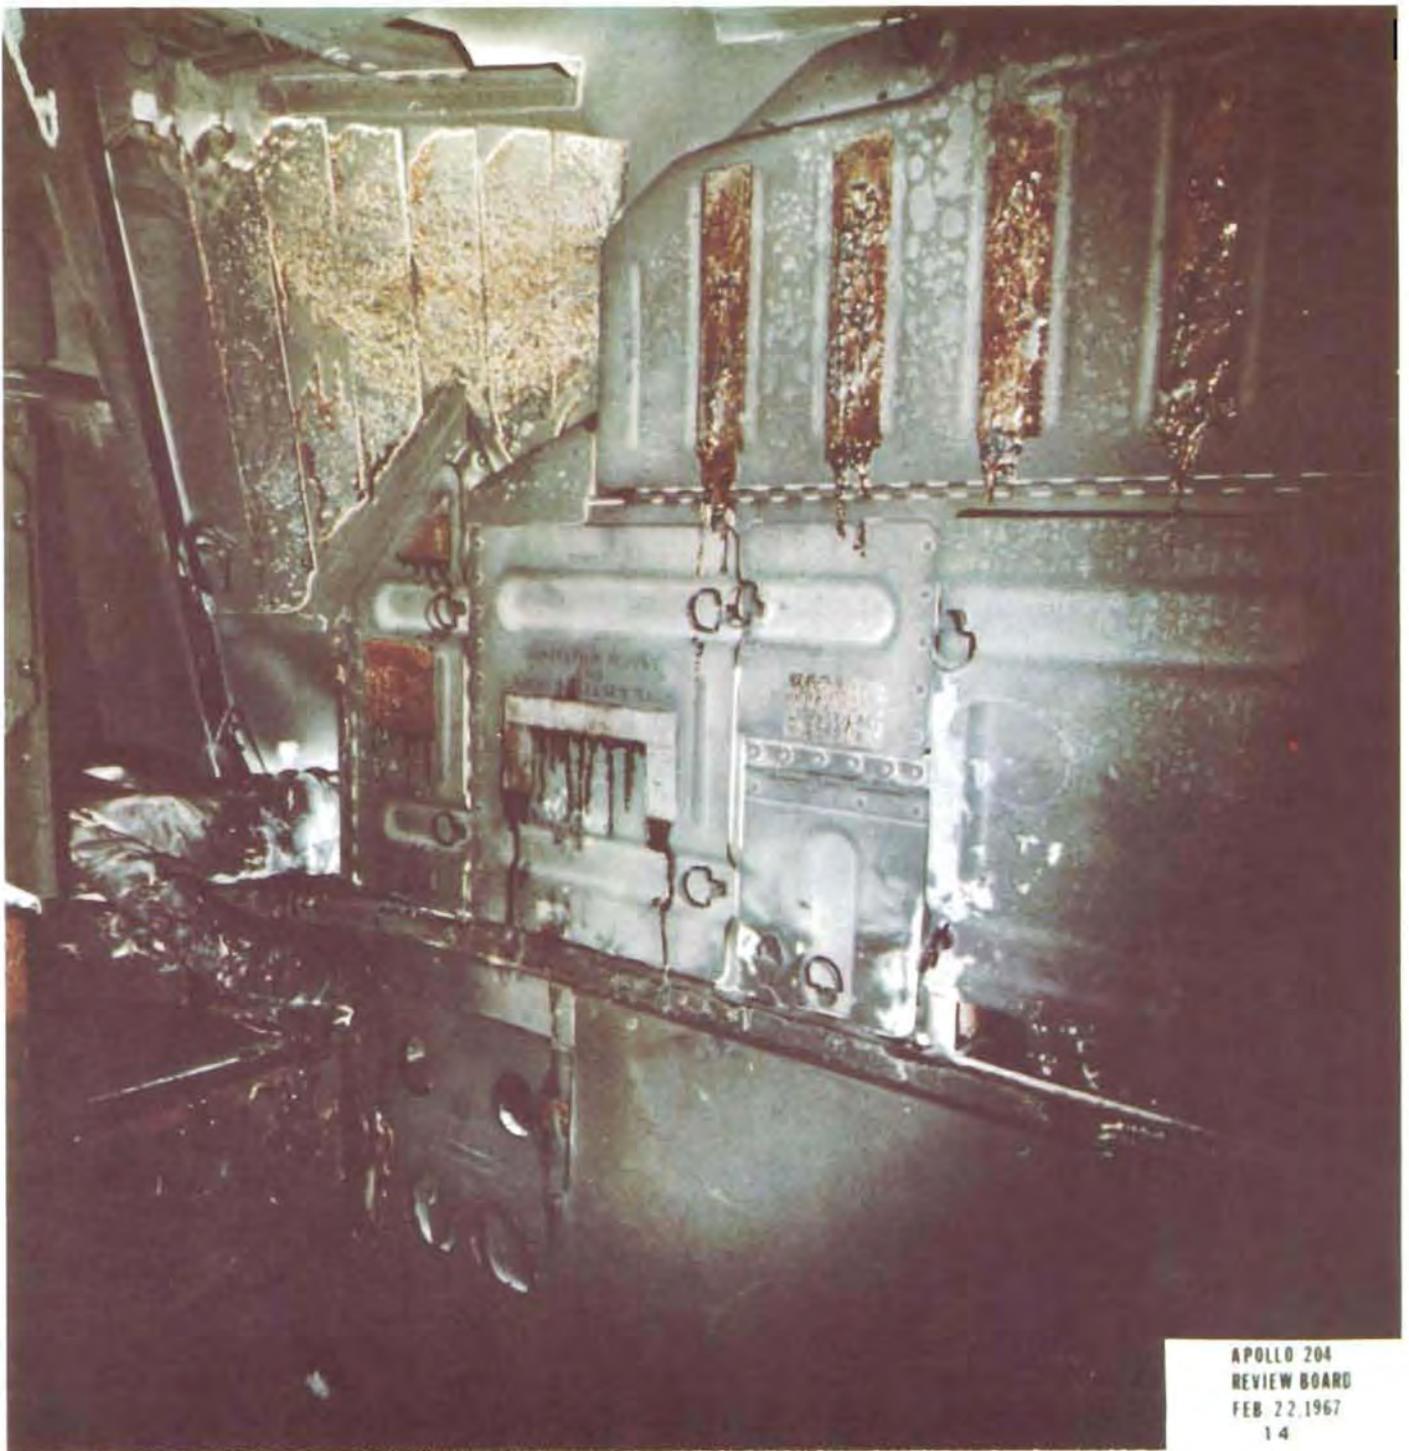
EXTREME RIGHT HAND CORNER ABOVE LOWER EQUIPMENT BAY AND RIGHT HAND EQUIPMENT BAY

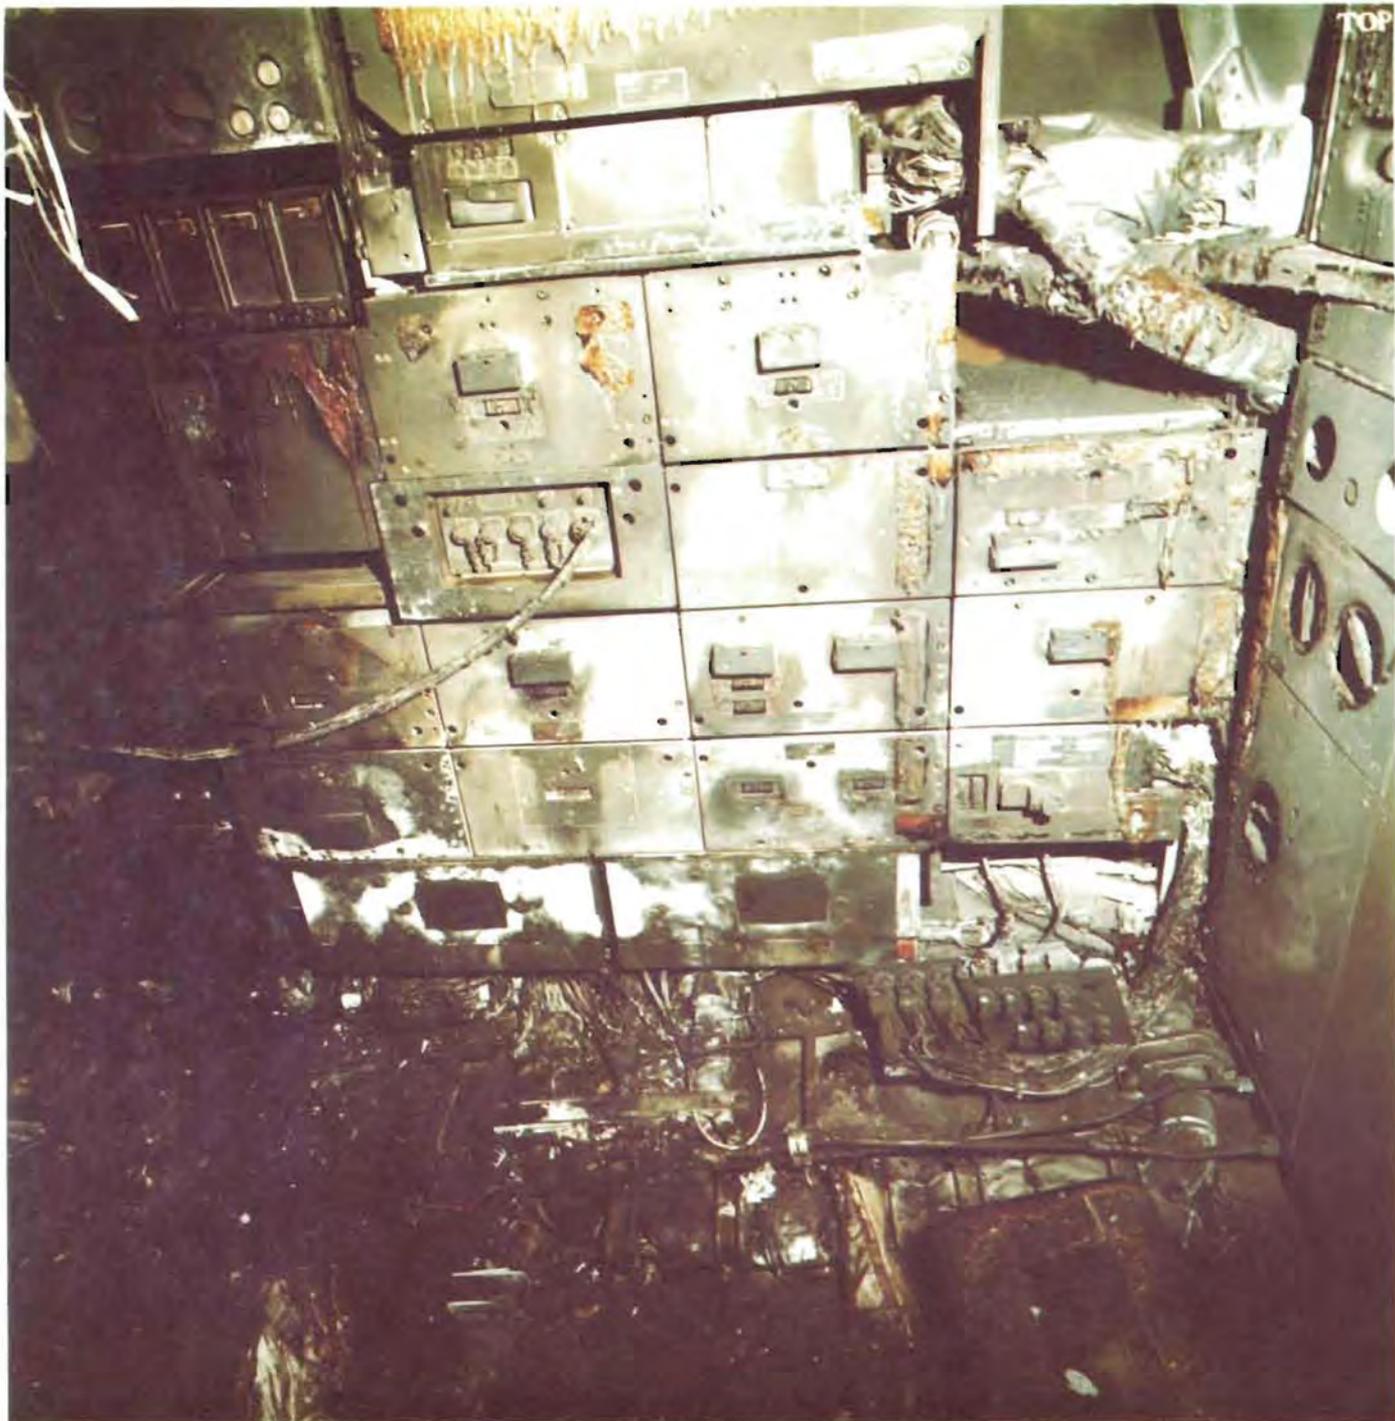
ENCLOSURE V-4

RIGHT HAND SECTION OF LOWER EQUIPMENT BAY

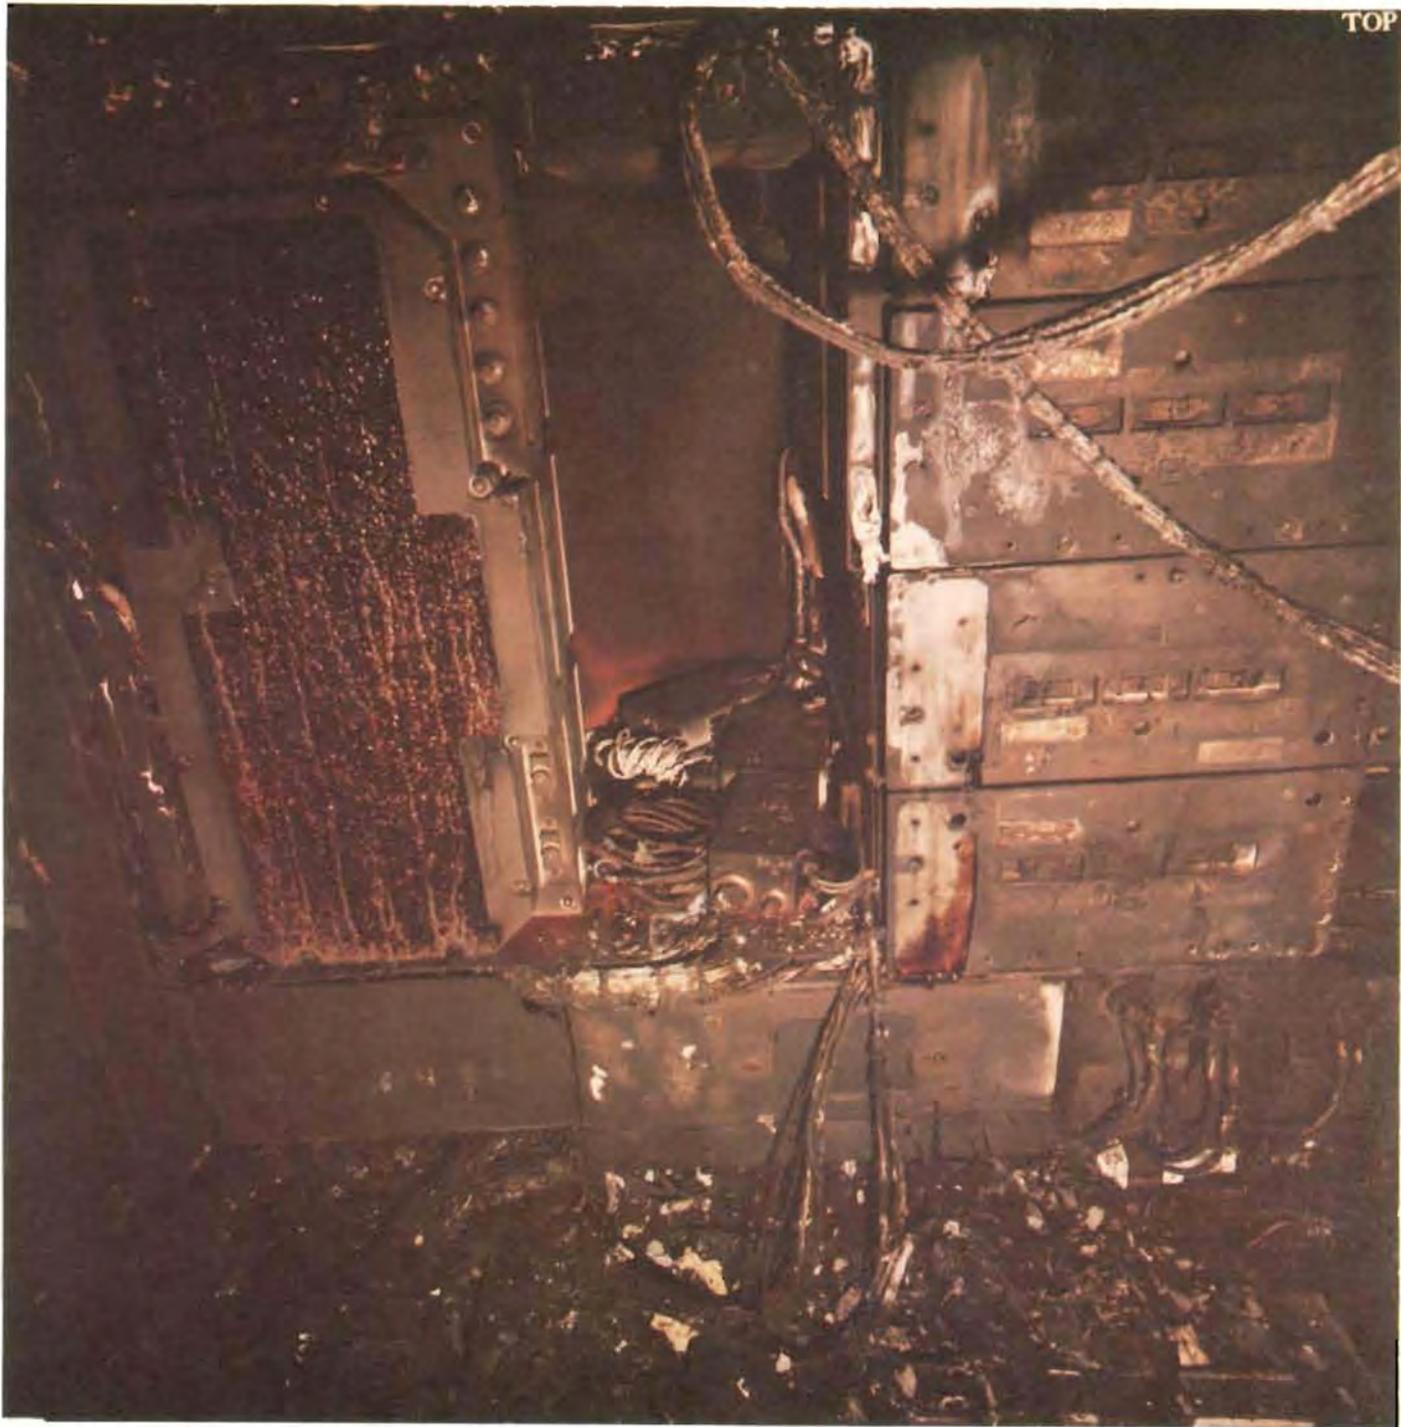
LOWER LEFT HAND SECTION OF LOWER EQUIPMENT BAY

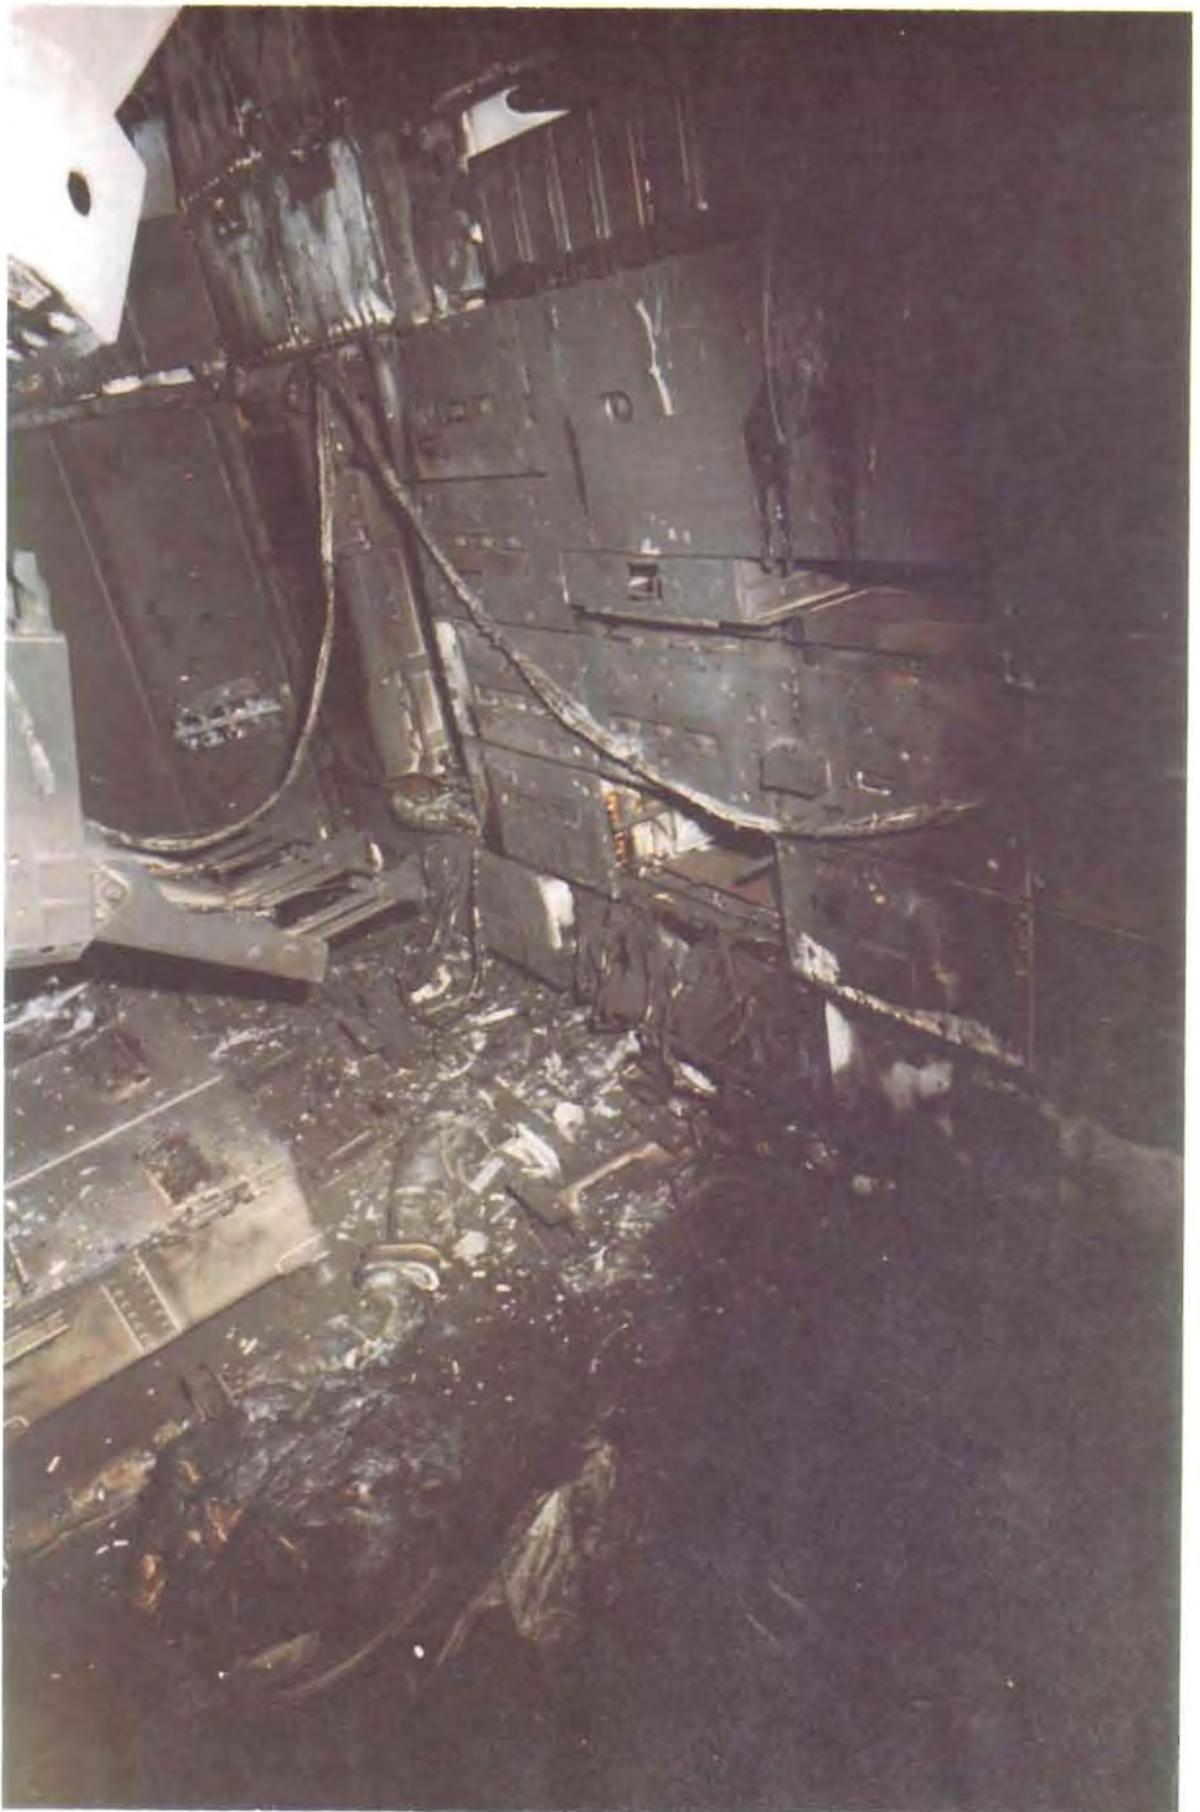
VIEW OF FLOOR BELOW LOWER EQUIPMENT BAY  
ENCLOSURE V-6

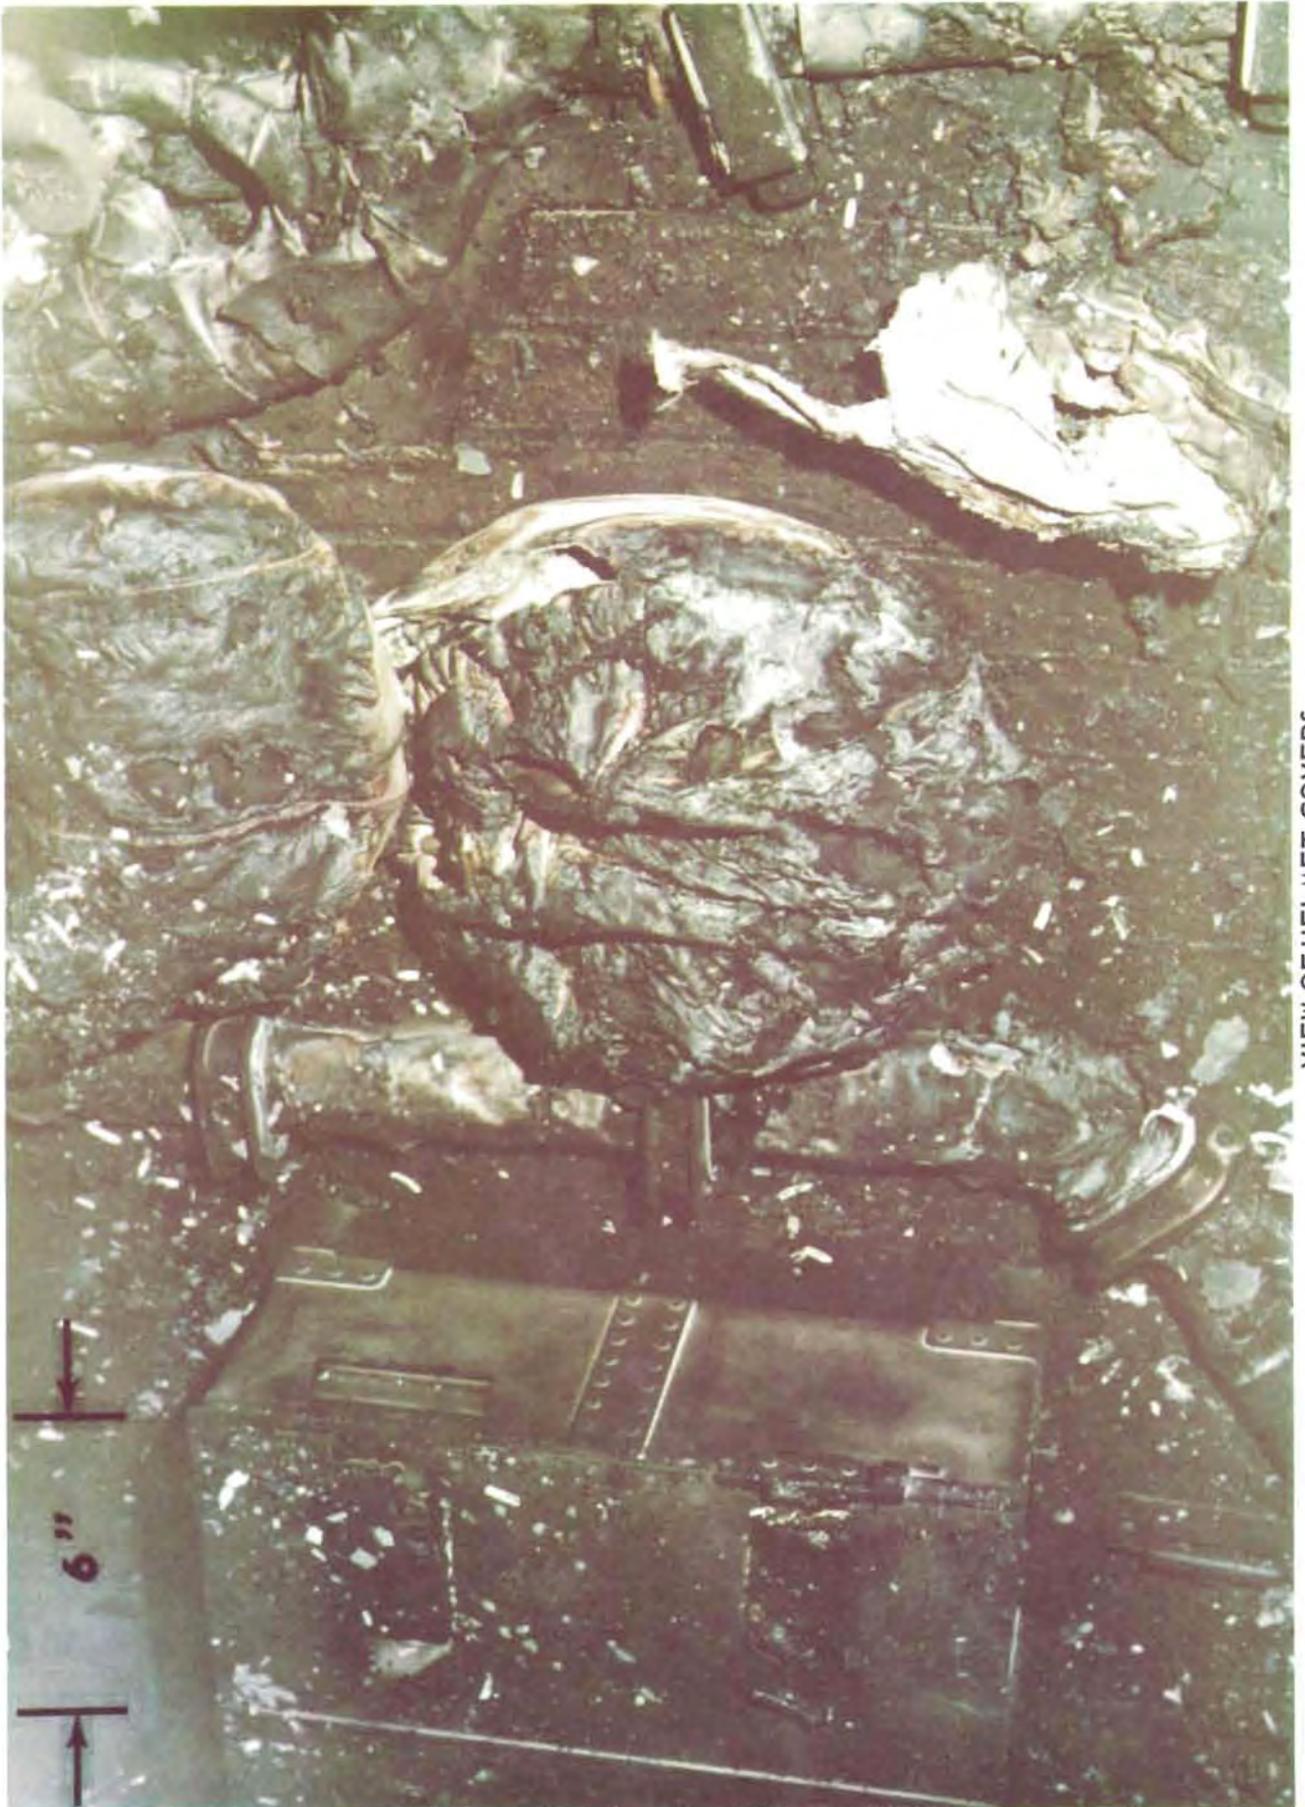
ENCLOSURE V-7

VIEW OF HELMET COVERS

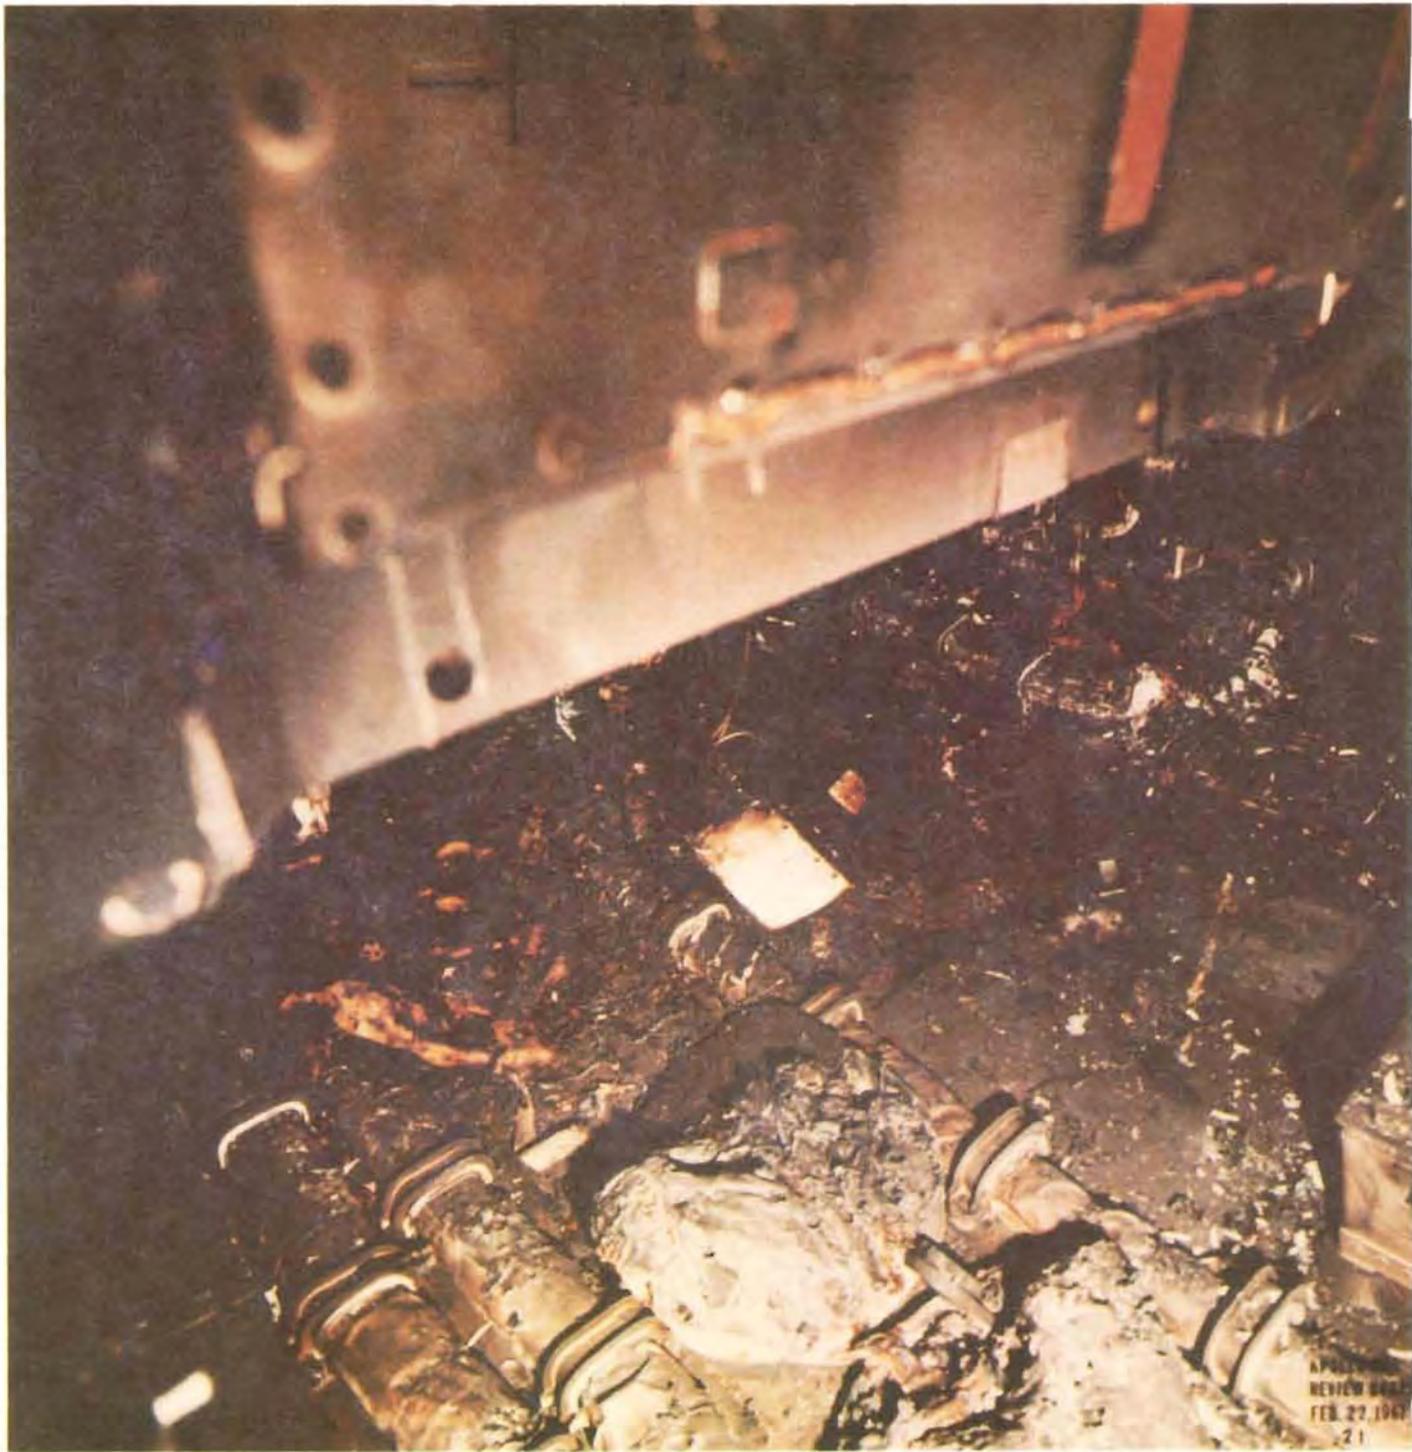
ENCLOSURE V - 8

VIEW OF HELMET COVERS

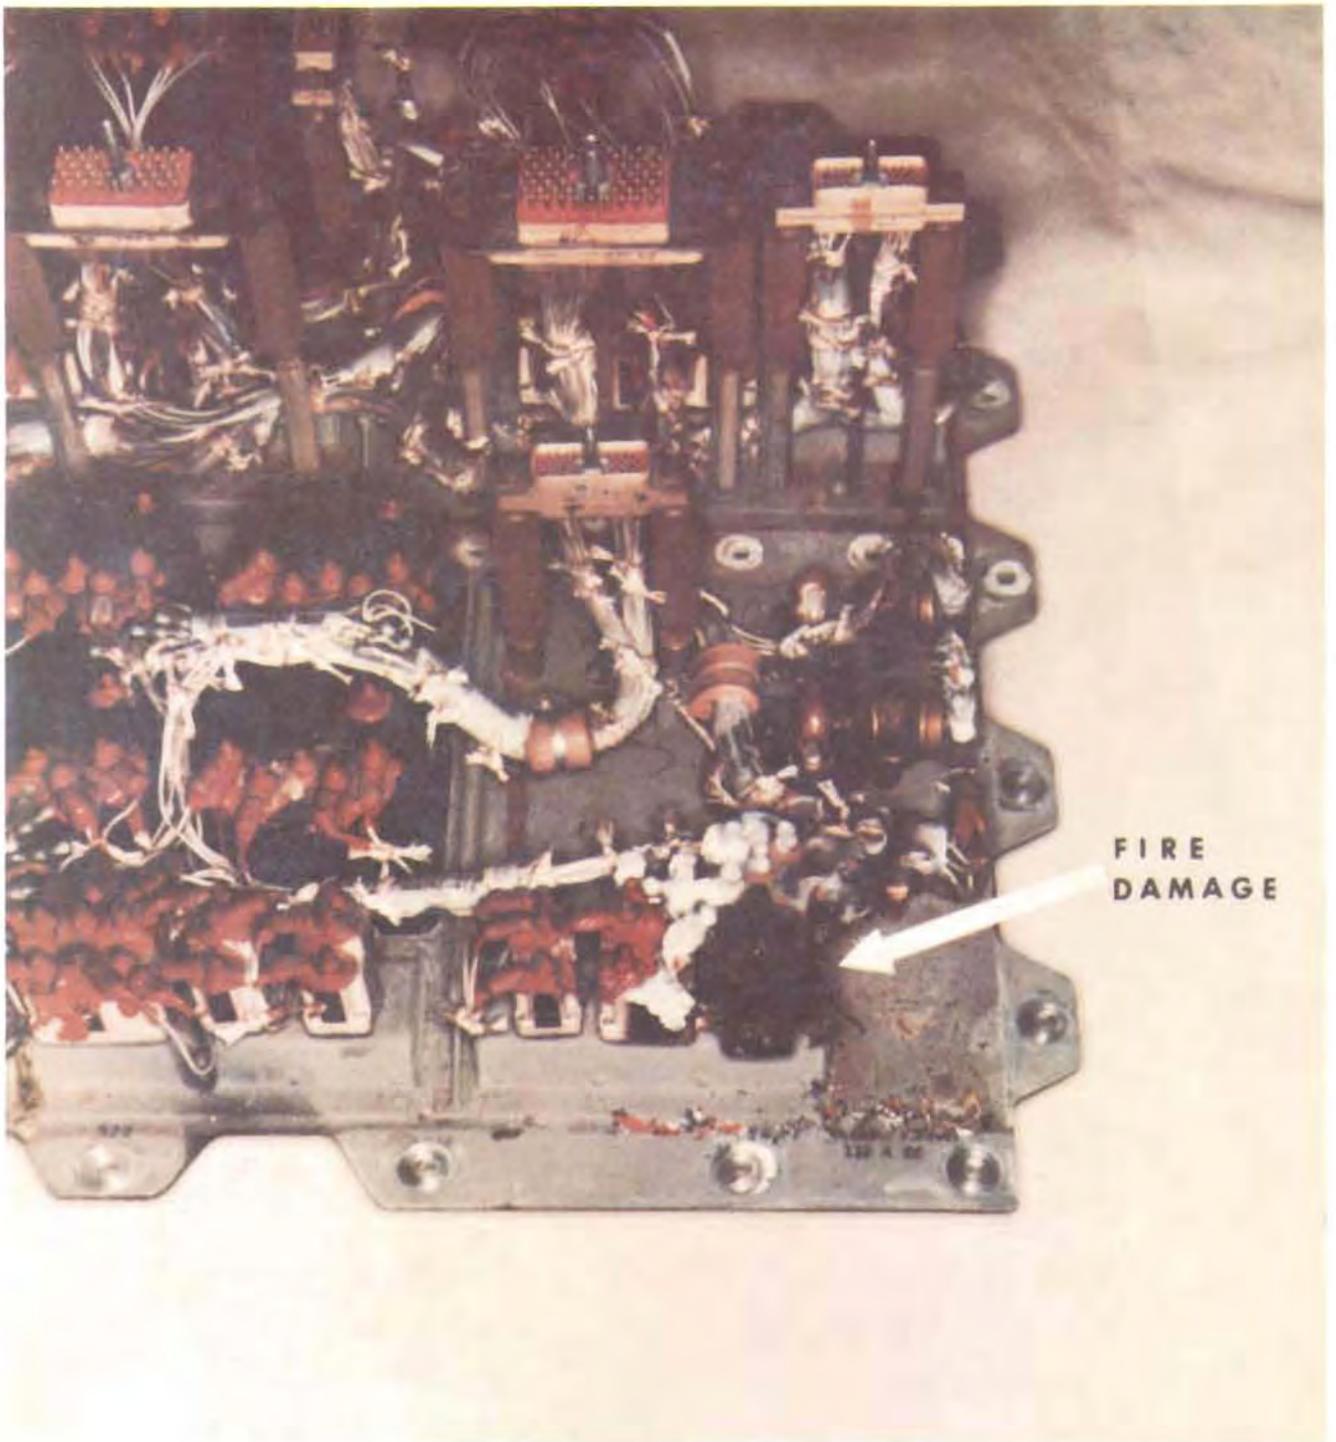
INTERIOR VIEW OF PANEL 13 SHOWING DAMAGE NEAR THUMB WHEELS

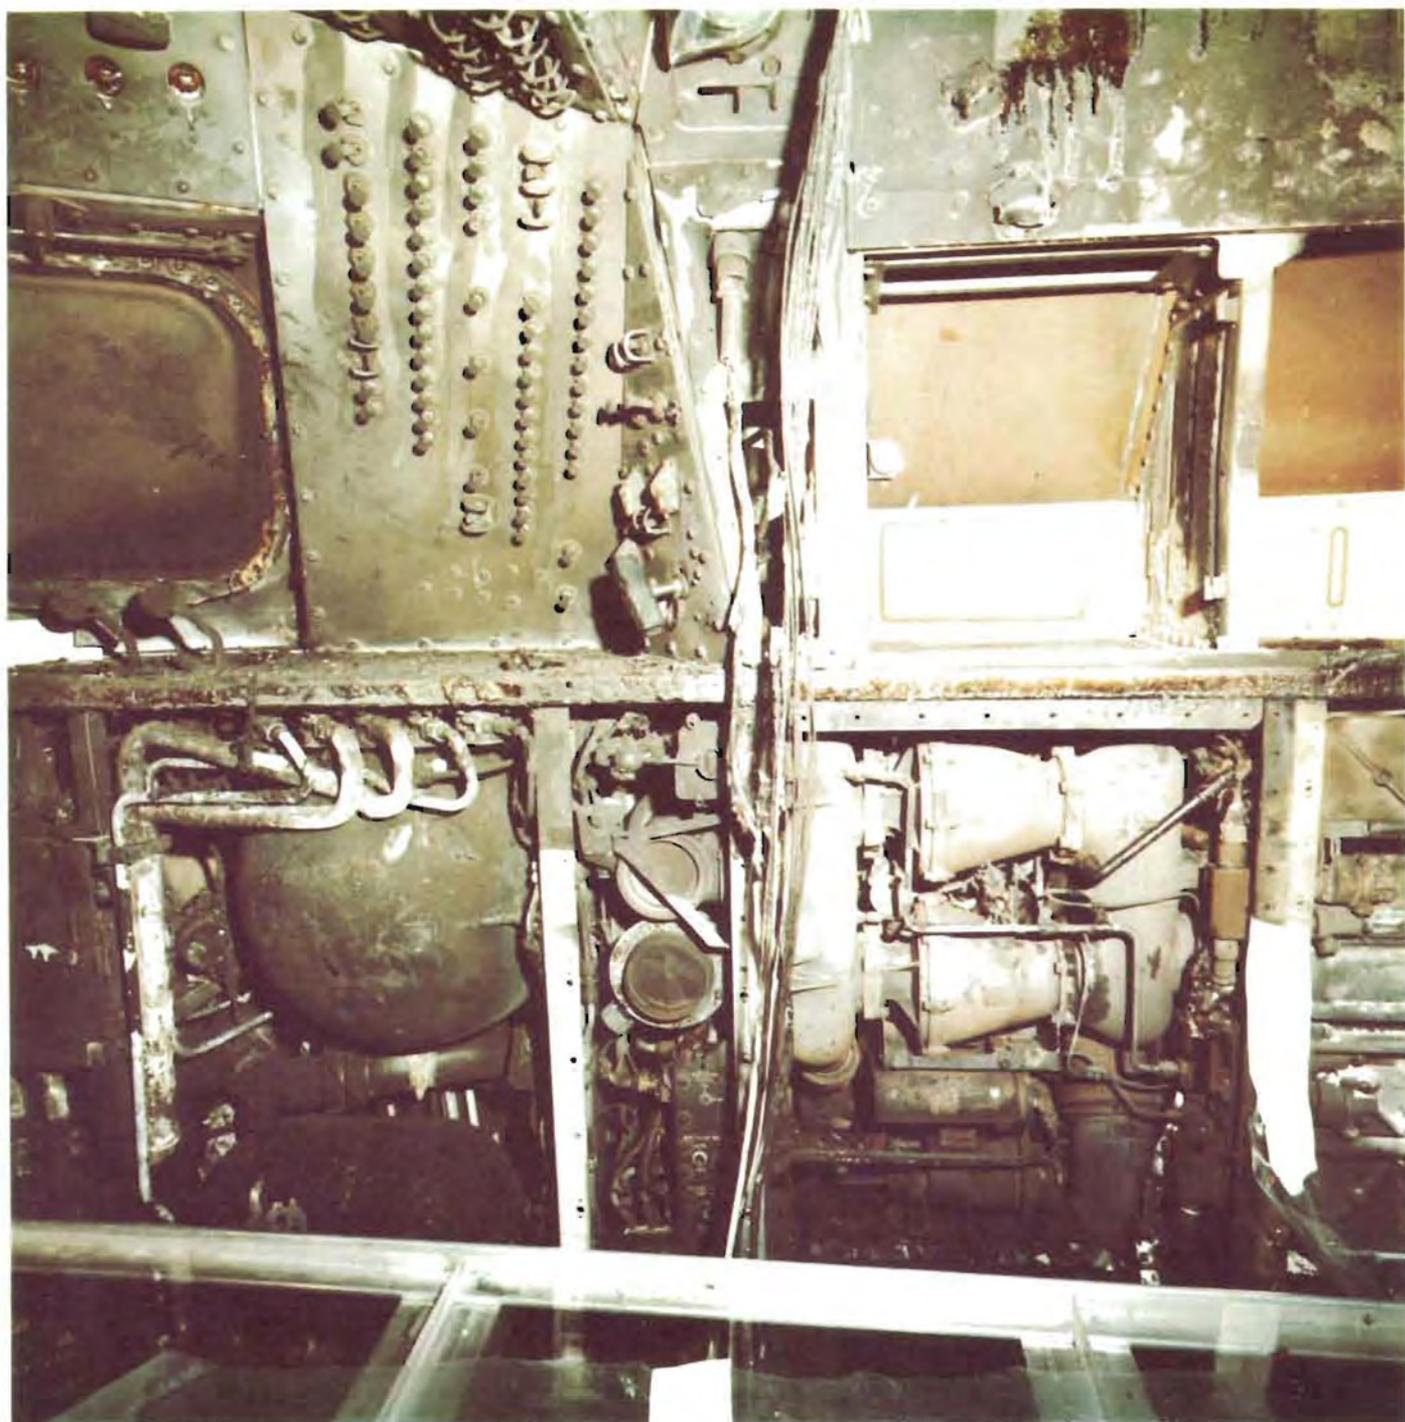
ENCLOSURE V-10

VIEW OF ENVIRONMENTAL CONTROL UNIT

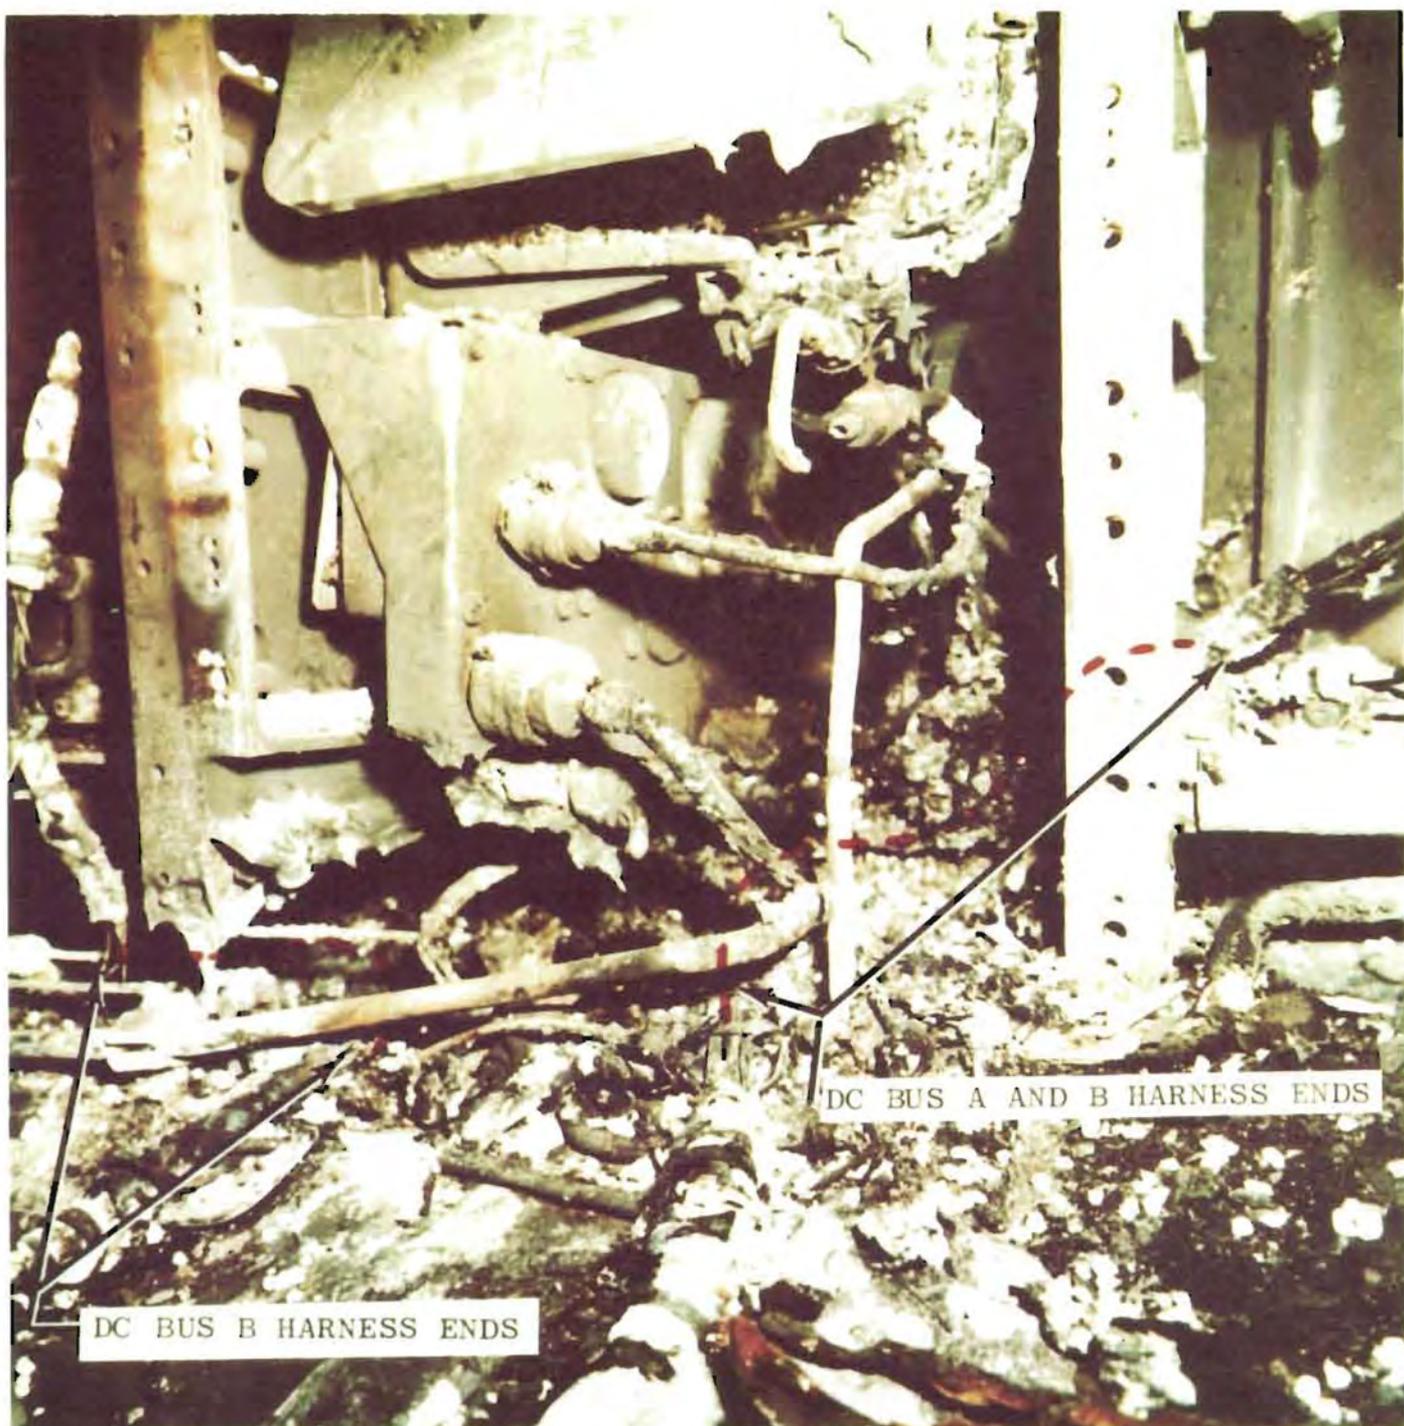
ENVIRONMENTAL CONTROL SYSTEM INSTRUMENTATION HARNESSSES  
AFTER ACCIDENT
