### **APOLLO SPACECRAFT**

### **TEST IN PROGRESS AT TIME OF ACCIDENT**

Spacecraft 012 was undergoing a "Plugs Out Integrated Test" at the time of the accident on January 27, 1967. Operational Checkout Procedure, designated OCP FO-K-0021-1 applied to this test. Within this report this procedure is often referred to as OCP-0021.

**REPORT  
OF  
APOLLO 204 REVIEW BOARD**

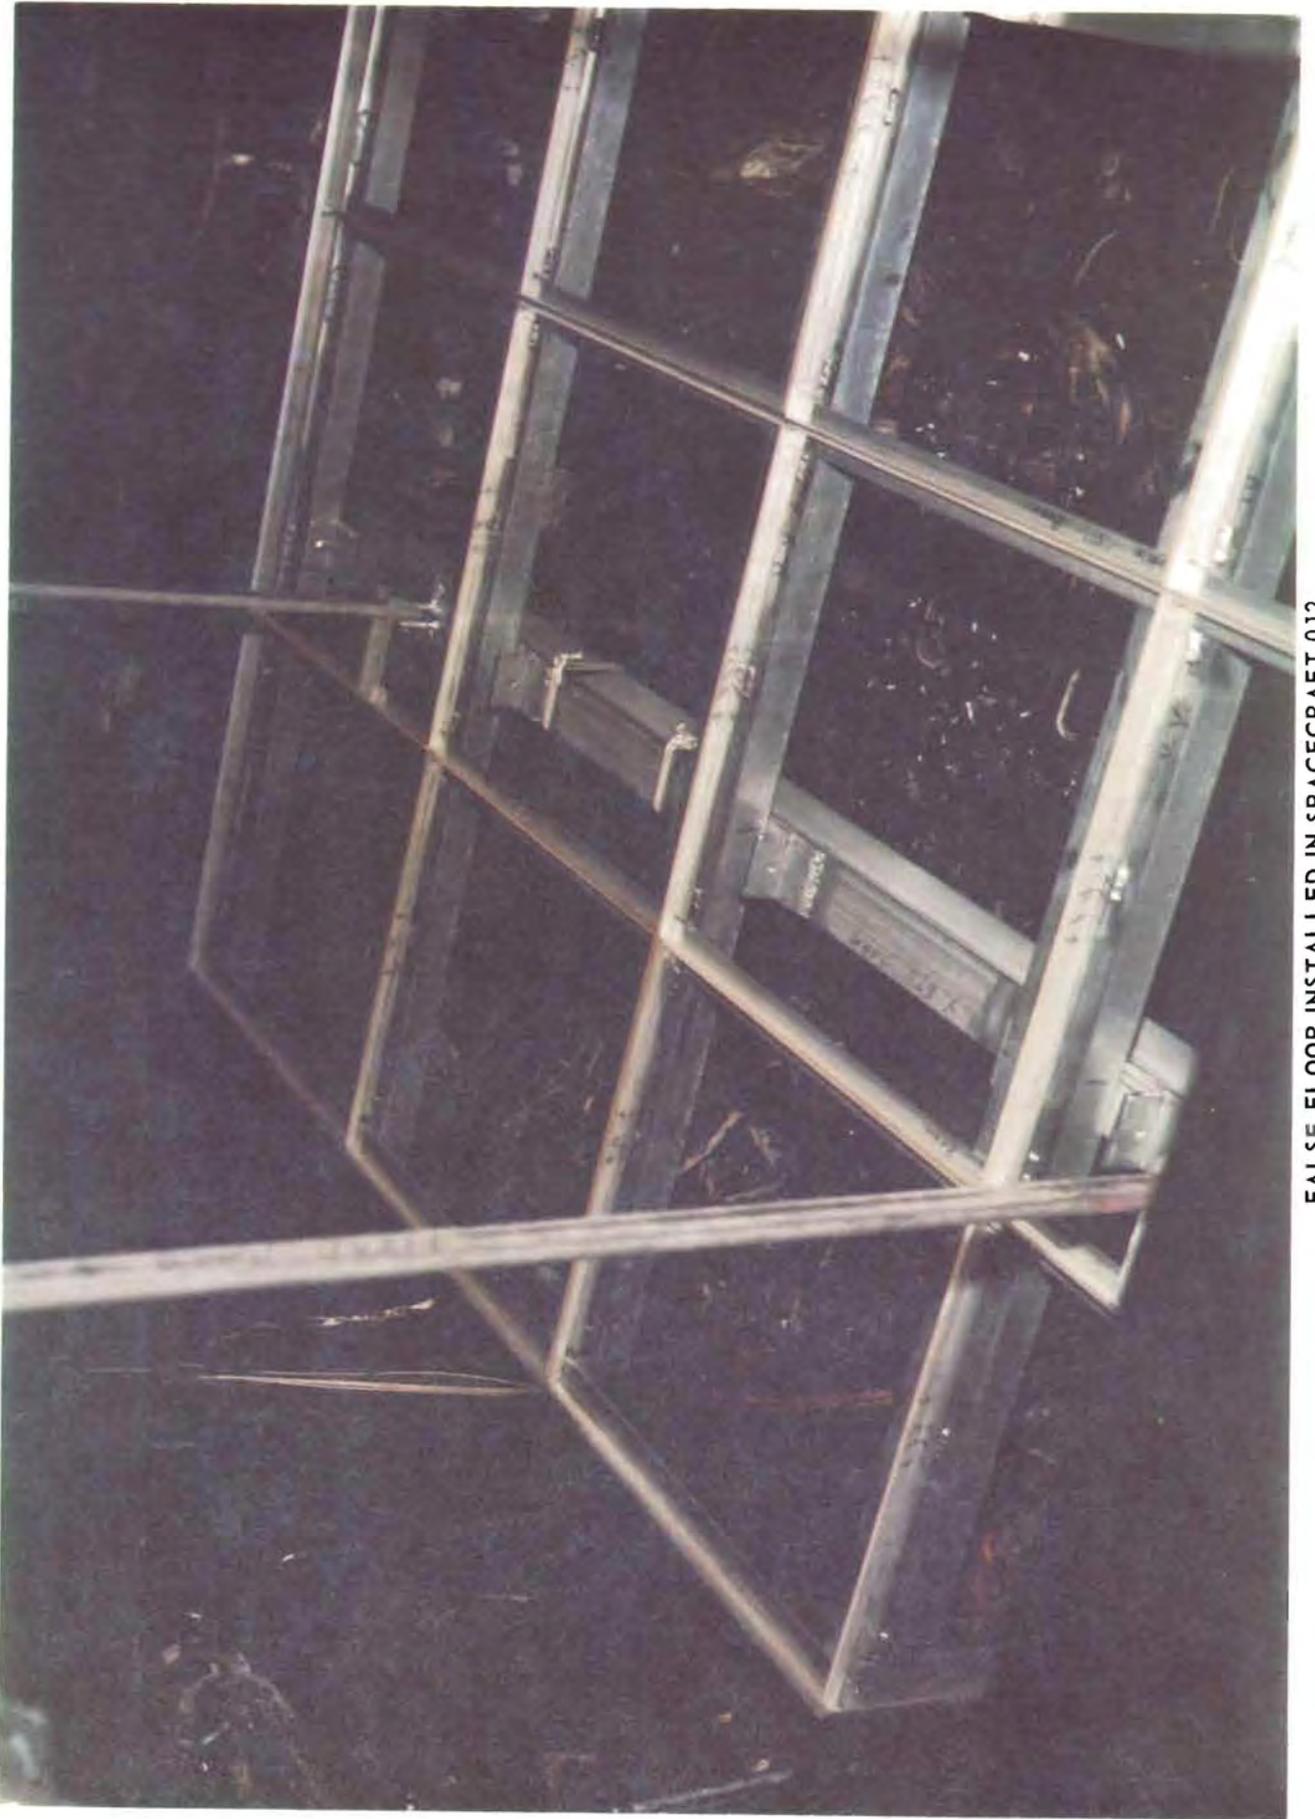
ENCLOSURE V - 12

(3) Representatives of the Board visited Launch Complex 34 and made a very detailed inspection of movable platforms A-7 and A-8 which surrounded the Apollo Spacecraft. During this inspection, the installation of the false floor in the Command Module was observed. Since removal of the astronauts' couches a false floor was constructed and suspended from the Command Module ceiling and entrance hatch. This will facilitate inspection of the floor of the module without disturbing any evidence of the fire damage.

FALSE FLOOR INSTALLED IN SPACECRAFT 012

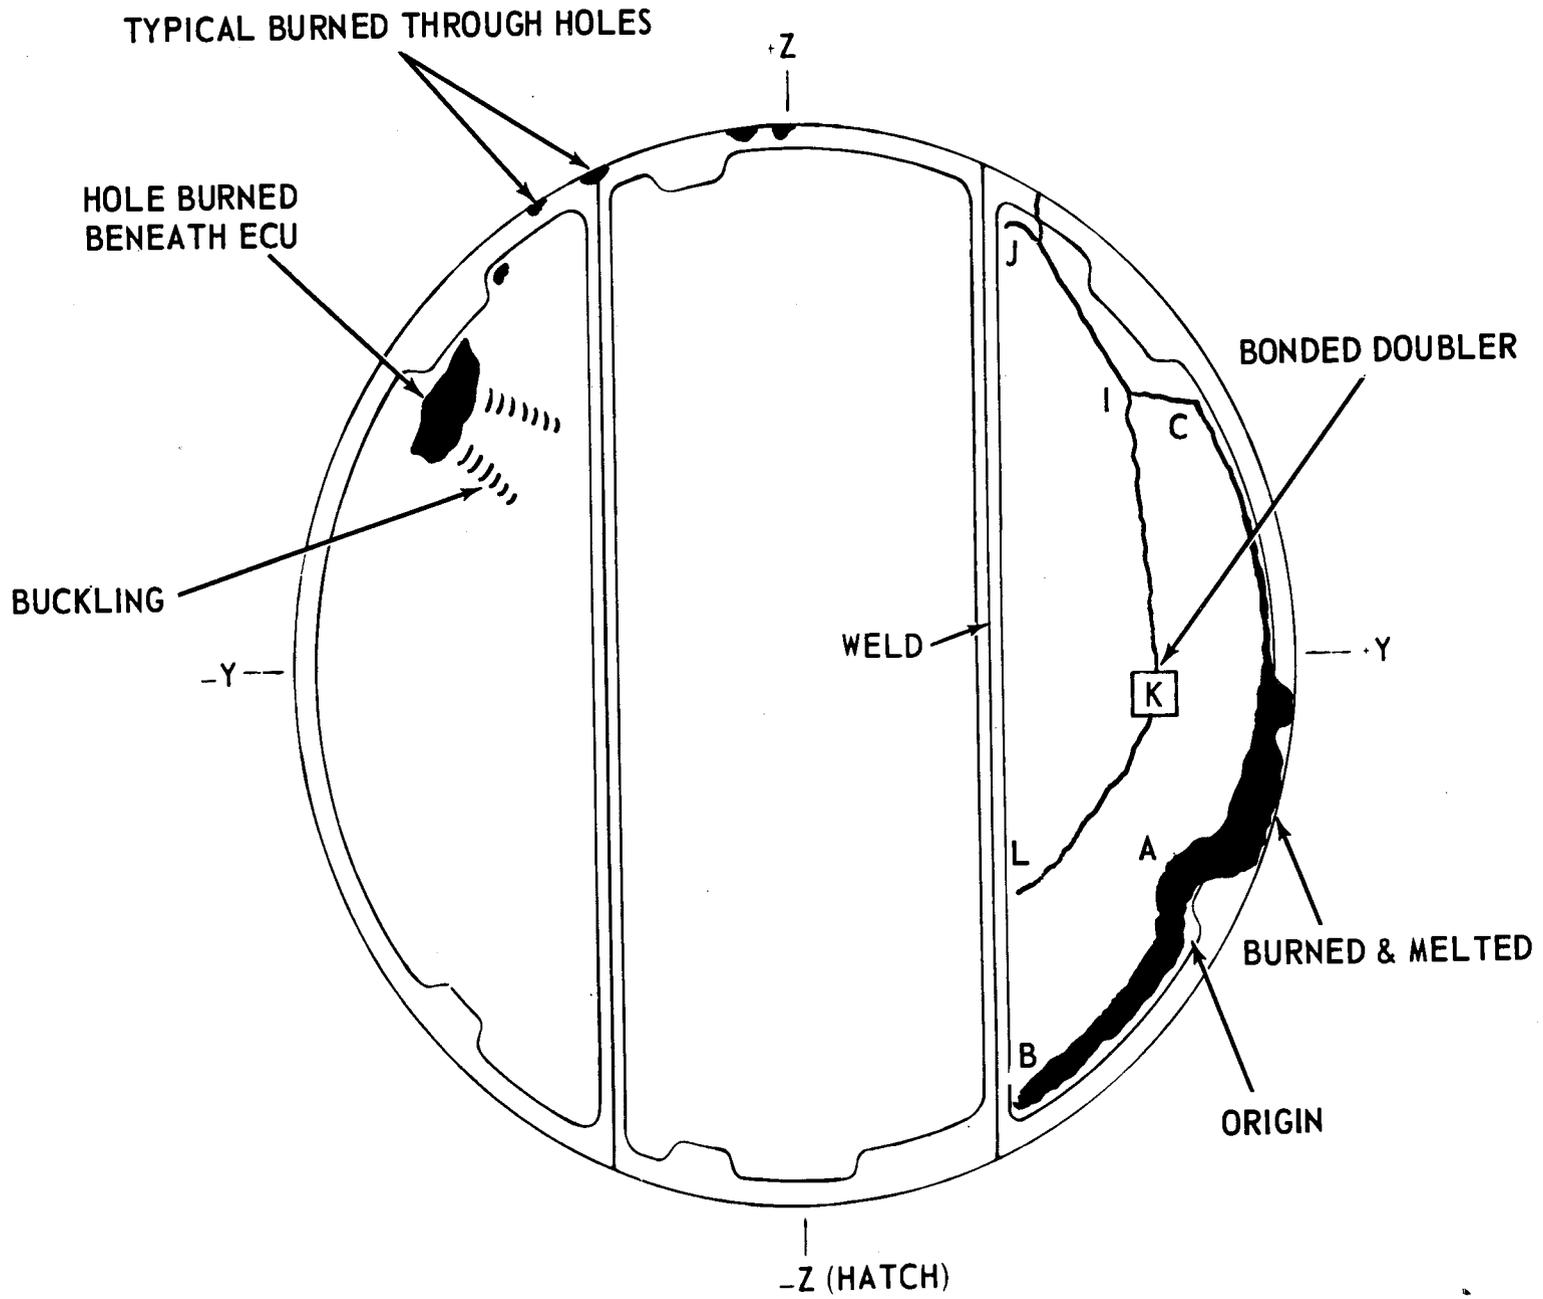
1. The aft heat shield was removed from C/M 012 in accordance with the master plan for disassembly. Close inspection of the C/M disclosed that the rupture in the floor extended approximately 2/3 around its circumference. This is much greater than originally estimated.

OUTER FACE SHEET OF AFT BULKHEAD

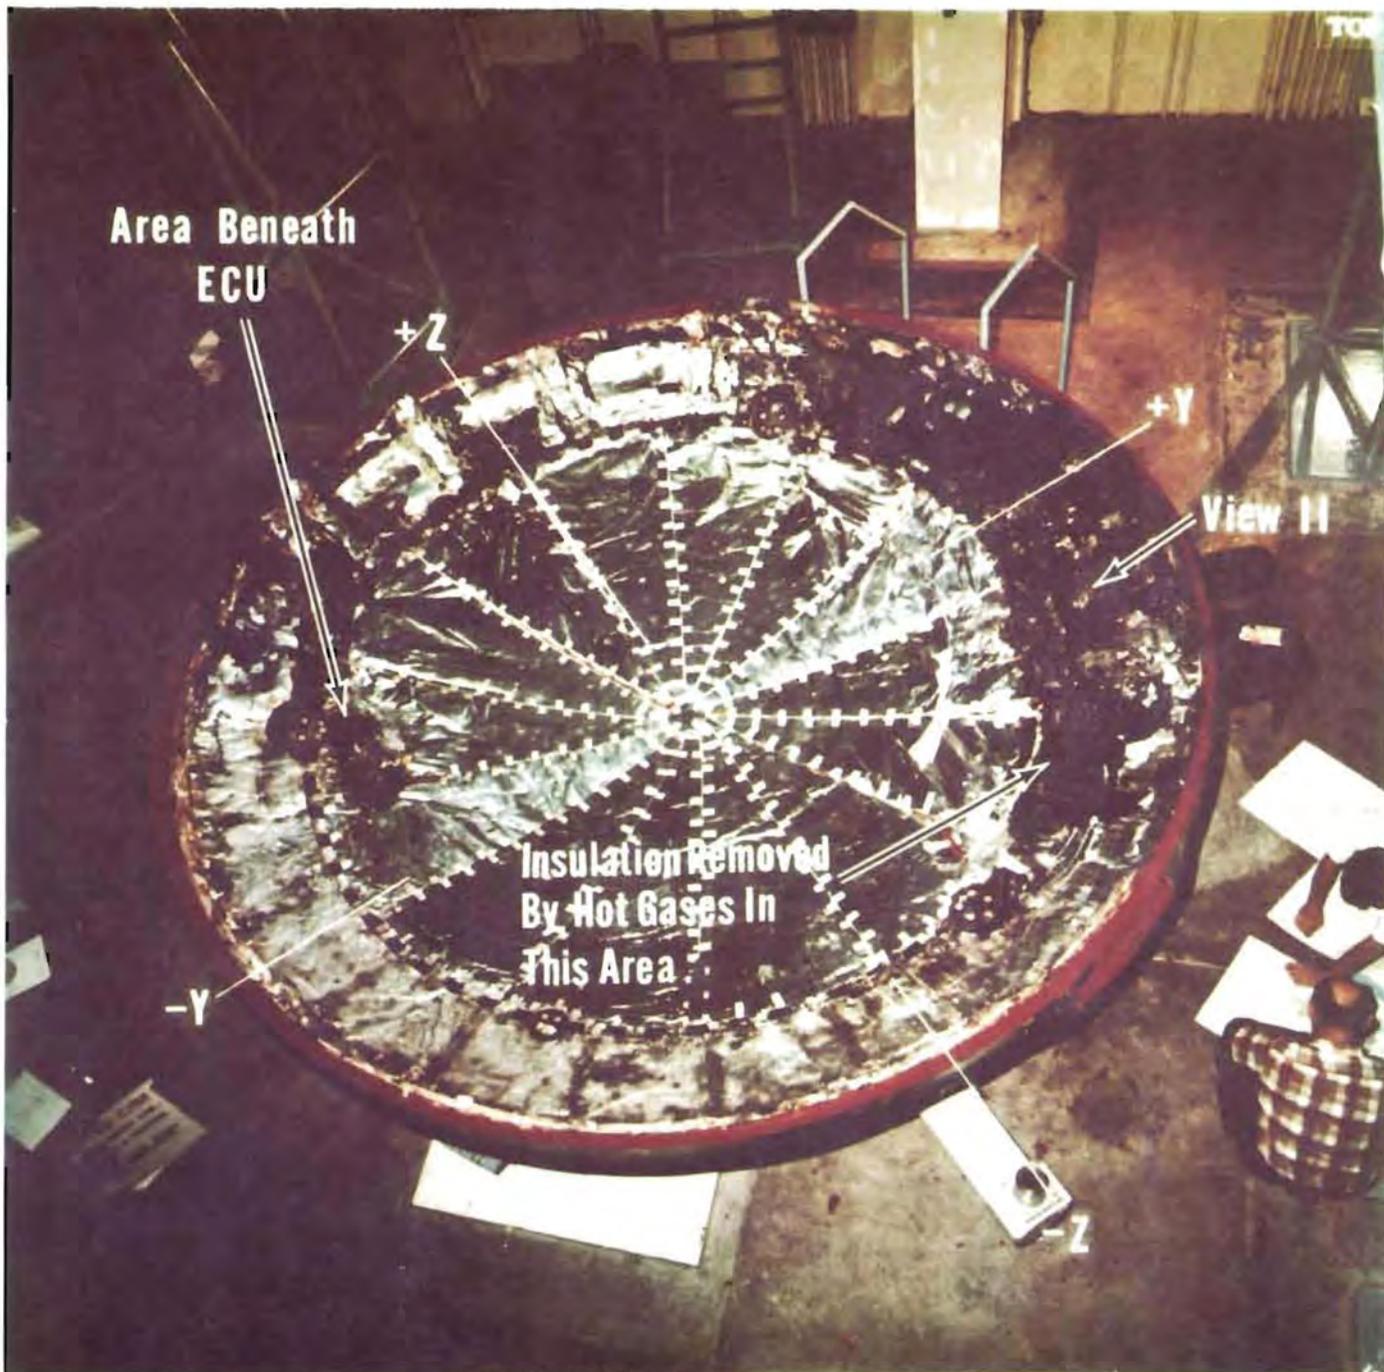
AFT HEATSHIELD DAMAGE

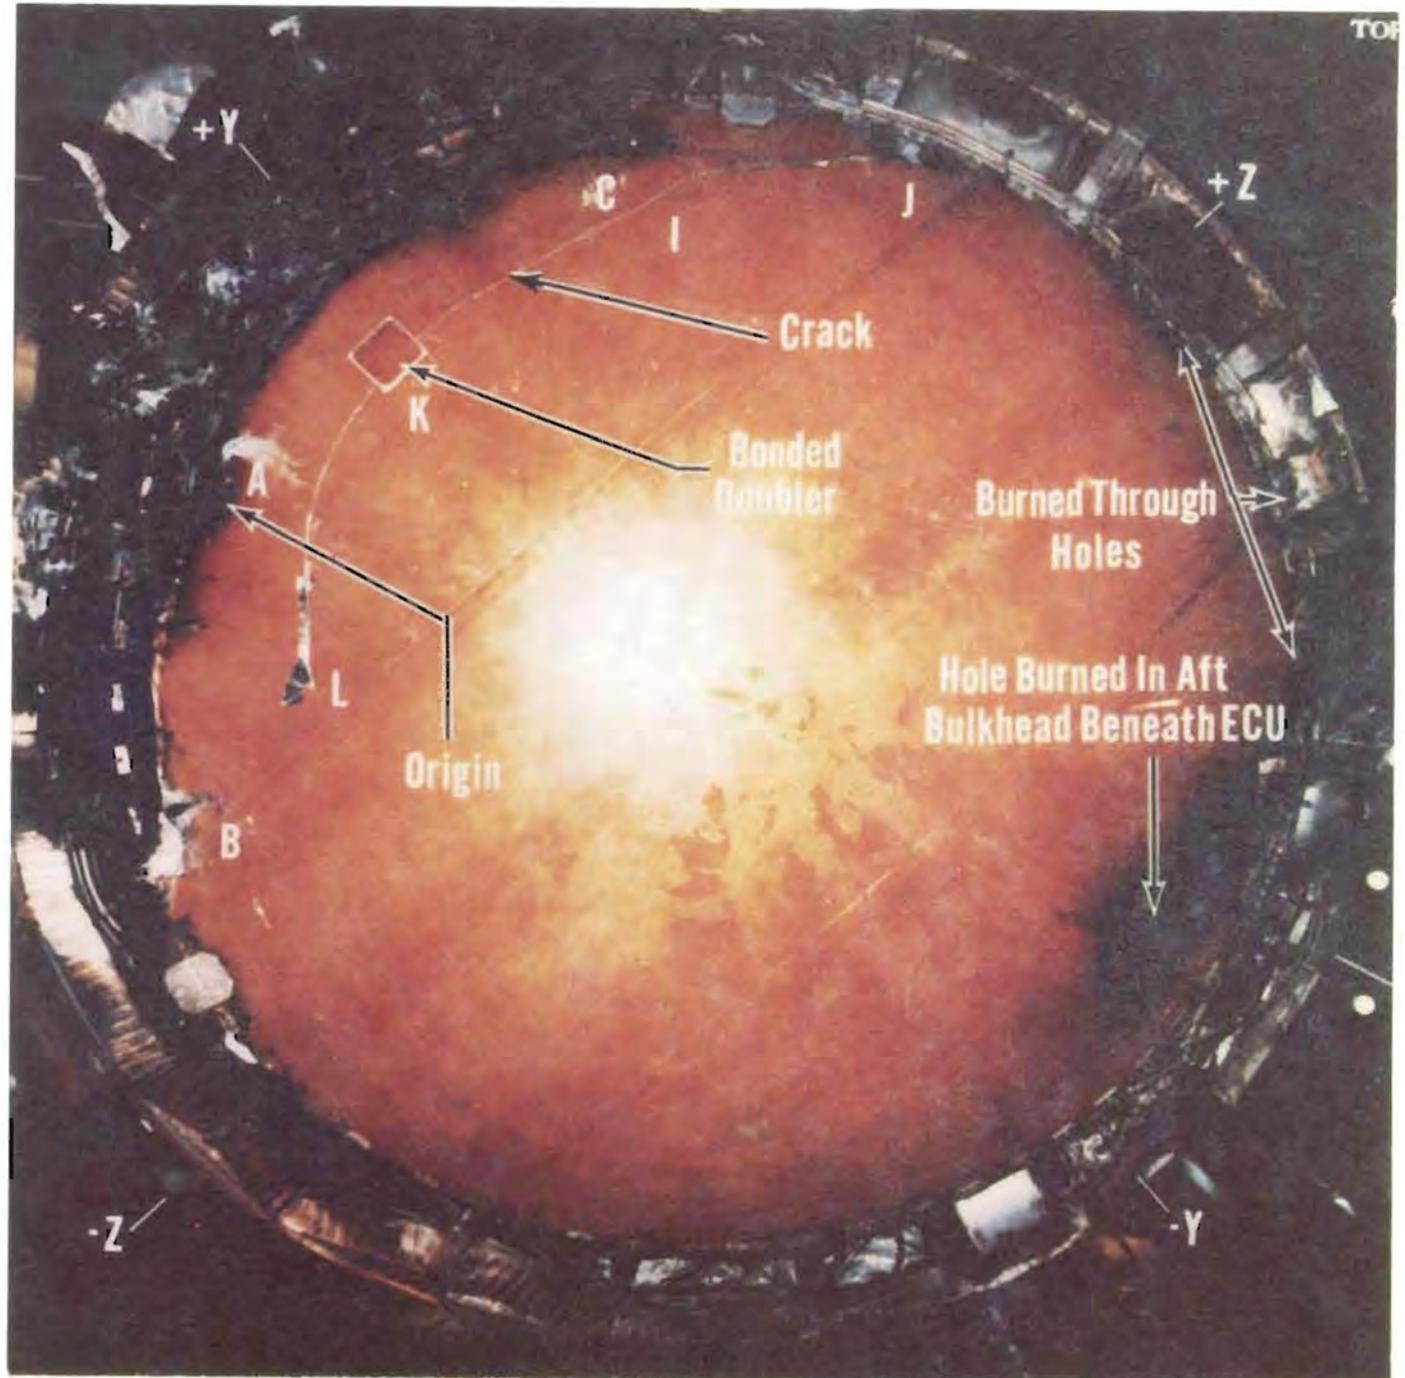
AFT BULKHEAD OF CREW COMPARTMENT

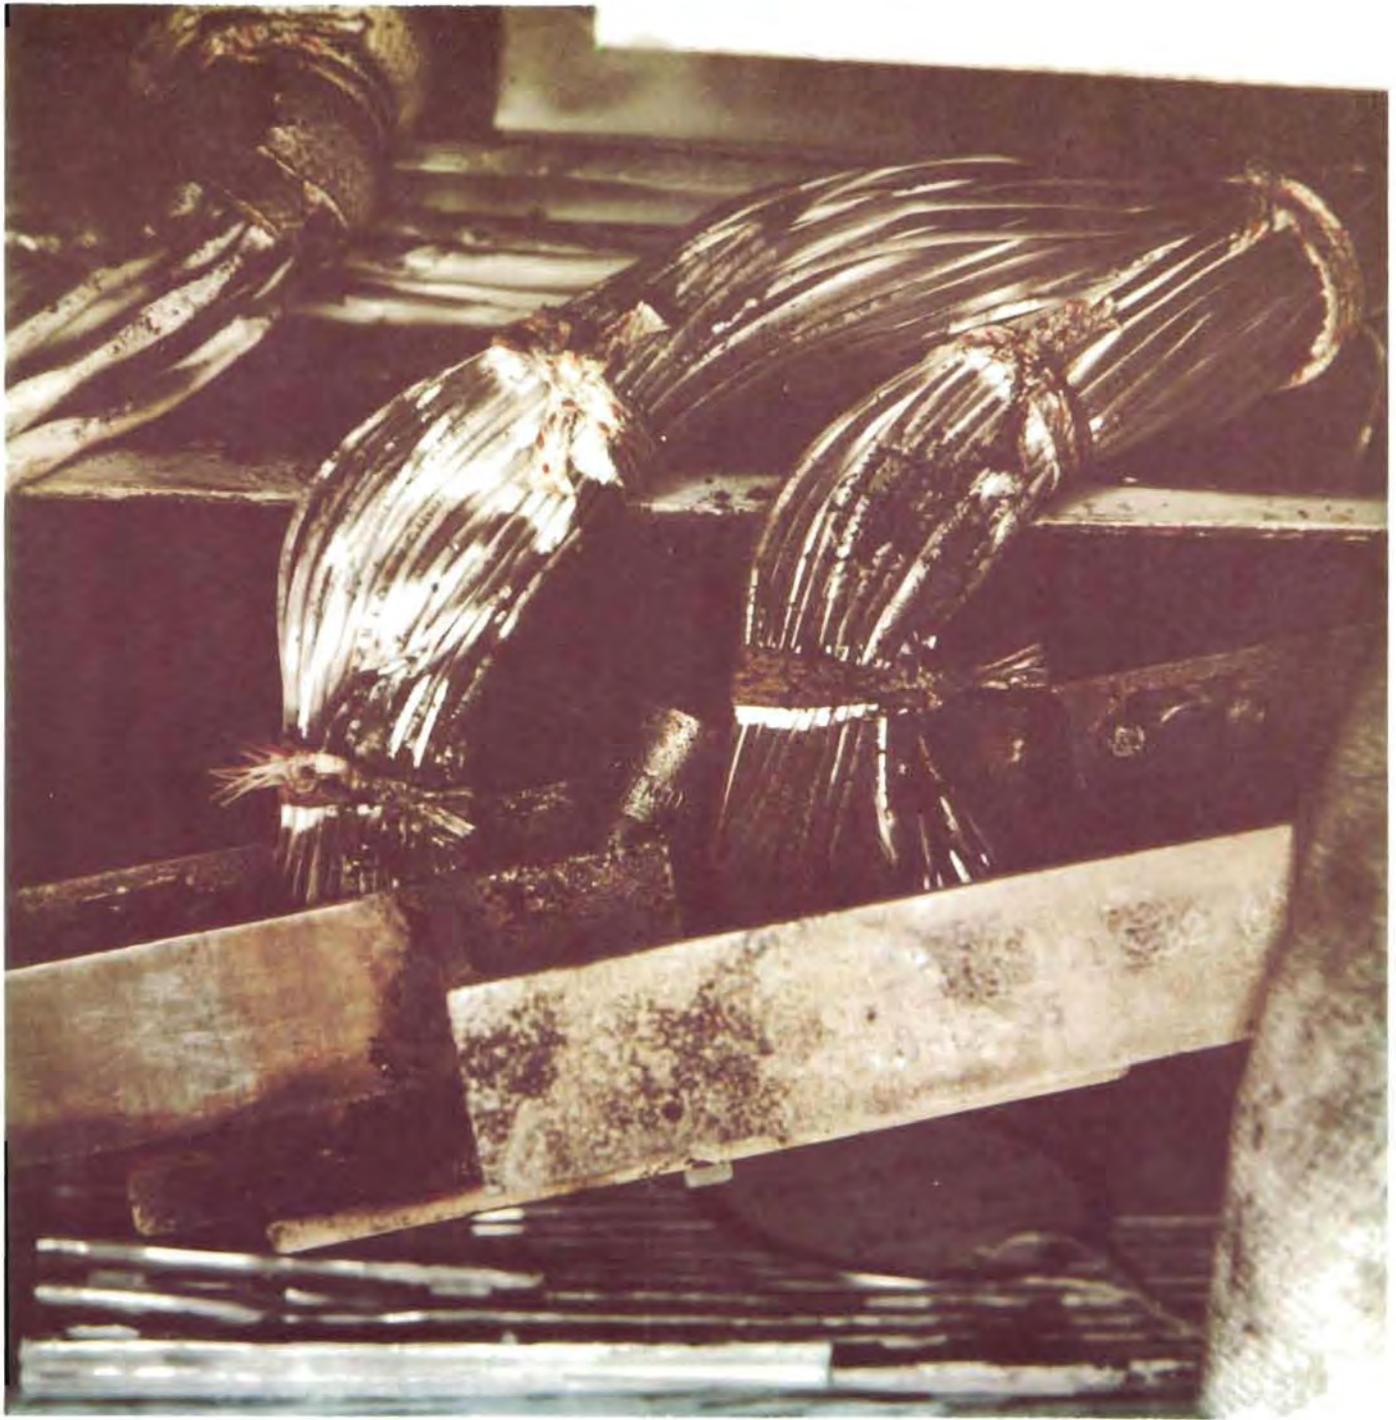
WIRING ASSESSMENT

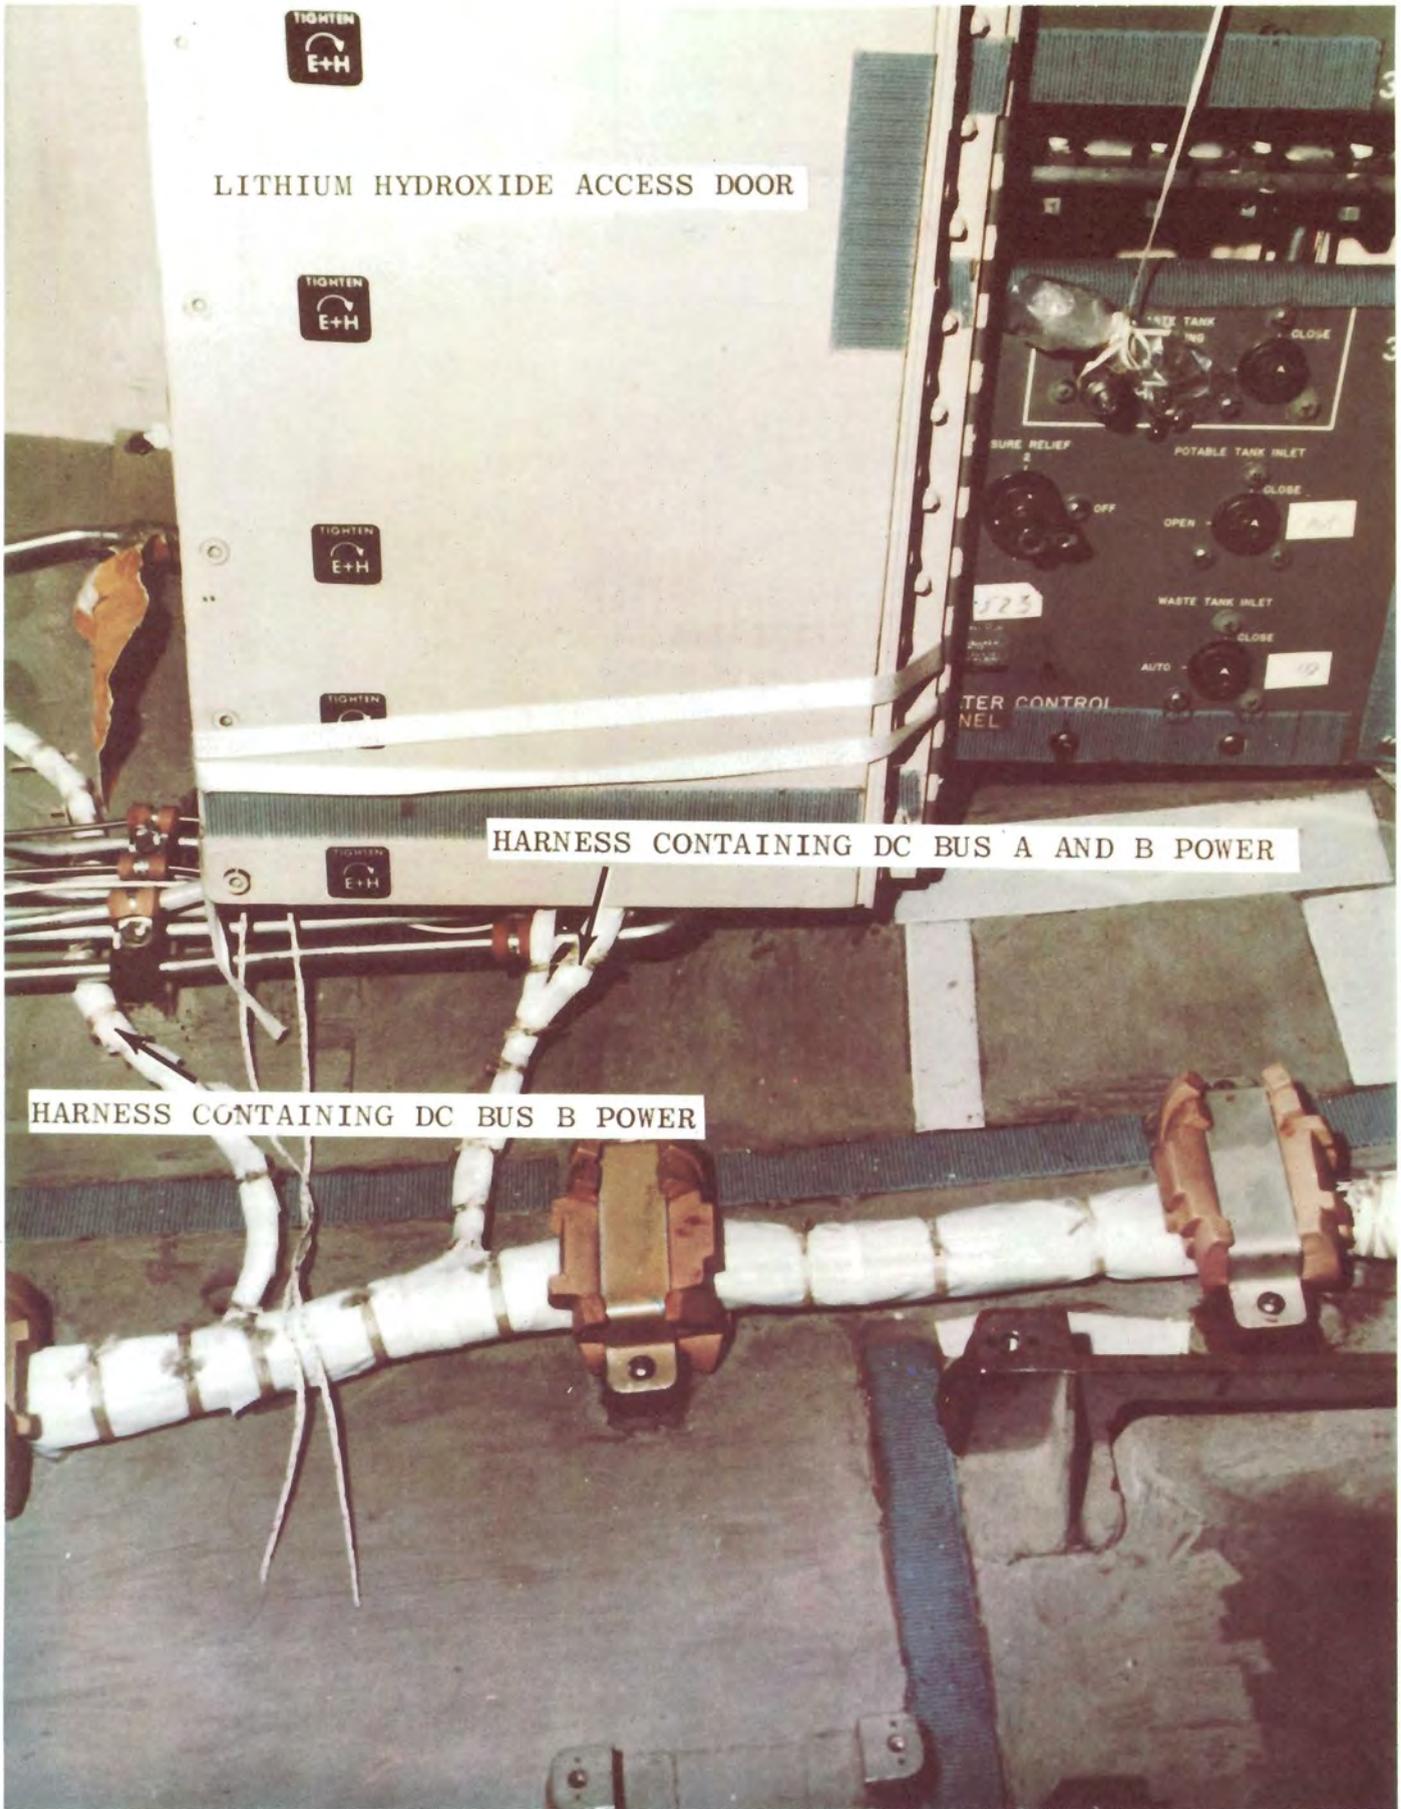
- V -28 Photograph - View of Wire Bundle in Command Module 014 Containing DC Power Leads Passing Over Tubing and Entering Environmental Control Unit. A Similar Arrangement Existed in Command Module 012.

SPACECRAFT 014 ENVIRONMENTAL CONTROL SYSTEM INSTRUMENTATION HARNESS
