# Battery Passivation Strategies for Satellites at End of Mission

NASA Battery Workshop

Bruno Samaniego – Airbus Defence & Space  
Huntsville, AL- 15<sup>th</sup> November 2017

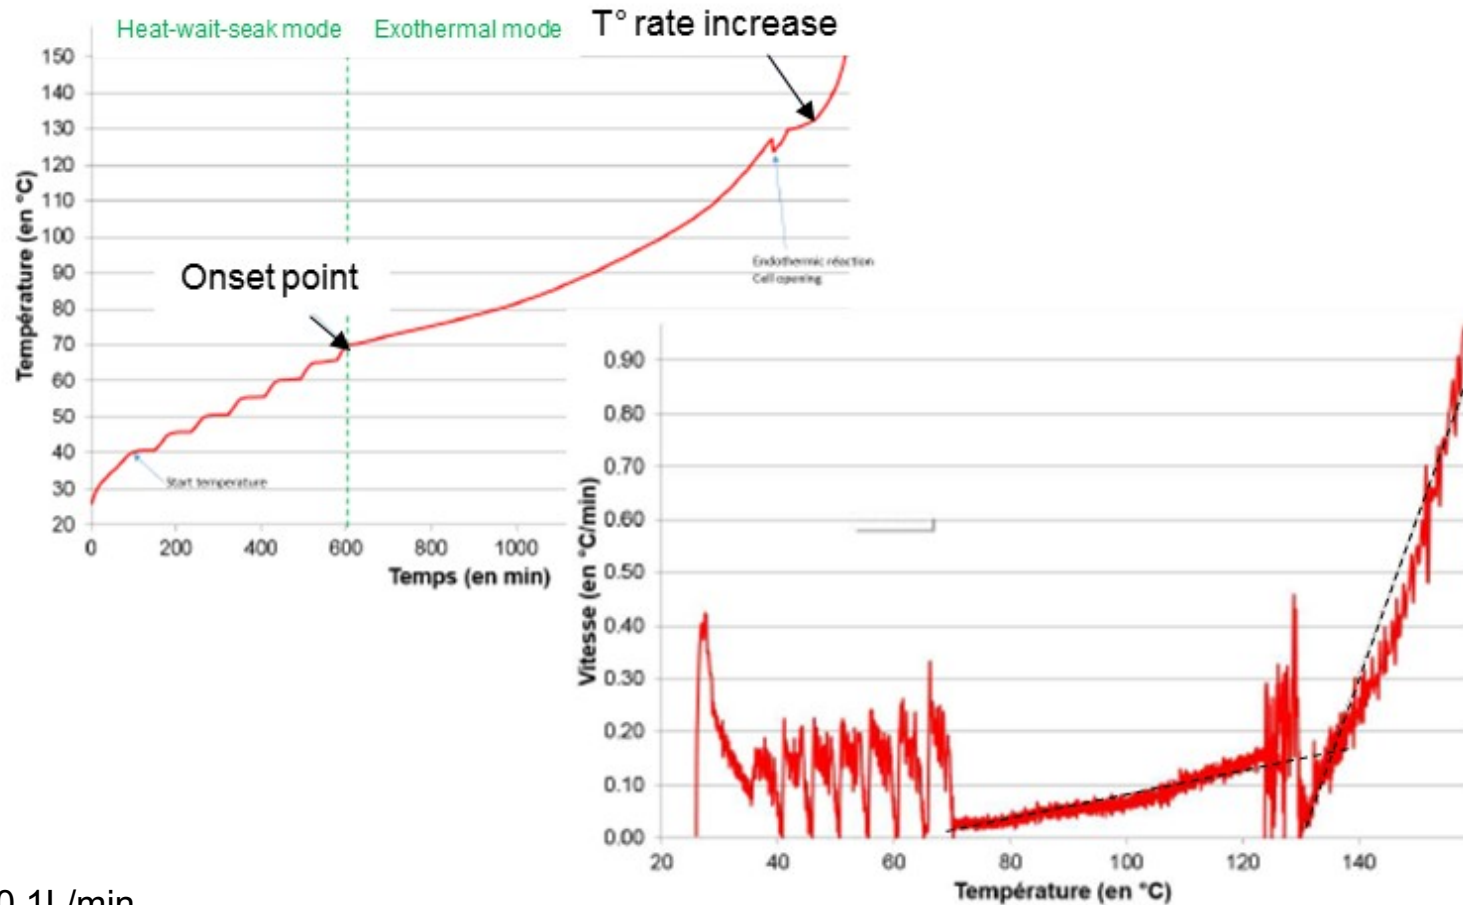
- N2 flow : 0.1L/min
- Charge the cell at C/10 up to defined SoC (100% SoC; 50% SoC; 0% SoC)
- Increase gradually the temperature until a thermal runaway appears. Stop heating.
  - Temperature step: 5°C
  - Temperature rate sensitivity': >0.02°C/min. = thermal runaway
  - End temperature': 180°C (test stop)
  - Safety temperature rate': 1°C/min. (test stop)

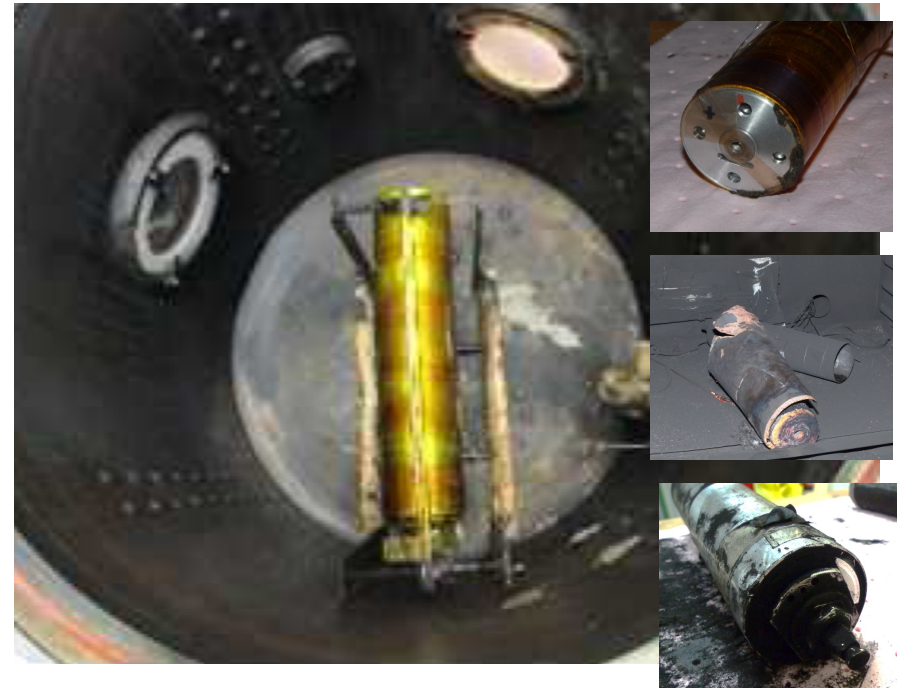
- **Aging reduces carbon reactivity** (more stable, well developed SEI layer) leading to more thermally stable cell

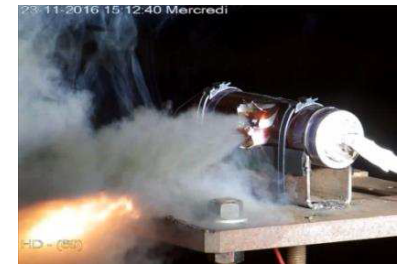
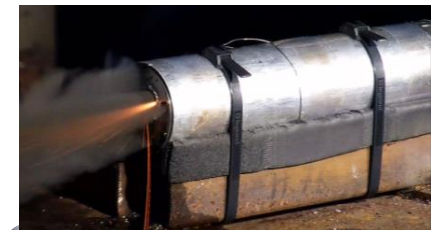
### RESULTS

Max temperature: 400°C

Max temperature: 680°C
