Progress on new methods, materials, and insights for safety Li-ion battery systems

Donal Finegan
NASA Battery Safety Workshop
18 Nov 2020

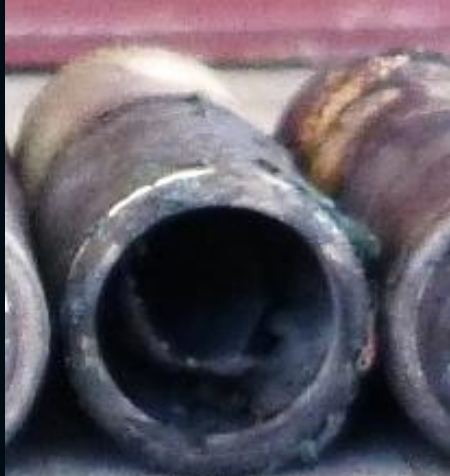
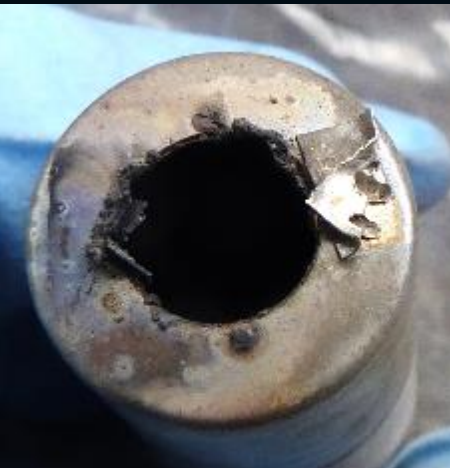
Bursting: Top

Bursting: Bottom

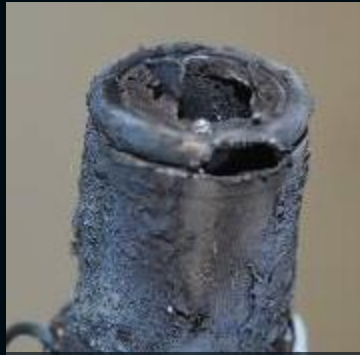
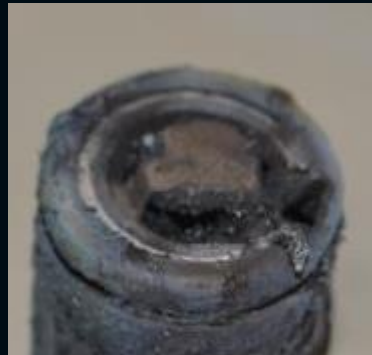
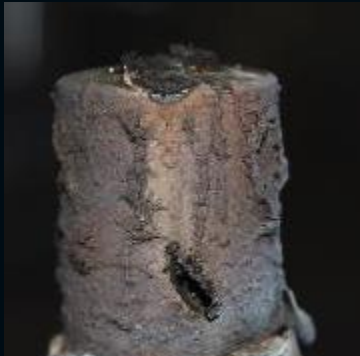
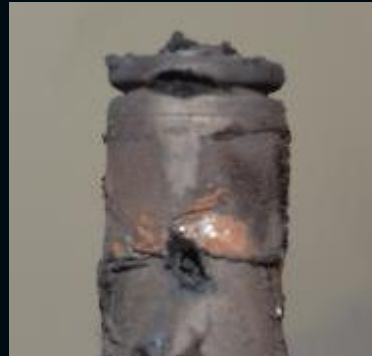
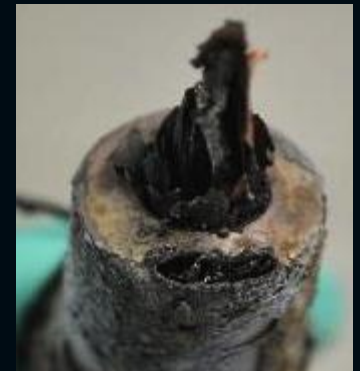
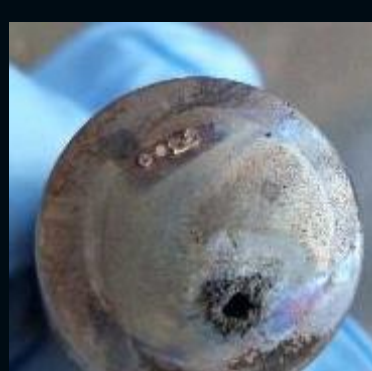
Breach: Top

Breach: Side

Breach: Bot

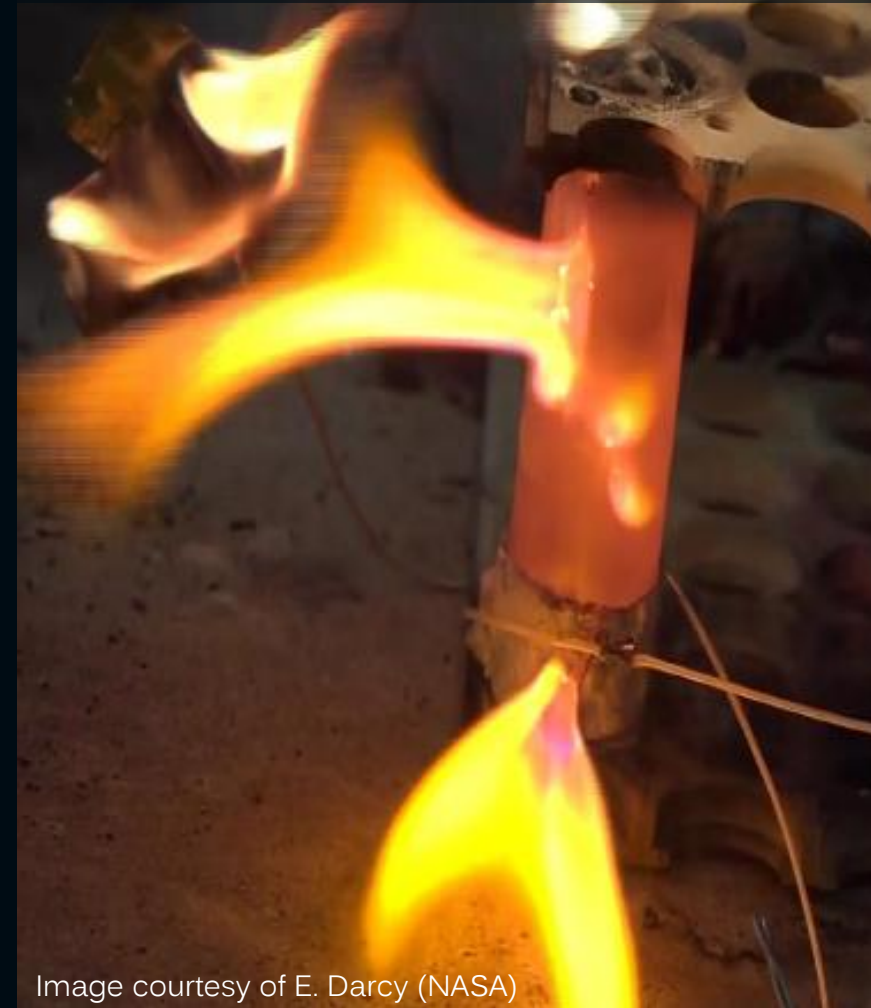
Hazardous flare stemming from breach

Most challenging failure mechanism to handle

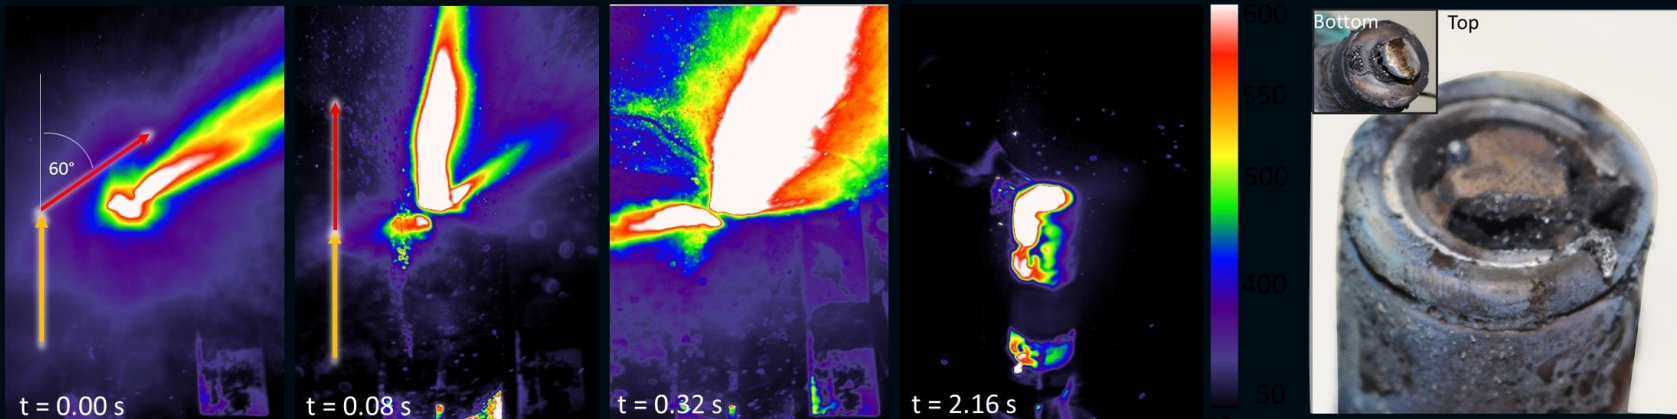
Characterizing breaching mechanism

Cell type: Li-ion 18650
Capacity: 3.4 Ah
State of Charge: 100 % (4.2 V)
Bottom vent: Yes
Wall thickness: 220 μm
Orientation of cell: Positive end up
Location of ISCD radially: 6 winds in
Location of ISCD longitudinally: Top
Side of ISCD in image: Right

Location of FOV longitudinally: Top
Frame rate: 2000 Hz
Frame dimension (Hor x Ver): 1822 x 1140 pixels
Pixel size: 10 μm

Cause of breach

- Reacting material fluidizes and flows towards the top vent
- Material deflects off the spin-groove, causing thermal stress
- The spin-groove melts leading to a breach and escape of hot material

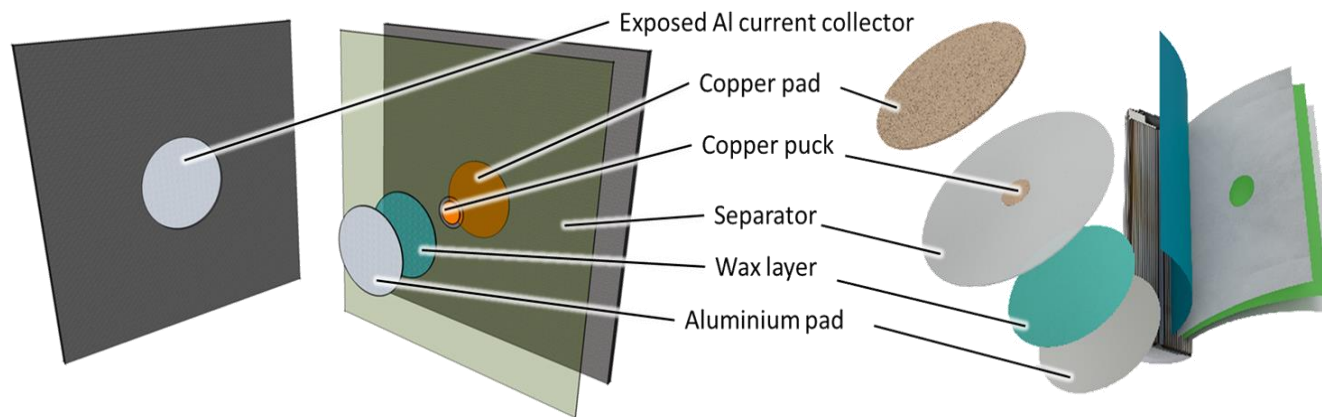
- 18650 cells were manufactured with the ISC device placed at 3 different longitudinal locations

ISC at bottom

ISC at top

ISC at midway

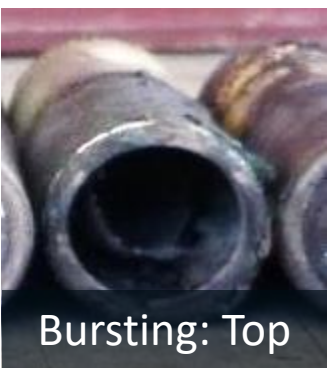
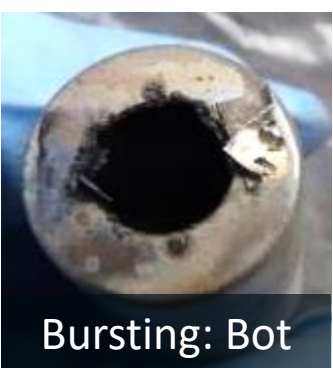
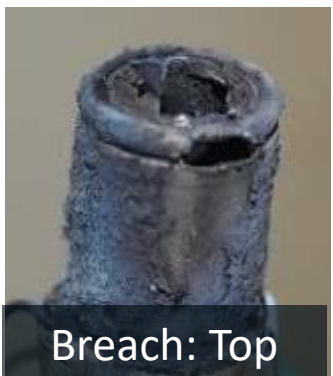
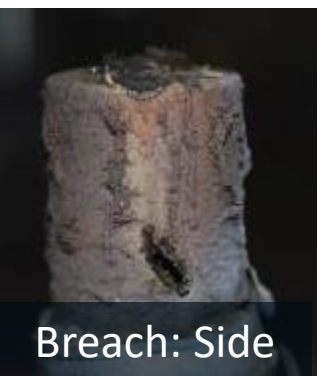
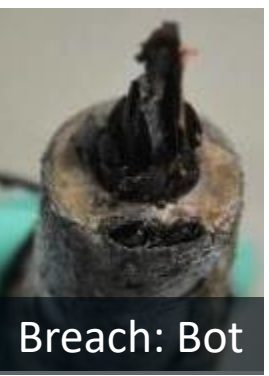
Risk map

From a study of 200 cells, the propensity of cell to undergo certain failure mechanisms, under certain conditions, was mapped.

The number in each box represents the fraction of cells of that particular design, to undergo a particular failure mechanism

1. Proximity of the ISC device to either end increases the risk of breach/ bursting at that end.
2. Thicker casings reduce the risk of bursting but have a similar risk of breaching.
3. Bottom vents reduce the risk of breaching overall, but increase the risk of bottom breaching.

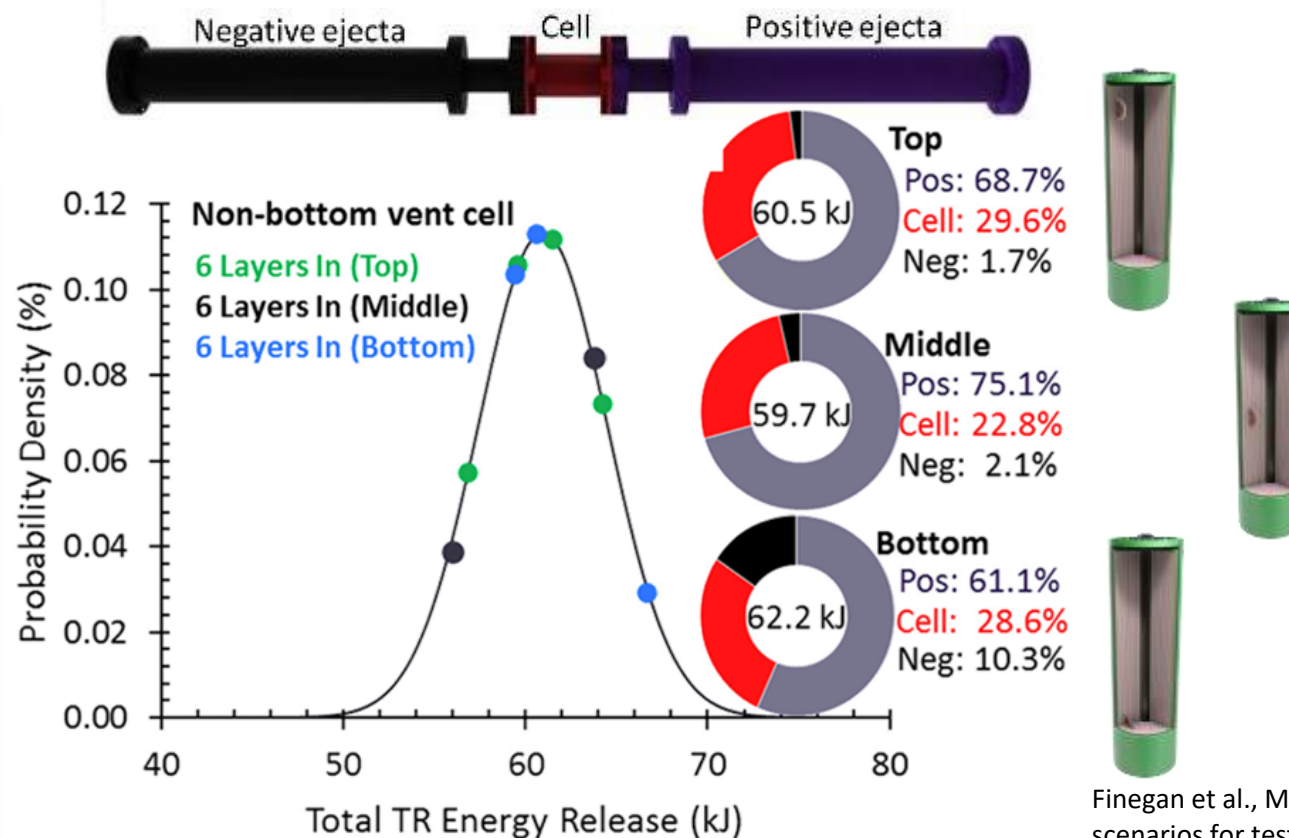
Fractional thermal runaway calorimeter (FTRC)

Ejected and non-ejected heat output

- 3.6 Ah 18650 cells
- Location of thermal runaway initiation **does not have significant impact on total heat output**, but does **influence the fraction of heat ejected**
- Around **70% of heat is ejected**, mostly through the positive vent
- Initiation near the bottom increases risk of bottom breach and heat from the bottom

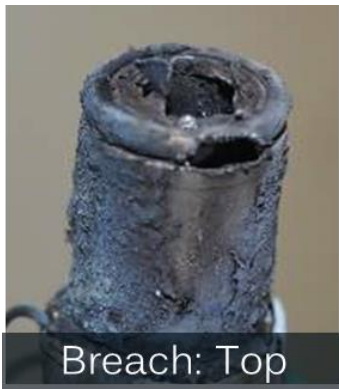
- The **highest risk** scenarios for pressure-induced breaches are when initiation of **thermal runaway** occurs near **either end of the 18650 cell**.
- Burst pressures can reach < 1.5 MPa for temperatures > 650 °C.
- If a cell produces 6 L of gas, and is clogged, the internal pressure could reach 30 Mpa..

Breach: Top

Explains increased risk of breaching occurring, but not the consistent location at spin groove

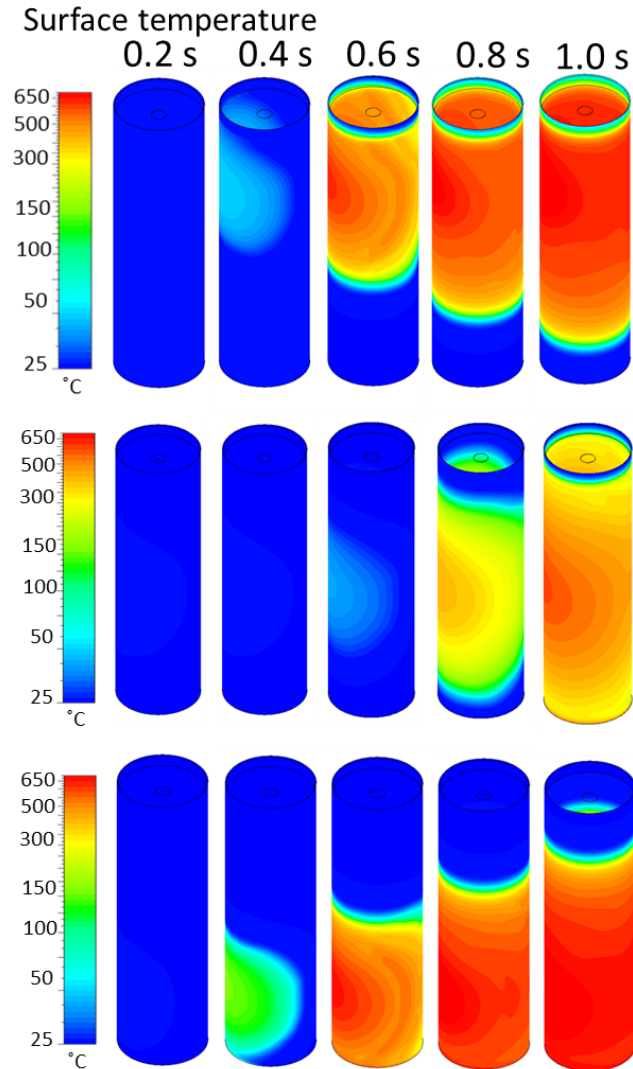
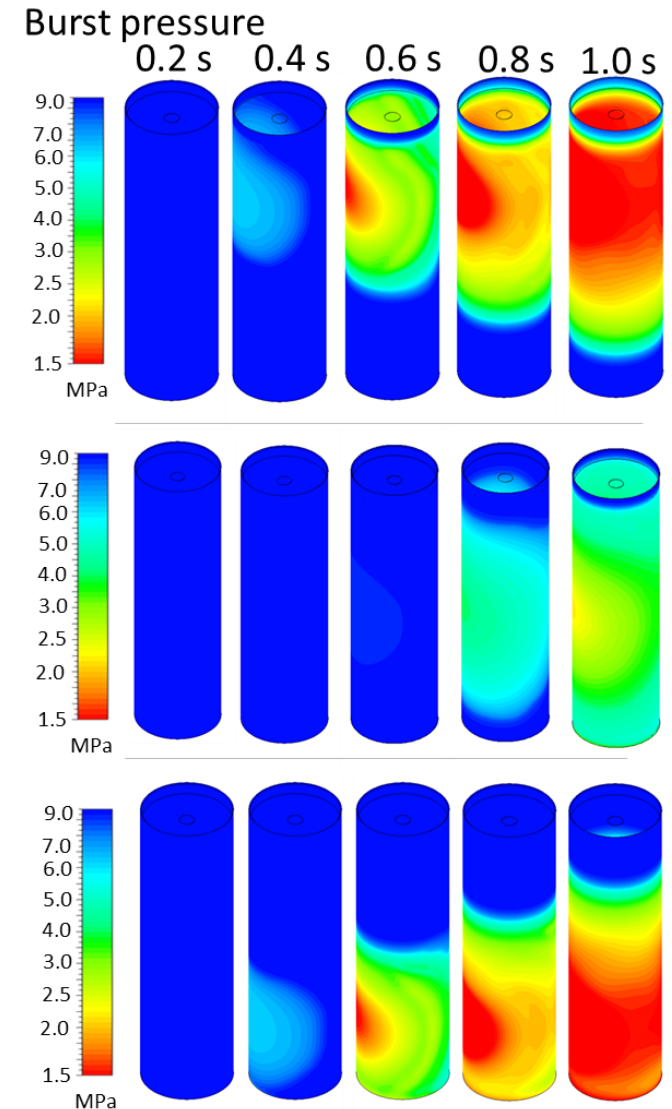
Based on tensile strength properties for S350GD mild steel

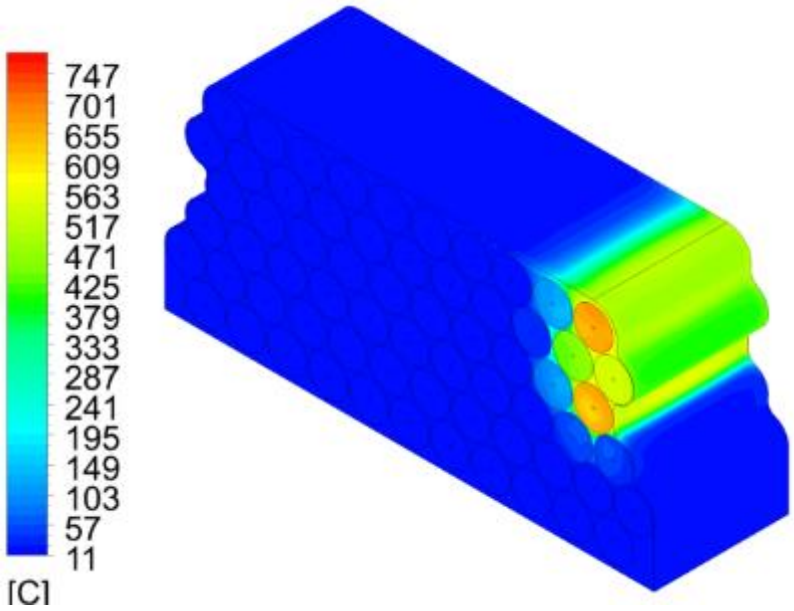
Heat sink sizing

- Single cell data applied to battery pack simulations
 - Modelling sizing of heat sinks to avoid propagation
 - Estimating temperatures of pack enclosures when subject to ejected heat
 - Spatially quantifying the distribution of heat within an enclosure following cell failure

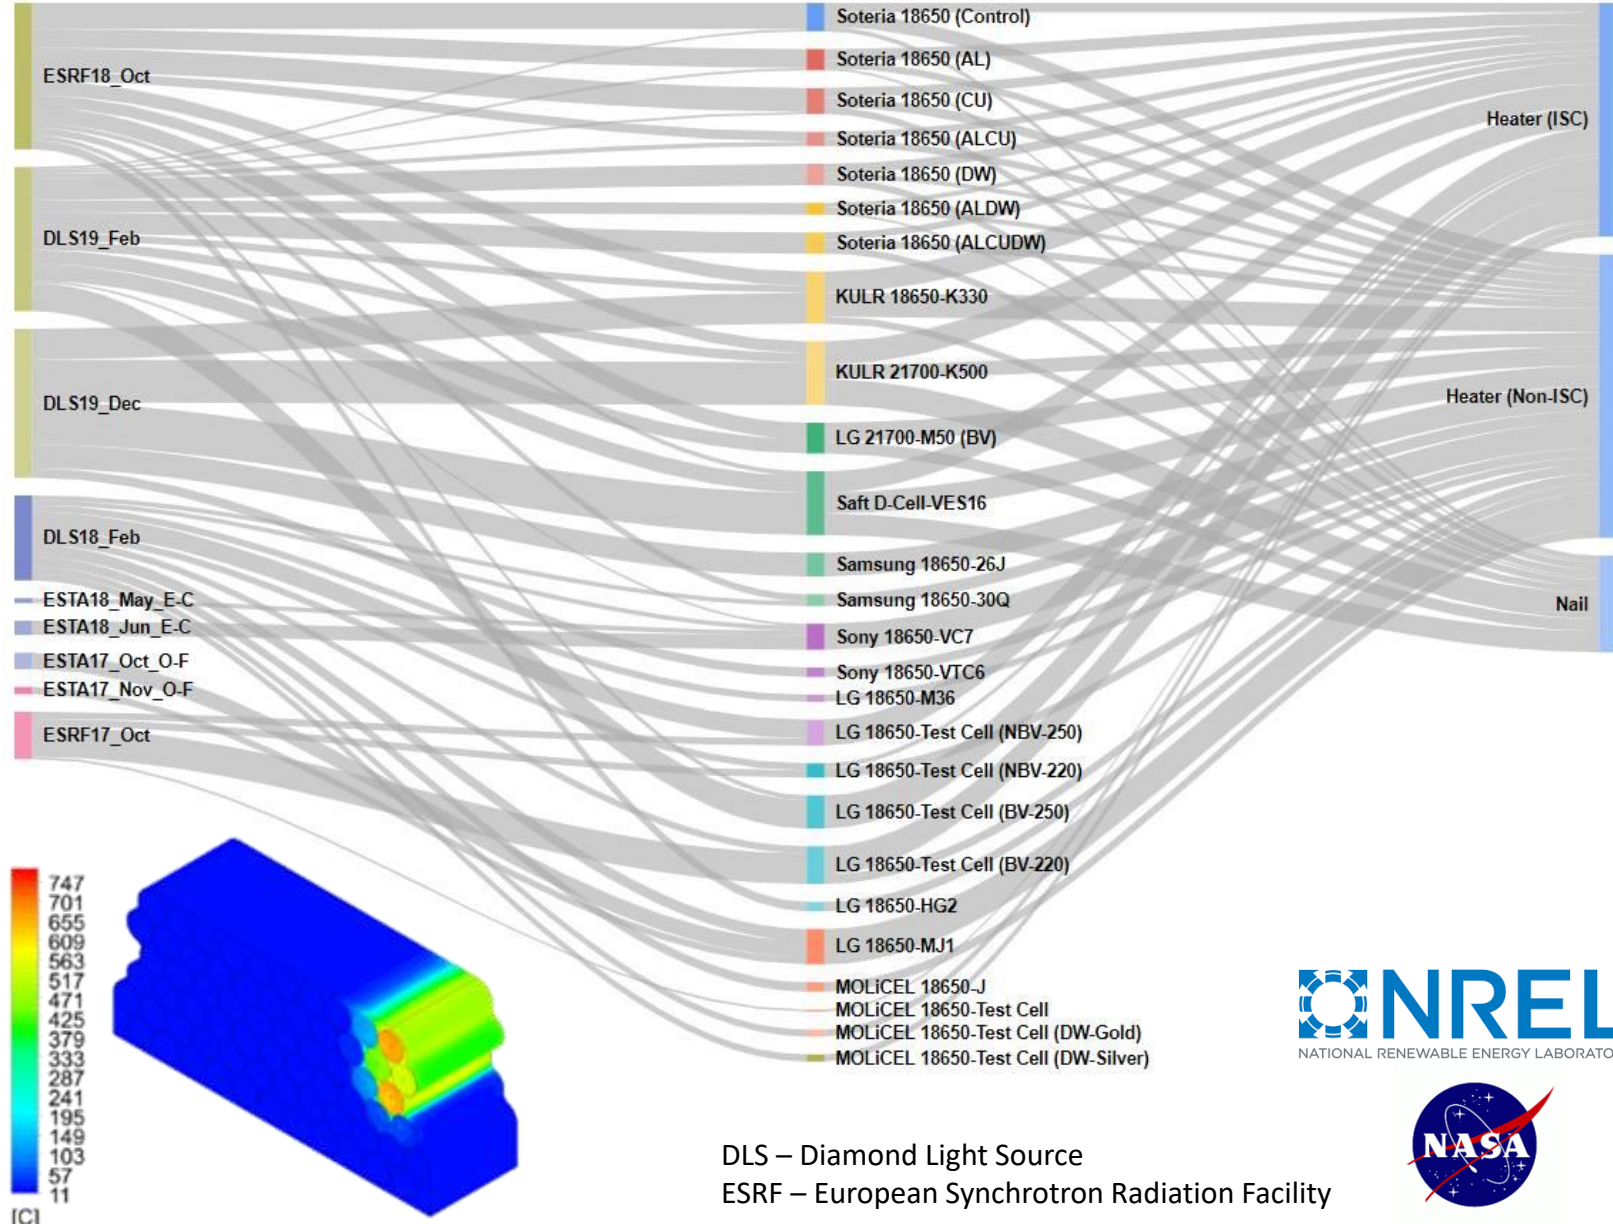
Battery failure databank

- Radiography and thermal data from over 300 tests of commercial cells
 - Providing engineers and researchers with data to inform models
- Link internal phenomena with external risks
- Compare heat output and mass ejection from different abuse mechanicals
 - Nail penetration
 - Thermal abuse
 - Internal short circuiting
- Compare different models of cells
 - Power cells
 - Energy cells

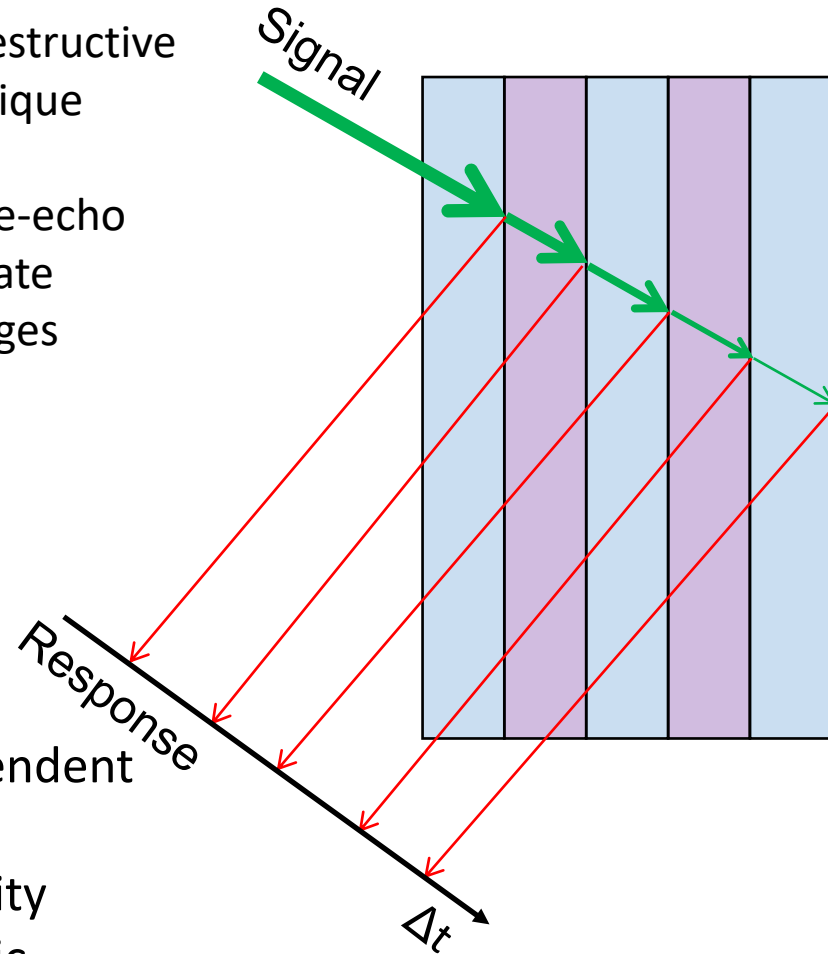
- Rapid in-line, non-destructive cell diagnostic technique
- High-frequency pulse-echo mechanism to evaluate electrode level changes

Figure 1: Illustrating the fundamental principles of acoustic time of flight

- Time of flight dependent on:
 - Material density
 - Material elastic modulus
 - Thickness
 - Structural changes

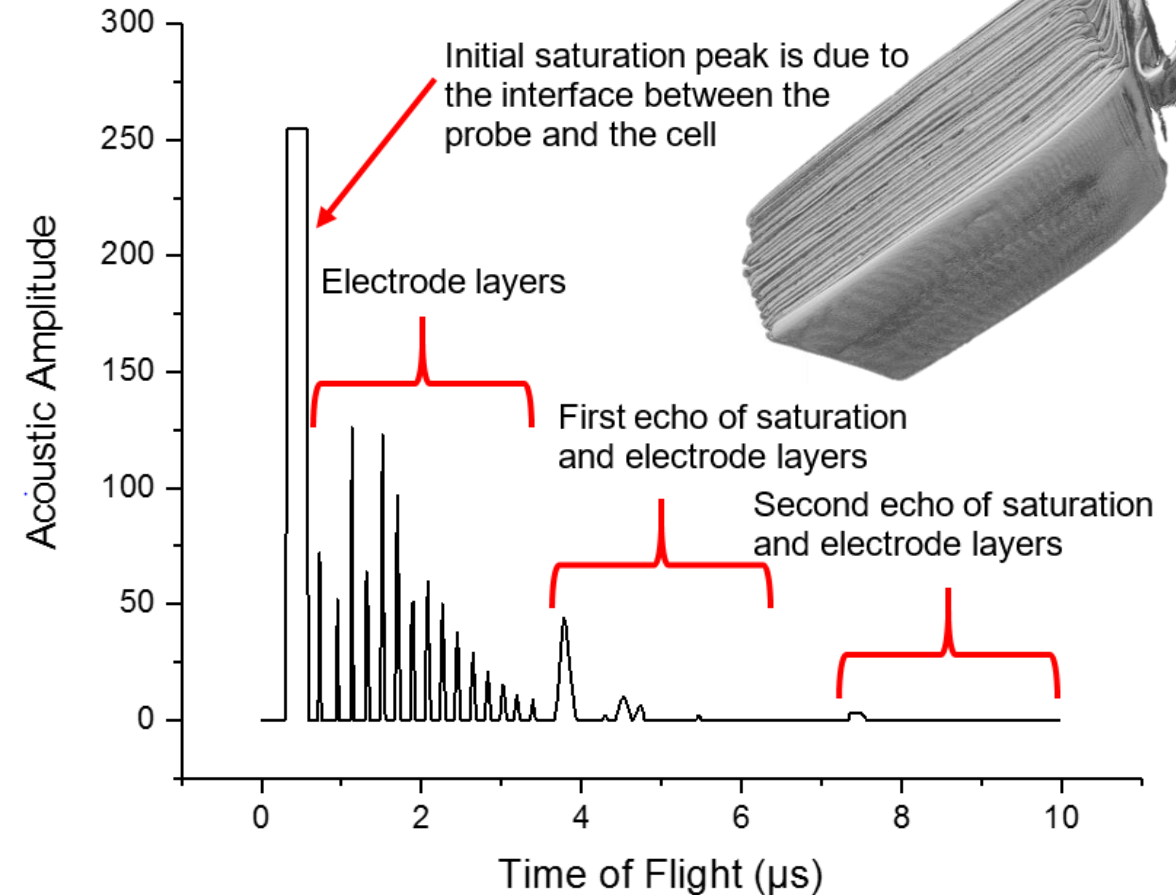
Figure 2: Representation of a characteristic acoustic time of flight waveform for a pouch cell, CT of corresponding pouch cell shown inset

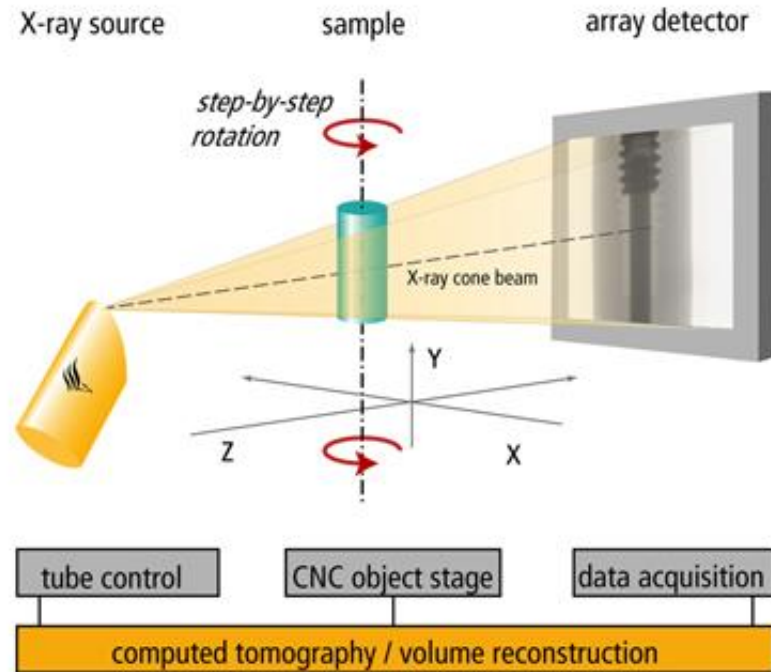
Figure 3: A simple schematic of the experimental set-up used in the Nikon XT H225 to produce simultaneous acoustic spectroscopy and X-ray imaging.

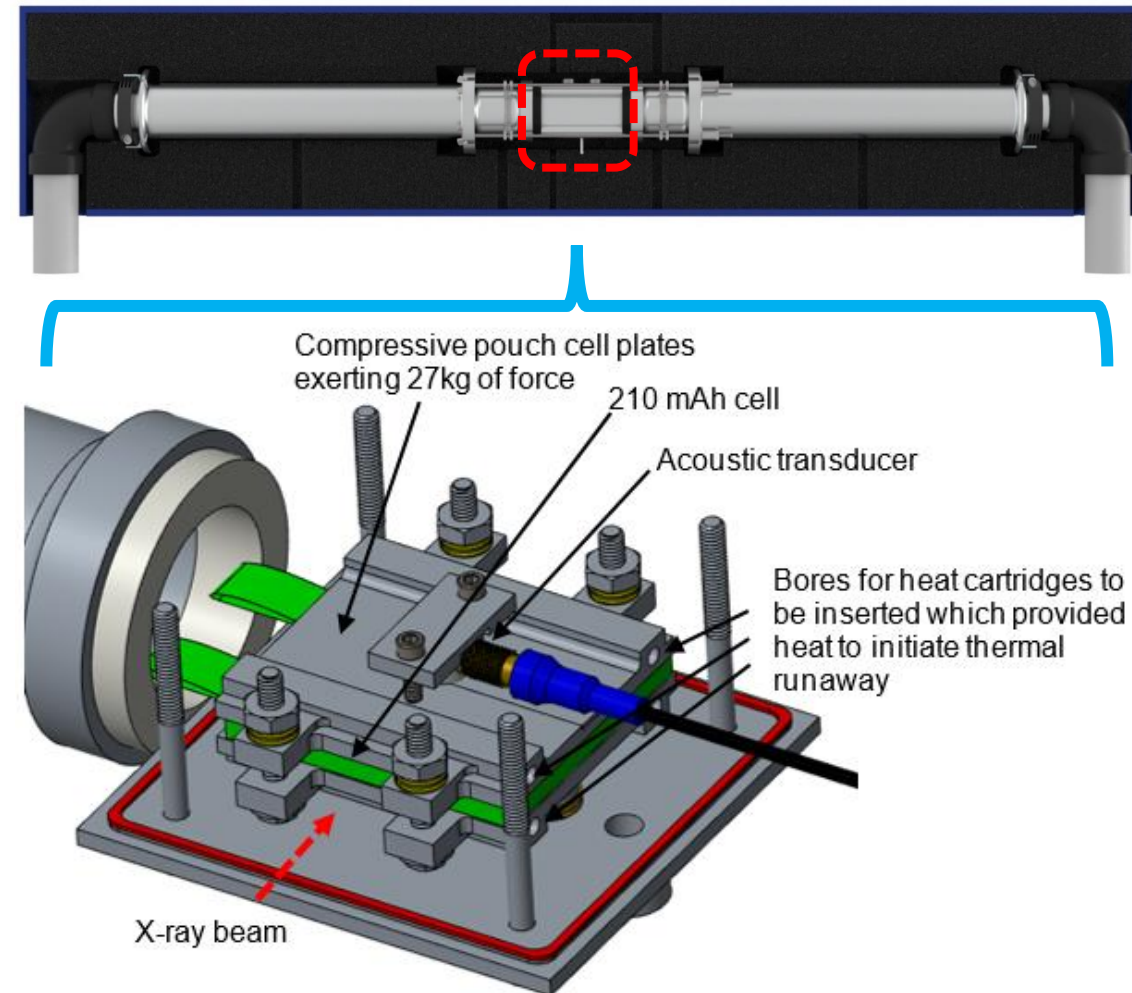
Figure 4: CAD rendering of the ultrasonic transducer in the pouch cell calorimeter cell chamber stack under compression

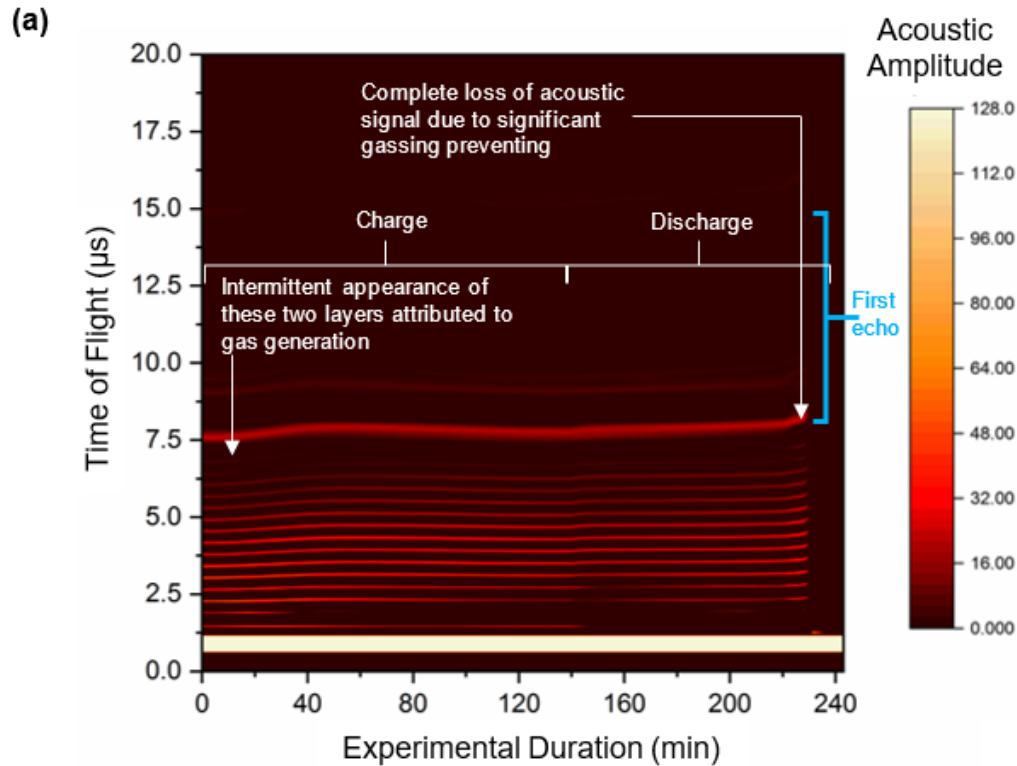
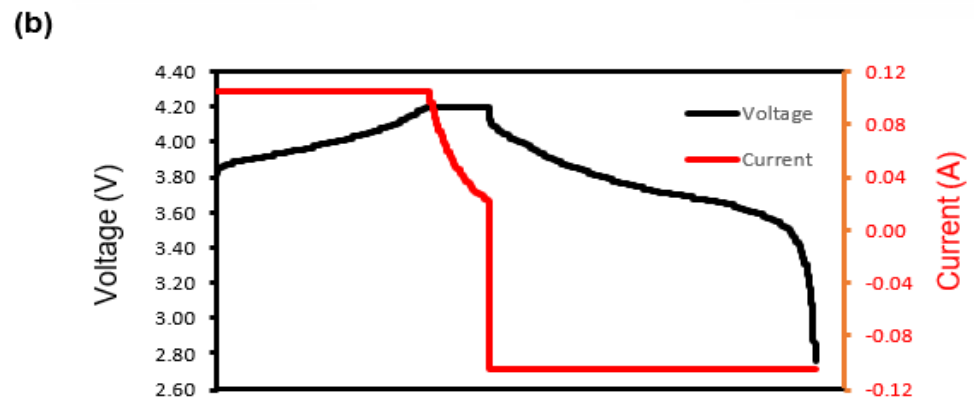
Instantaneous acoustic pulse-echo 'snapshot' acquisition, at Experimental Duration = 0 min

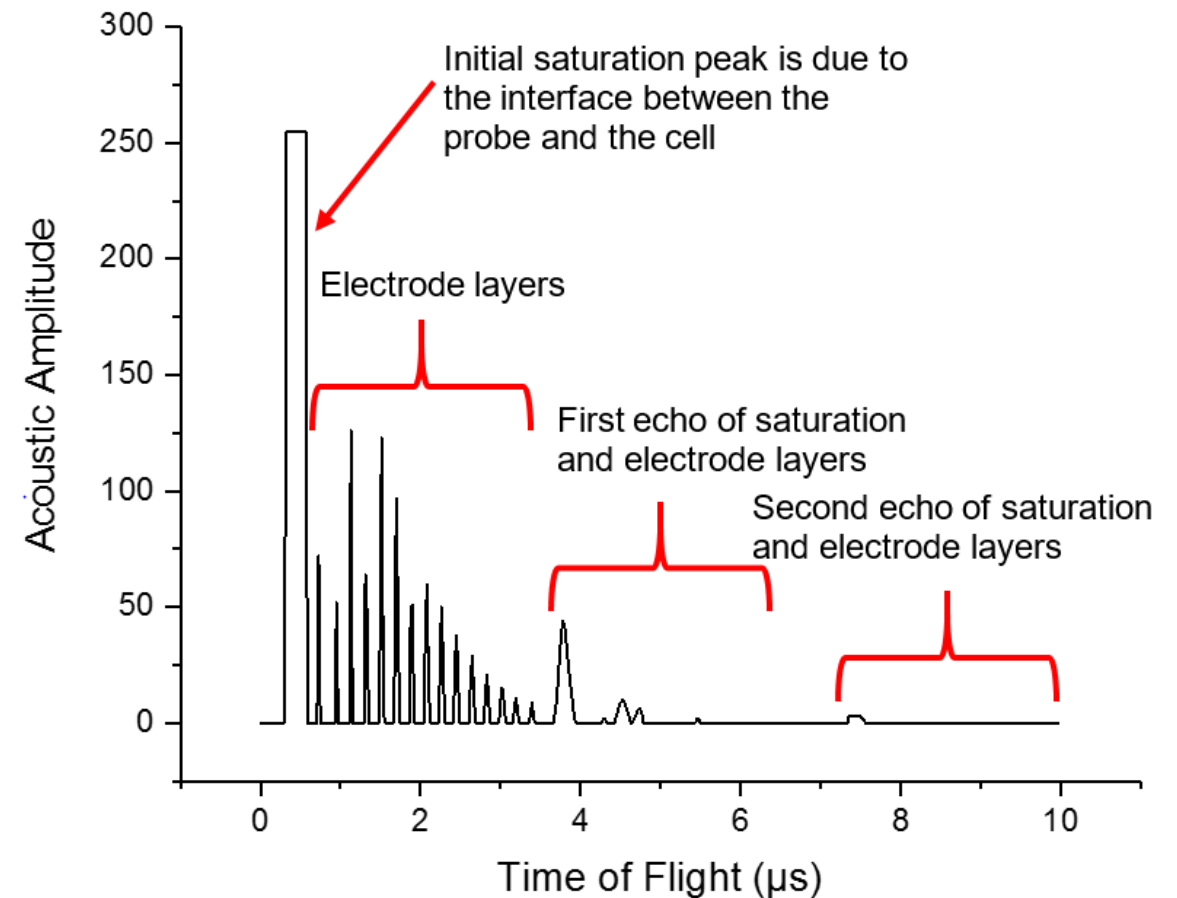
Figure 5: Acoustic time of flight during defect induced delamination during operation of a 210 mAh pouch cell.

- An **open-source database** of radiography and thermal data to be released soon.
- Acoustic technique demonstrated to enable detection of deformed electrode layers leading up to thermal runaway.

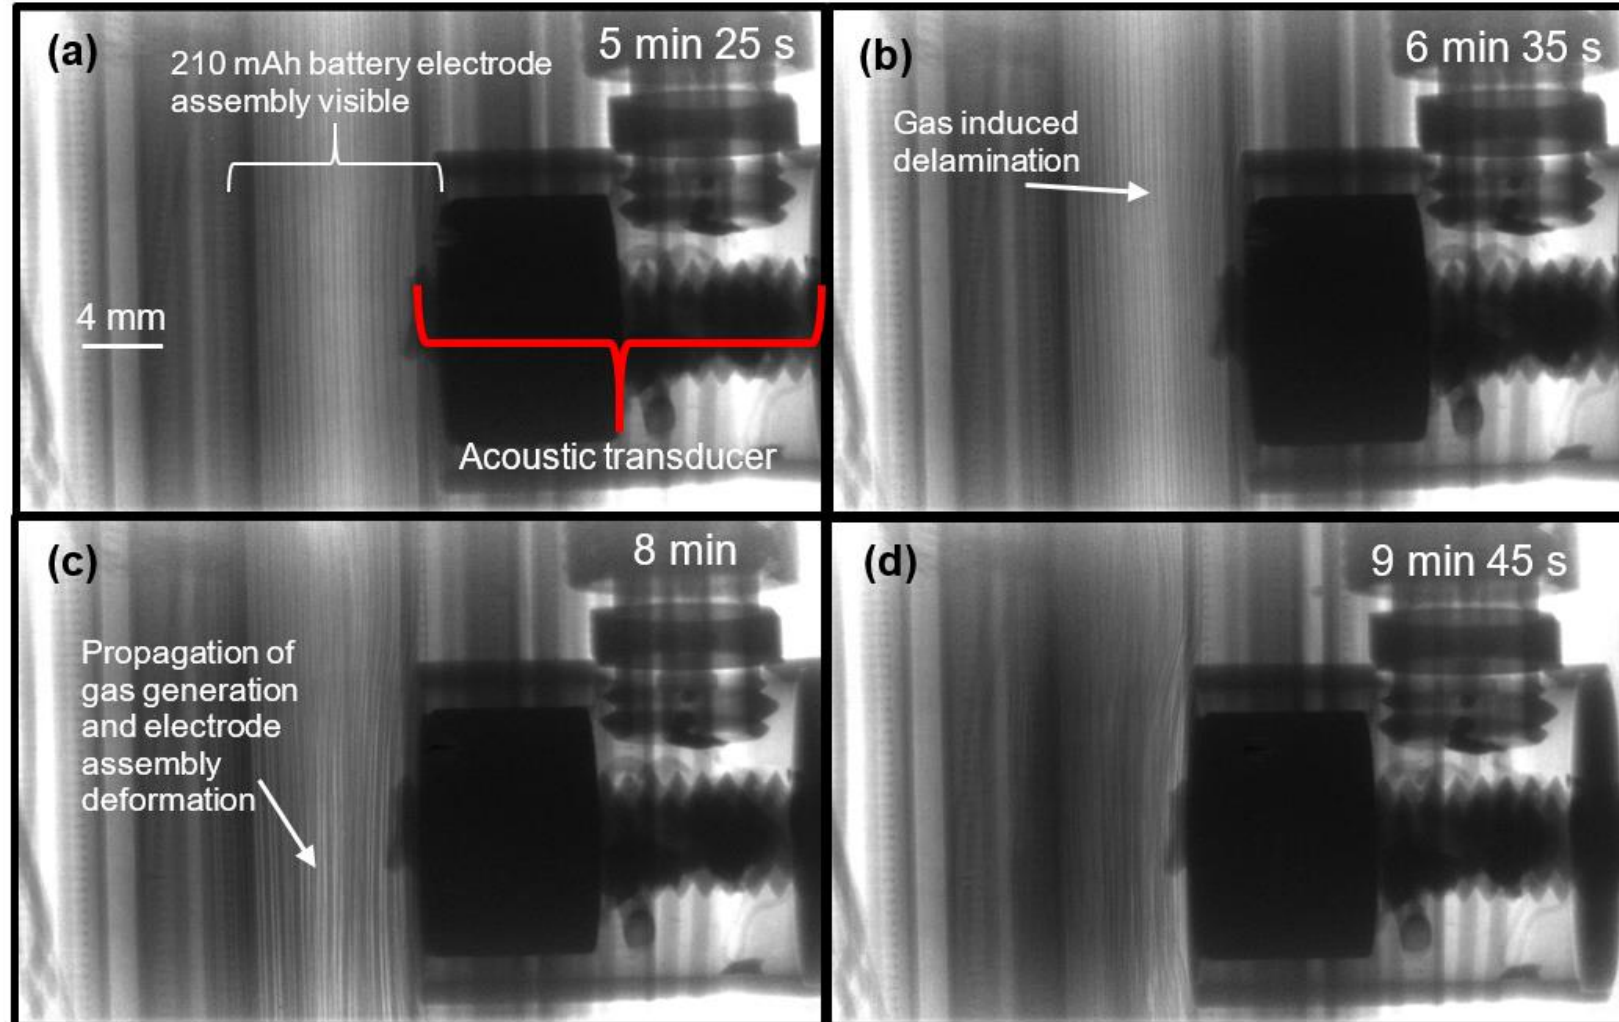
Figure 8: Selected radiography frames from Cell 1 highlighting significant structural changes during thermal runaway in the first failure test. Delamination and gas generation predicated the initiation of widespread thermal runaway.

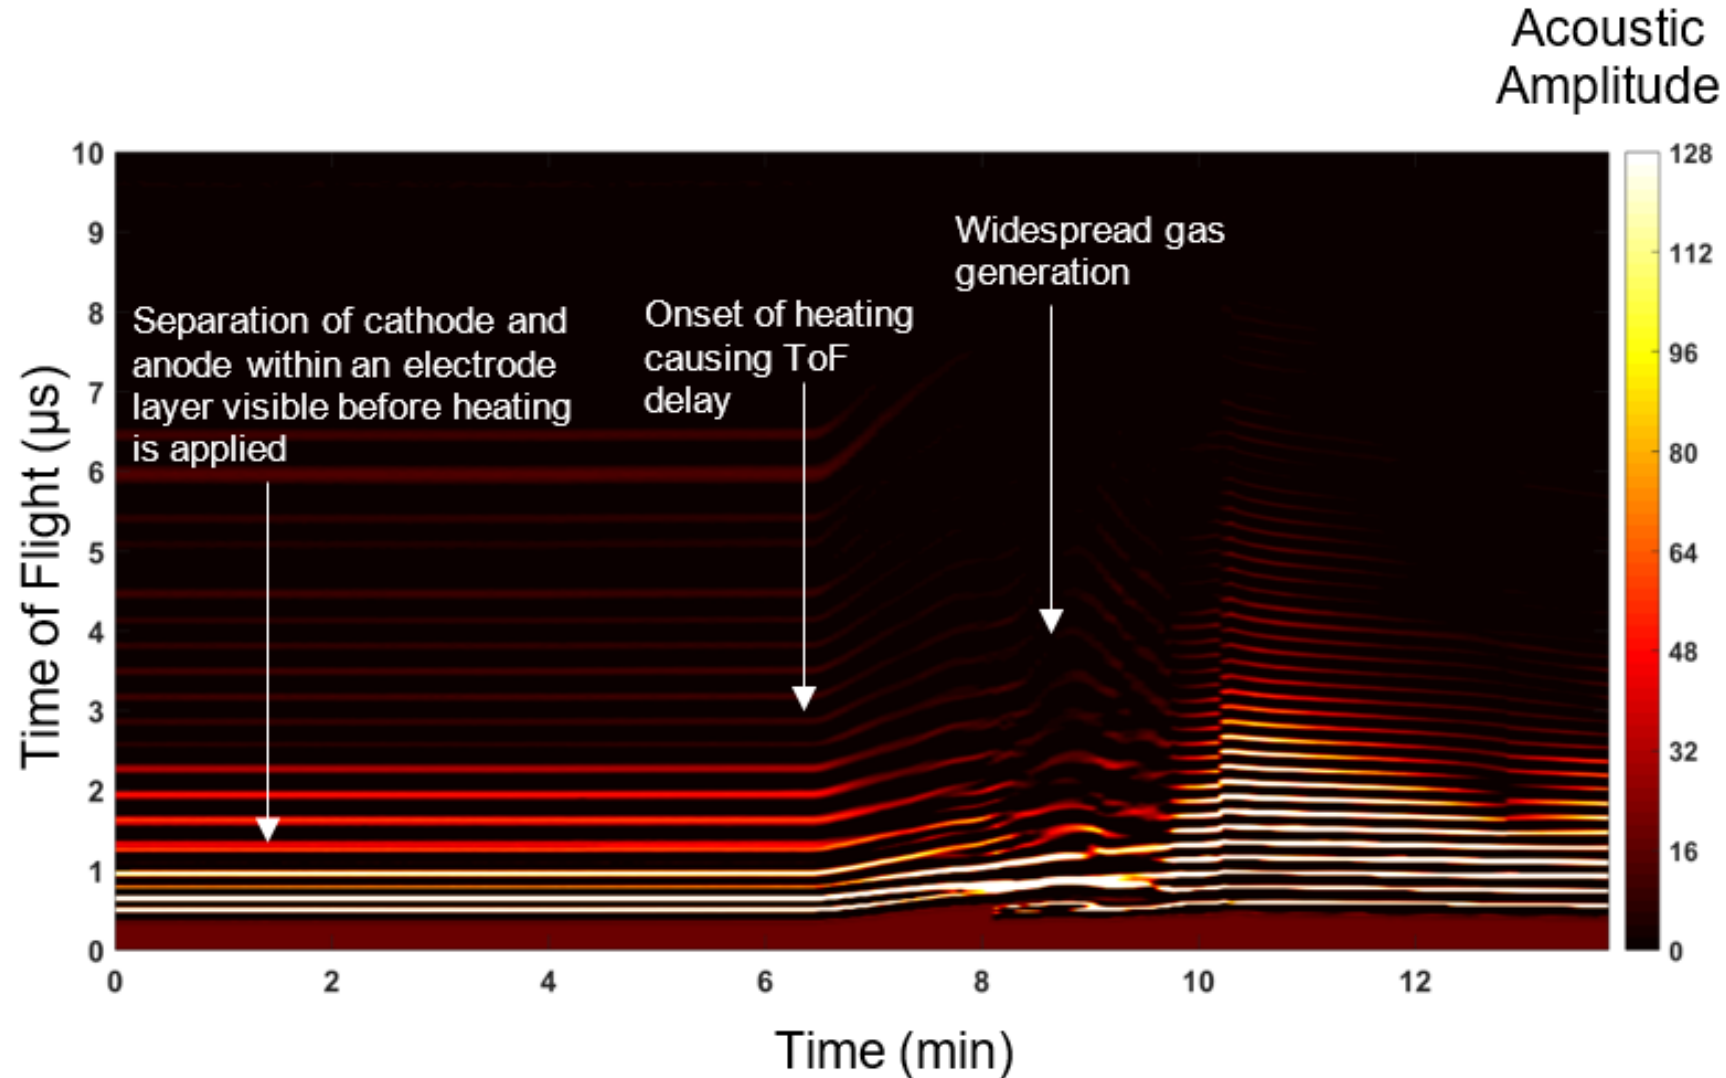
Figure 9: Acoustic time of flight during thermal runaway of Cell 1

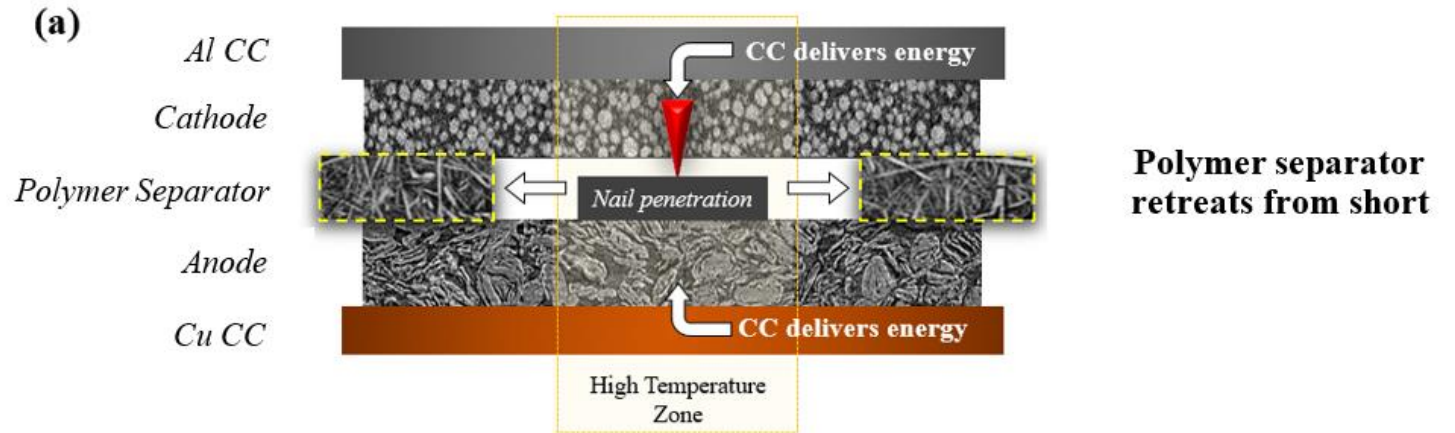
Typical cell failure from nail penetration

- Anode and cathode contact via the nail causes an unmitigated short-circuit
- Elevated temperatures due to Joule heating causes thermal decomposition of electrode components, initially with the polyolefin separator and electrolyte
- In cells with the PCC, the PCC would react to the elevated temperatures before the separator could fail, this would prevent cathode-anode contact as well as electrically isolating the cathode from the nail and the anode.
- Whether the PCC's safety mechanism acted before the failure of the 10 μm polypropylene separator would dictate the efficacy of the PCC.

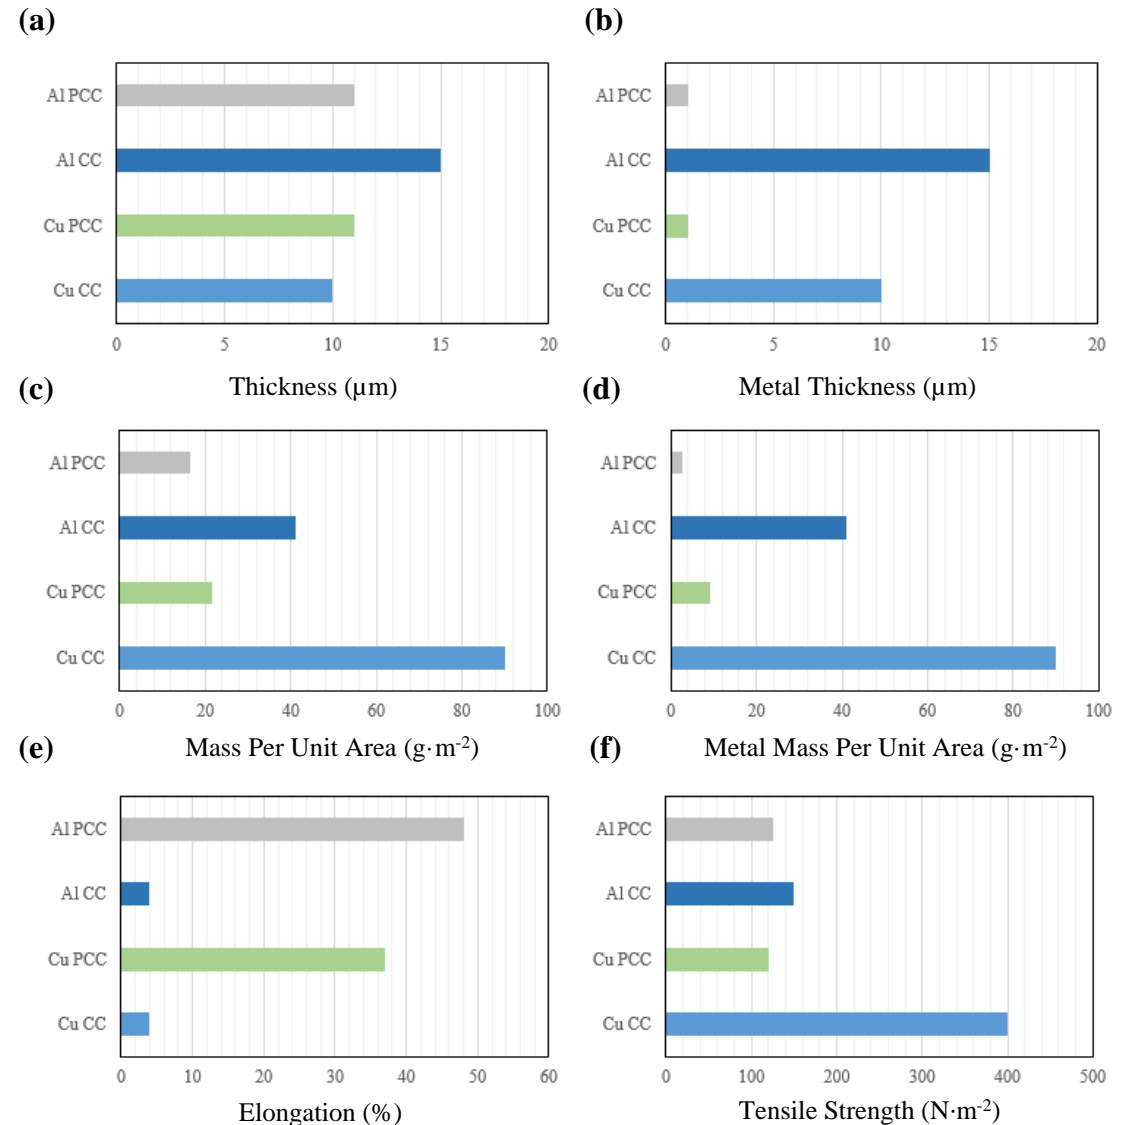
PCCs: Gravimetric Energy Density

- Similar thicknesses to commercial metal foil current collectors (CCs):
 - Al CC: 15 μm , Al PCC: 11 μm
 - Cu CC: 10 μm , Cu PCC: 11 μm
- PCCs have a polymer substrate (ca. 8 μm thickness) with ca. 0.5 μm metal film coating of Al or Cu
- Therefore, a significant reduction in the amount of metal required by the PCC compared to commercial metal foils used as current collectors
- This reduction in metal is noticeable on the cell level as the average mass reduction was 2.2 grams, ca. 5% of total mass of a commercial metal foil CC control cell
- Mechanical properties of PCCs allow for assimilation with current cylindrical cell roll-to-roll manufacturing technology

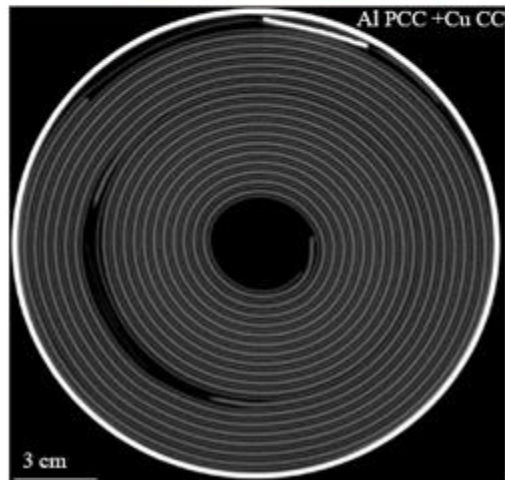
Group 1, G1

Al PCC

Cu CC

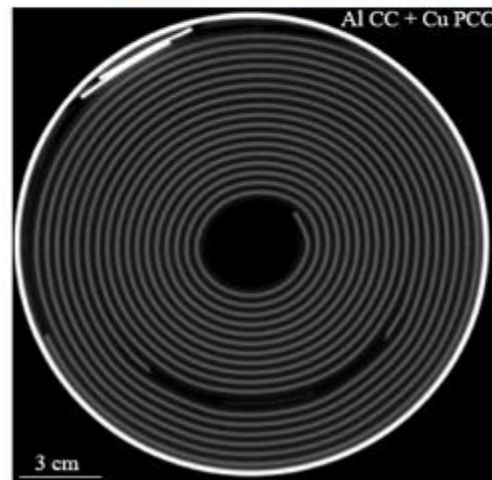
Group 2, G2

Al CC

Cu PCC

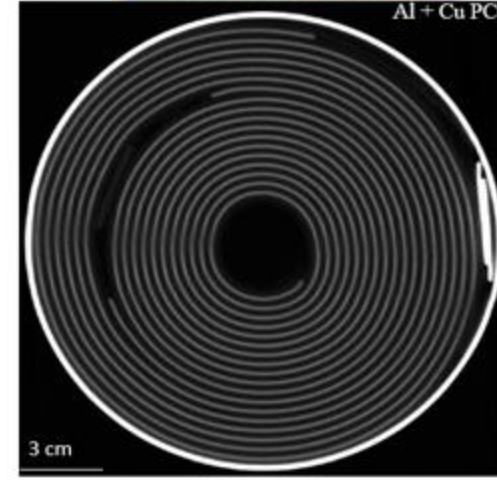
Group 3, G3

Al PCC

Cu PCC

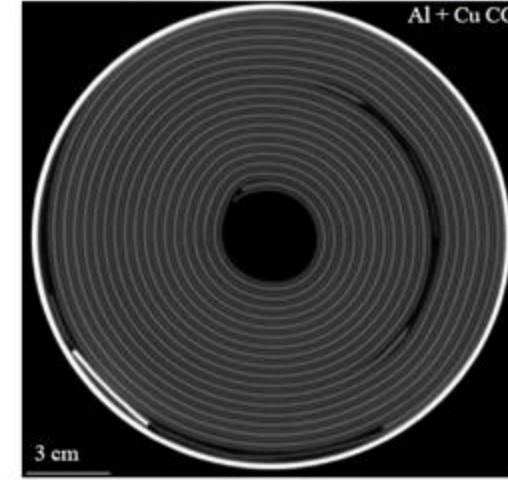
Group 4, G4

Al CC

Cu CC
