Progress on new methods, materials, and insights for safety Li-ion battery systems

Donal Finegan
NASA Battery Safety Workshop
18 Nov 2020

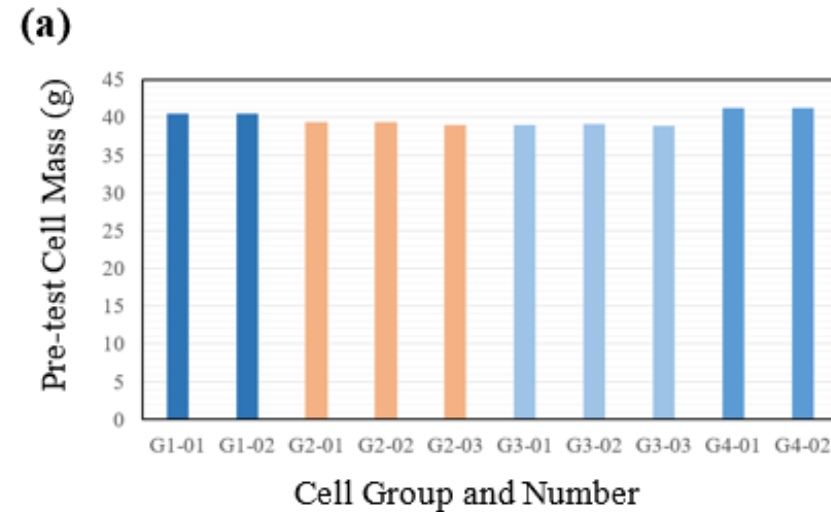
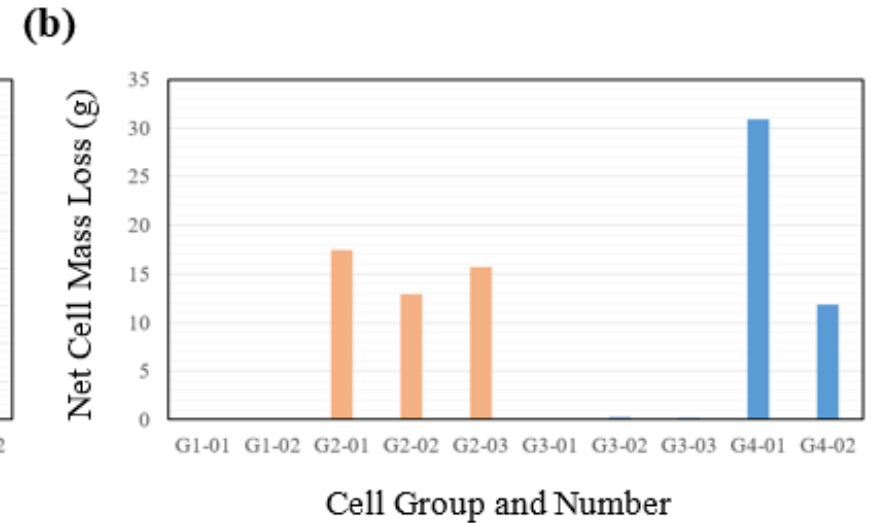
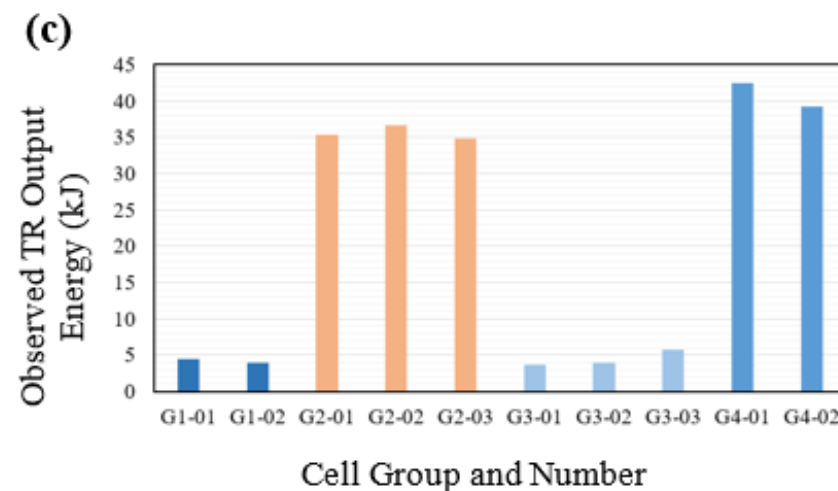
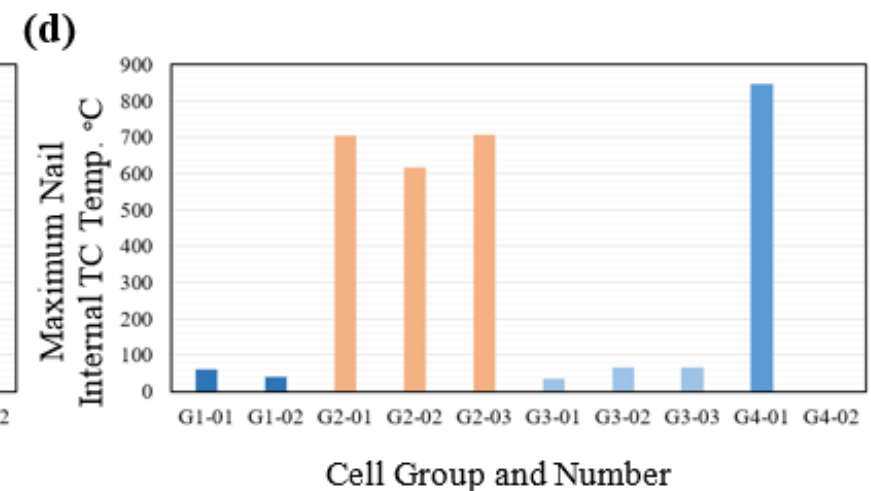
Results: Failure Prevention and Calorimetry

- Mass reduction in cells with one or both of the PCCs, mass reduction of 2.2 g with both
- Significant difference in observed TR output energy, maximum nail TC temperature and net cell mass loss with Al PCC cells
- Cu PCC alone did not protect the cells from undergoing thermal runaway but mitigation of the output energy was observed. This was due to the nail in contact with the cell during penetration, thus the Cu PCC despite protecting the anode, the graphite was connected to the cell can and shorted with the unprotected cathode.

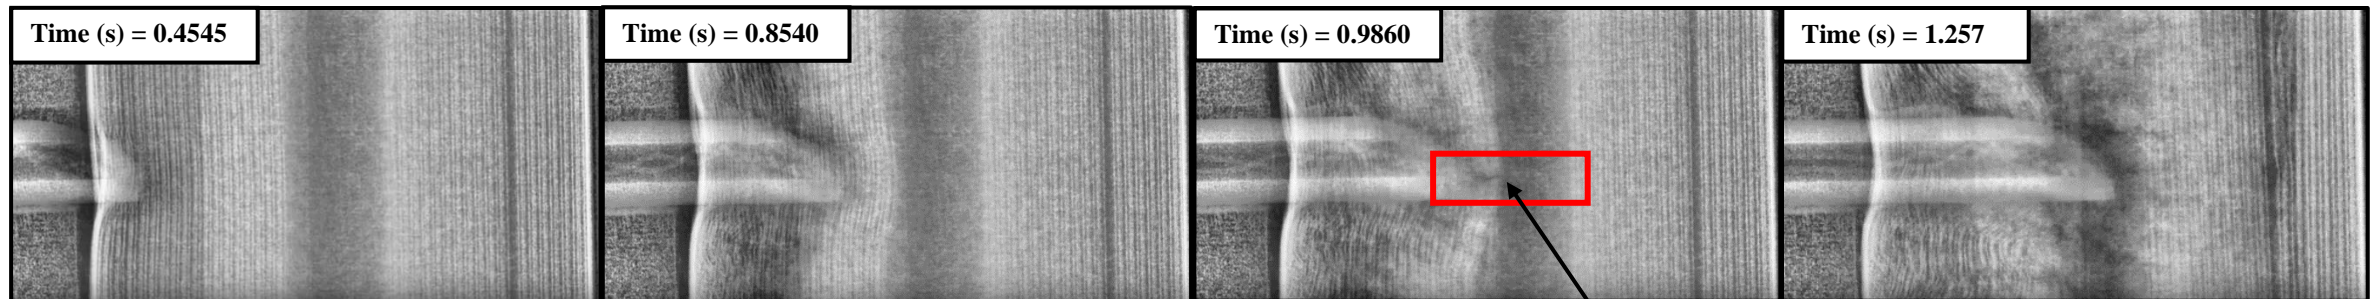
(a) G4-01 (Al CC + Cu CC) Radiography

Characteristic cracking when Al PCC is absent

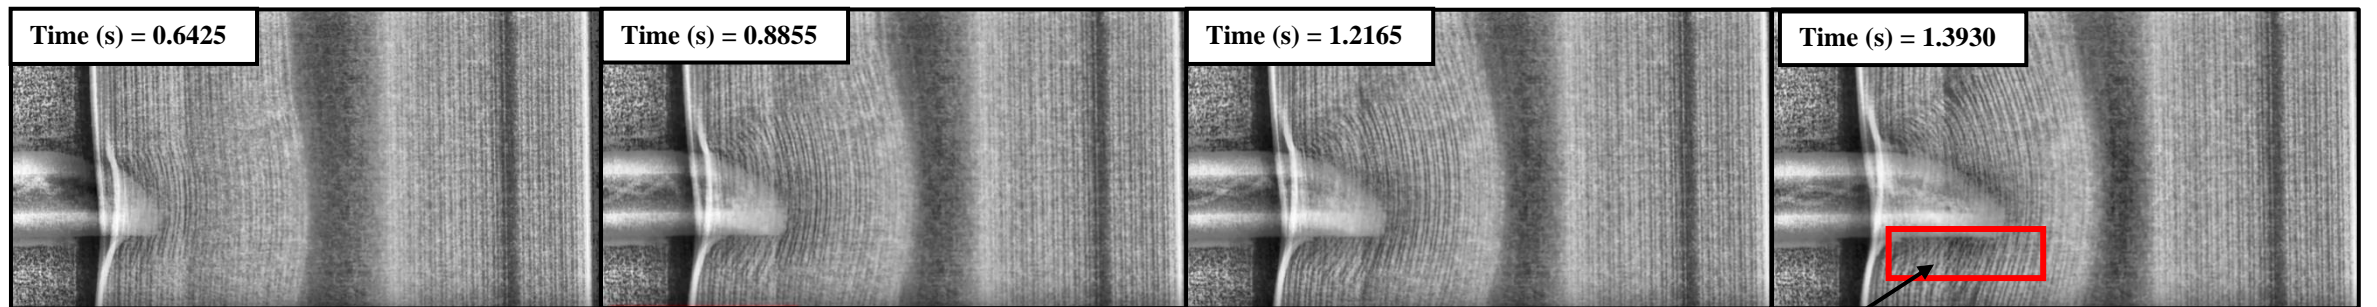
(b) G1-01 (Al PCC + Cu CC) Radiography

Electrode layers adjacent to nail splitting

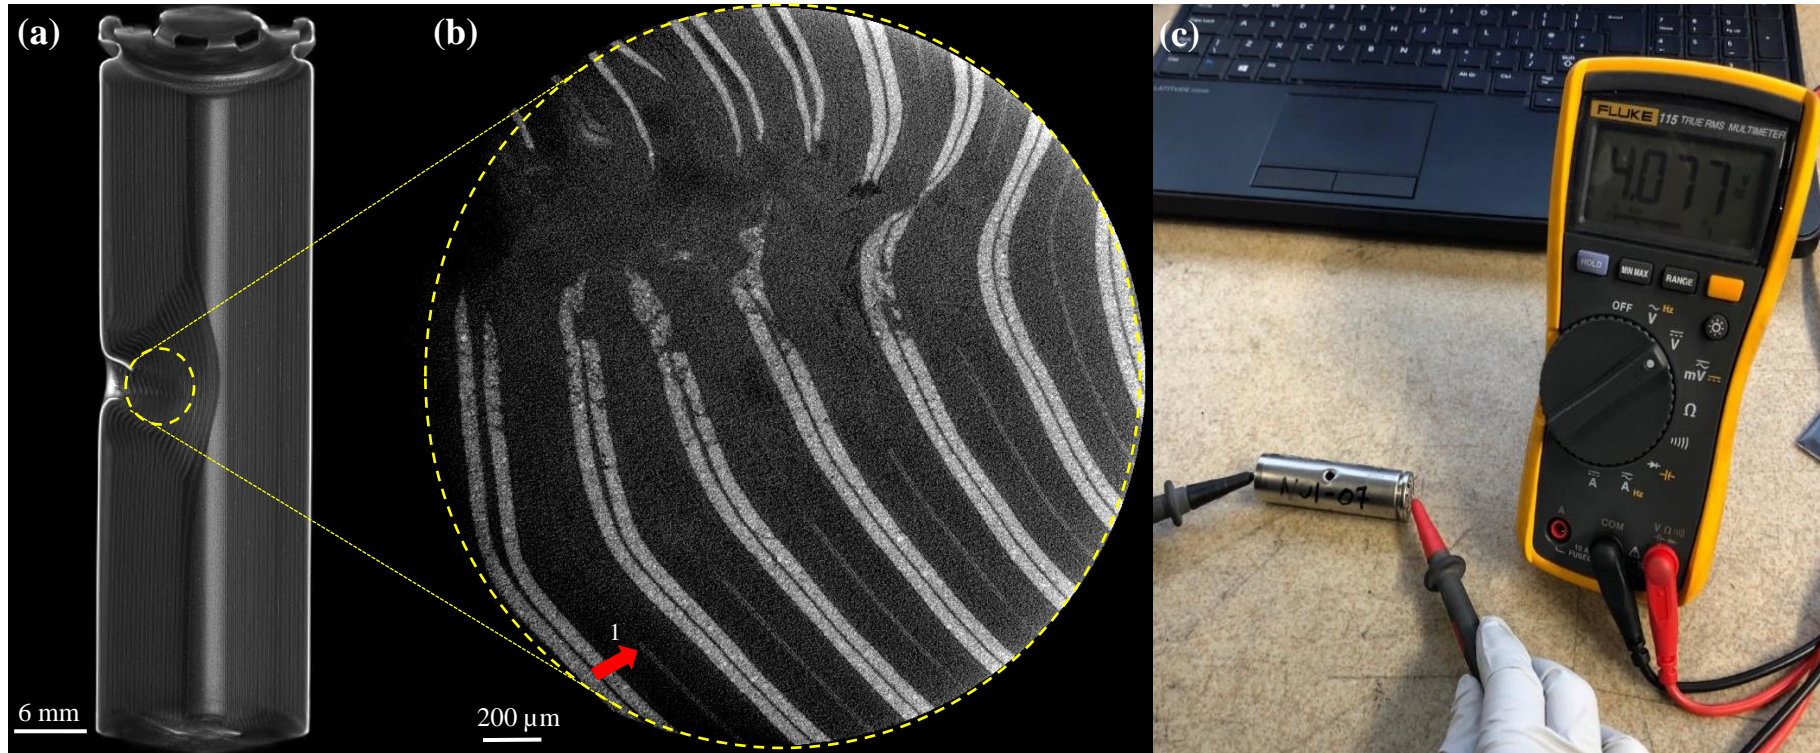
Results: Post-mortem CT and 4.077 V

Sub-micron X-ray CT reveal Al PCC had shrunk away from the elevated temperature of the nail, which caused the microscopic short-circuit. This prevented further short-circuiting, subsequent OCV measurement showed 4.077 V. Cells retained voltage for over 10 months.
