Appendix B-Orbiter Historic Photos

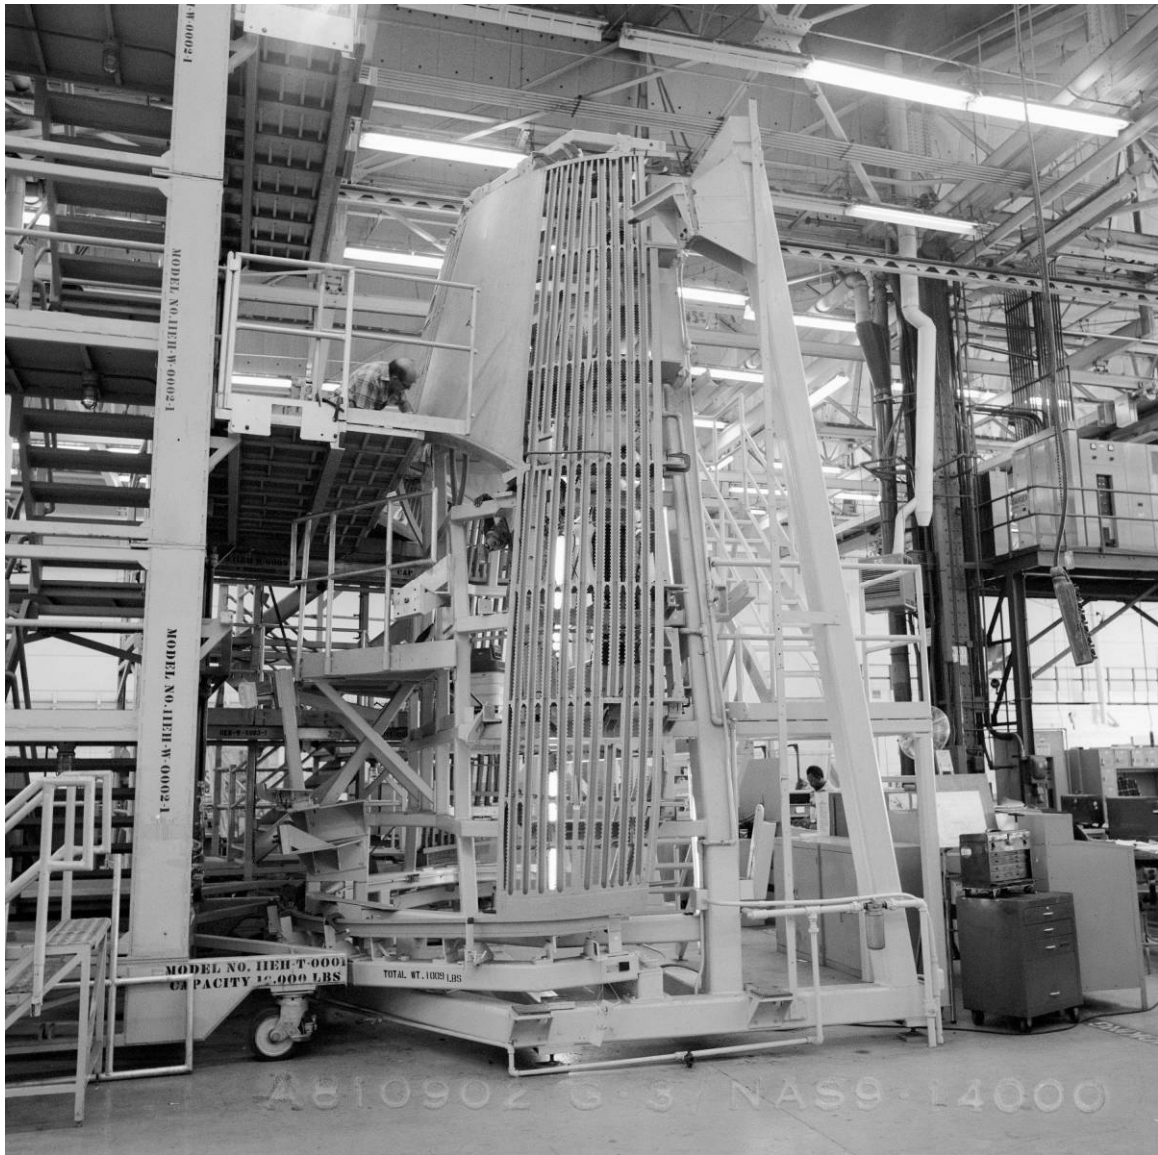
Figure B-3. Manufacturing of *Discovery's* upper forward fuselage, NAR Building 290, Downey, California, September 2, 1981.
Source: NASA, Johnson Space Center Image Repository, JSC2010-03146.

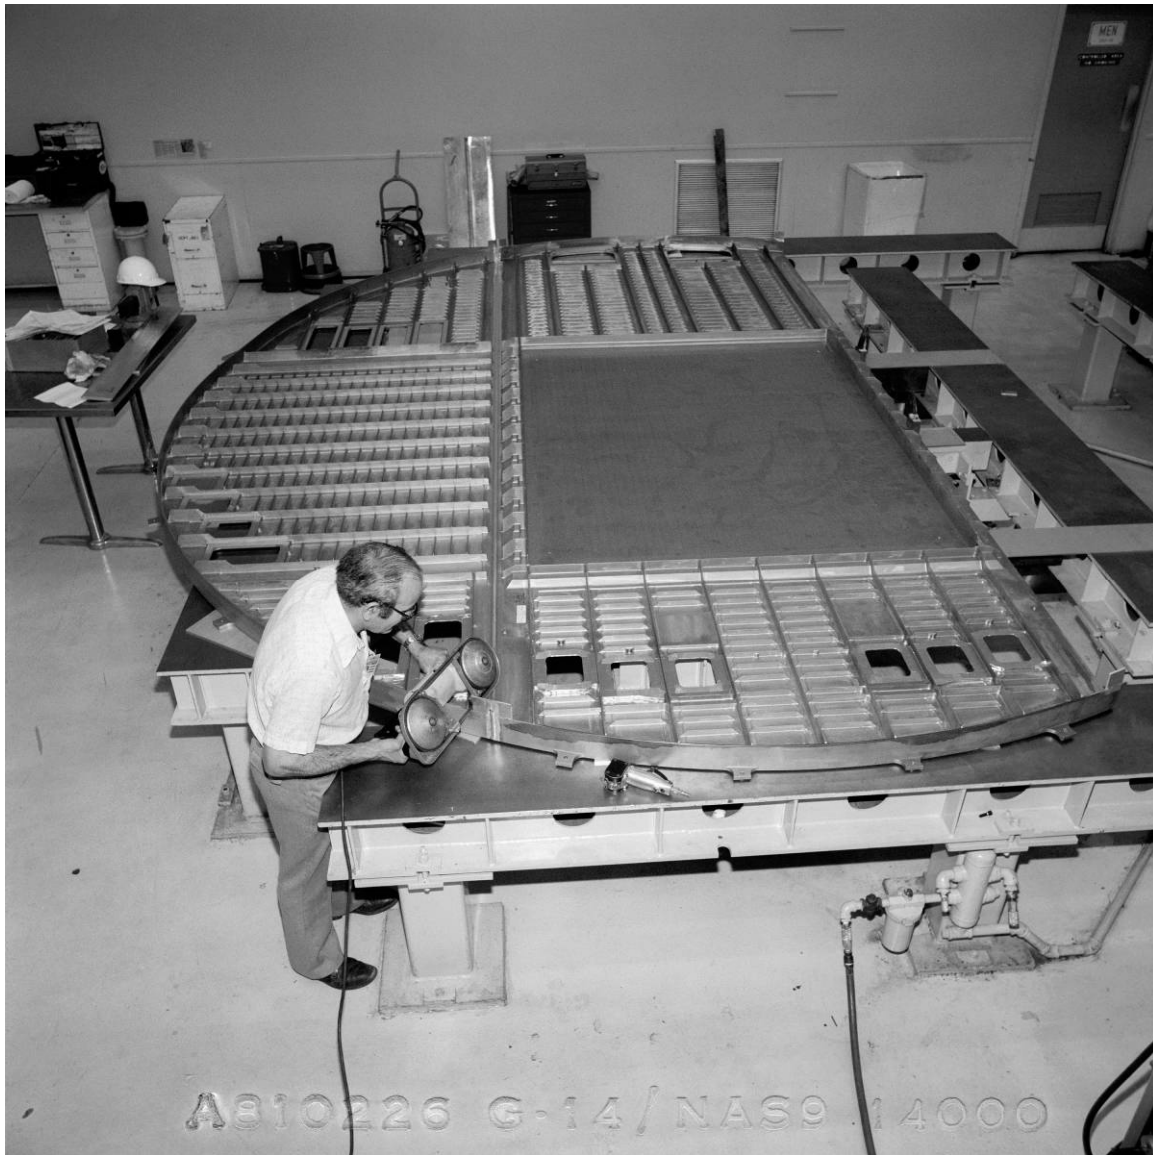
Figure B-5. Manufacturing of *Discovery's* crew module aft bulkhead, NAR Building 290, Downey, California, February 26, 1981.
Source: NASA, Johnson Space Center Image Repository, JSC2010-03081.

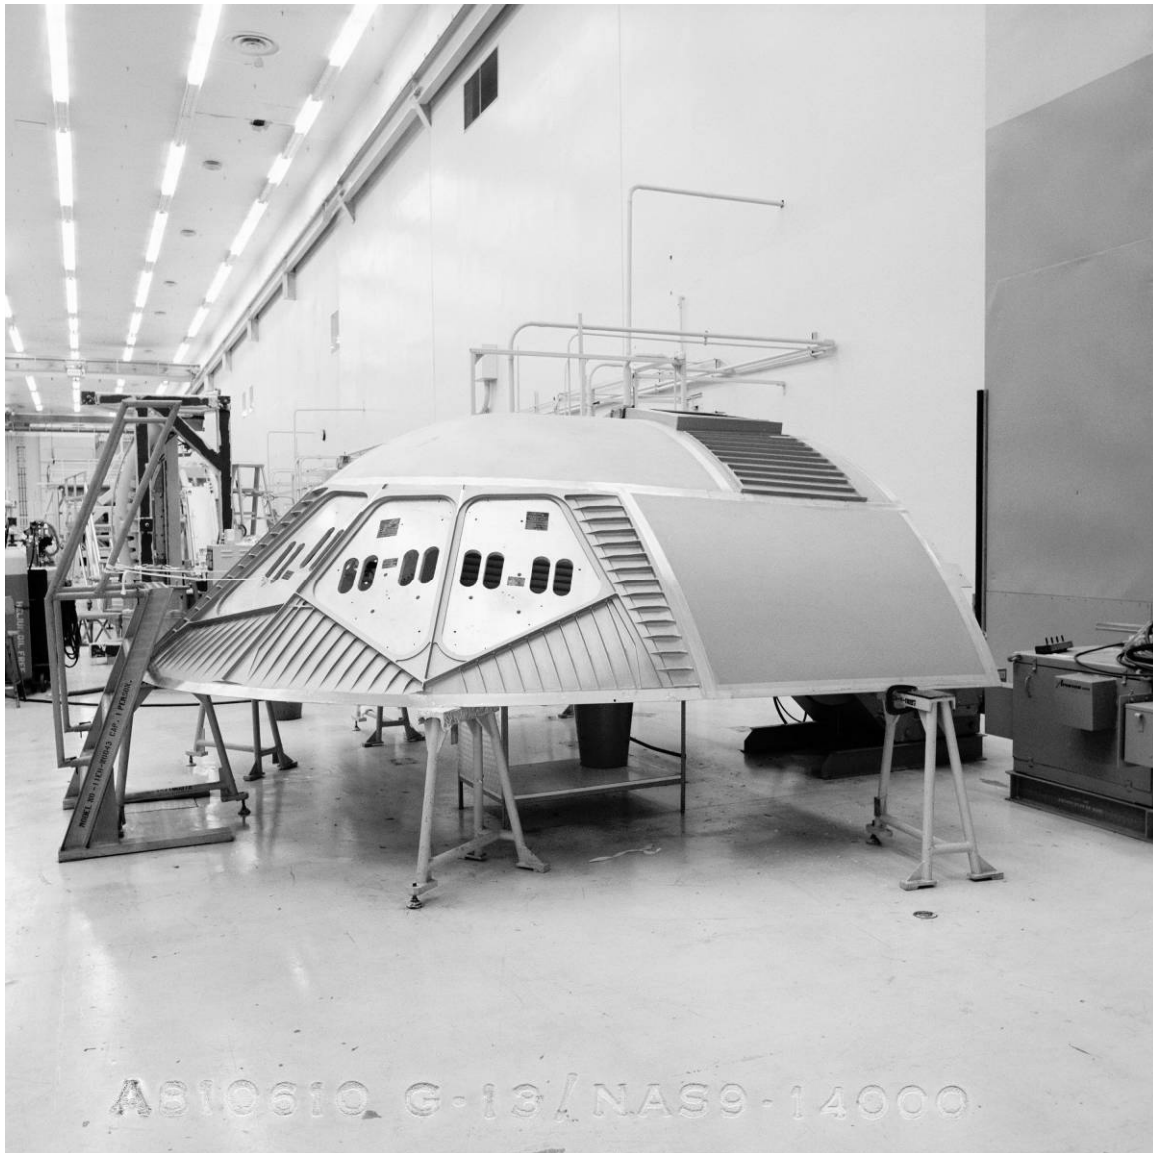
Figure B-6. Upper skin panel assembly for *Discovery's* crew module, NAR Building 290, Downey, California, June 10, 1981.
Source: NASA, Johnson Space Center Image Repository, JSC2010-03105.

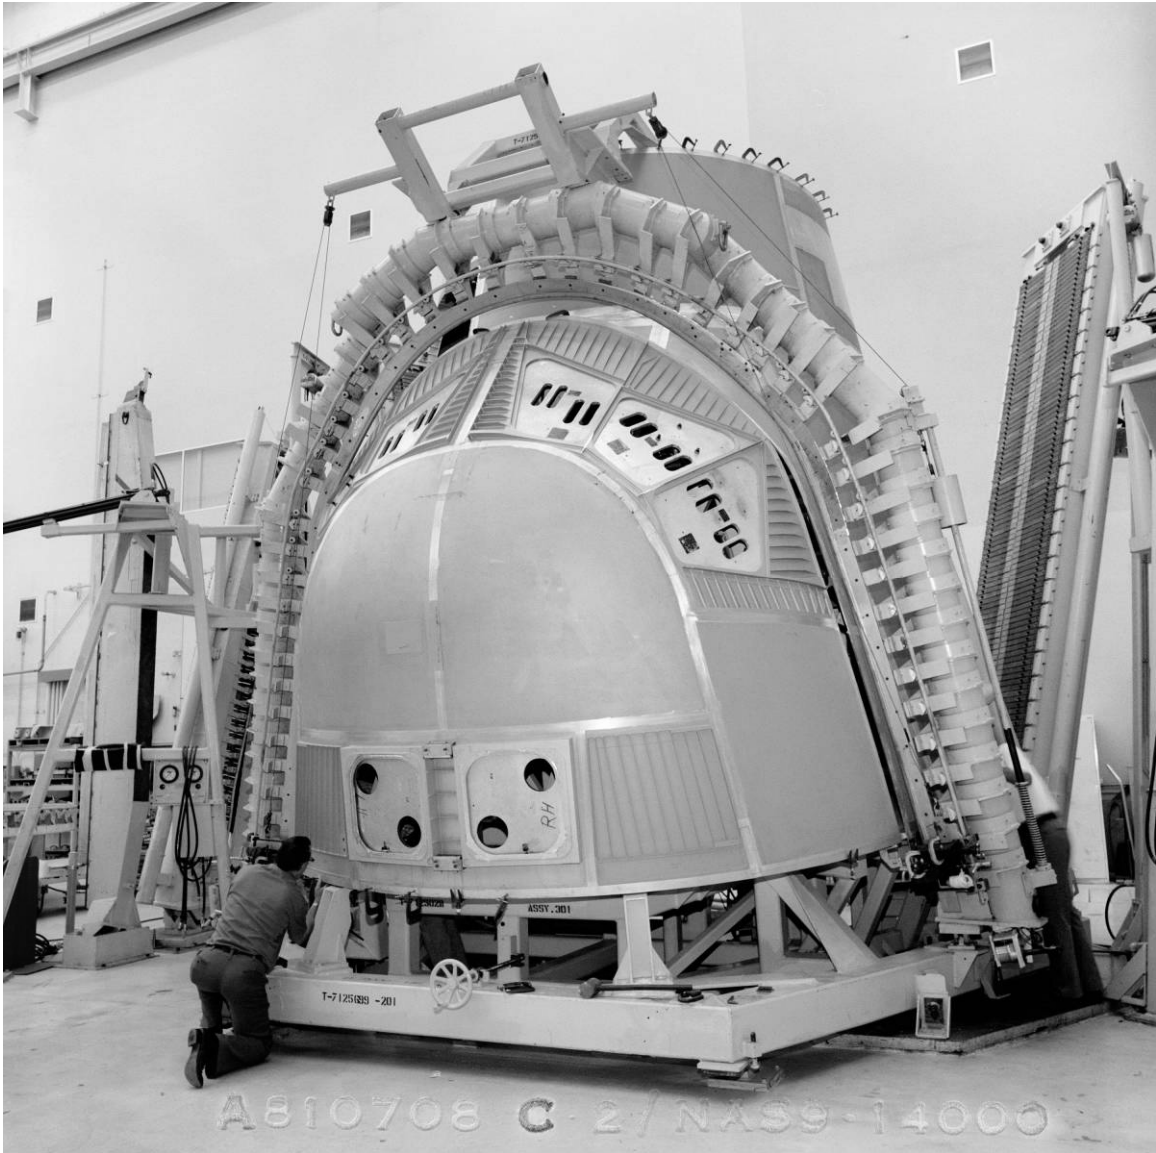
Figure B-8. Primary structure assembly for *Discovery's* crew module in weld tool, NAR Building 290, Downey, California, July 8, 1981.
Source: NASA, Johnson Space Center Image Repository, JSC2010-03119.

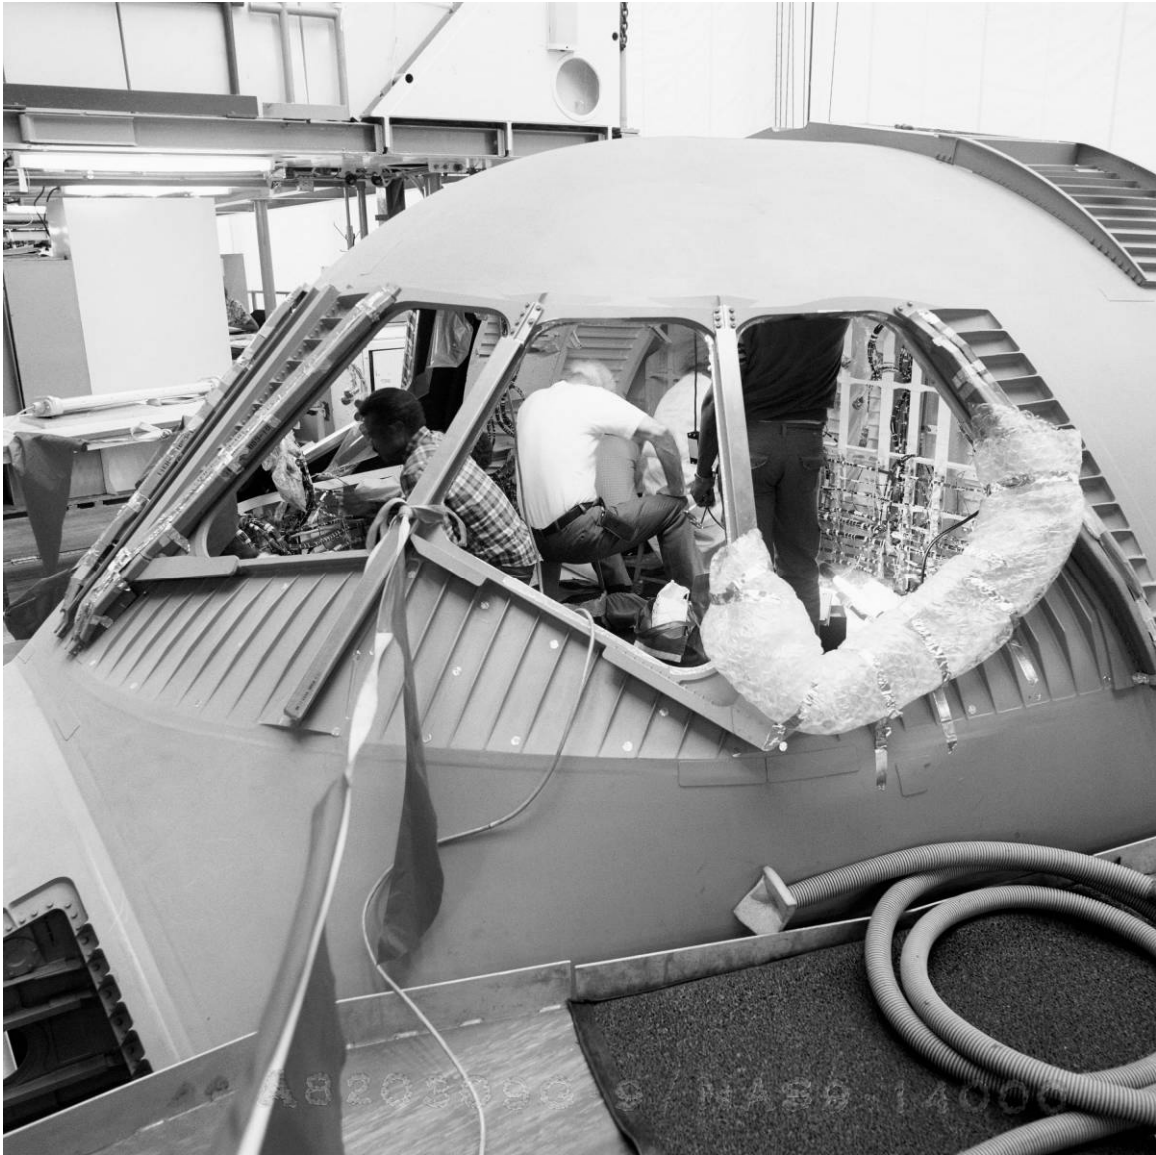
Figure B-9. Manufacturing operations on *Discovery's* flight deck, NAR Building 290, Downey, California, March 9, 1982.
Source: NASA, Johnson Space Center Image Repository, JSC2010-03245.

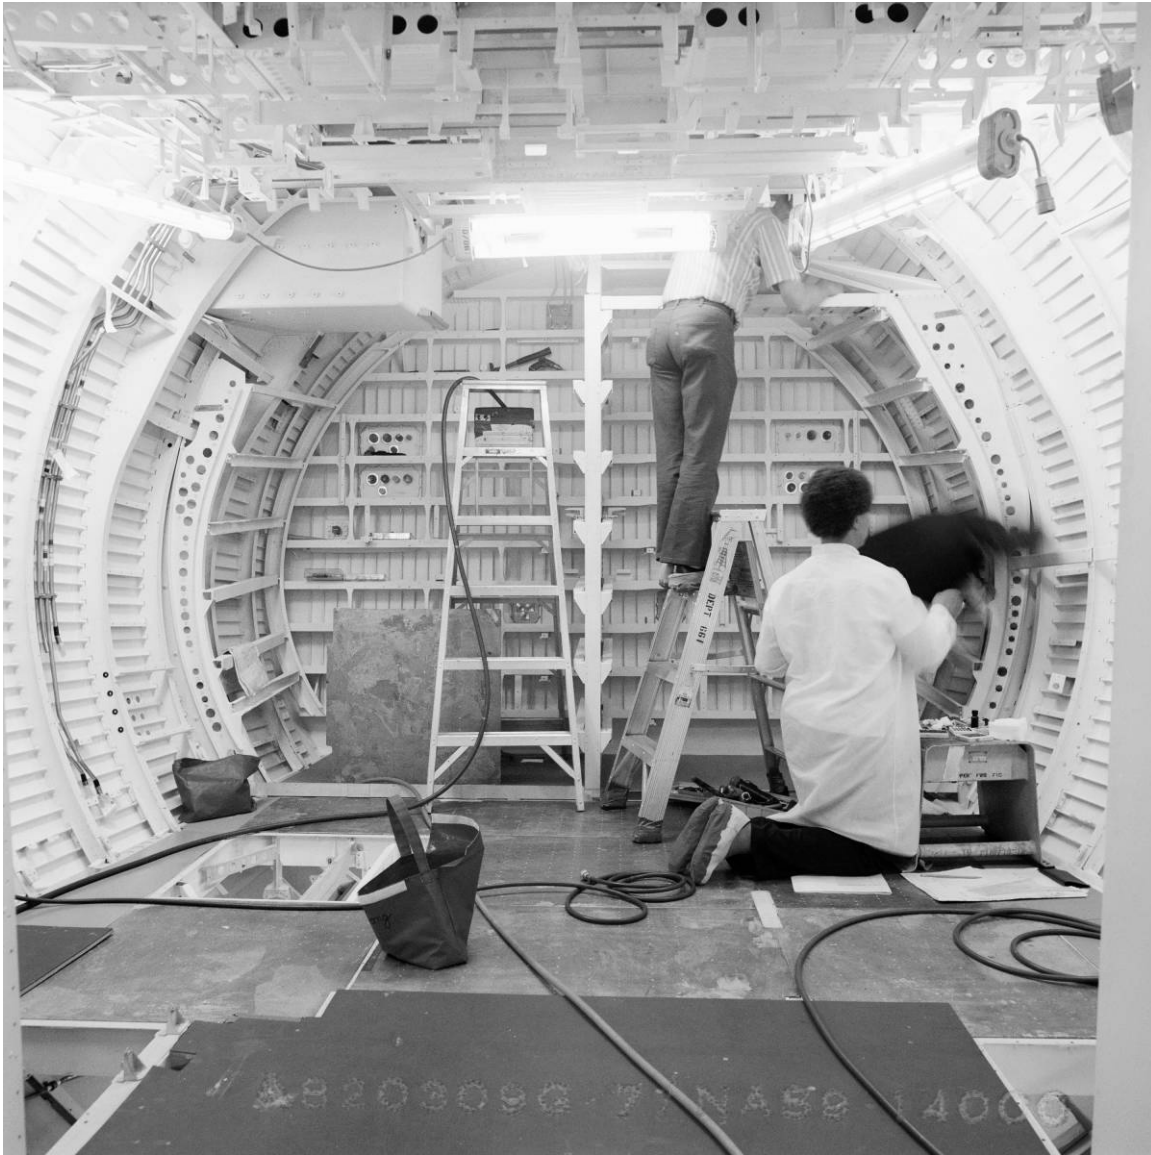
Figure B-11. Manufacturing operations on *Discovery's* middeck, NAR Building 290, Downey, California, March 9, 1982.
Source: NASA, Johnson Space Center Image Repository, JSC2010-03244.

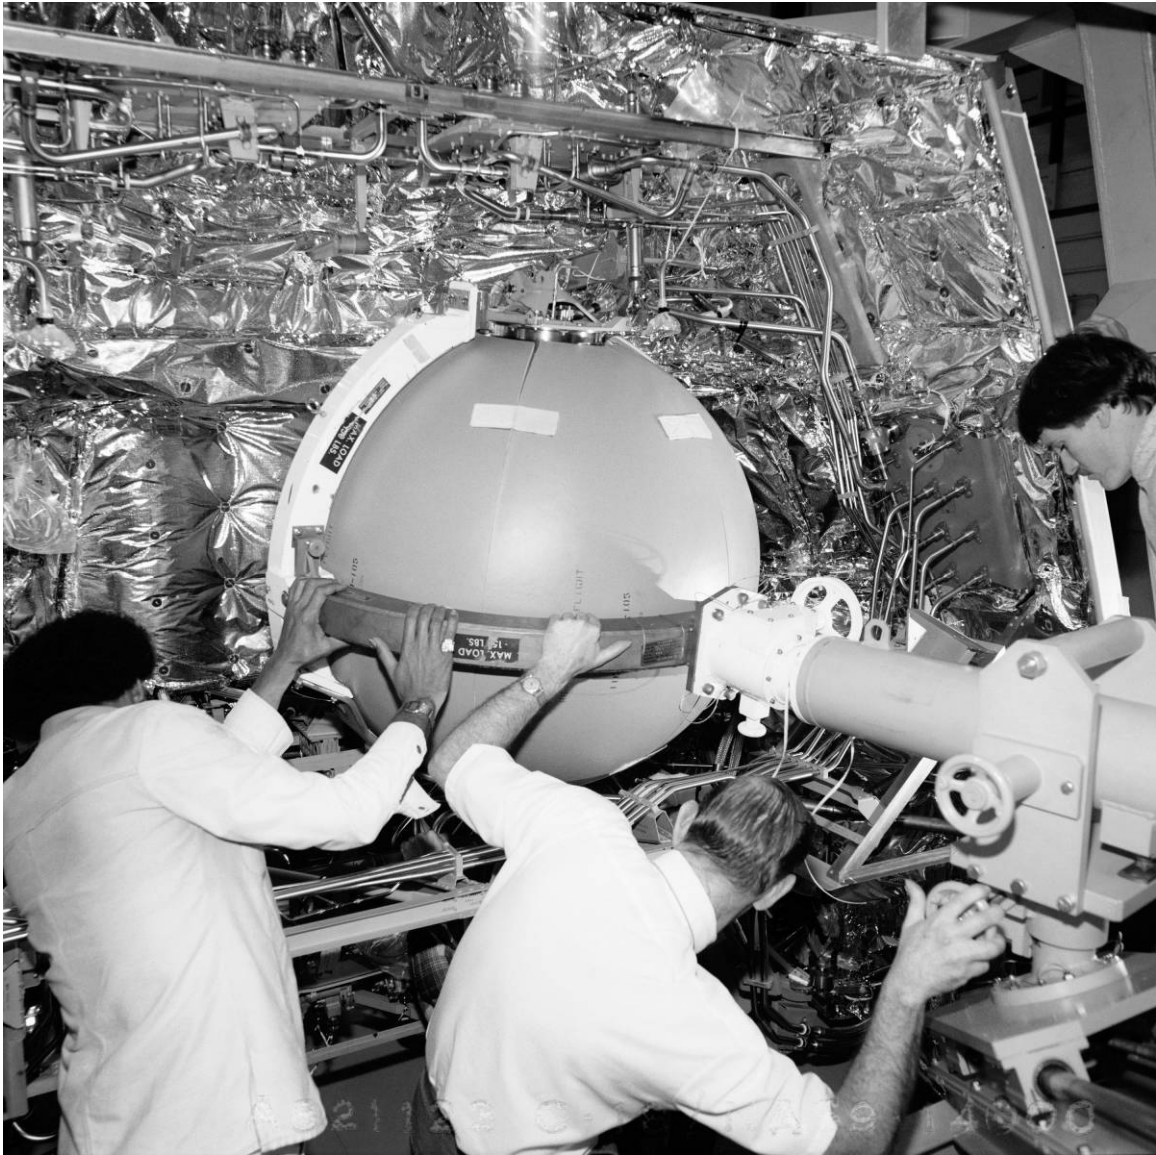
Figure B-14. Fuel tank being installed into *Discovery's* FRCS module, NAR Building 1, Downey, California, November 23, 1982.
Source: NASA, Johnson Space Center Image Repository, JSC2010-03369.

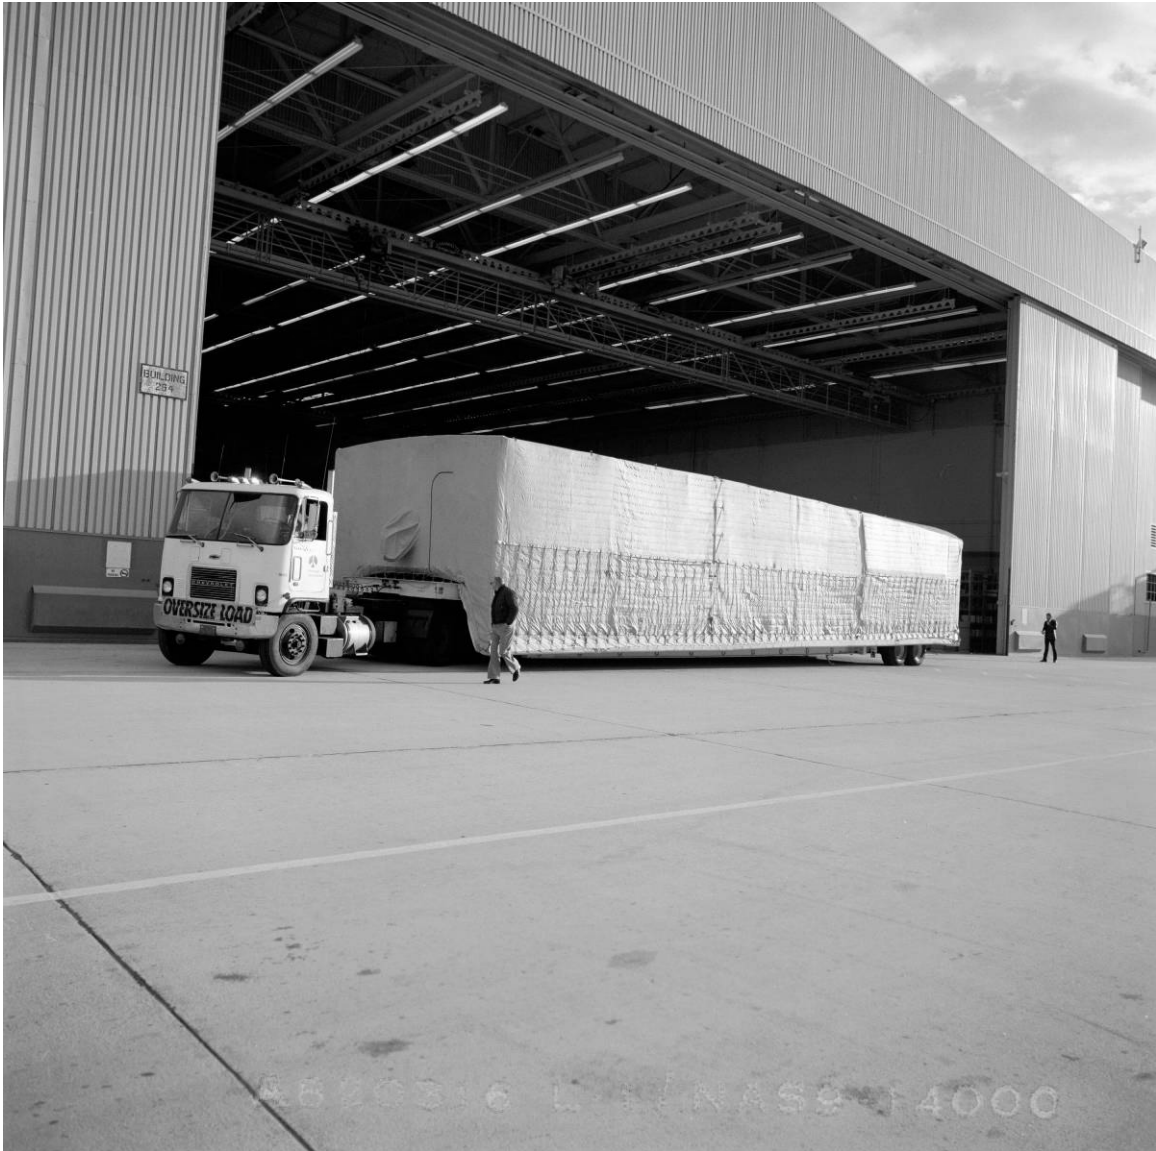
Figure B-19. Arrival of *Discovery*'s midfuselage at AFP 42 for final assembly, March 16, 1982.
Source: NASA, Johnson Space Center Image Repository, JSC2010-03249.

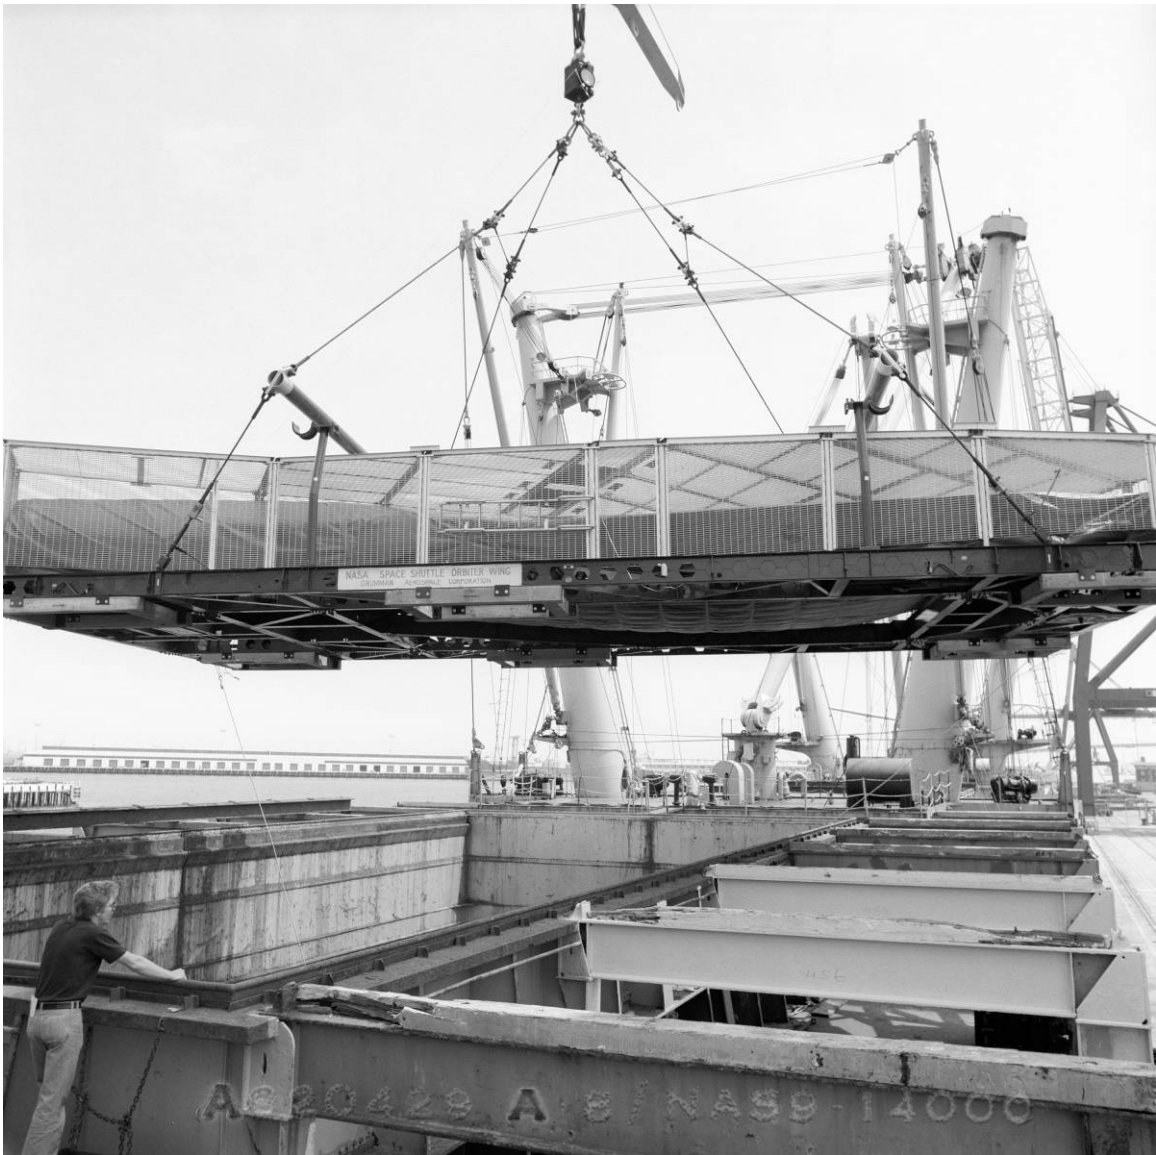
Figure B-21. *Discovery's* port wing being offloaded from ship at the Los Angeles Harbor for delivery to AFP 42, April 29, 1982.

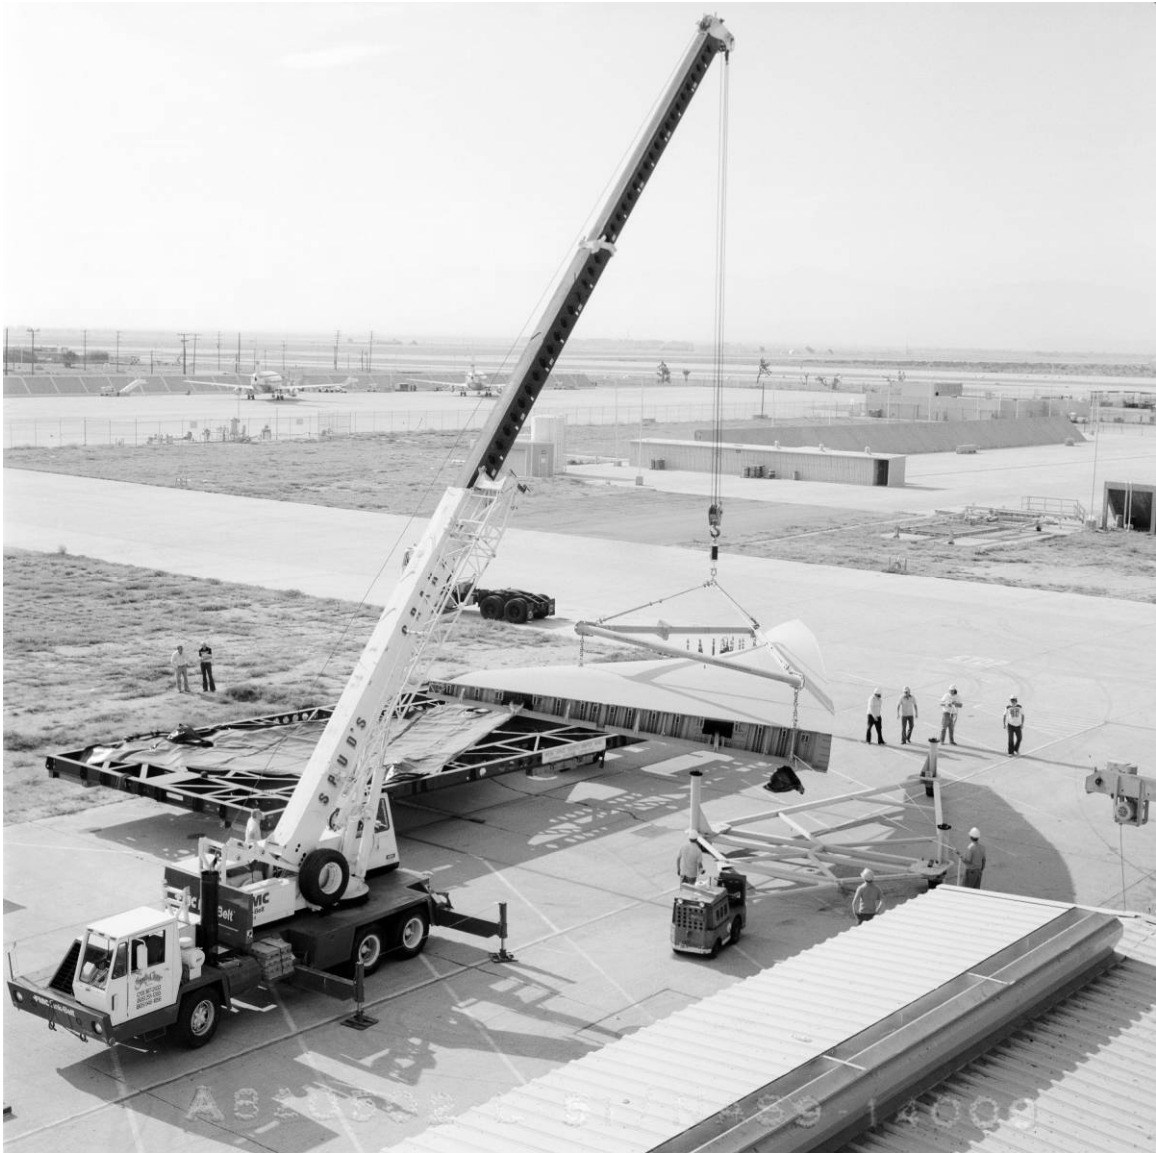
Figure B-22. *Discovery's* port wing being offloaded from transporter at AFP 42, May 2, 1982.
Source: NASA, Johnson Space Center Image Repository, JSC2010-03283.

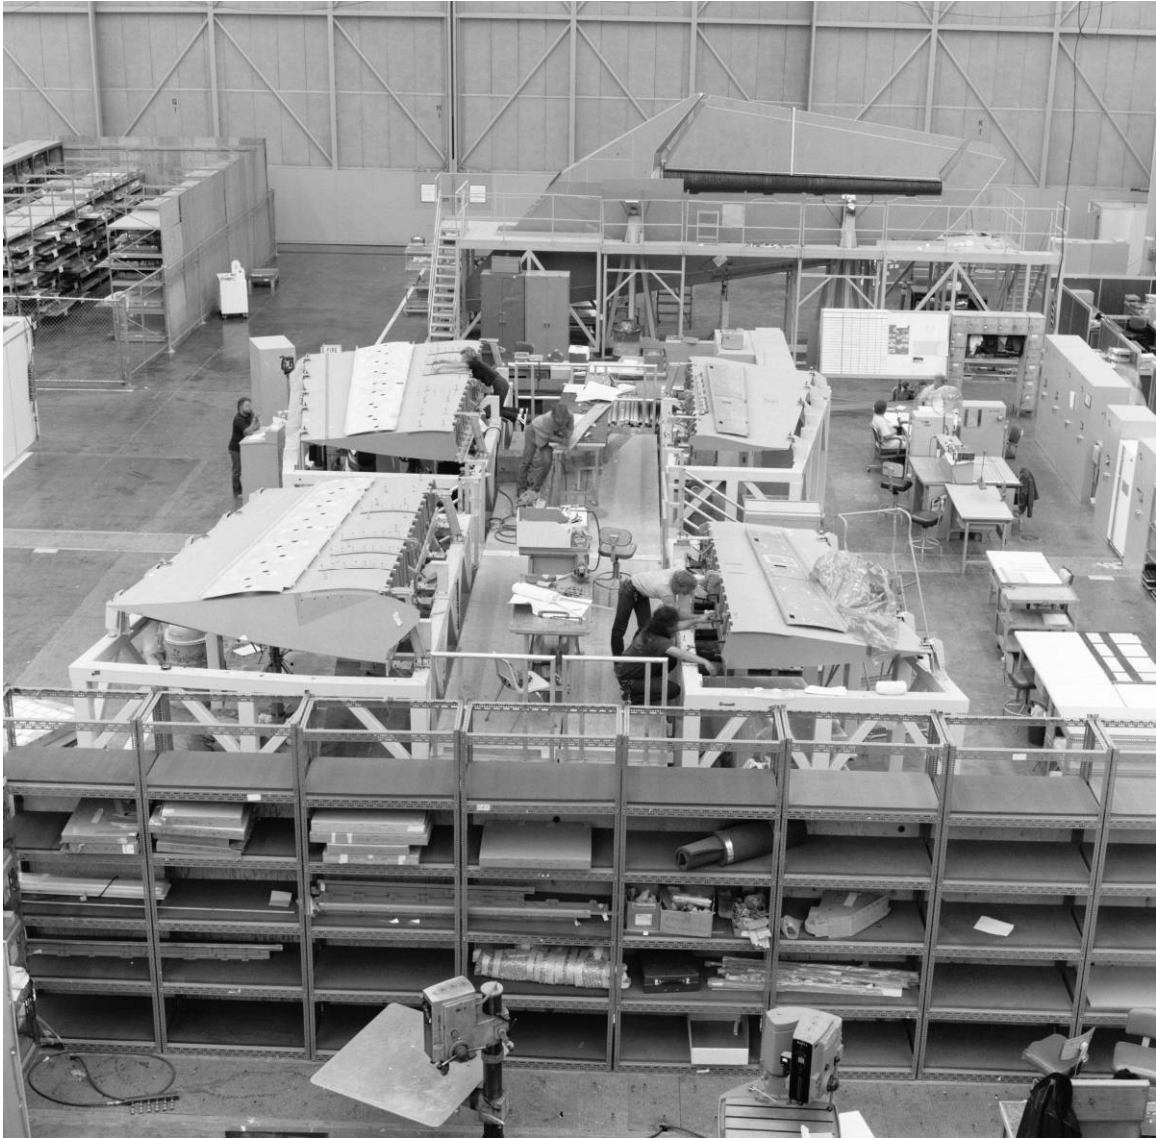
Figure B-27. Inspection of *Discovery's* elevons, High Bay 1, AFP 42,
September 14, 1982.

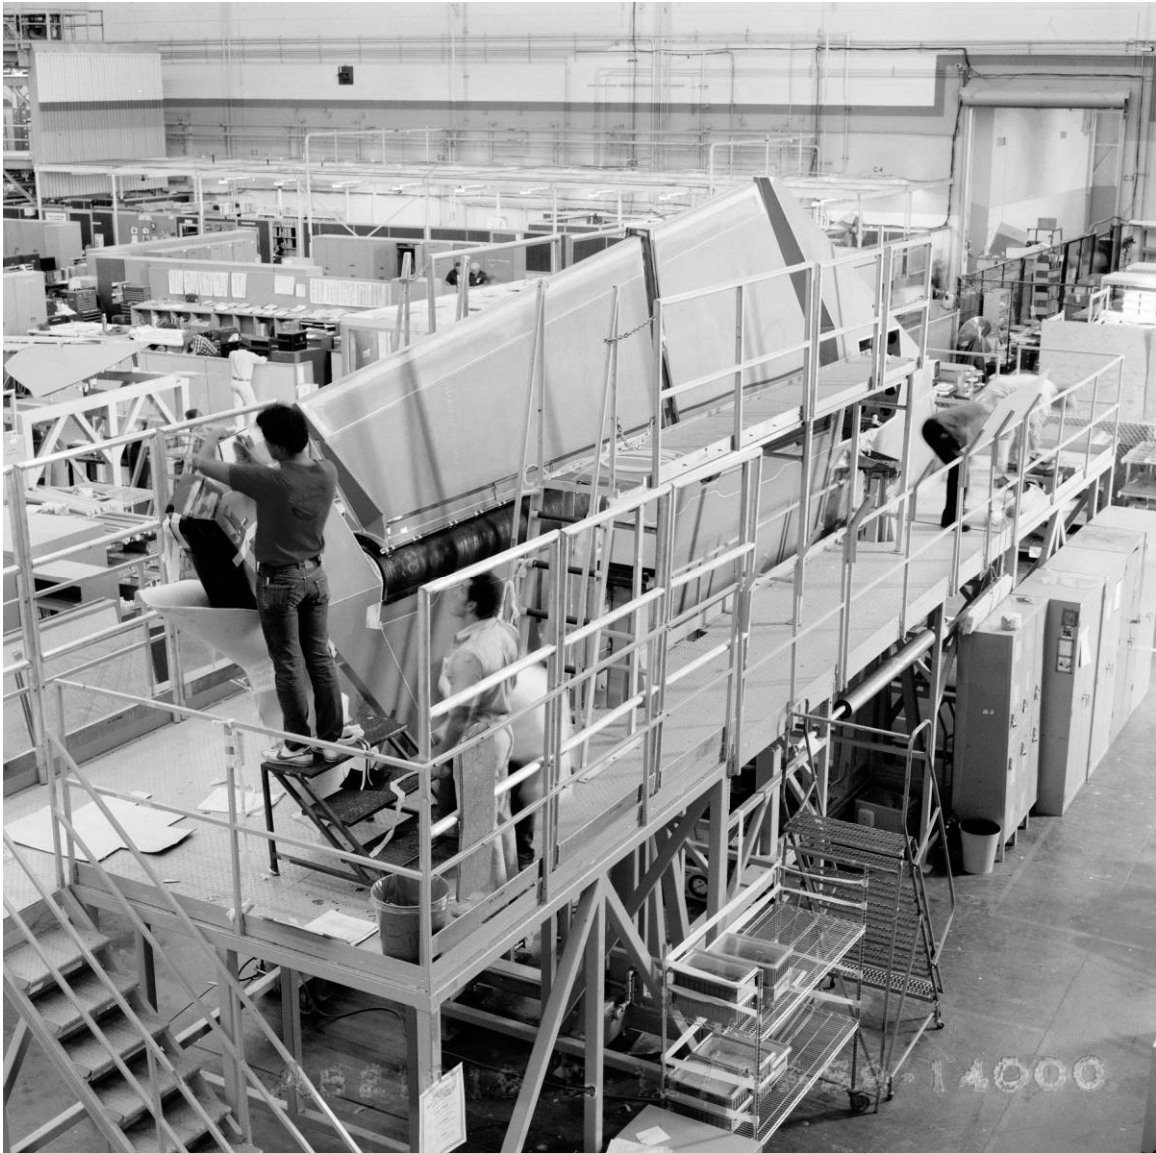
Figure B-30. Installation of TPS on *Discovery's* vertical stabilizer, AFP 42, October 19, 1982.
Source: NASA, Johnson Space Center Image Repository, JSC2010-03353.

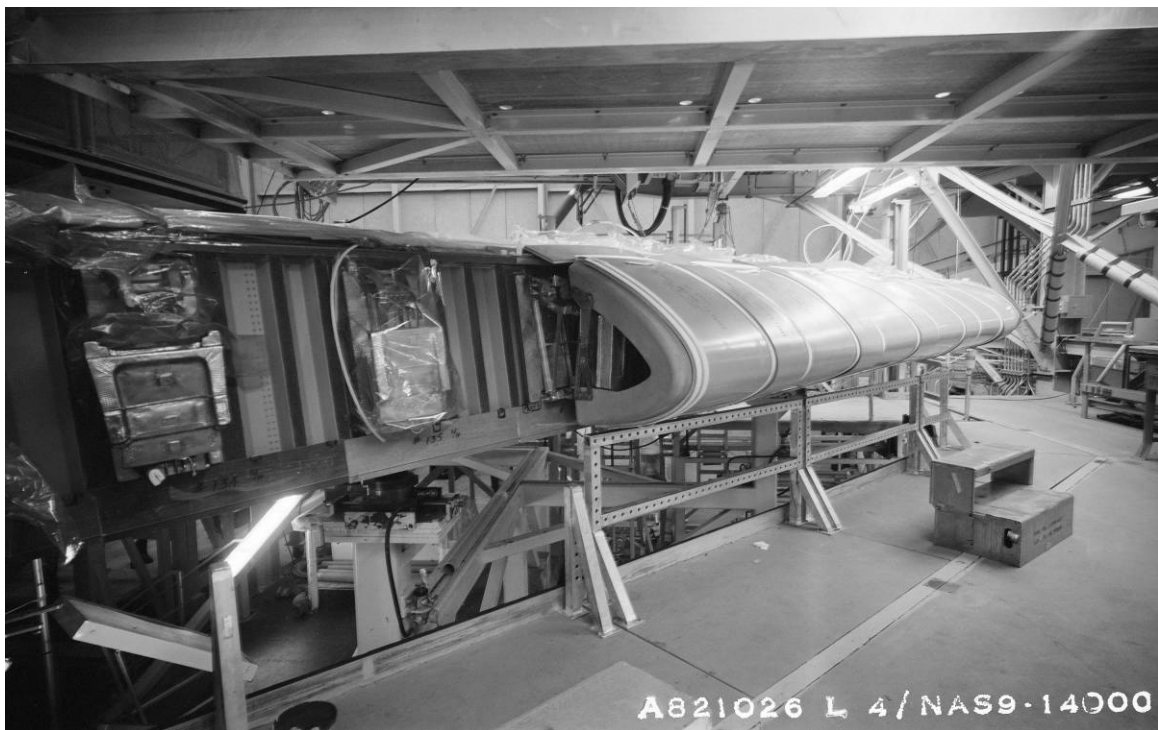
Figure B-31. Installation of wing leading edge on *Discovery's* port wing in High Bay 2, AFP 42, October 26, 1982.

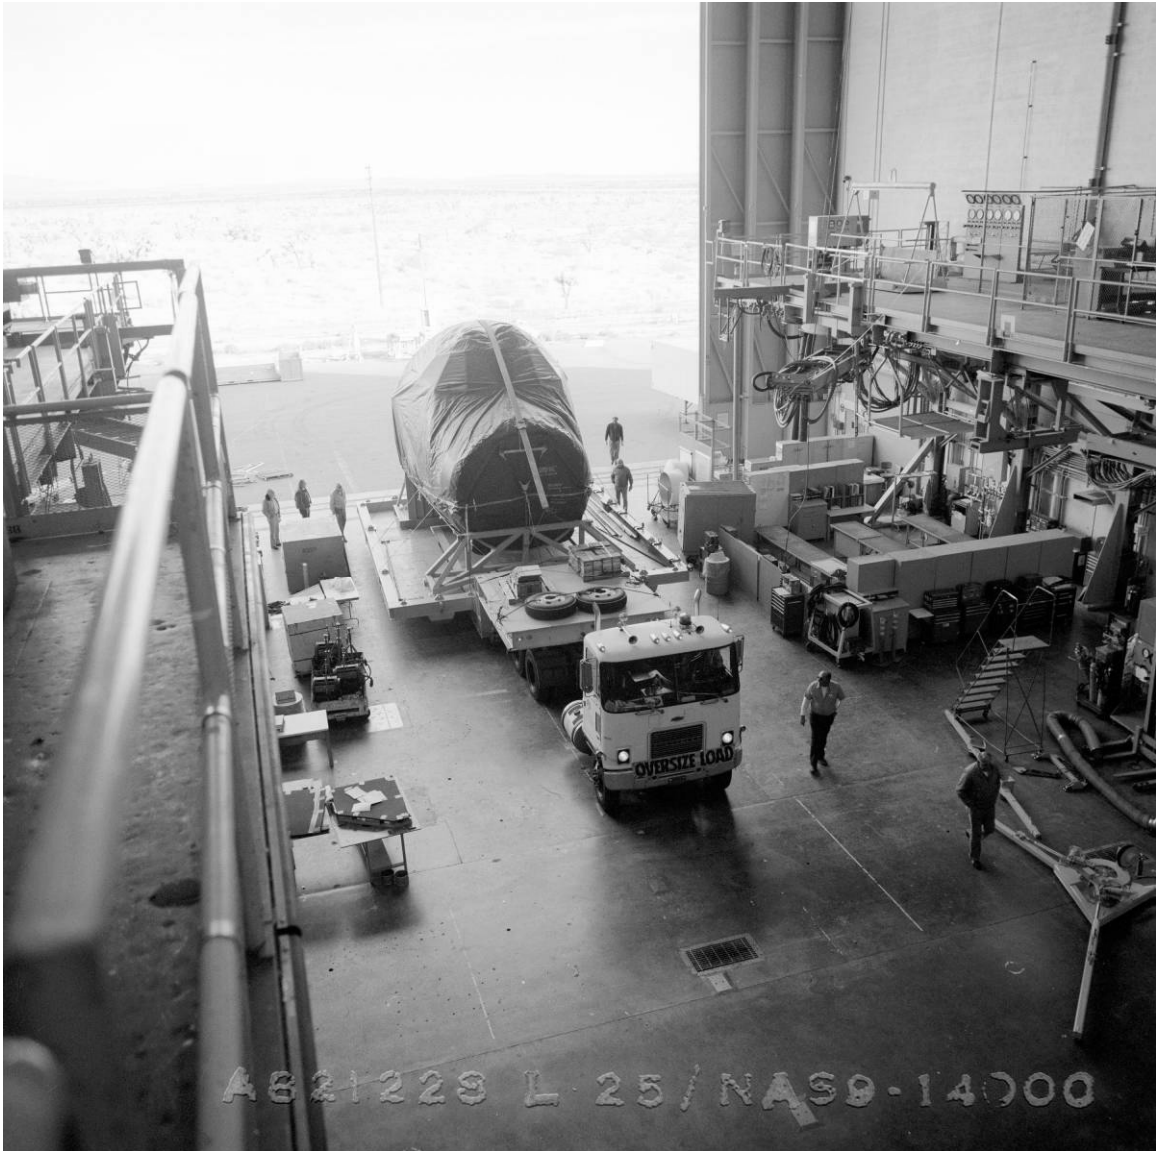
Figure B-33. Arrival of *Discovery's* crew module at AFP 42, December 28, 1982.
Source: NASA, Johnson Space Center Image Repository, JSC2010-03388.

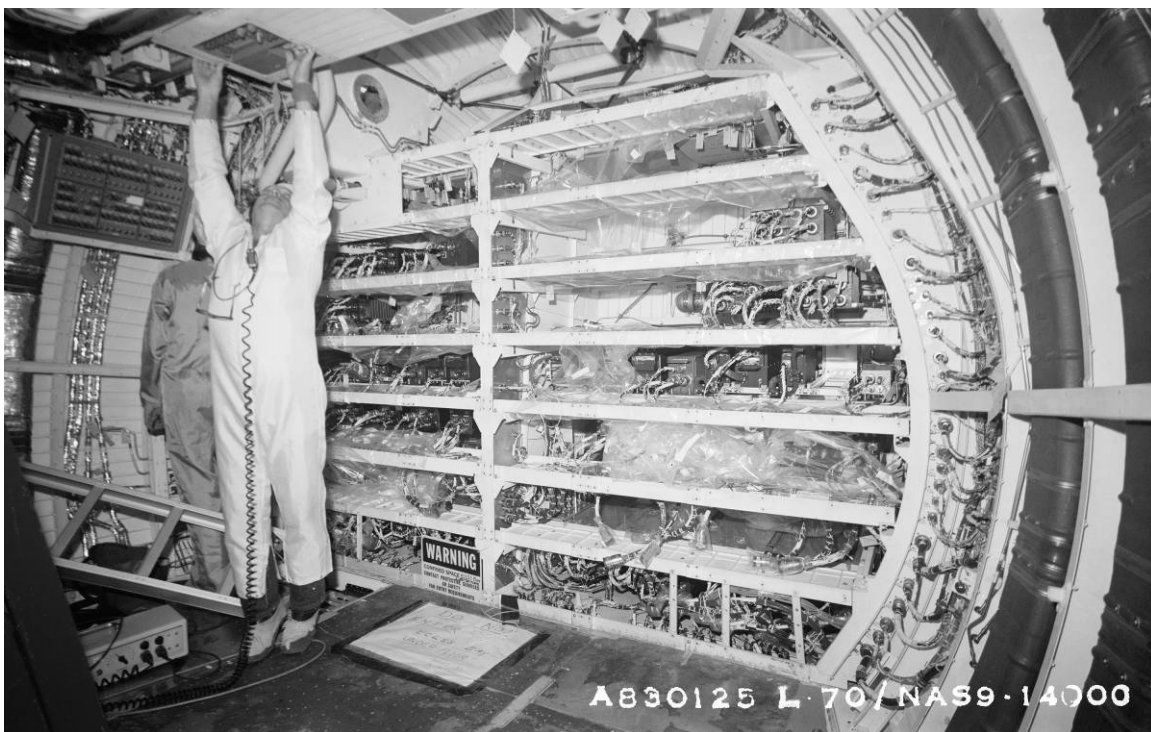
Figure B-39. Manufacturing progress on *Discovery's* middeck in High Bay 2, AFP 42, January 25, 1983.
Source: NASA, Johnson Space Center Image Repository, JSC2010-03590.

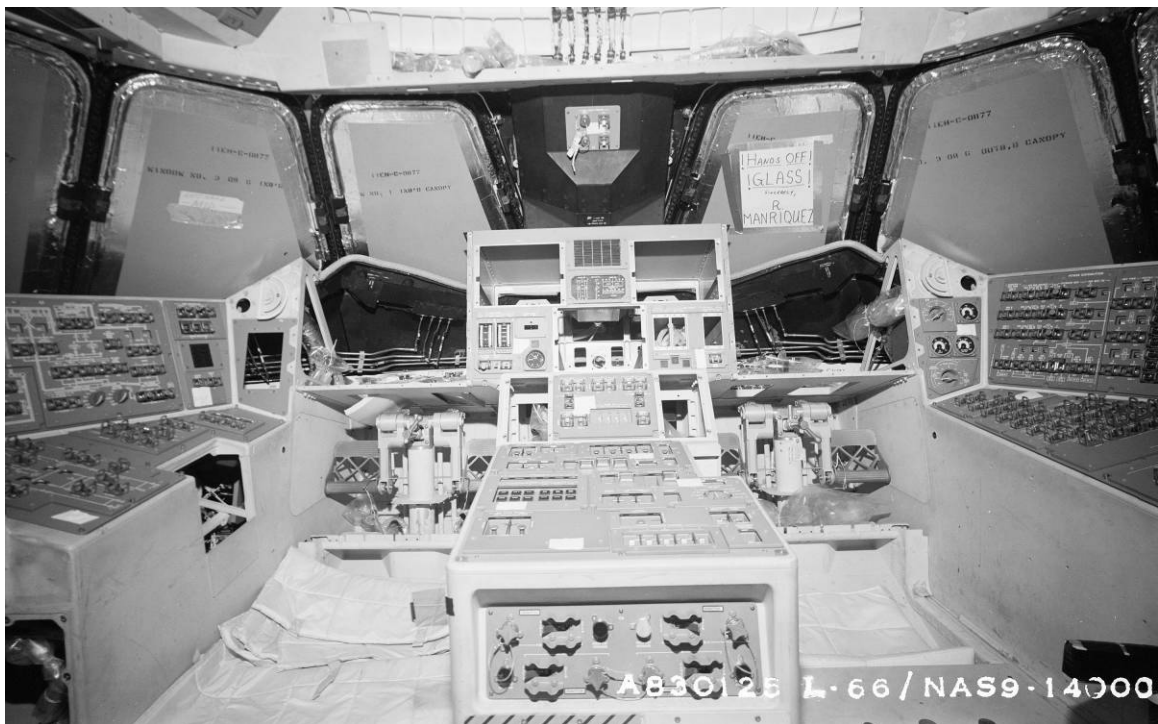
Figure B-40. Manufacturing progress on *Discovery's* flight deck in High Bay 2, AFP 42, January 25, 1983.

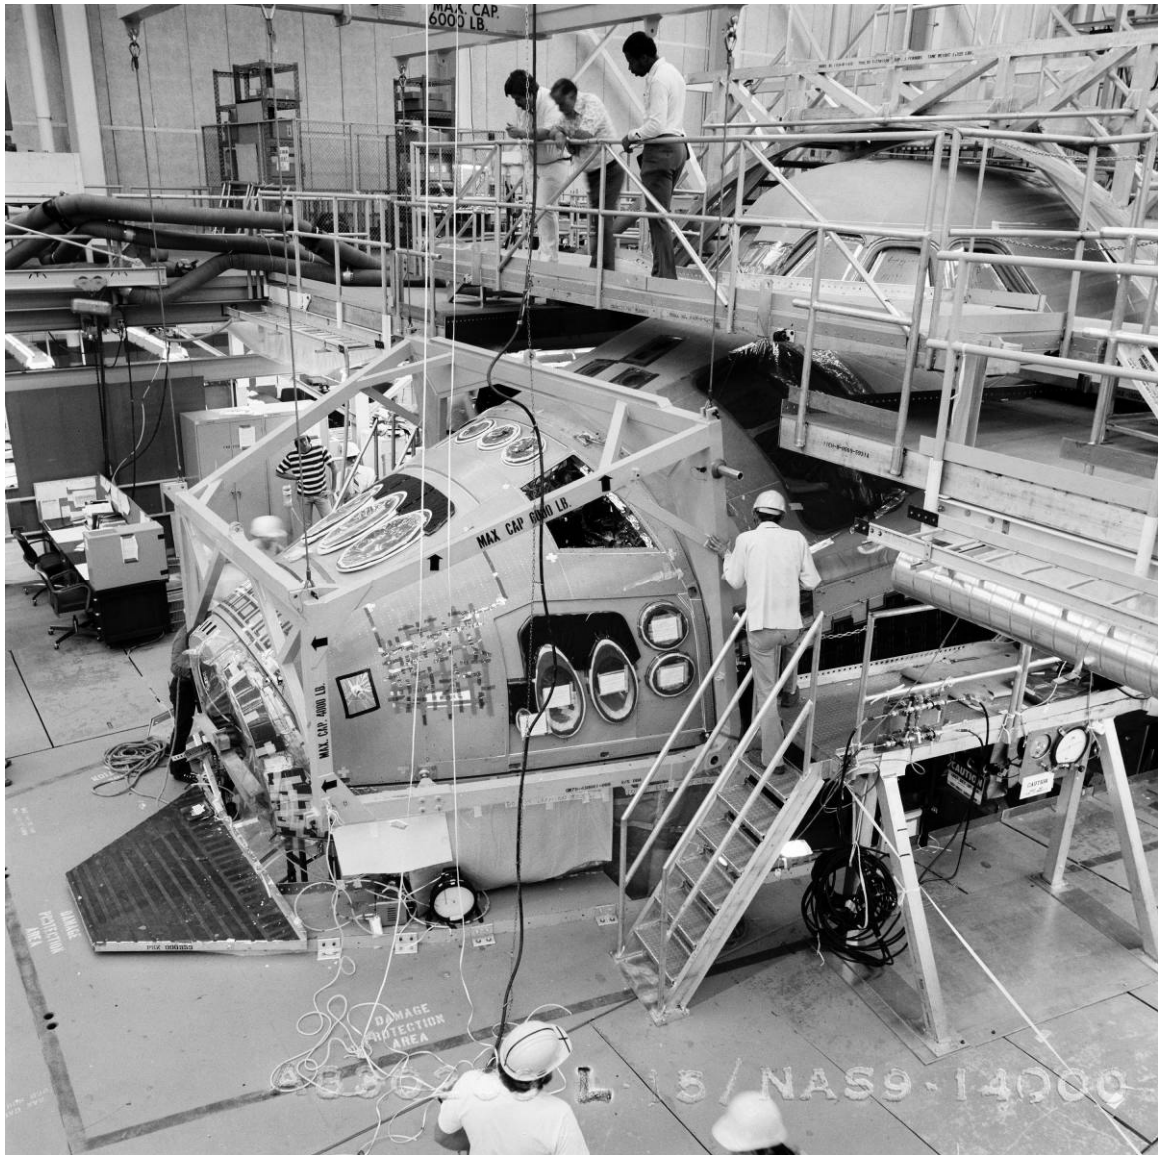
Figure B-41. Installation of *Discovery's* FRCS module in High Bay 2, AFP 42, February 9, 1983.
Source: NASA, Johnson Space Center Image Repository, JSC2010-03410.

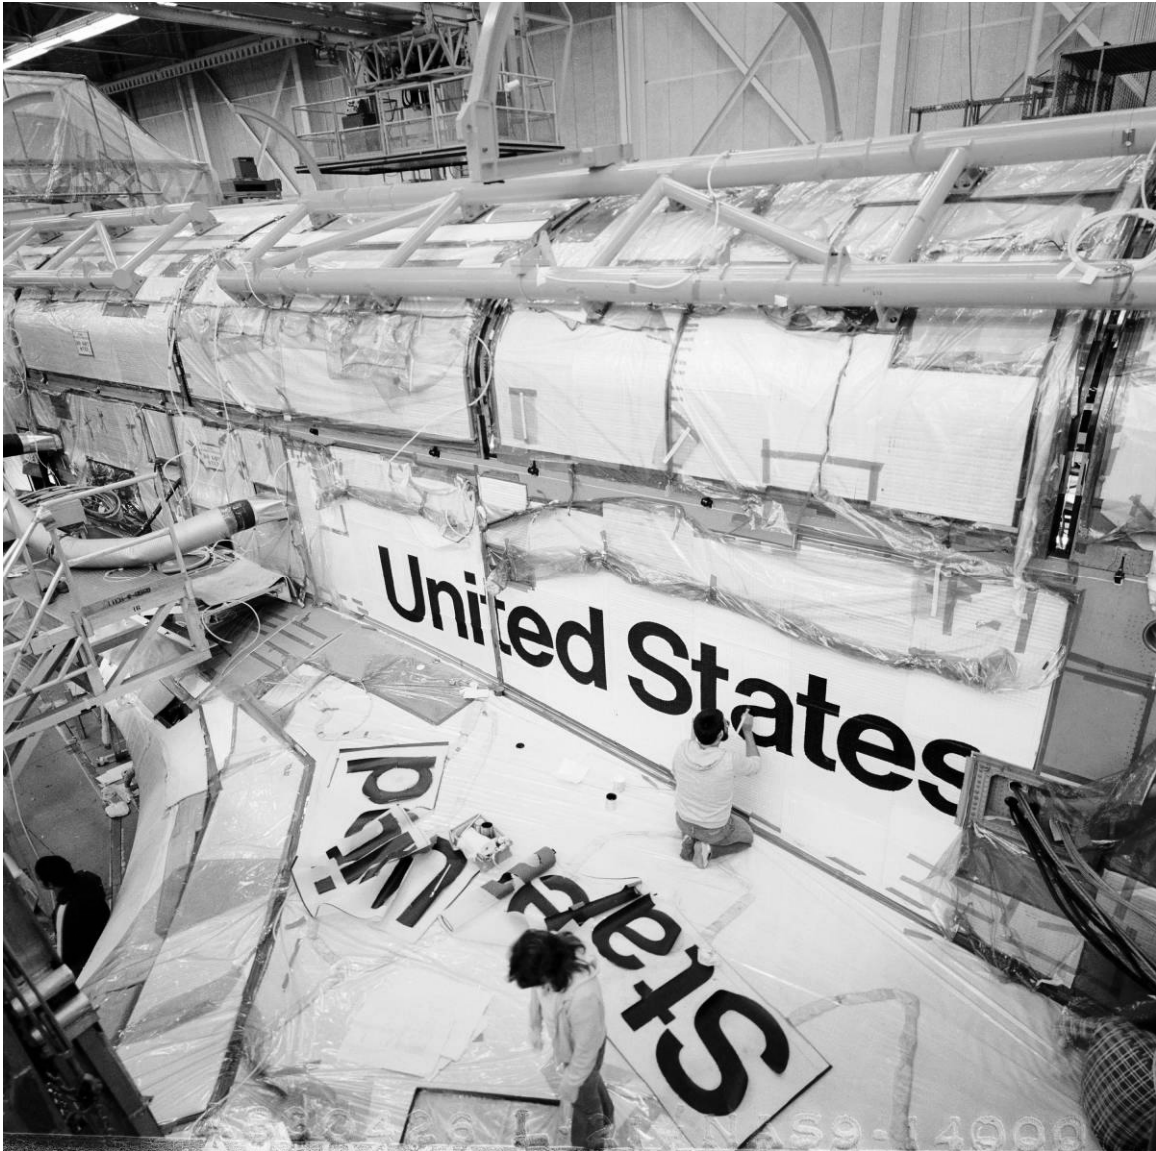
Figure B-48. Painting of *Discovery*'s midfuselage in High Bay 2, AFP 42, April 26, 1983.
Source: NASA, Johnson Space Center Image Repository, JSC2010-03443.
