Appendix B-Orbiter Historic Photos

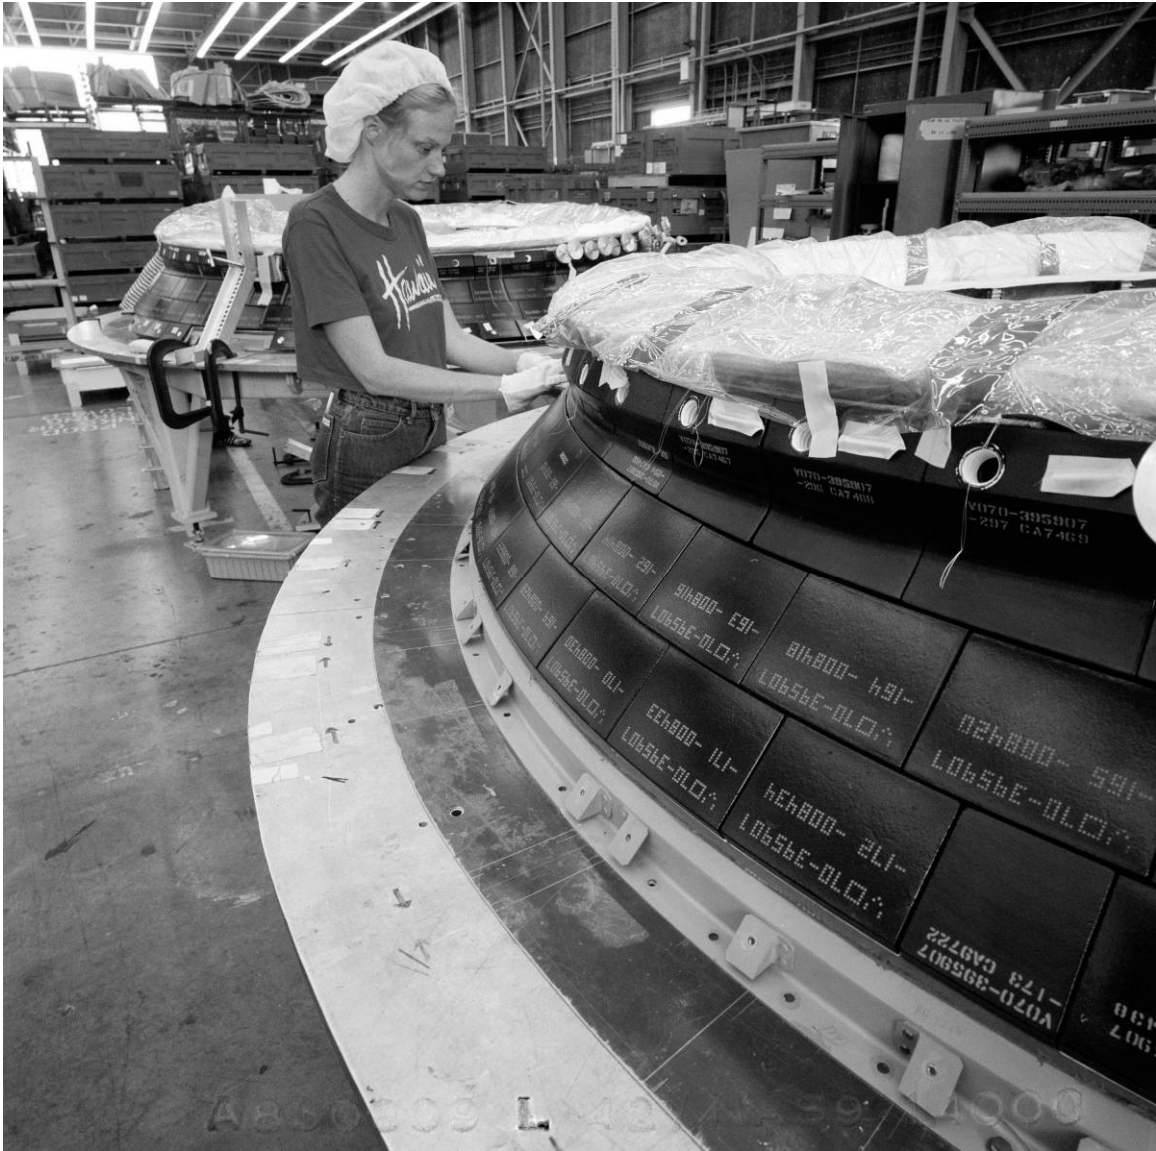
Figure B-55. Installation of HRSI on one of *Discovery*'s SSME dome heat shields at AFP 42, August 9, 1983.

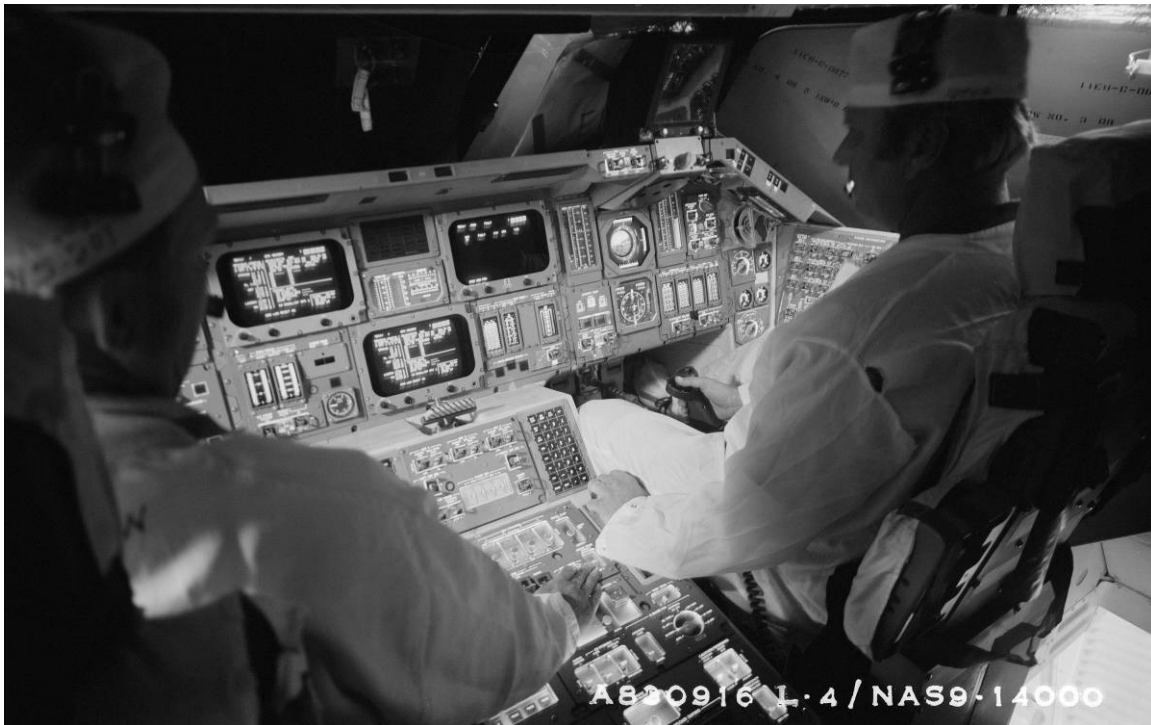
Figure B-56. Technicians working on *Discovery's* flight deck in High Bay 2, AFP 42, September 16, 1983.

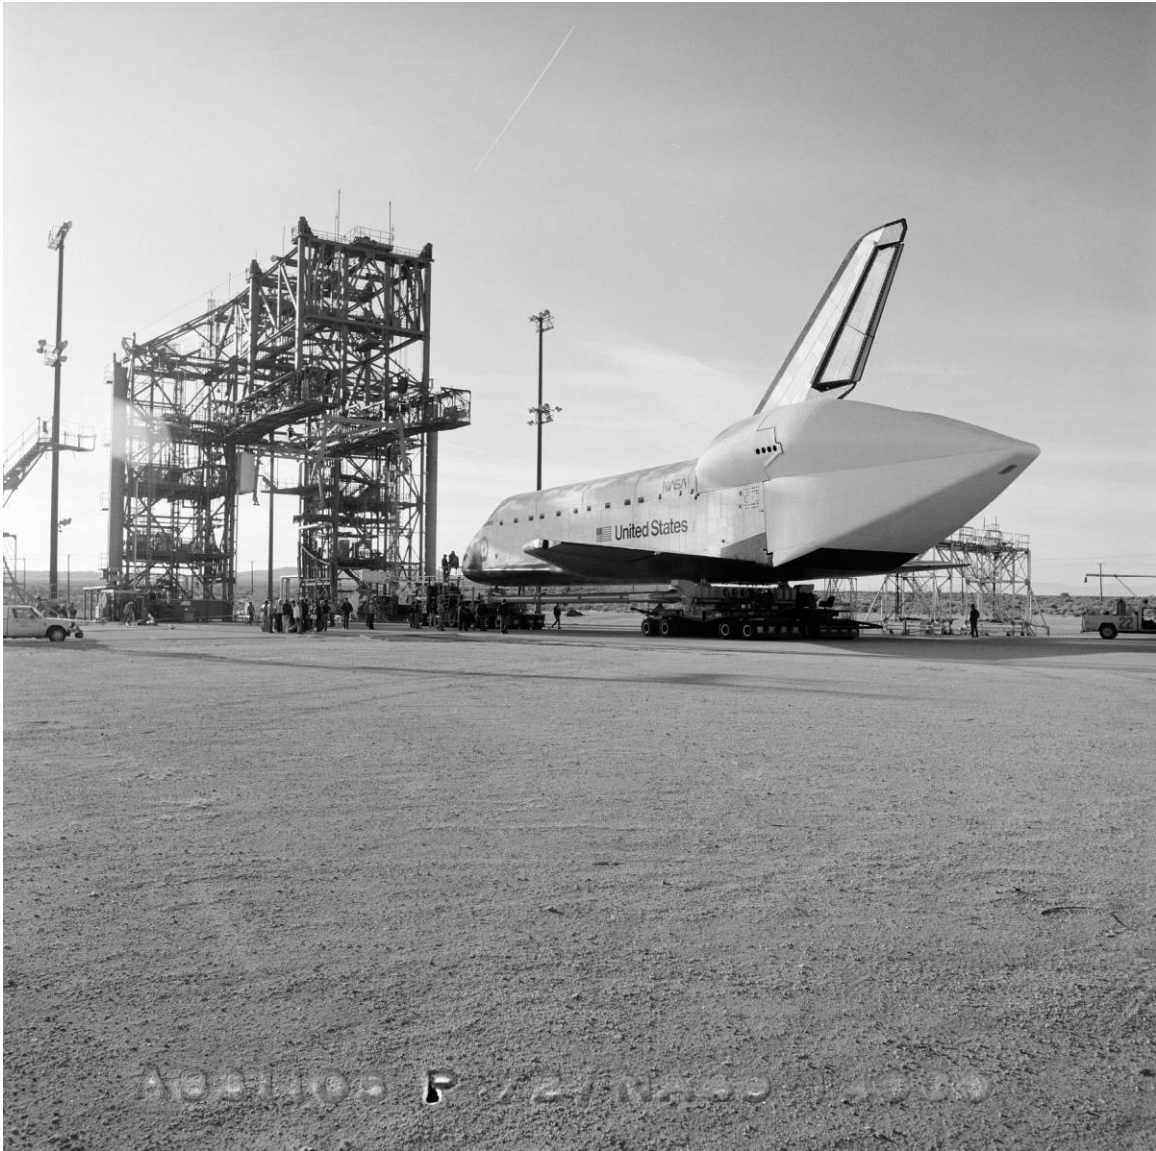
Figure B-60. *Discovery* ready to be positioned in the Mate-Demate Device at DFRC for attachment to the SCA for delivery to KSC, November 5, 1983.
Source: NASA, Johnson Space Center Image Repository, JSC2010-00016.

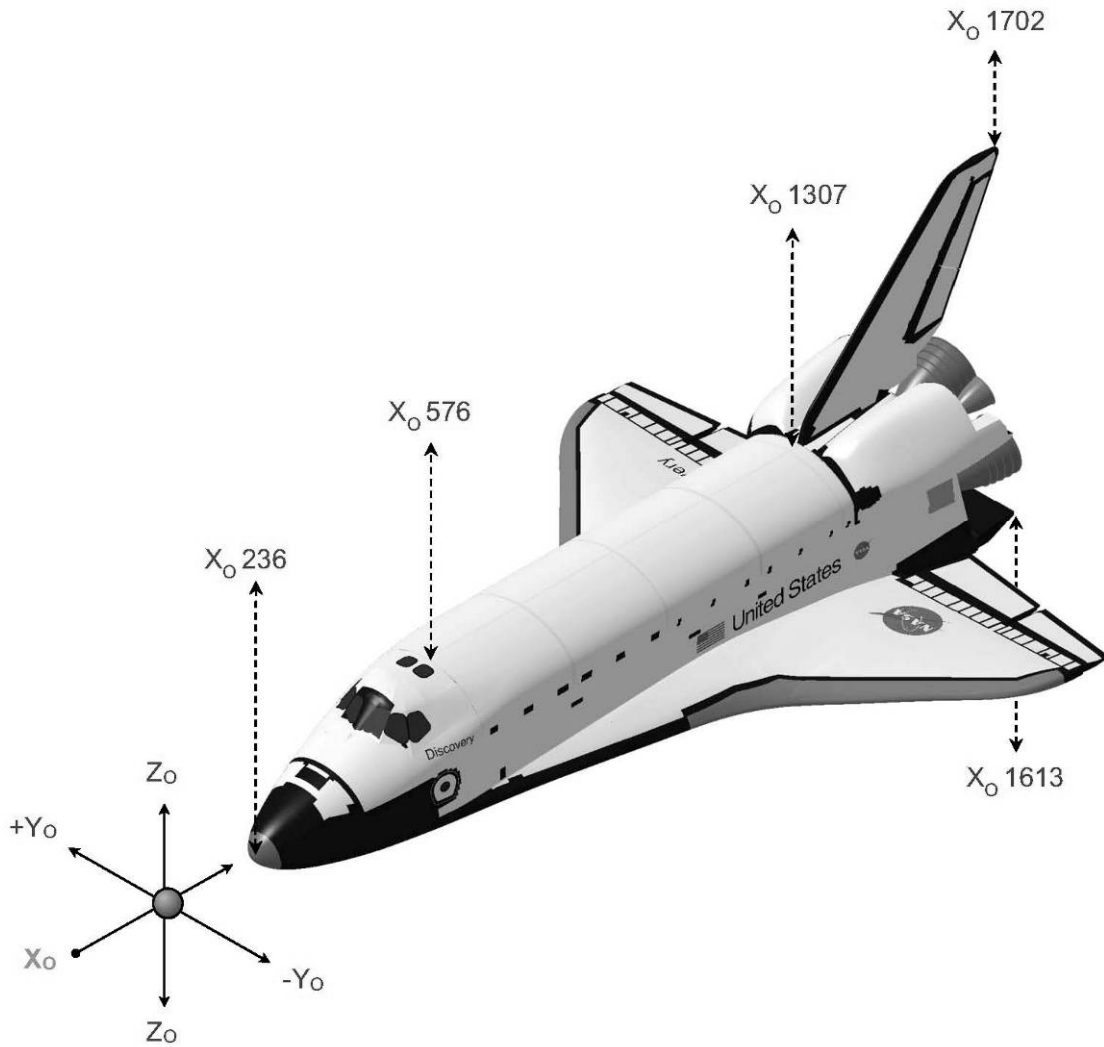
Figure B-62. Orbiter vehicle coordinate system.

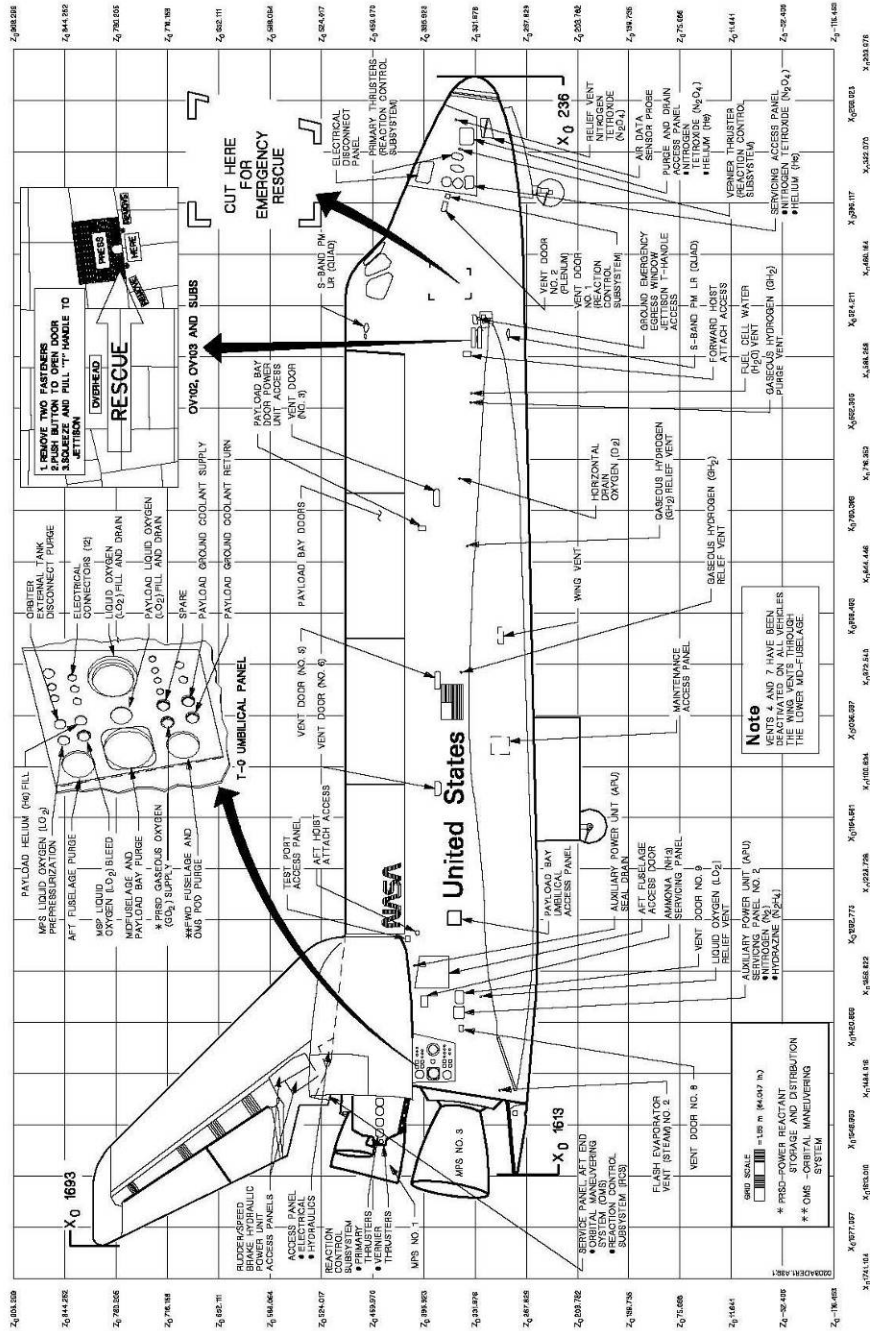
Figure B-67. Diagram of the starboard view of the orbiter vehicle.
 Source: NASA, *Shuttle Operational Data Book*, Volume 4, part 1, Figure 2-3a.

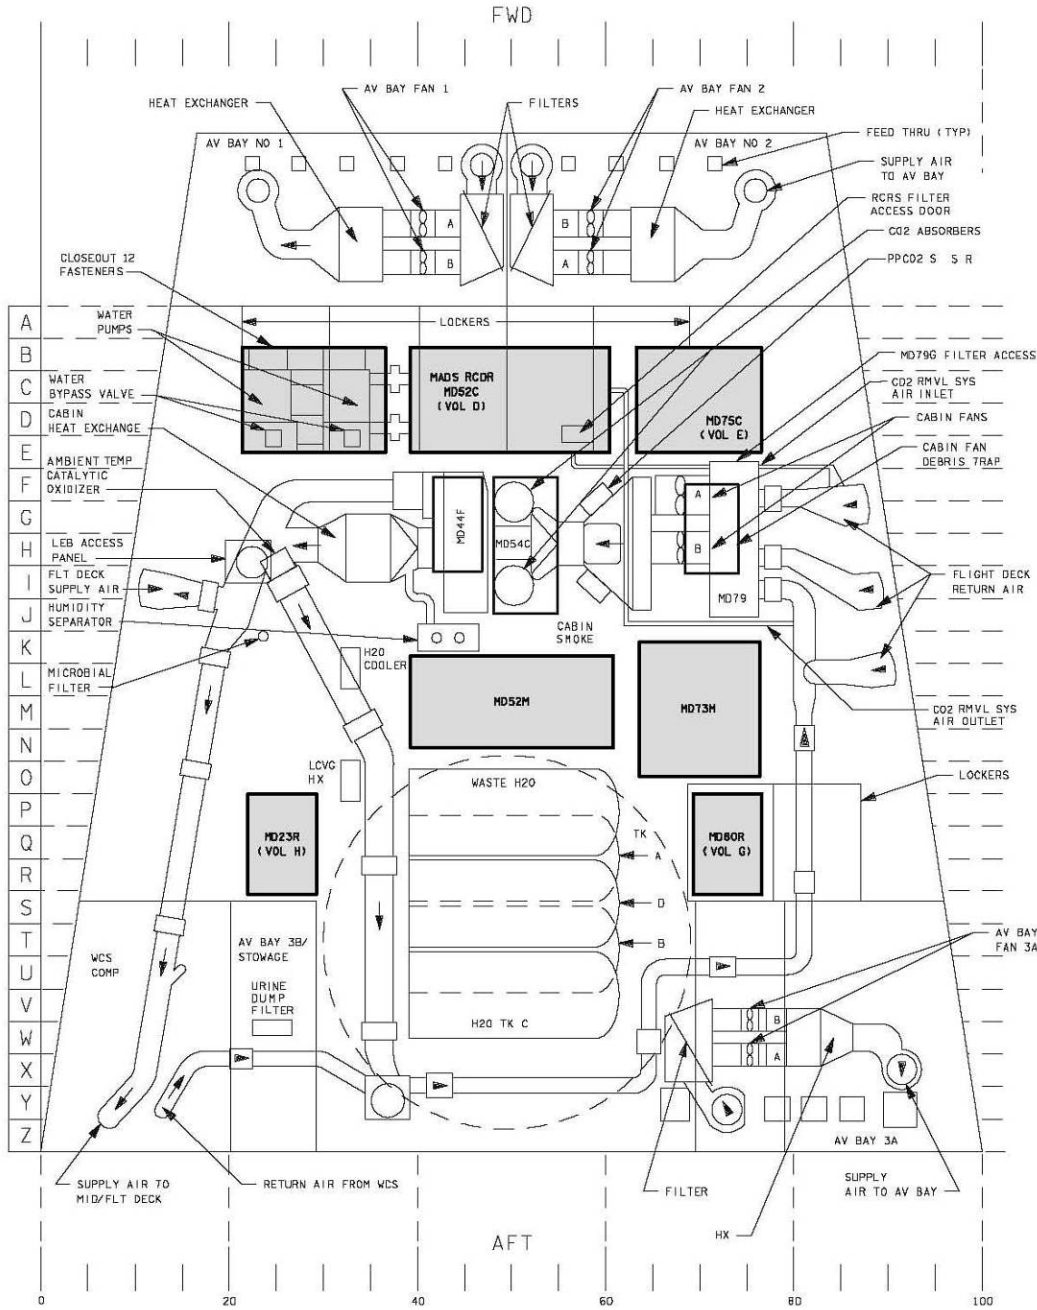
Figure B-89. Diagram of *Discovery's* equipment bay.
 Source: USA, *Environmental Control and Life Support System*, 3-4.

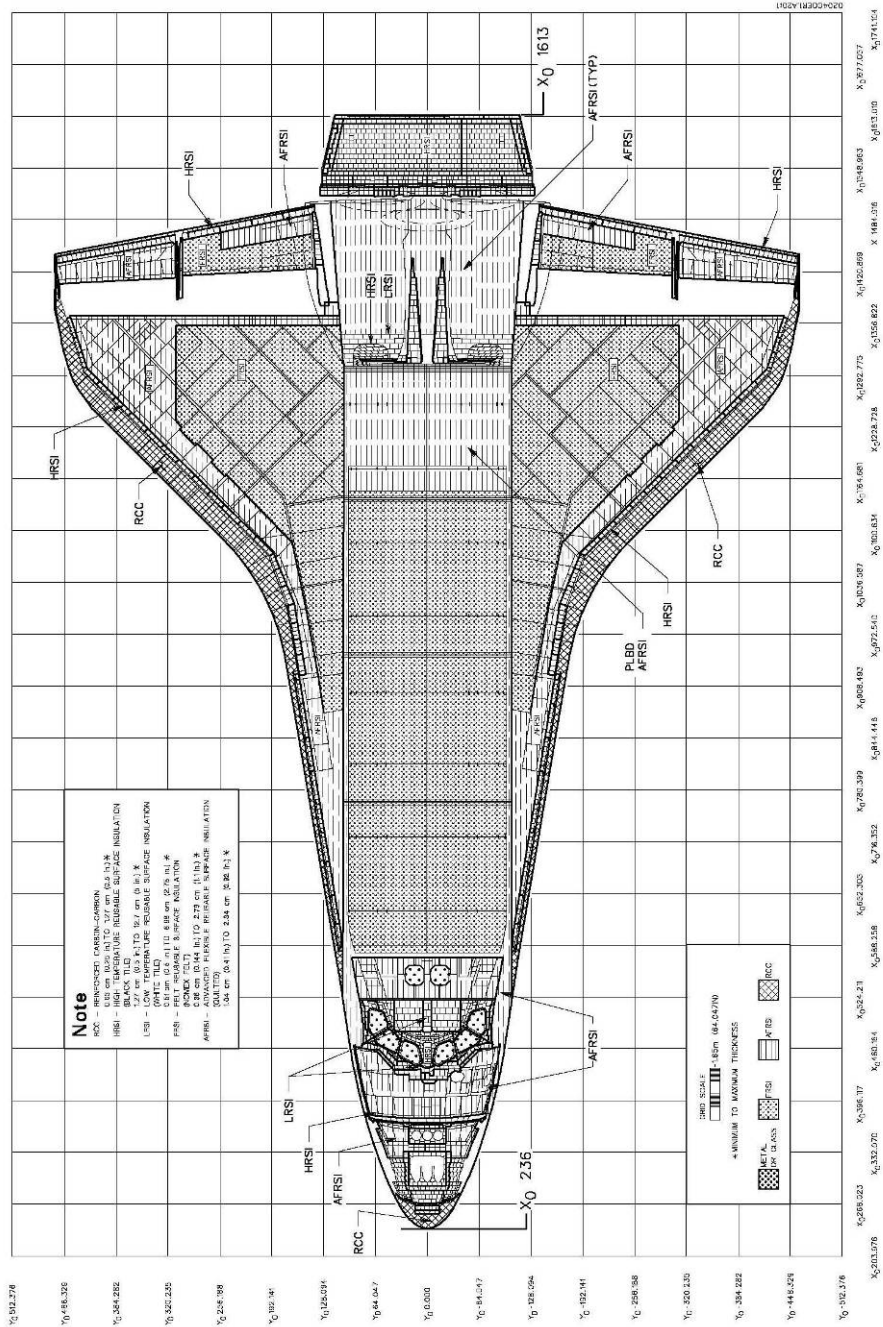
Figure B-103. Diagram of the TPS on the top of *Discovery*.
 Source: NASA, *Shuttle Operational Data Book*, Volume 4, part 2, Figure 2-4c.

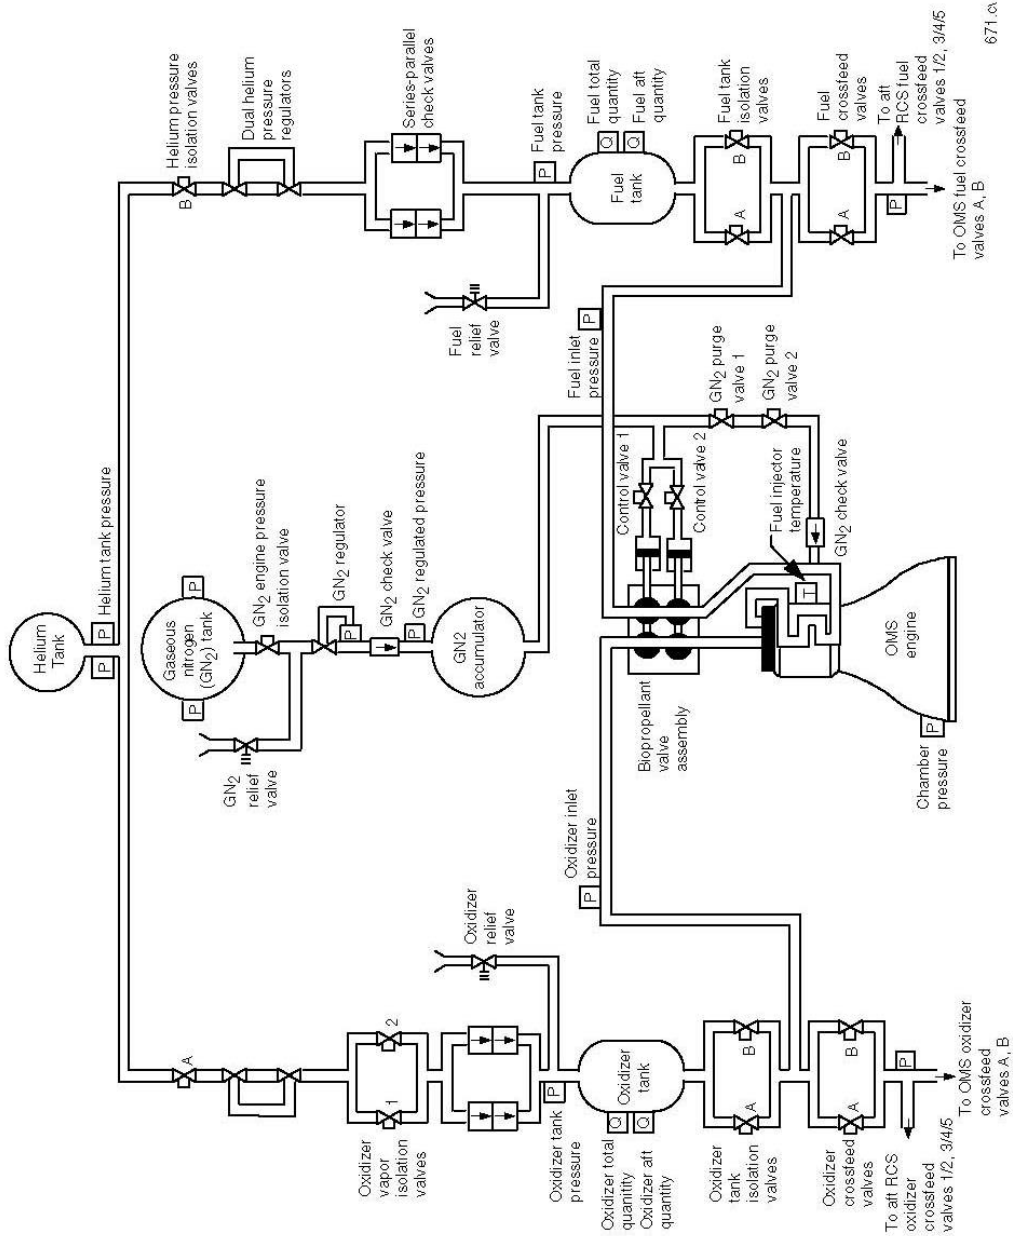
Figure B-139. Diagram of the pressurization and feed system for one OMS engine (the other is identical).

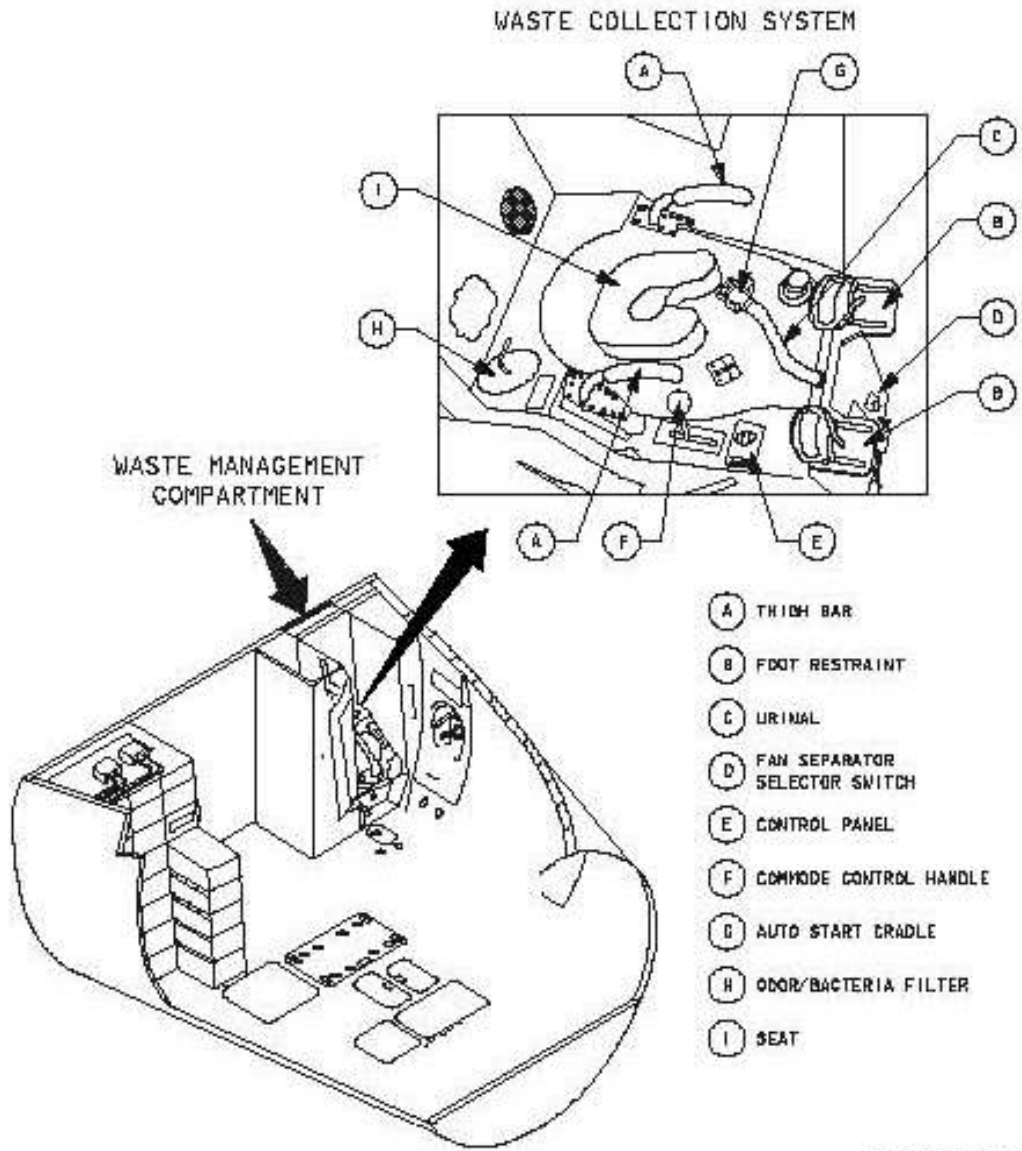
Figure B-147. Diagram of the waste management system.
 Source: USA. *Shuttle Crew Operations Manual*, 2.25-3.

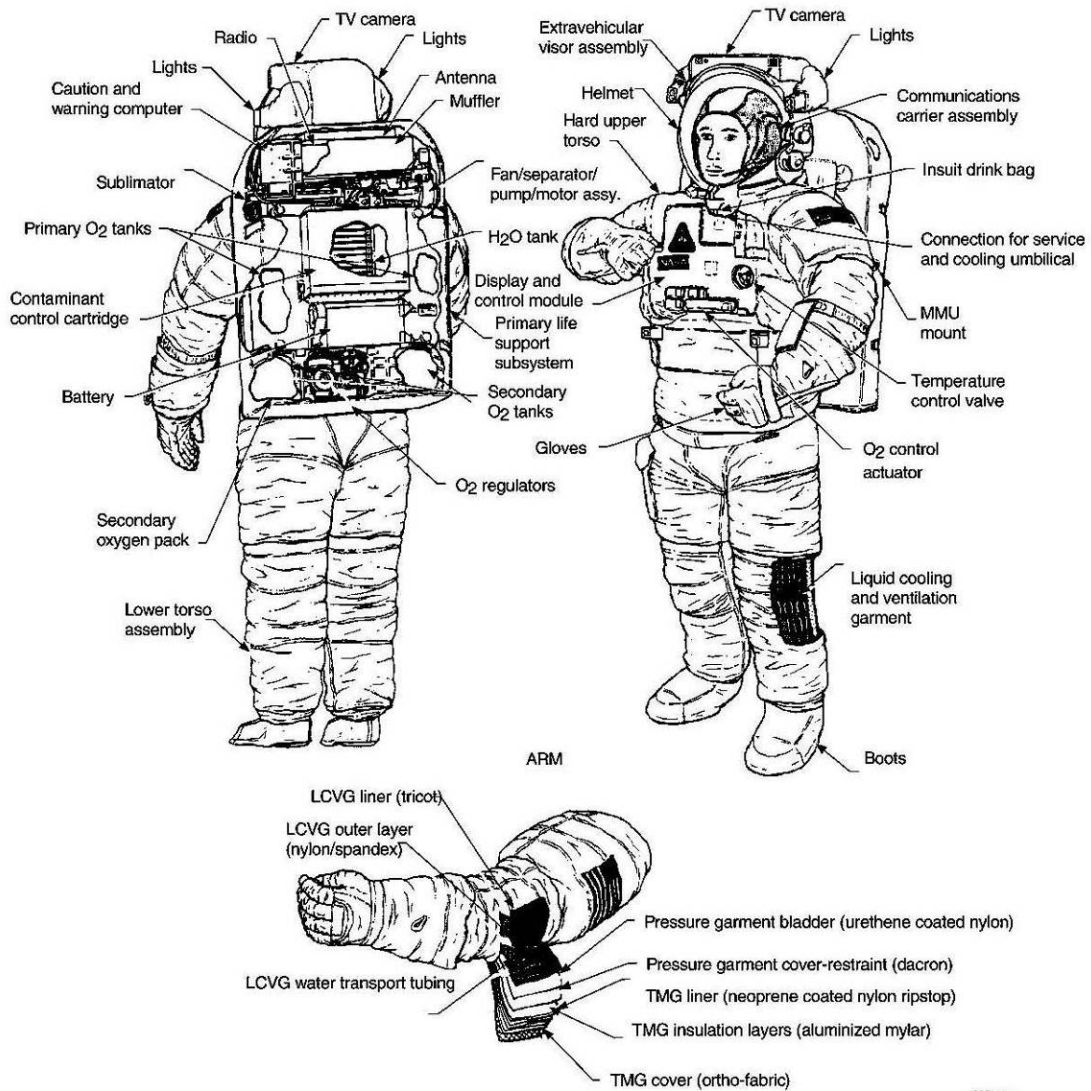
Figure B-148. Diagram of the extravehicular mobility unit.
 Source: USA. *Shuttle Crew Operations Manual*, 2.11-2.
