Appendix D-ET Historic Photos

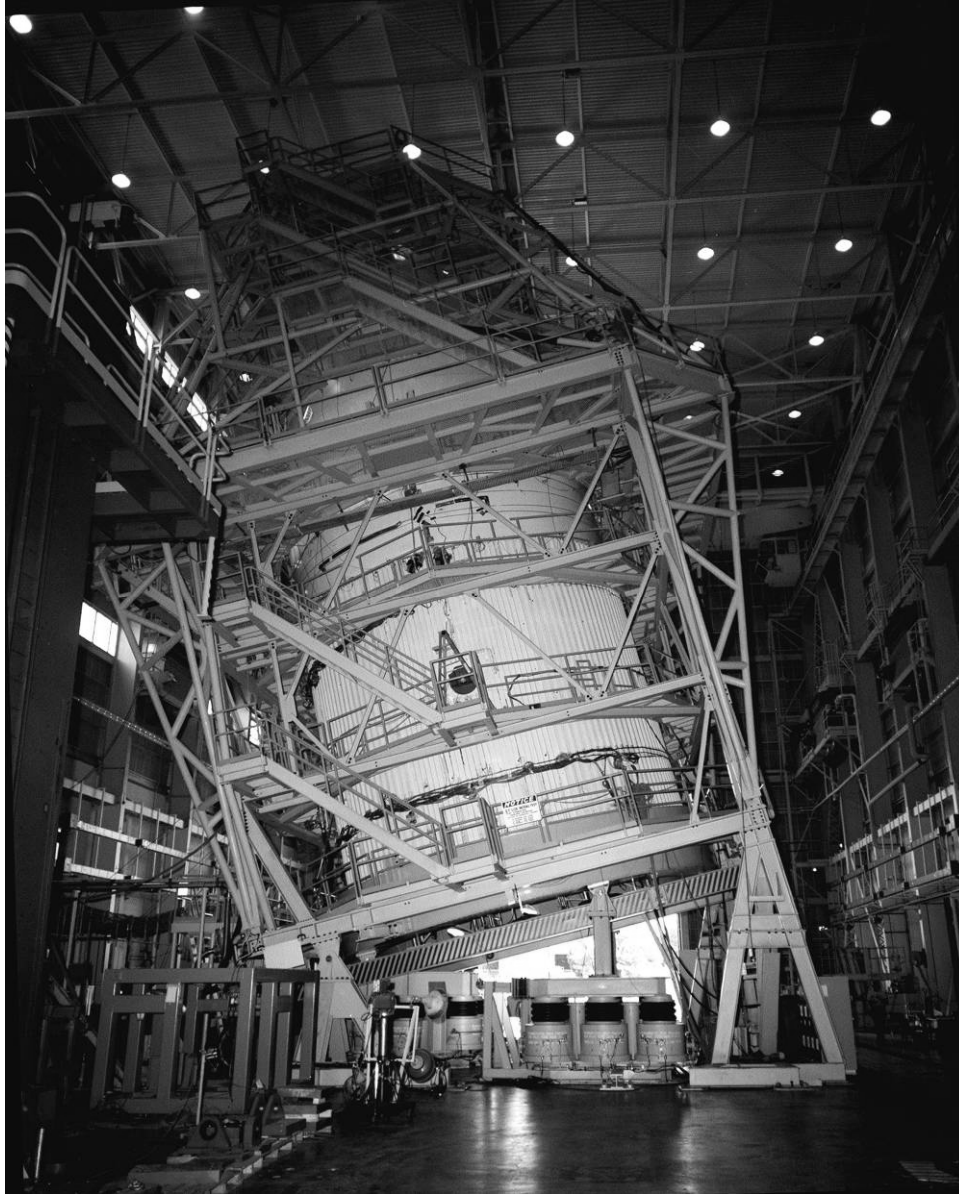
Figure D-2. Liquid oxygen tank of the ET during a hydroelastic modal test at MSFC,
May 1, 1978.

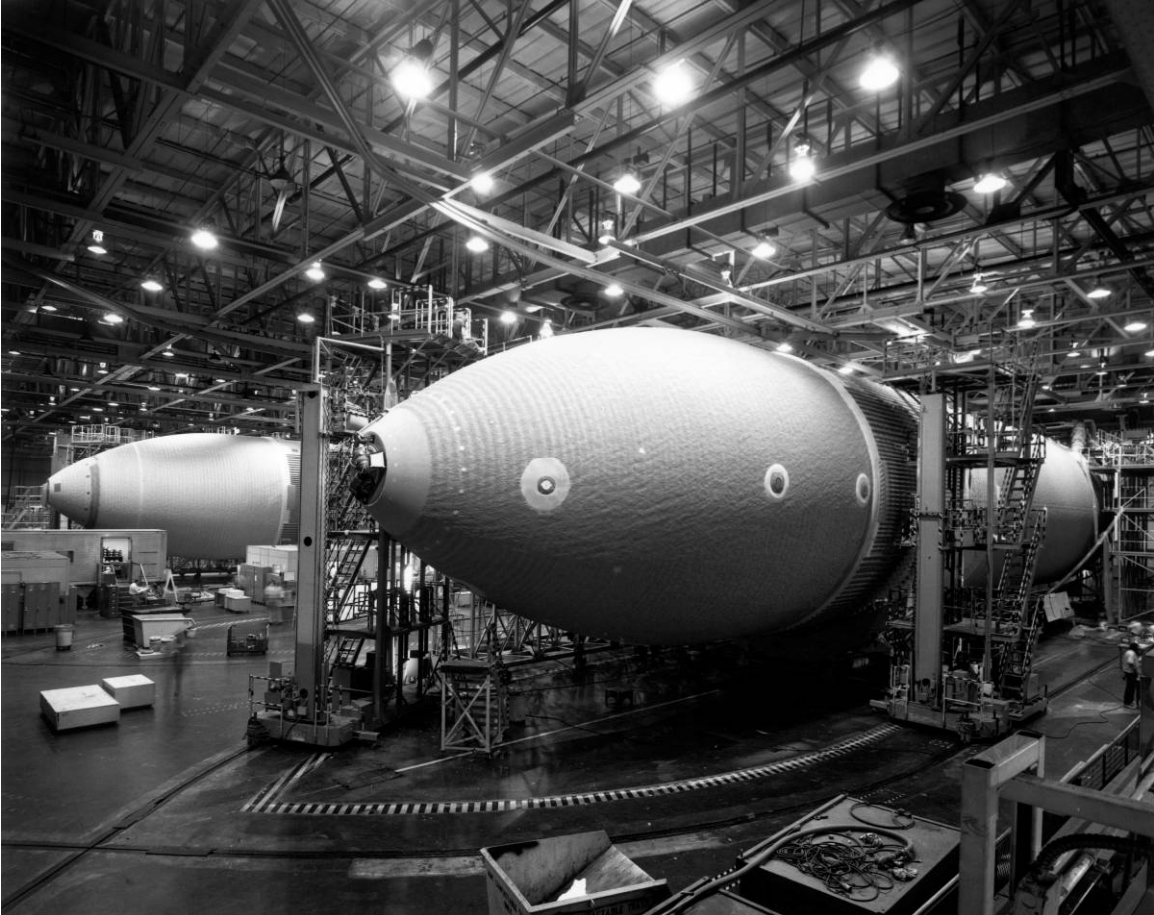
Figure D-5. A Standard Weight Tank (foreground) and a Lightweight Tank (rear) in final assembly at MAF, date unknown.

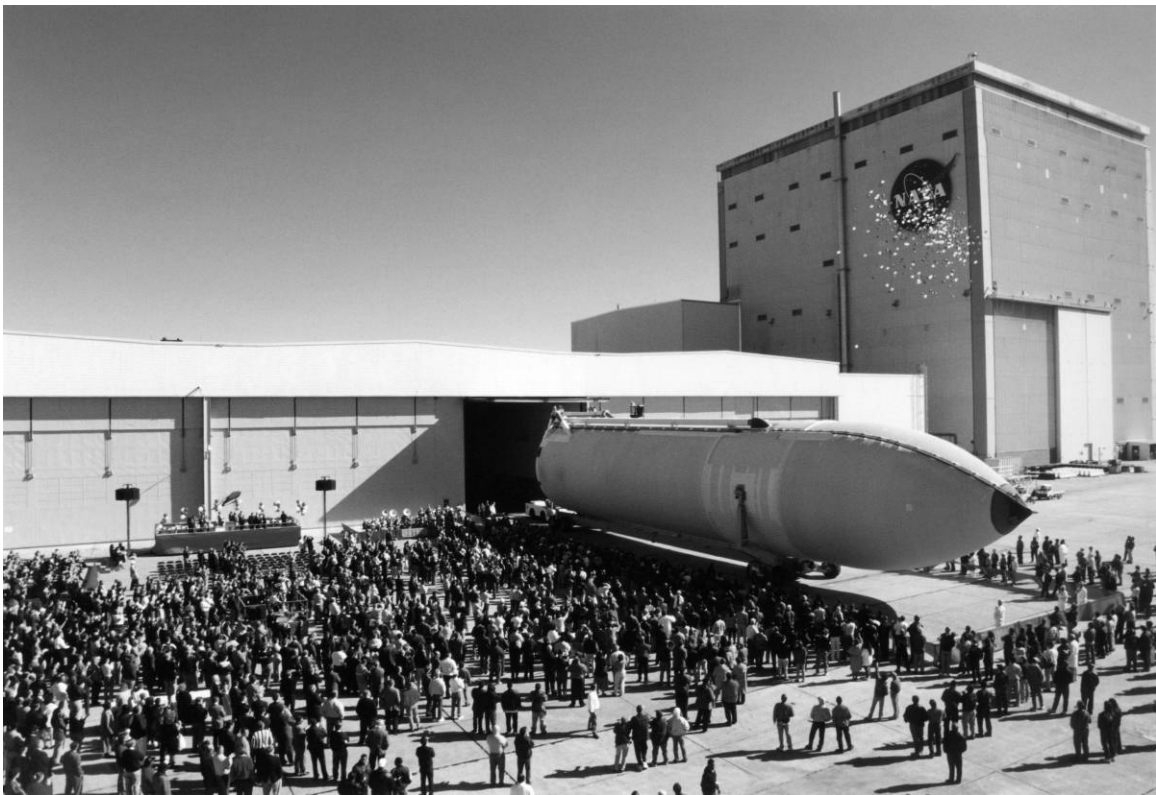
Figure D-8. First Super Lightweight Tank (ET-96) rolls out, January 16, 1998.
Source: NASA, Johnson Space Center, Imagery Online, jsc2010e009775.

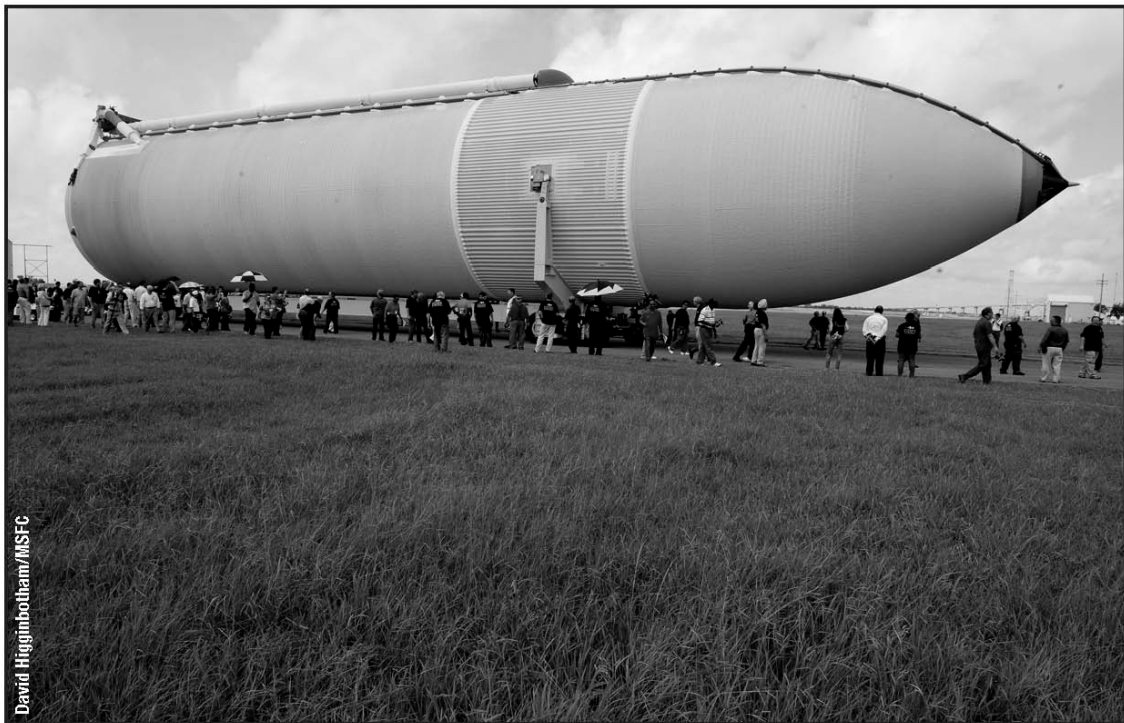
ET-138 begins its rollout to the Michoud harbor.

Figure D-9. The last of 136 tanks (ET-138) is rolled out at Michoud, July 8, 2010.
Source: NASA, Marshall Space Flight Center, *Marshall Star*, July 15, 2010, 1.

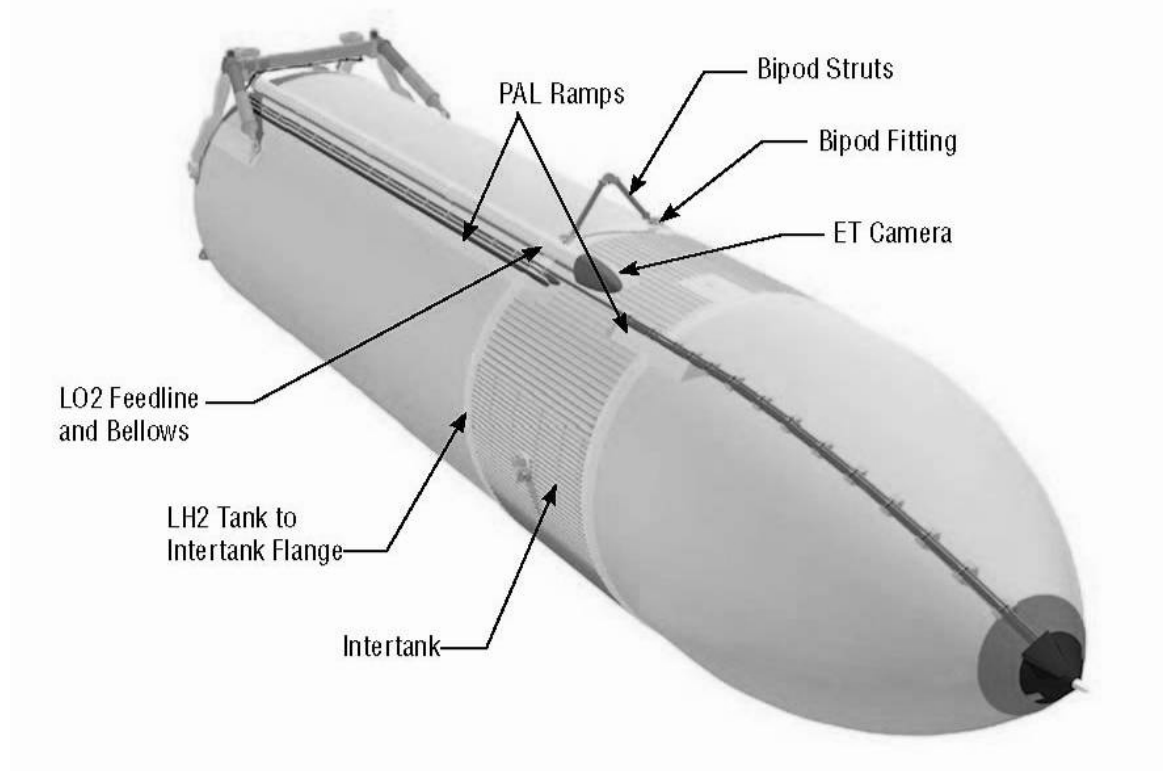
Figure D-10. Diagram showing improvements to the ET following the *Columbia* accident.
Source: NASA, Marshall Space Flight Center, *NASA Facts: Improvements to the Space Shuttle's External Tank*, 1; accessed at http://www.nasa.gov/centers/marshall/pdf/119016main_Shuttle_ET_FS.pdf.

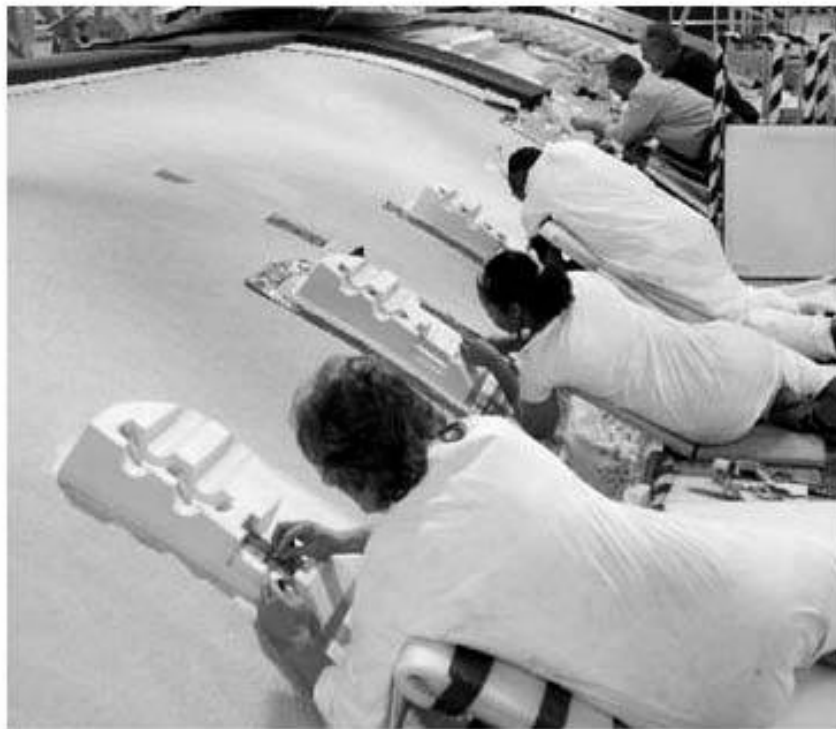
Figure D-12. Lockheed Martin technicians installing ice/frost ramps.
Source: NASA, *NASA Facts: Space Shuttle External Tank ET-128, STS-124*, 2; accessed at http://www.nasa.gov/centers/marshall/pdf/228641main_8-368946_%282%29.pdf.

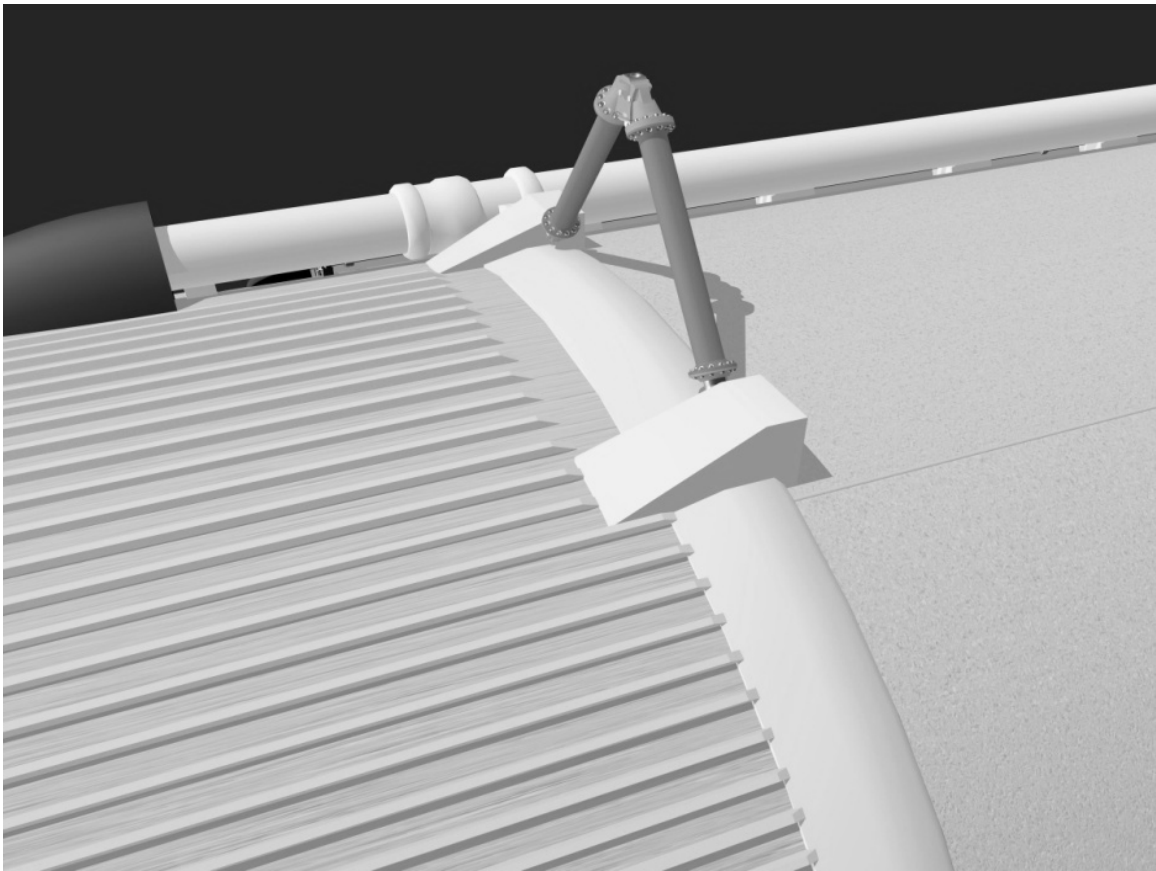
Figure D-13. Forward bipod fitting, pre-*Columbia* accident.
Source: NASA, Marshall Space Flight Center/Lockheed Martin, accessed at
http://www.nasa.gov/centers/marshall/images/content/104648main_99505main_Bipod_Pre-Columbia_2400x1800.jpg

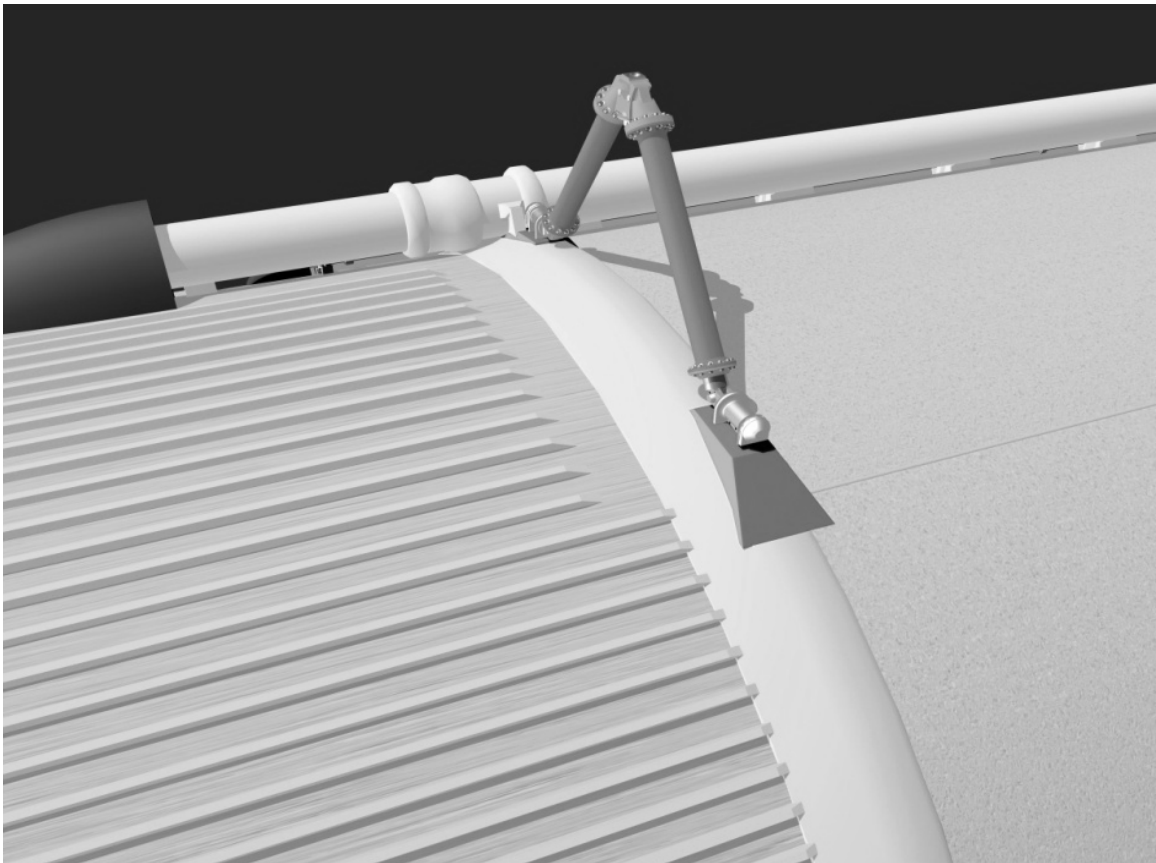
Figure D-14. Forward bipod redesign.

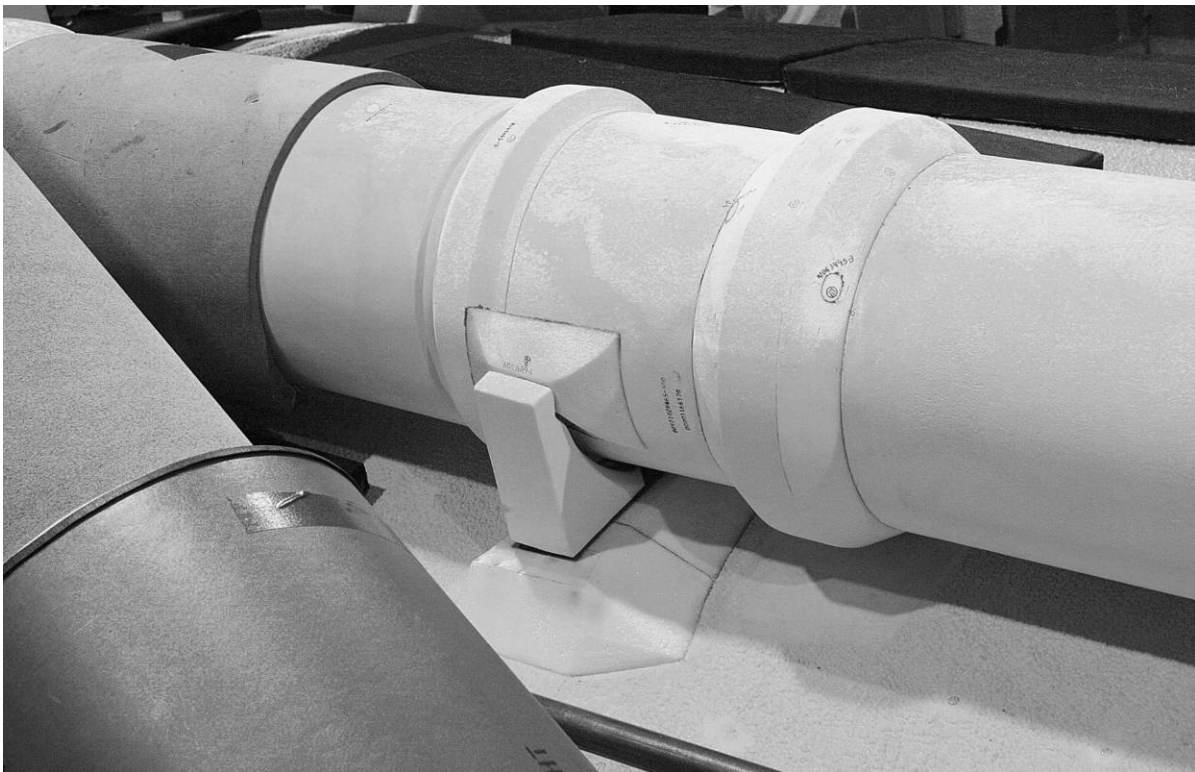
Figure D-15. Redesigned liquid oxygen feedline bellows, August 12, 2004.
Source: NASA, Marshall Space Flight Center/Lockheed Martin, accessed at
http://www.nasa.gov/centers/marshall/images/content/104640main_99417main_Bellows_8-12-04_2400x1541.jpg.

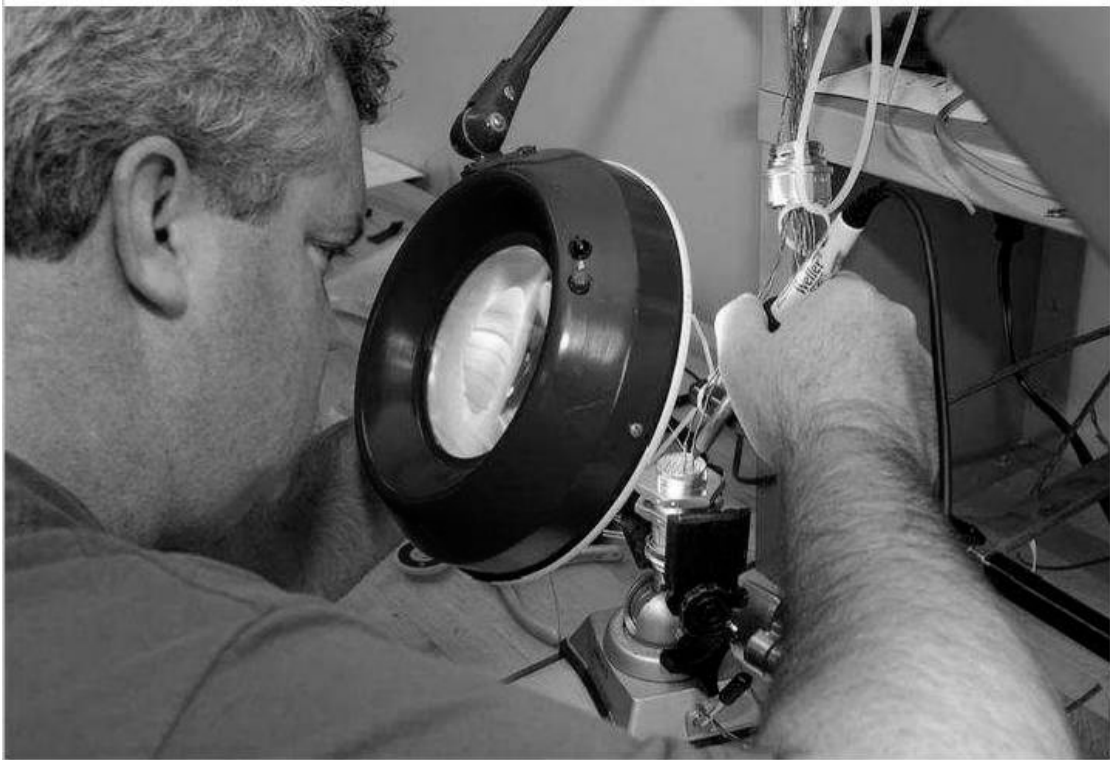
Figure D-16. A technician working on an ECO connector.

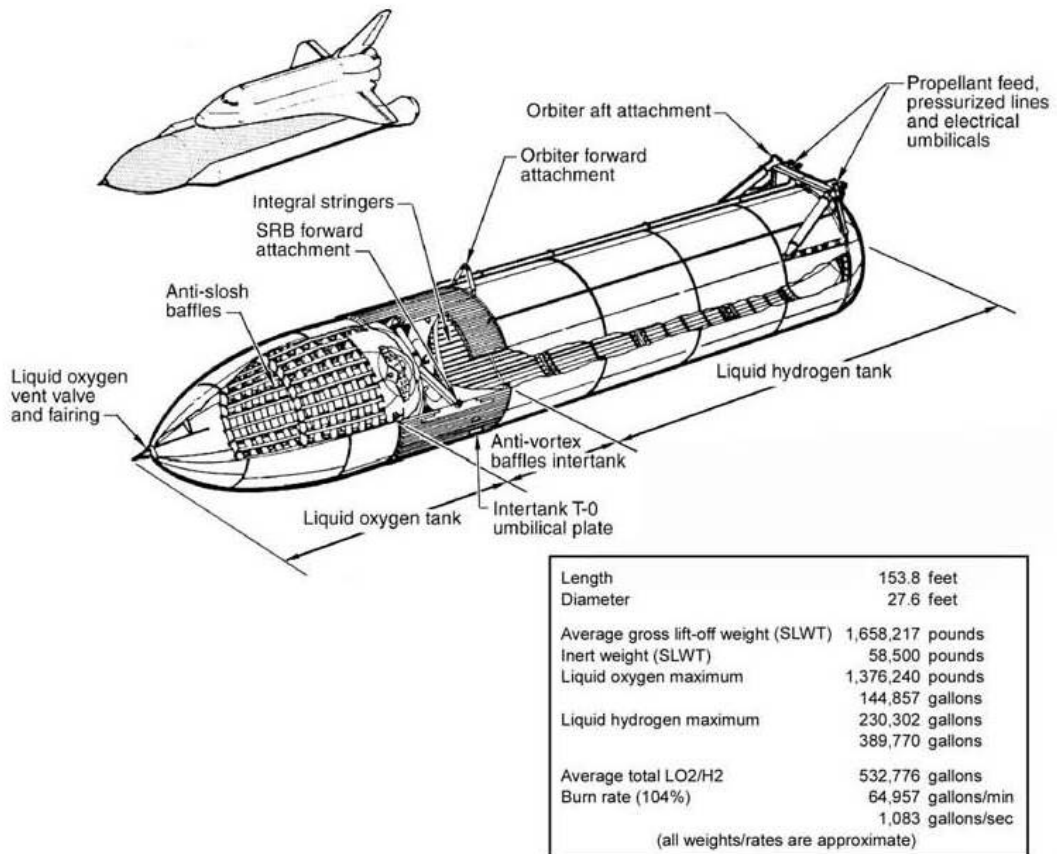
usa007587_034r1.tif

Figure D-17. Diagram of the Super Lightweight Tank.
 Source: USA, *Shuttle Crew Operation Manual*, 1.3-1.

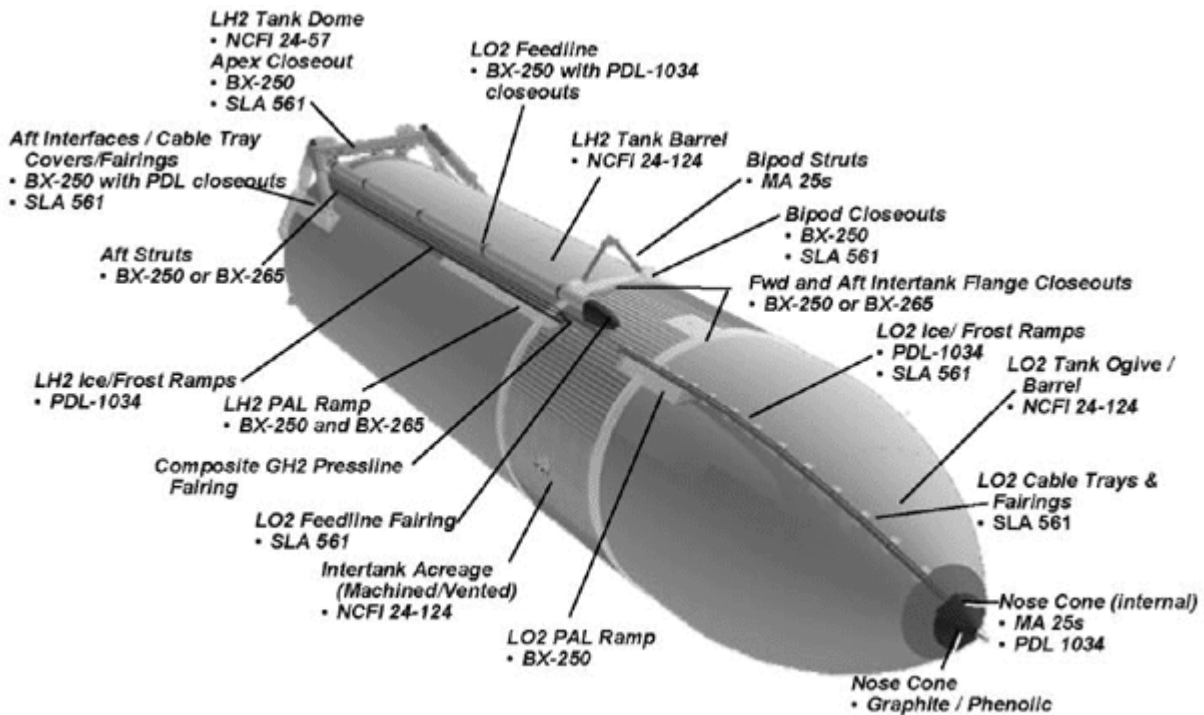
Figure D-18. Diagram of the External Tank.
 Source: NASA, Marshall Space Flight Center, accessed at
http://maf.msfc.nasa.gov/et_overview.html

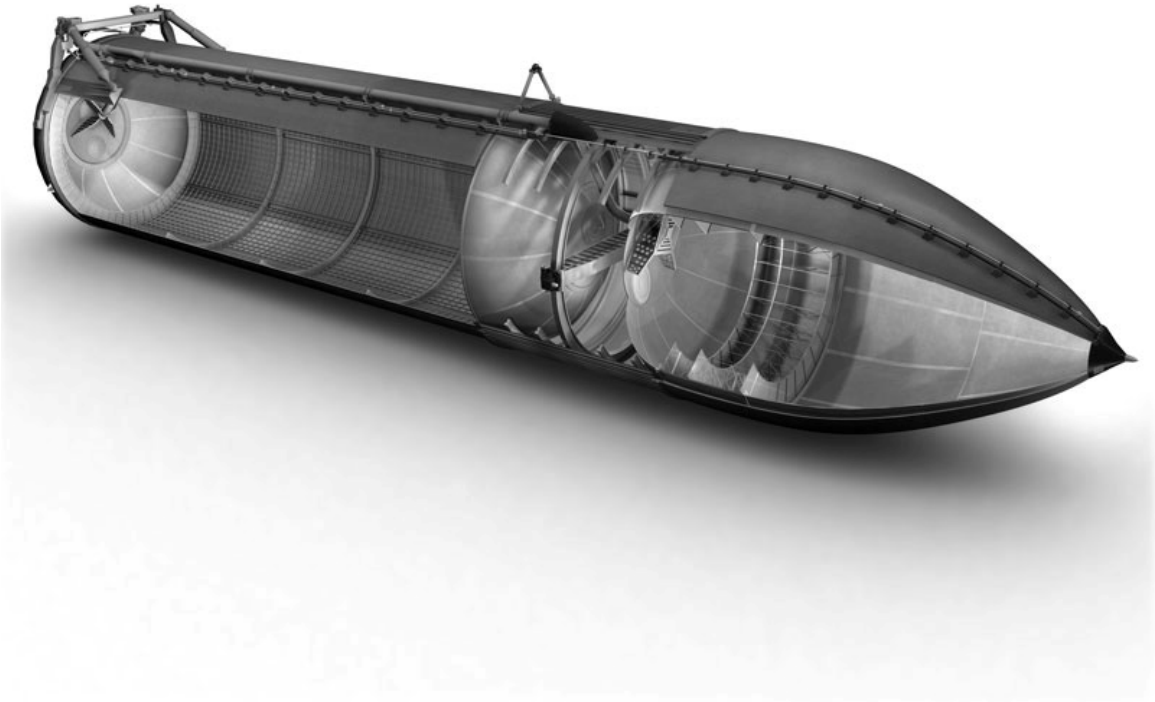
Figure D-19. Cutaway view of the External Tank.
Source: NASA, Johnson Space Center, Imagery Online, jsc2010e009729.

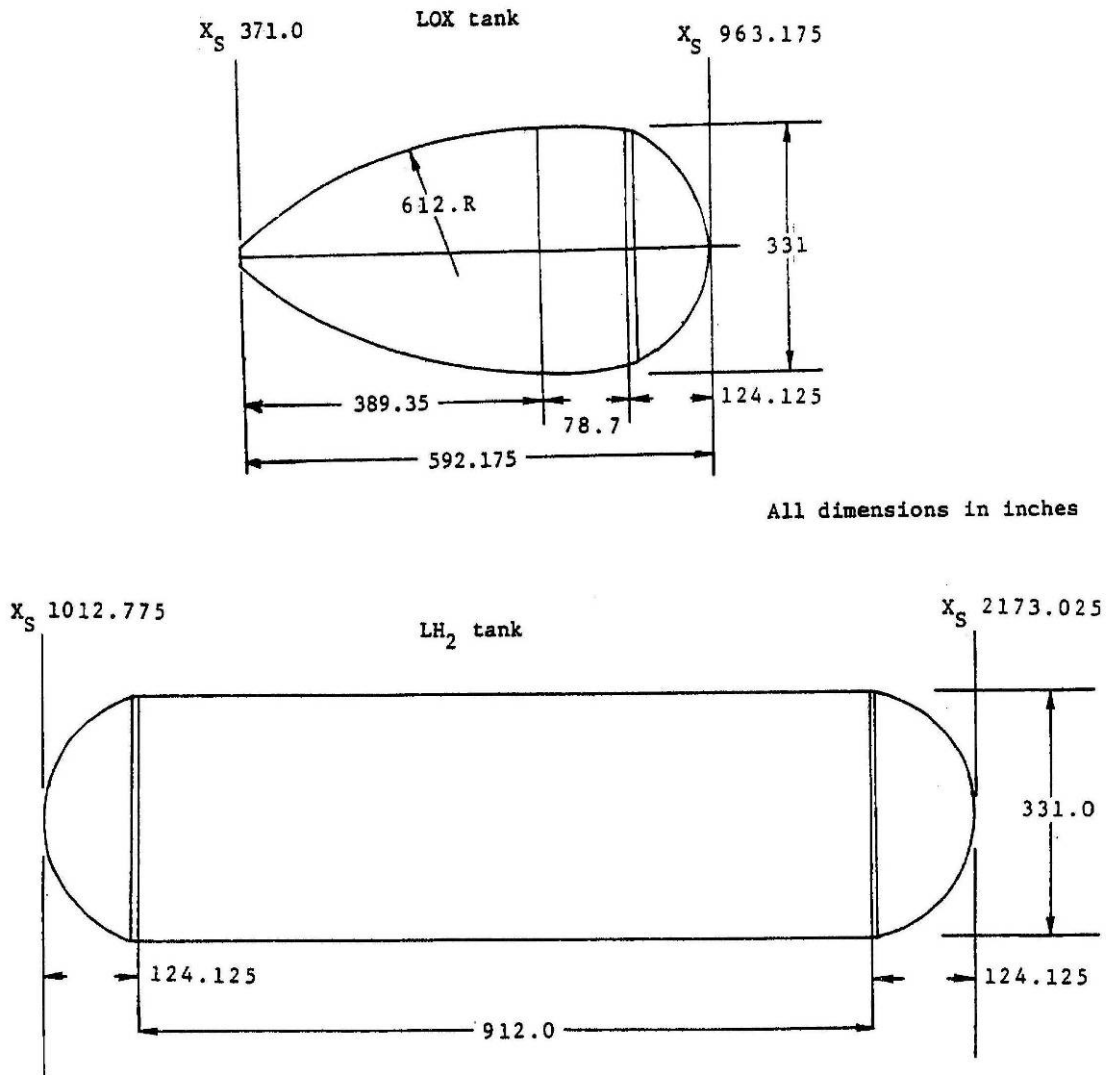
Figure D-20. General dimensions of the ET LO₂ (LOX) and LH₂ tanks.
Source: NASA, *Shuttle Operational Data Book*, Volume 1, Figure 4.4-2.

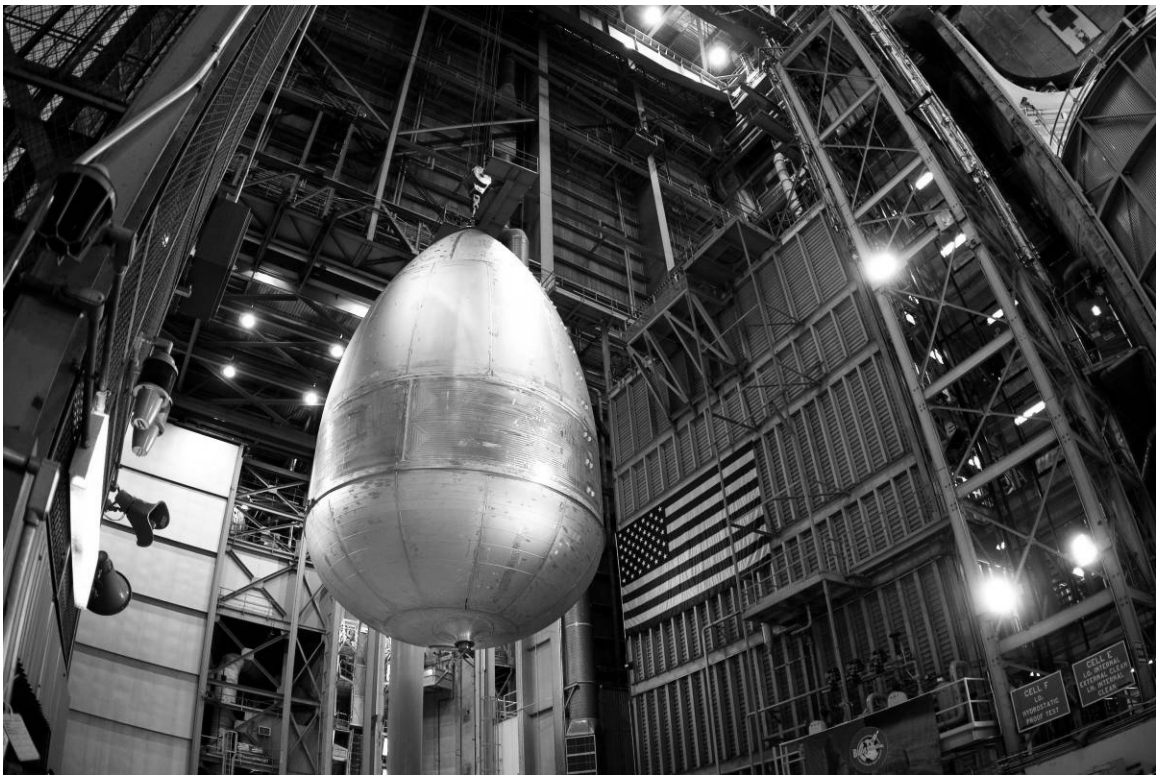
Figure D-21. The liquid oxygen tank for ET-138 at MAF, May 19, 2009.
Source: NASA, Johnson Space Center, Imagery Online, jsc2010e009667.

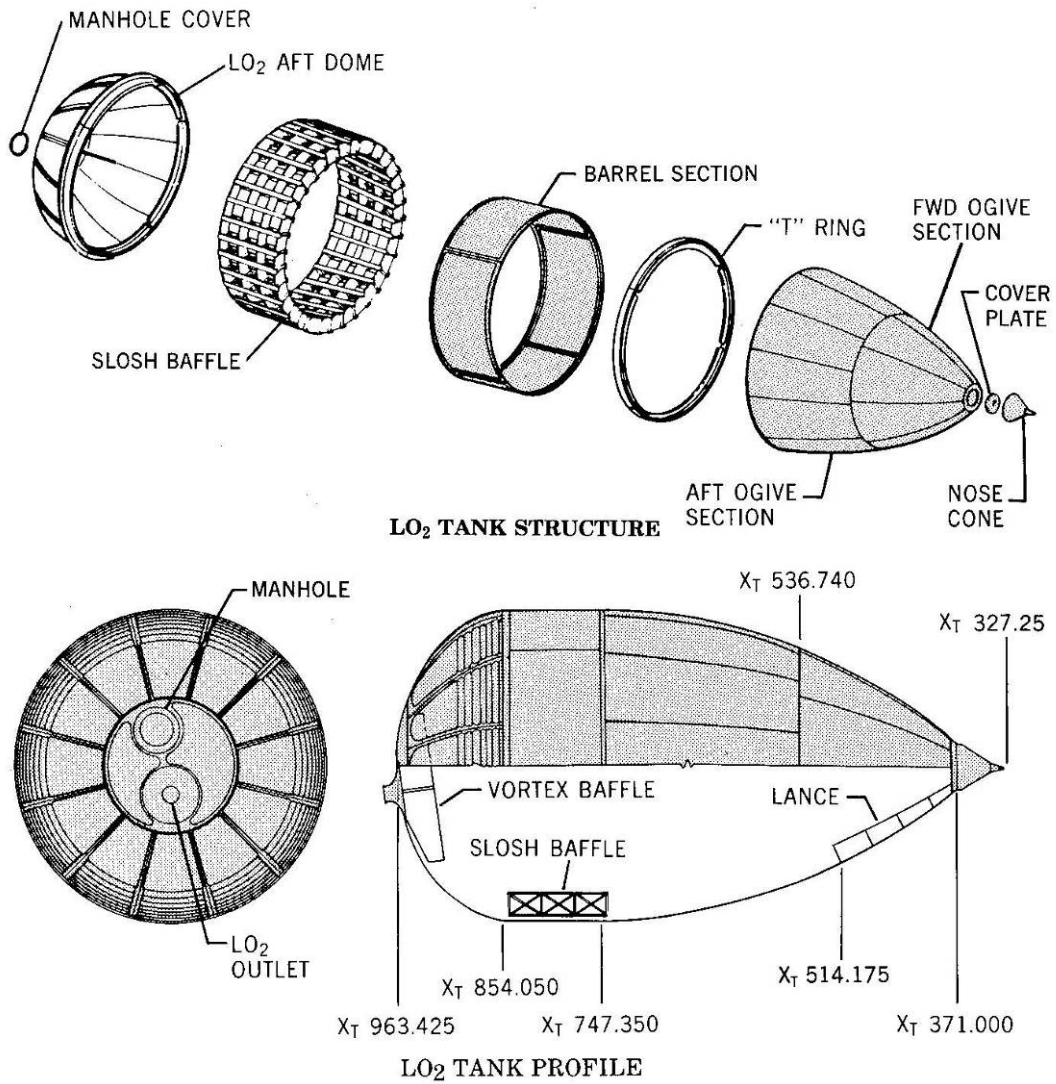
Figure D-22. Diagram of the liquid oxygen tank.
 Source: Martin Marietta, *Space Shuttle External Tank. System Definition Handbook*,
 Volume I, VI-2.

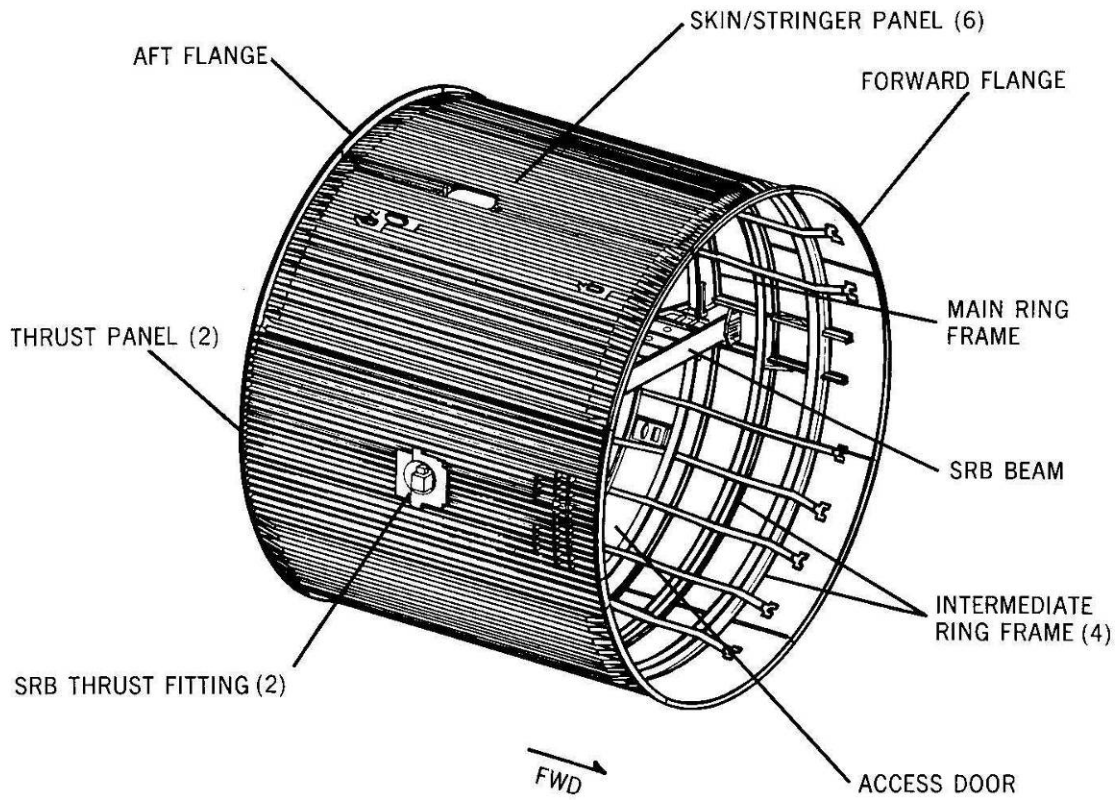
Figure D-24. Diagram of the intertank.
Source: Martin Marietta, *Space Shuttle External Tank. System Definition Handbook*,
Volume I, VII-2.

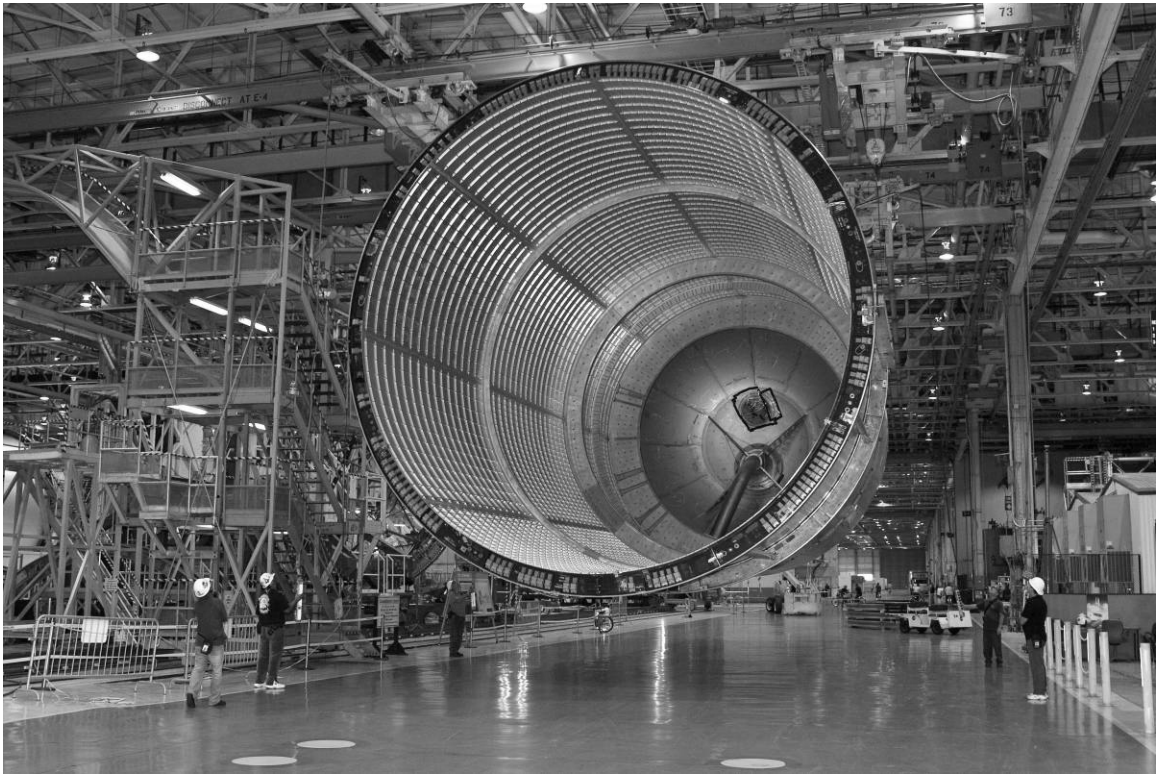
Figure D-26. The interior of a liquid hydrogen tank during assembly at MAF, August 28, 2008.
Source: NASA, Johnson Space Center, Imagery Online, jsc2010e009742.

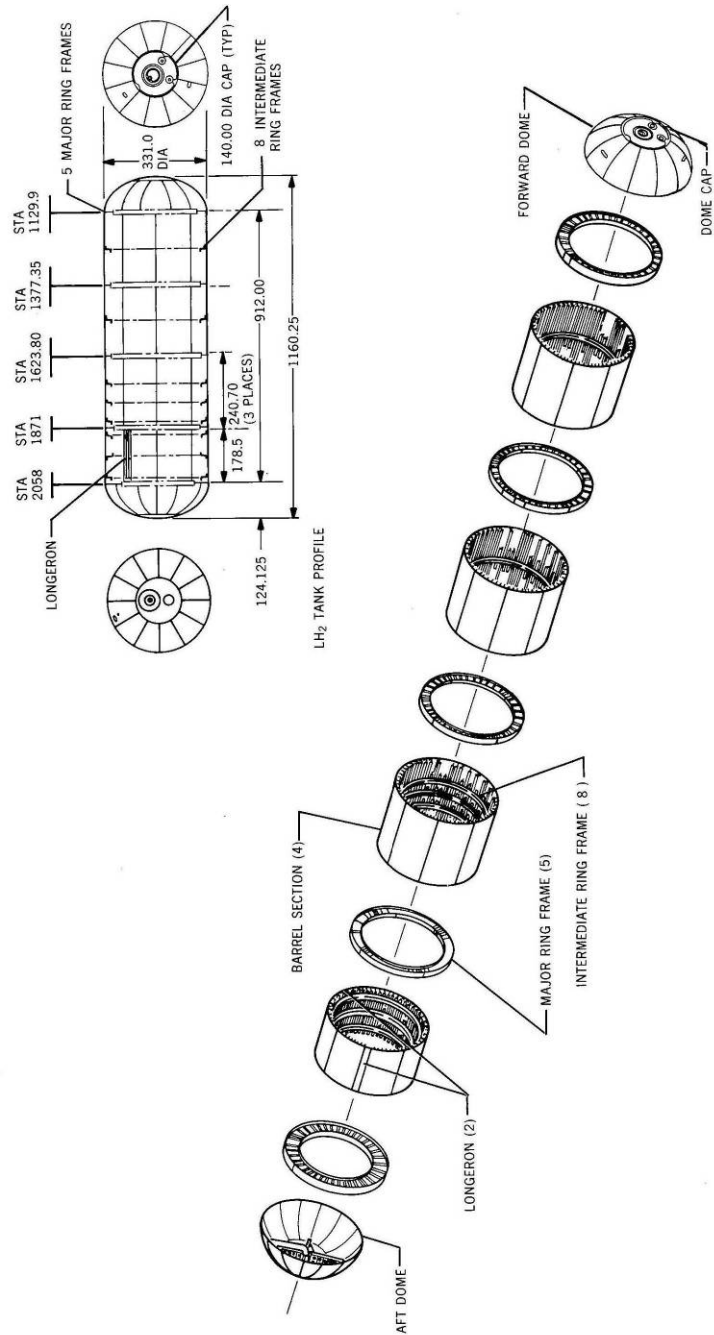
Figure D-27. Diagram of the liquid hydrogen tank.
 Source: Martin Marietta, *Space Shuttle External Tank. System Definition Handbook*,
 Volume I, VIII-3/VIII-4.

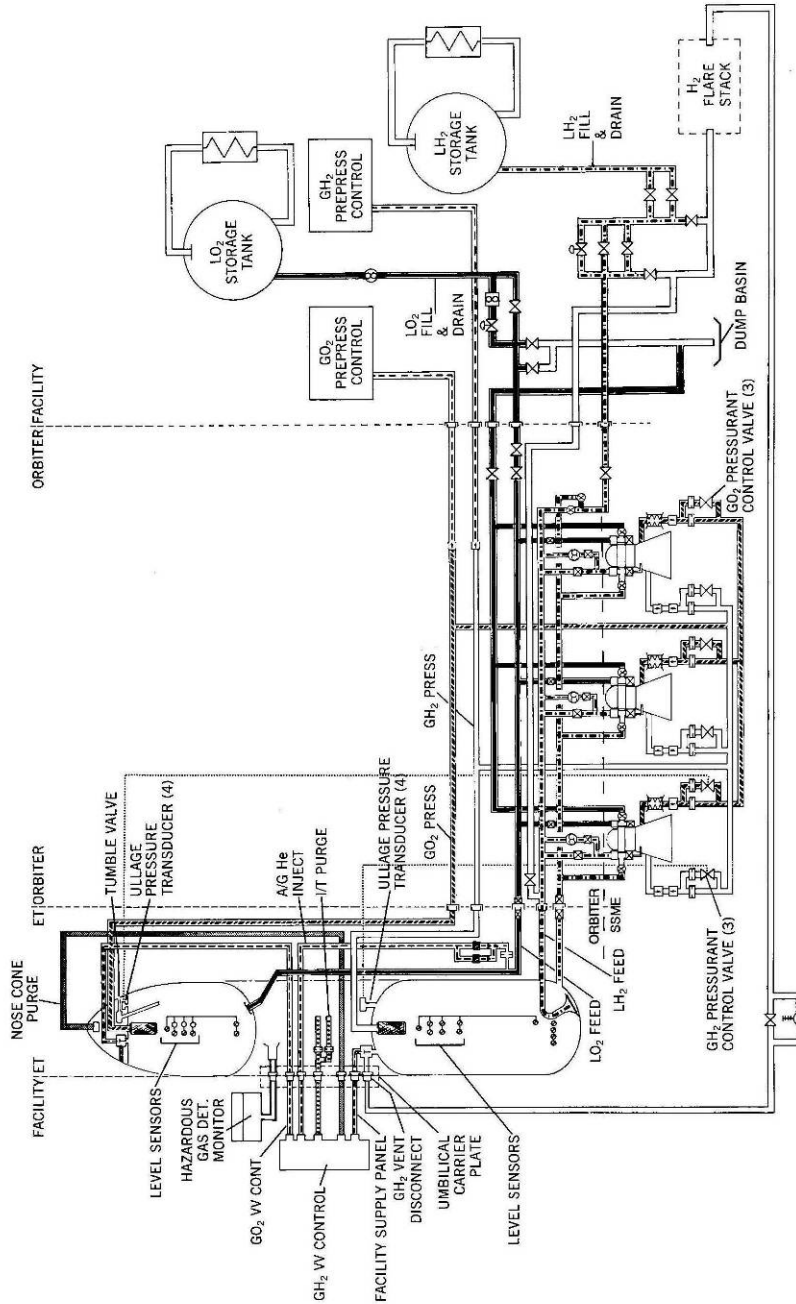
Figure D-28. Schematic of the main propulsion system.
 Source: Martin Marietta, *Space Shuttle External Tank. System Definition Handbook*,
 Volume I, IX-7/IX-8.

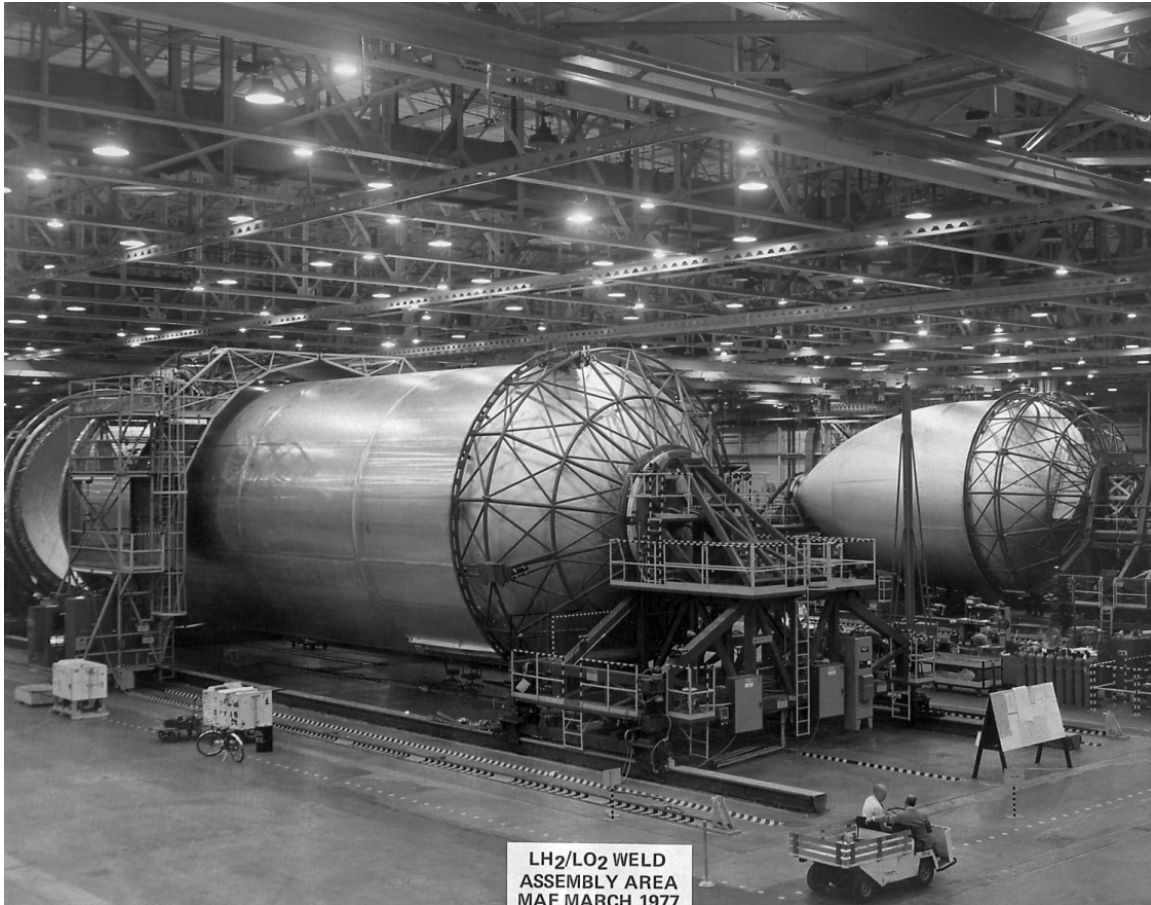
Figure D-29. Liquid hydrogen tank and liquid oxygen tank for the ET being assembled in the weld assembly area of MAF, March 1, 1977.

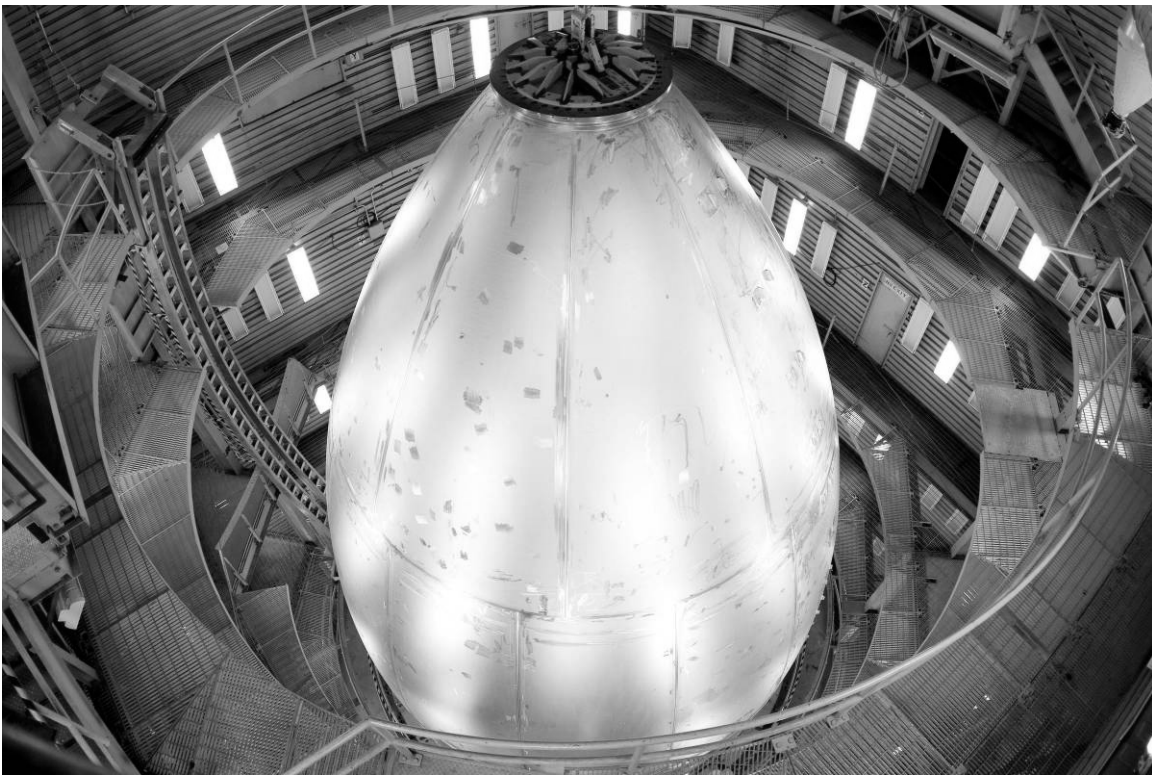
Figure D-30. The LO2 tank for ET-138 leaves proof testing cell at MAF, May 31, 2009.
Source: NASA, Johnson Space Center, Imagery Online, jsc2010e009664.

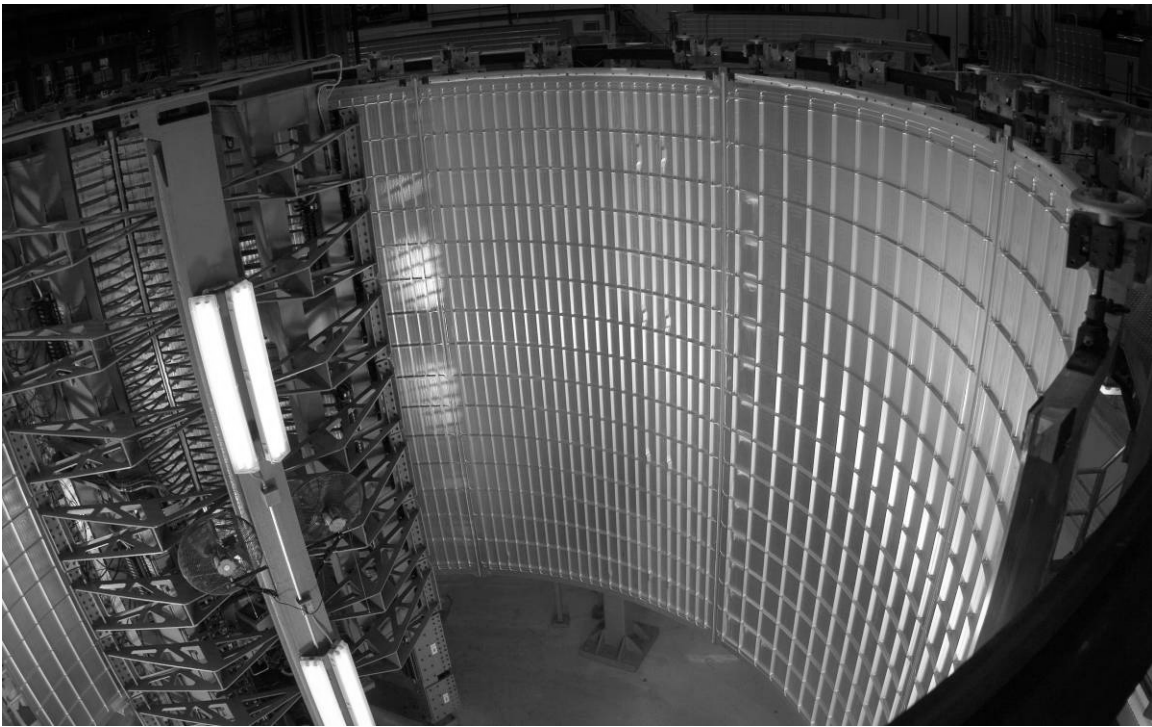
Figure D-31. Friction stir welding of LH2 barrel panels at MAF, August 28, 2008.
Source: NASA, Johnson Space Center, Imagery Online, jsc2010e009645.
