Appendix D-ET Historic Photos

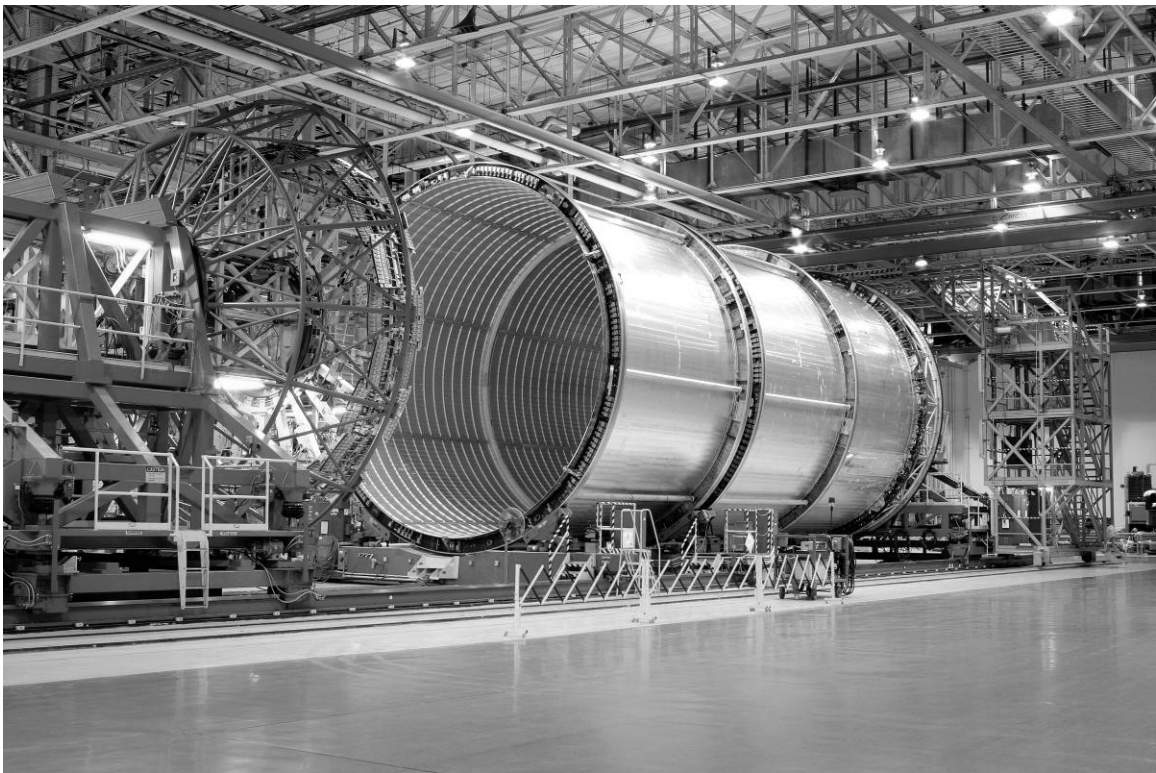
Figure D-32. LH2 tank on the 5068 weld tool at MAF, unknown date.
Source: NASA, Johnson Space Center, Imagery Online, jsc2010e009754.

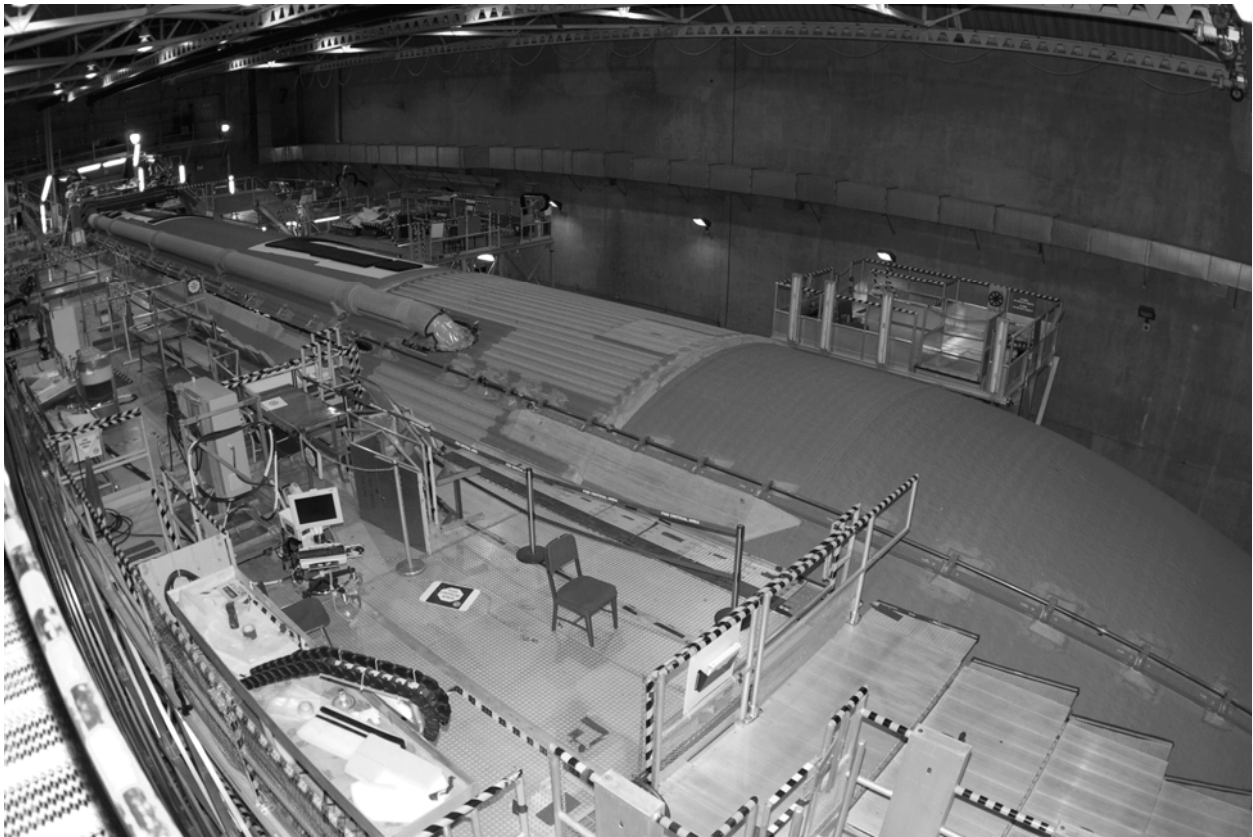
Figure D-35. ET-122 in Test & Checkout Building, October 7, 2009.
Source: <http://www.lockheedmartin.com/data/assets/ssc/michoud/PhotoGallery/ET-122-4-hi.gif>.

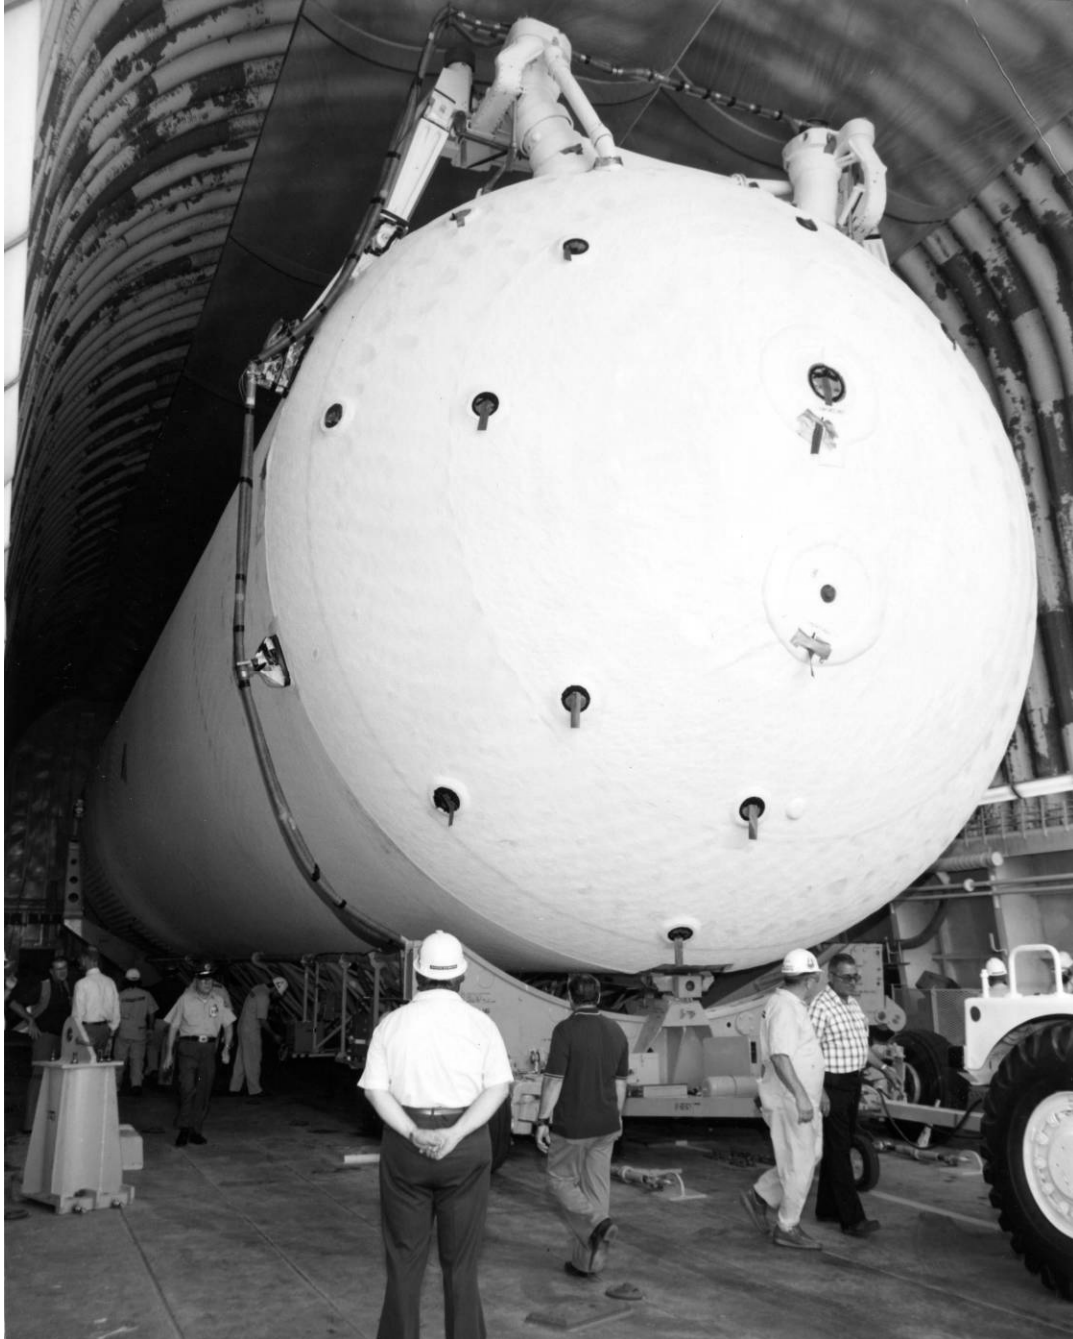
Figure D-36. ET-1 ready to be rolled into barge for 900-mile journey to KSC, June 29, 1979.
Source: NASA, Johnson Space Center, Imagery Online, jsc2010e009727

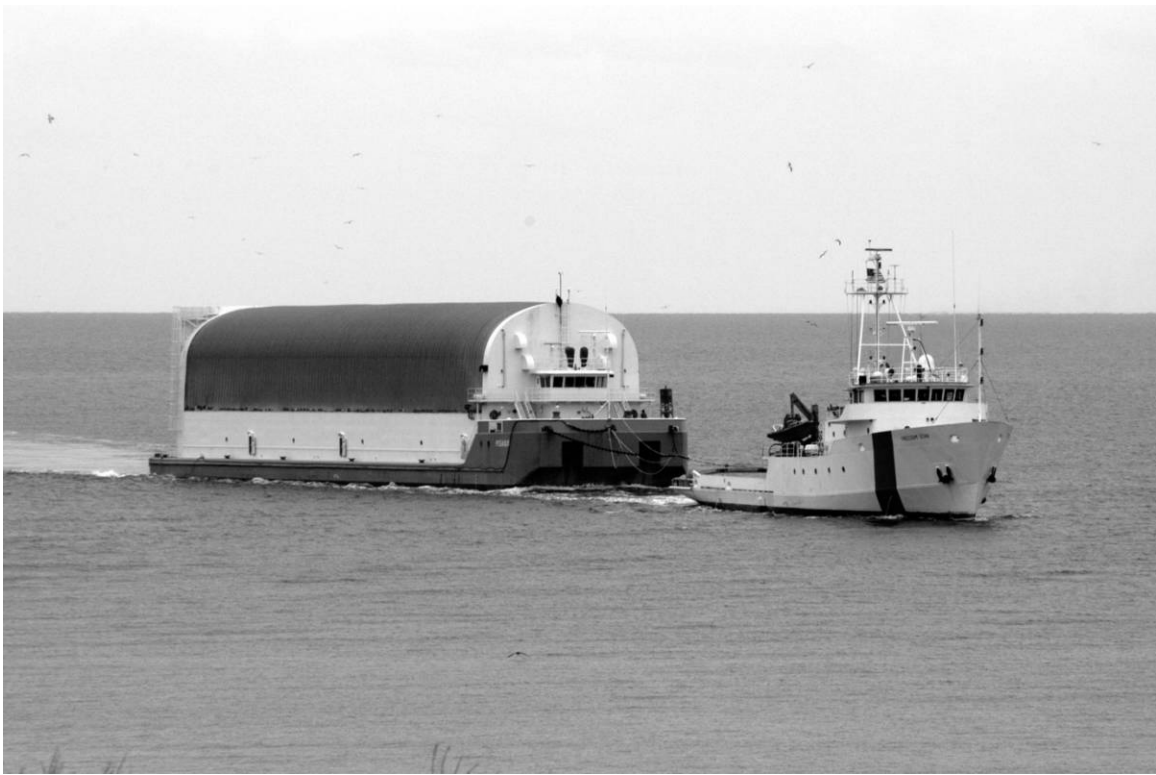
Figure D-37. The barge *Pegasus* carrying ET-121 being towed by SRB retrieval ship *Freedom Star*, March 9, 2005.

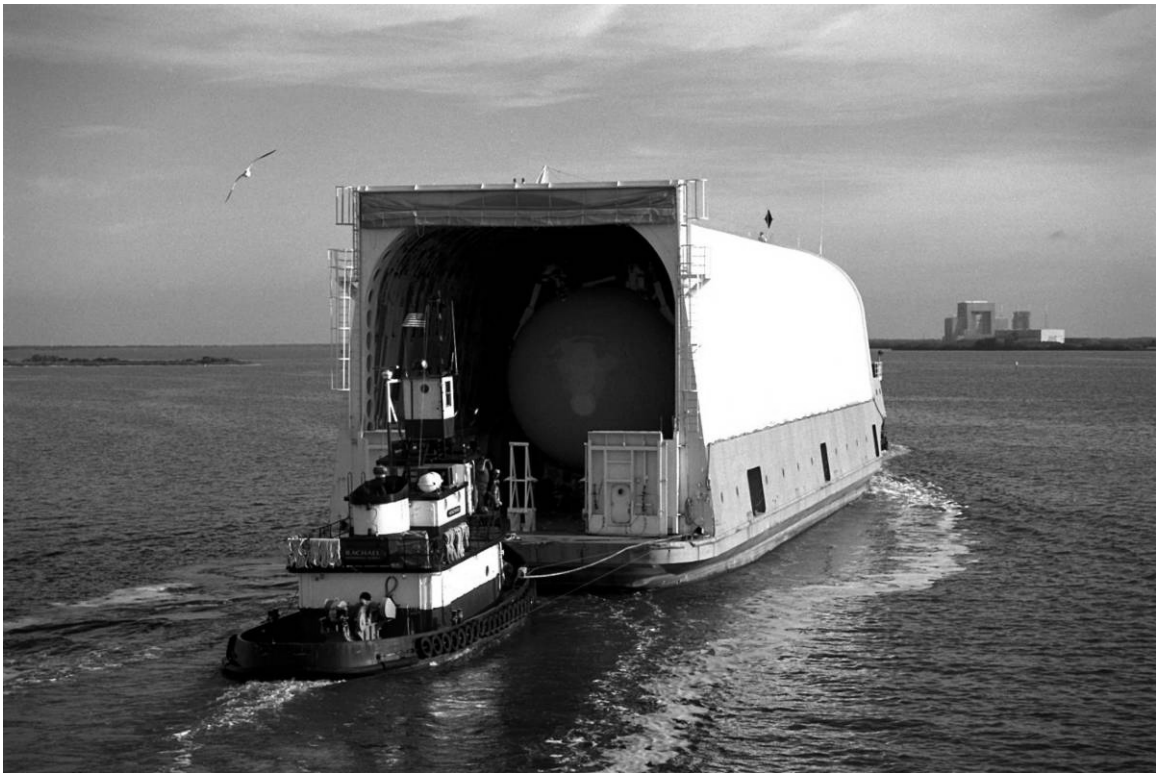
Figure D-38. The first Super Lightweight Tank is transported to KSC's VAB, February 6, 1998.
Source: NASA, Kennedy Space Center, KSC-98PC-0272, accessed at
<http://www.nix.ksc.nasa.gov>.

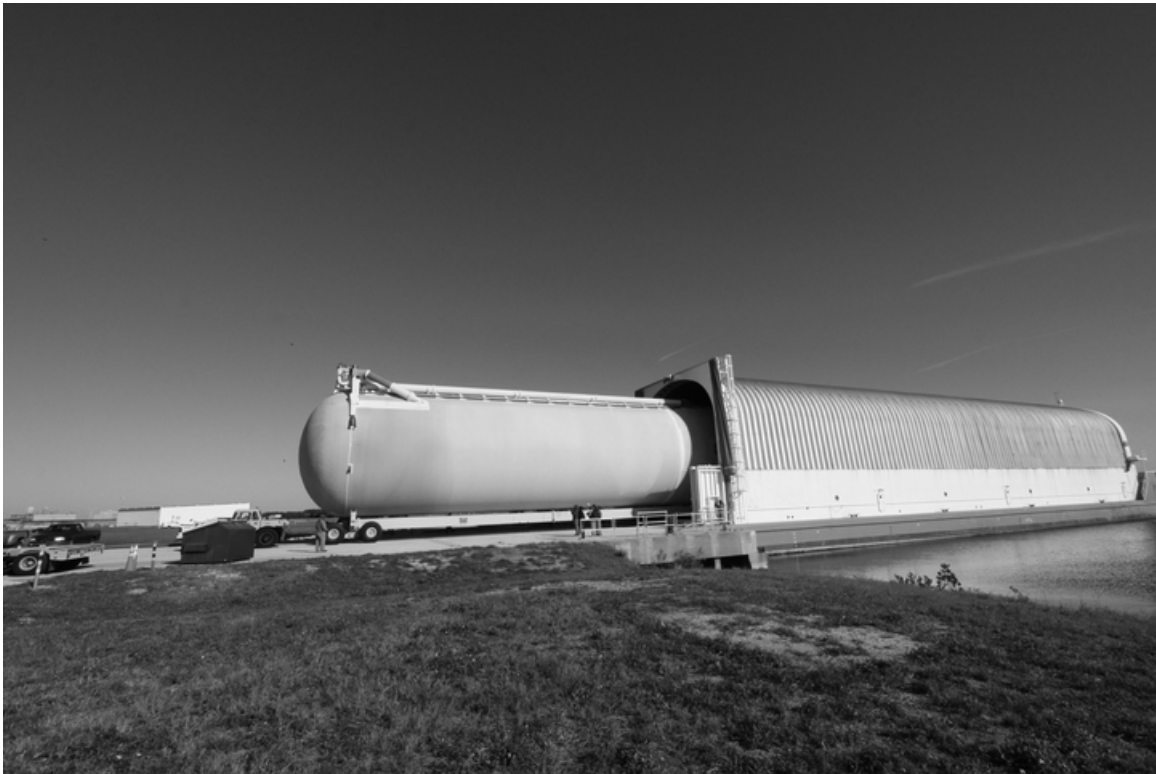
Figure D-39. ET-135 being offloaded at KSC's Barge Terminal Facility near the VAB,
January 5, 2010.

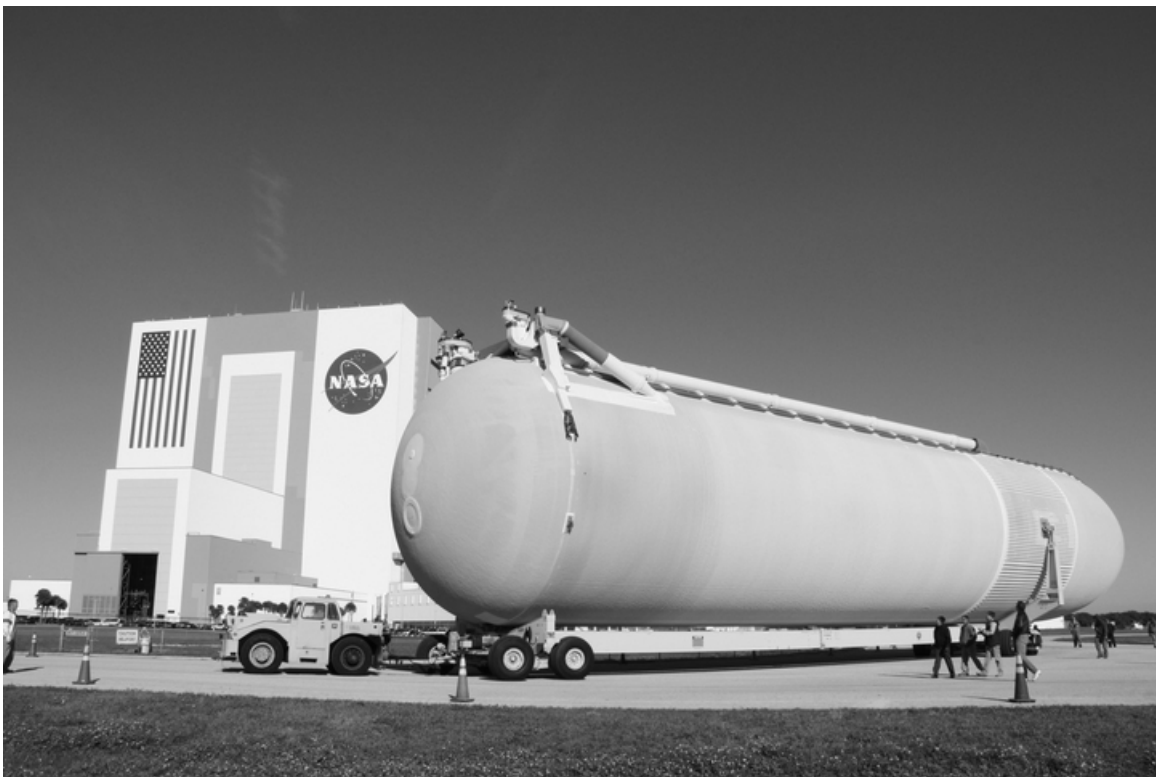
Figure D-40. ET-135 being towed on its transporter to the VAB, January 5, 2010.
Source: NASA Kennedy Space Center, KSC-2010-1003, accessed at
<http://mediaarchive.ksc.nasa.gov>.

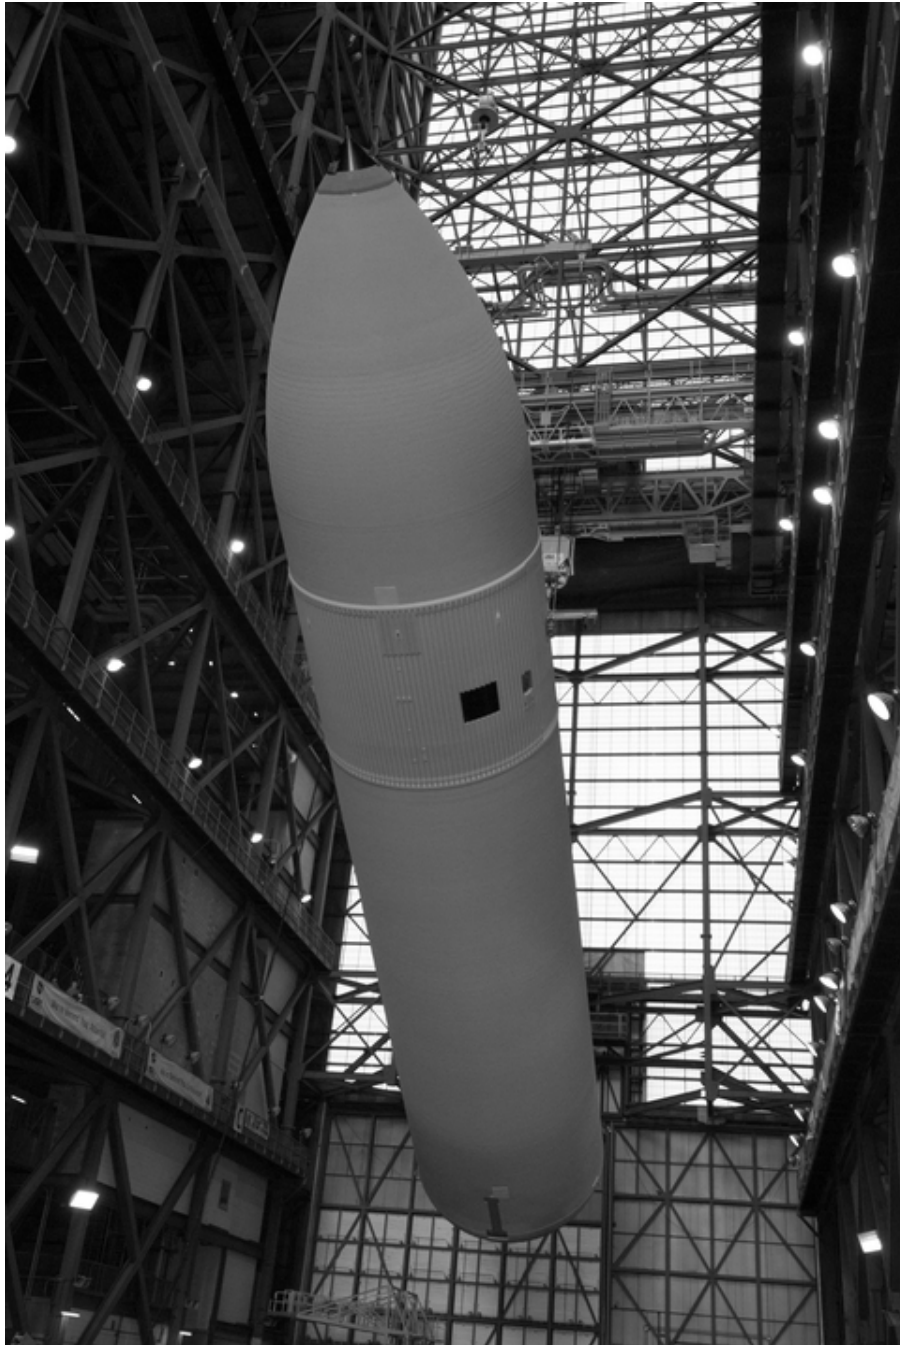
Figure D-41. ET-135 being rotated to vertical in KSC's VAB for placement into a test cell,
January 6, 2010.

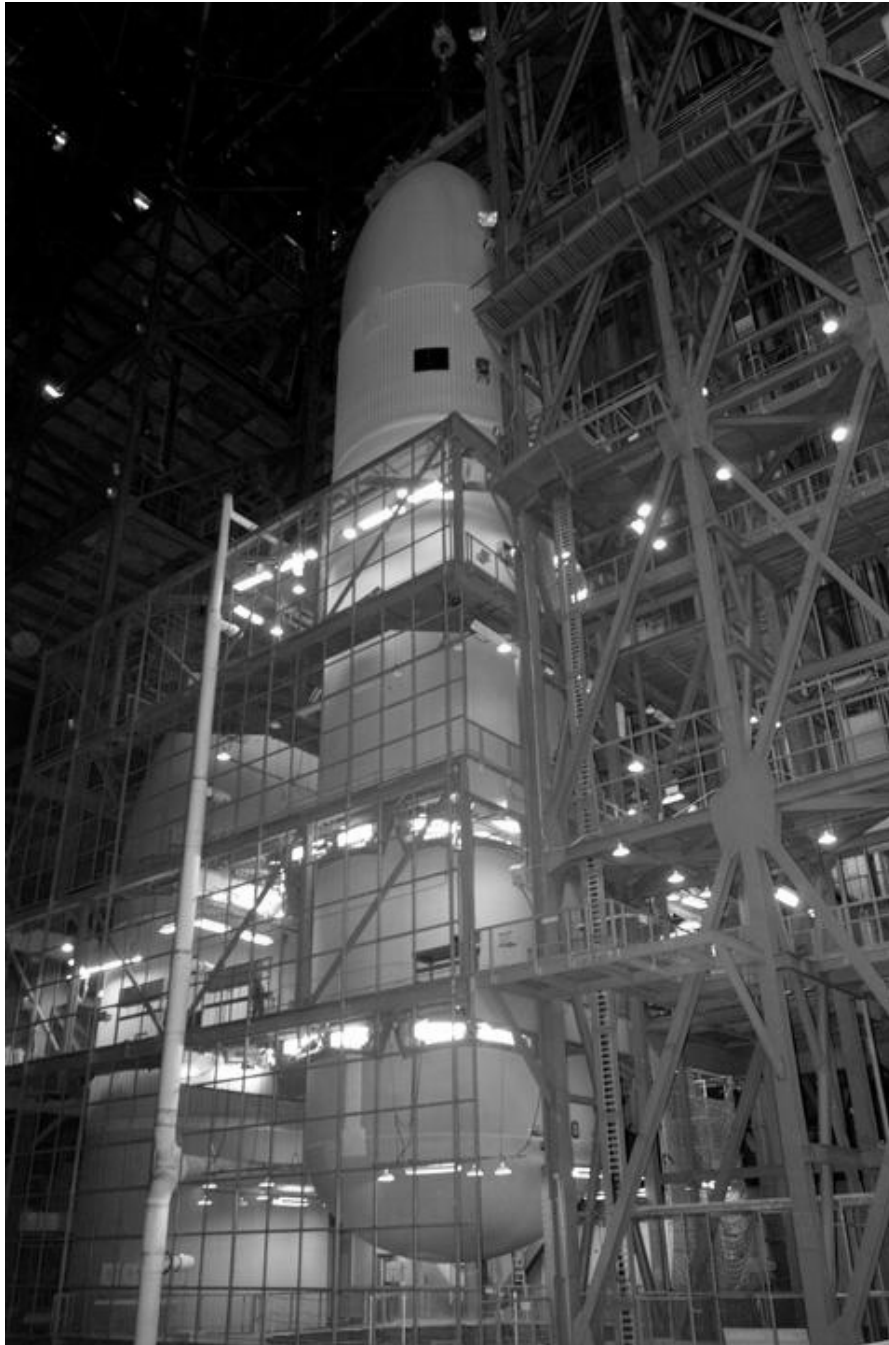
Figure D-42. The ET for STS-114 being lifted from a test cell in KSC's VAB for mating, February 28, 2005.
