Appendix E-SRB/RSRM Figures

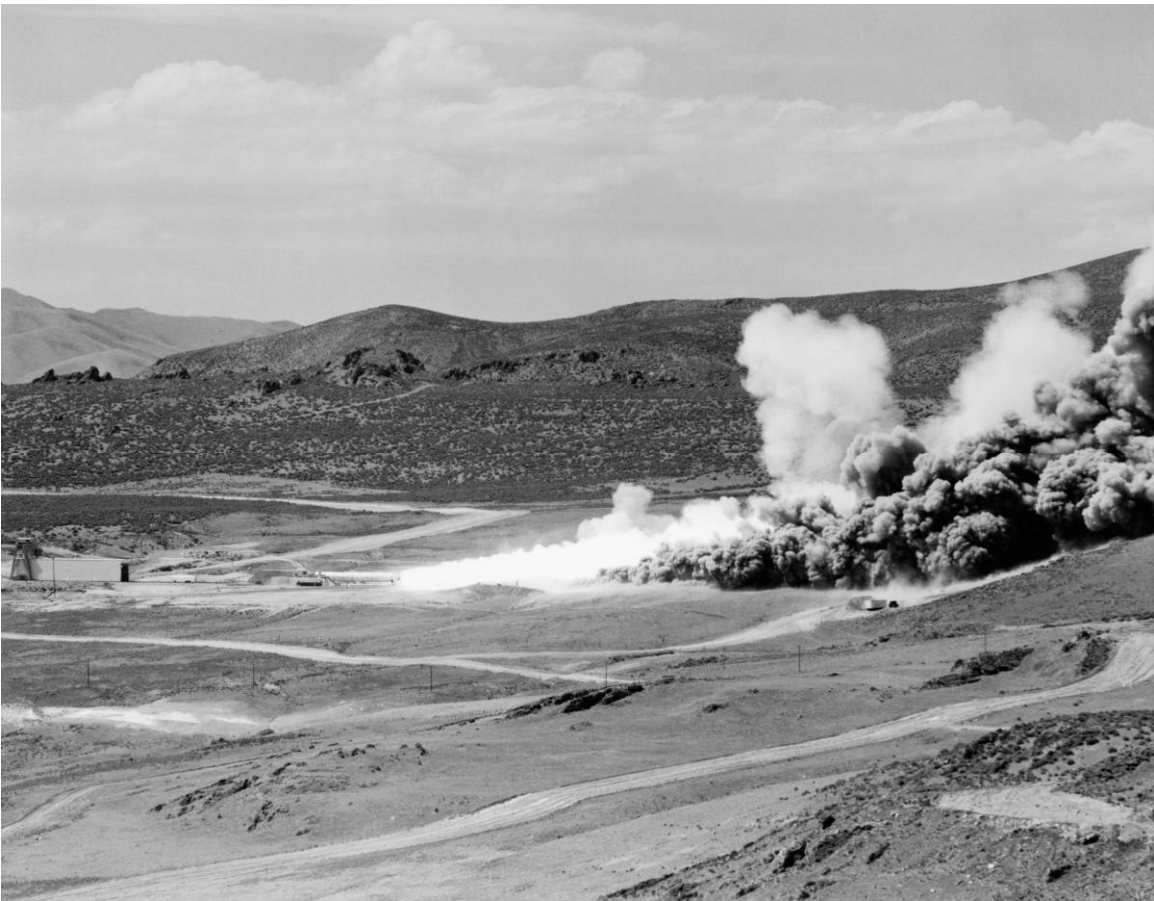
Figure No. E-1. SRB Development Motor-1 (DM-1) in test stand at Morton Thiokol facility at Wasatch, Utah, July 18, 1977.

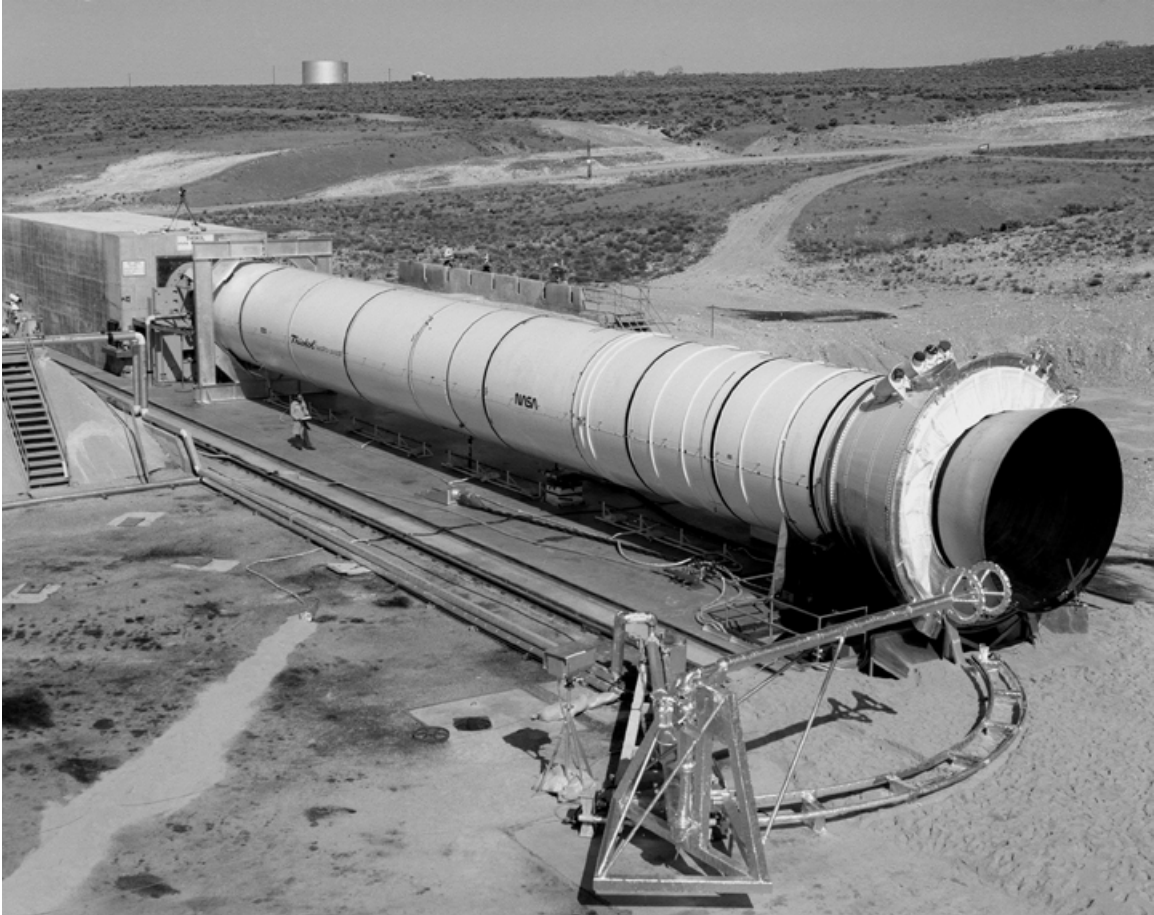
Figure No. E-2. SRB Qualification Motor-1 (QM-1) in test stand at Morton Thiokol facility at Wasatch, Utah, July 13, 1979.

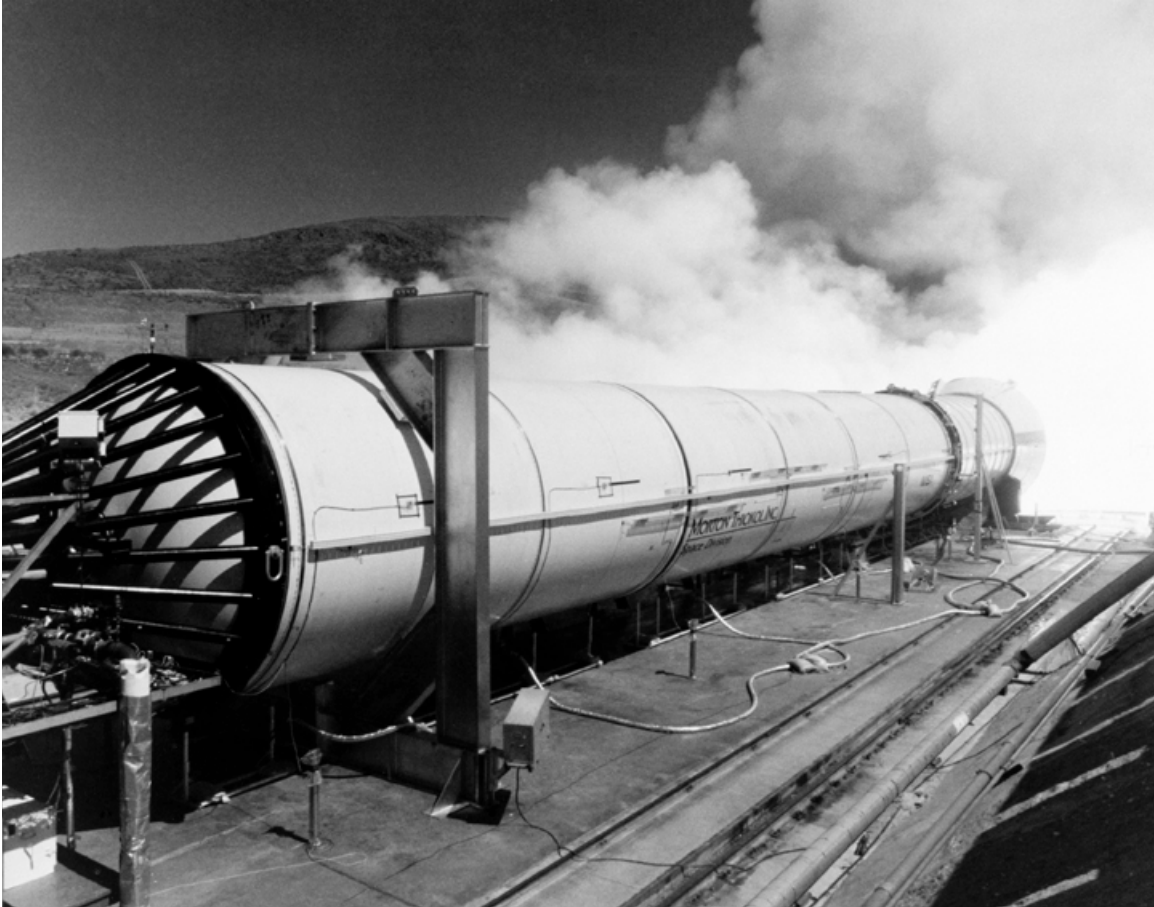
Figure No. E-3. Test firing of Development Motor-8 (DM-8) in test stand at Morton Thiokol's Wasatch, Utah, facility, August 27, 1987.

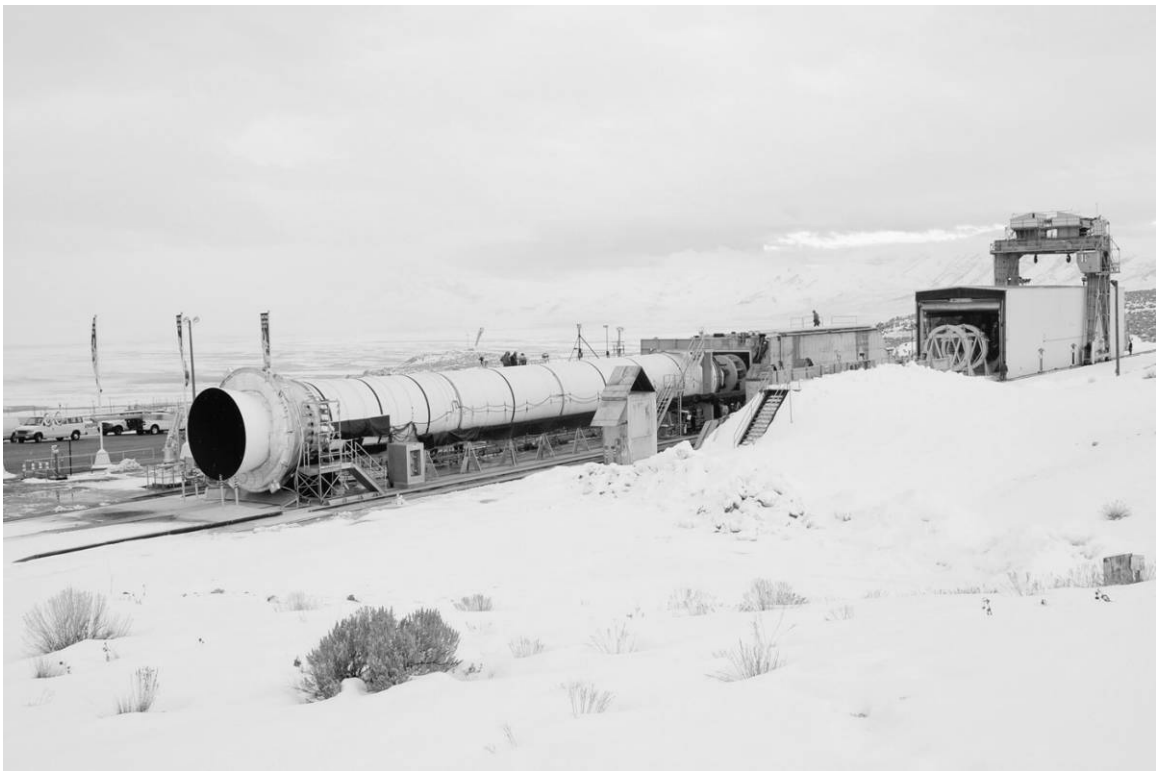
Figure No. E-4. Flight Support Motor (FSM)-17 test, February 25, 2010, at ATK in Promontory, Utah. This was the last RSRM test of the Space Shuttle program.
Source: NASA, accessed at http://www.nasa.gov/images/content/429987main_179307_002.jpg.

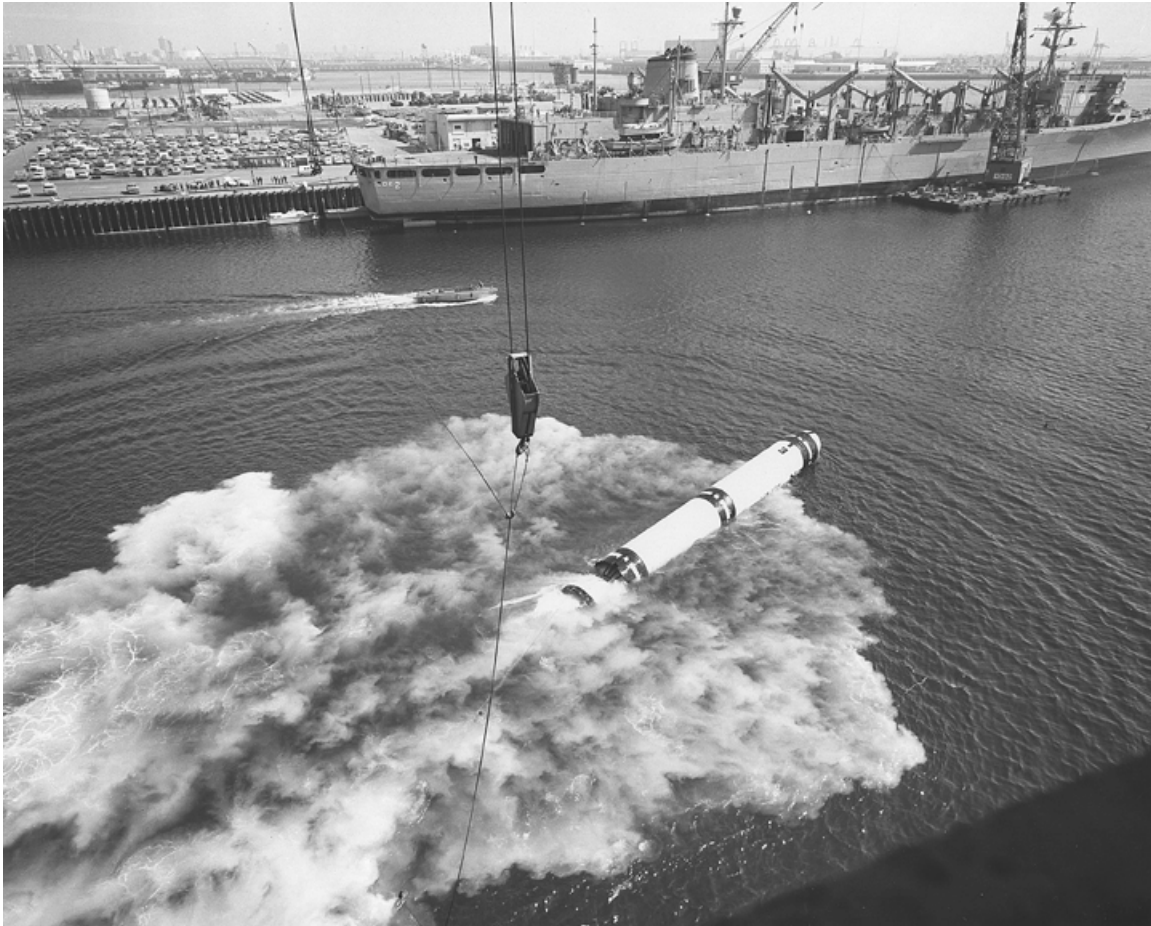
Figure No. E-5. Solid rocket booster drop tests at the Long Beach Naval Shipyard, California, 1973.

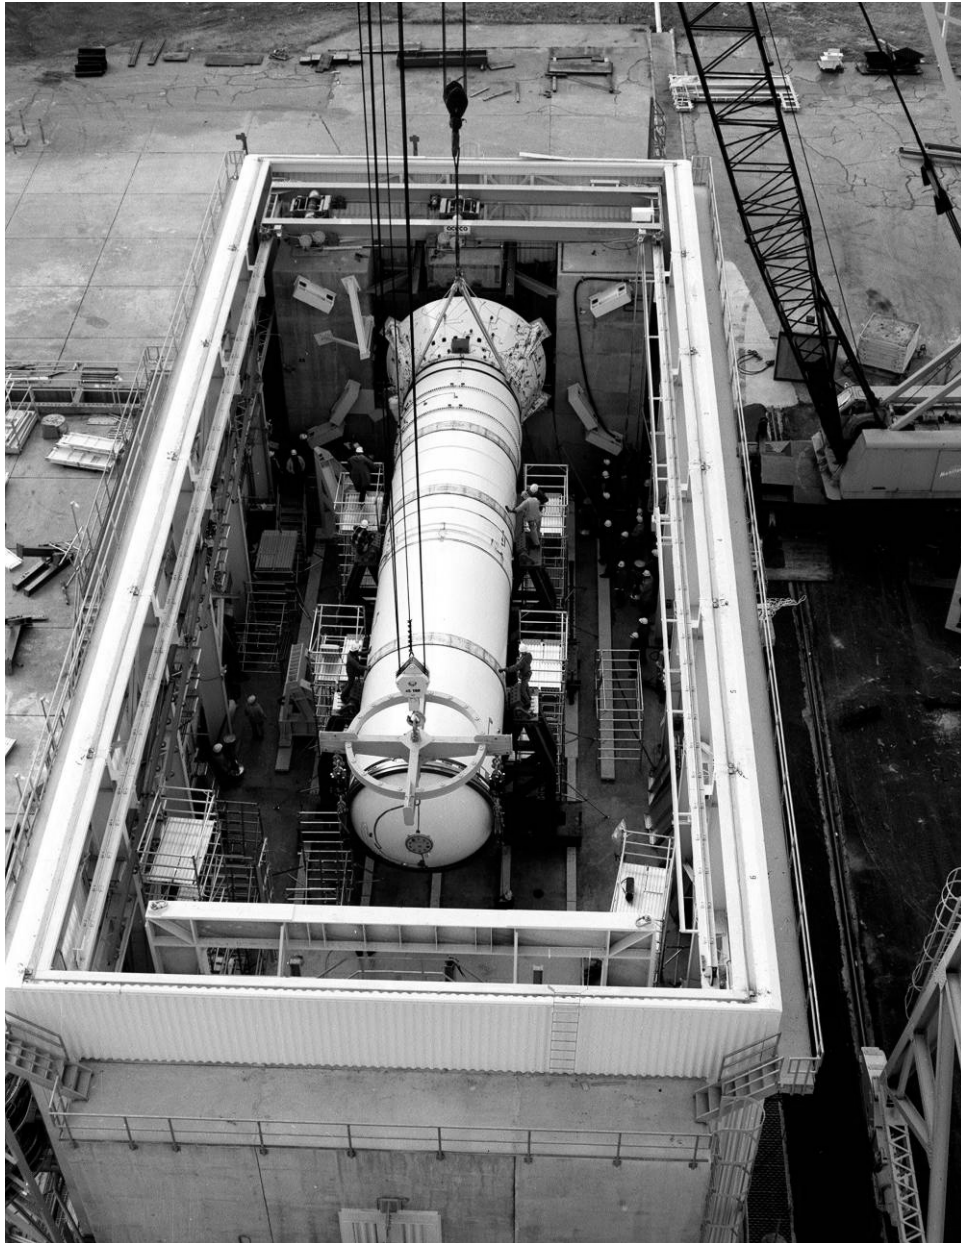
Figure No. E-6. Solid Rocket Booster Structural Test Article being installed at test facility at MSFC, December 1, 1977.

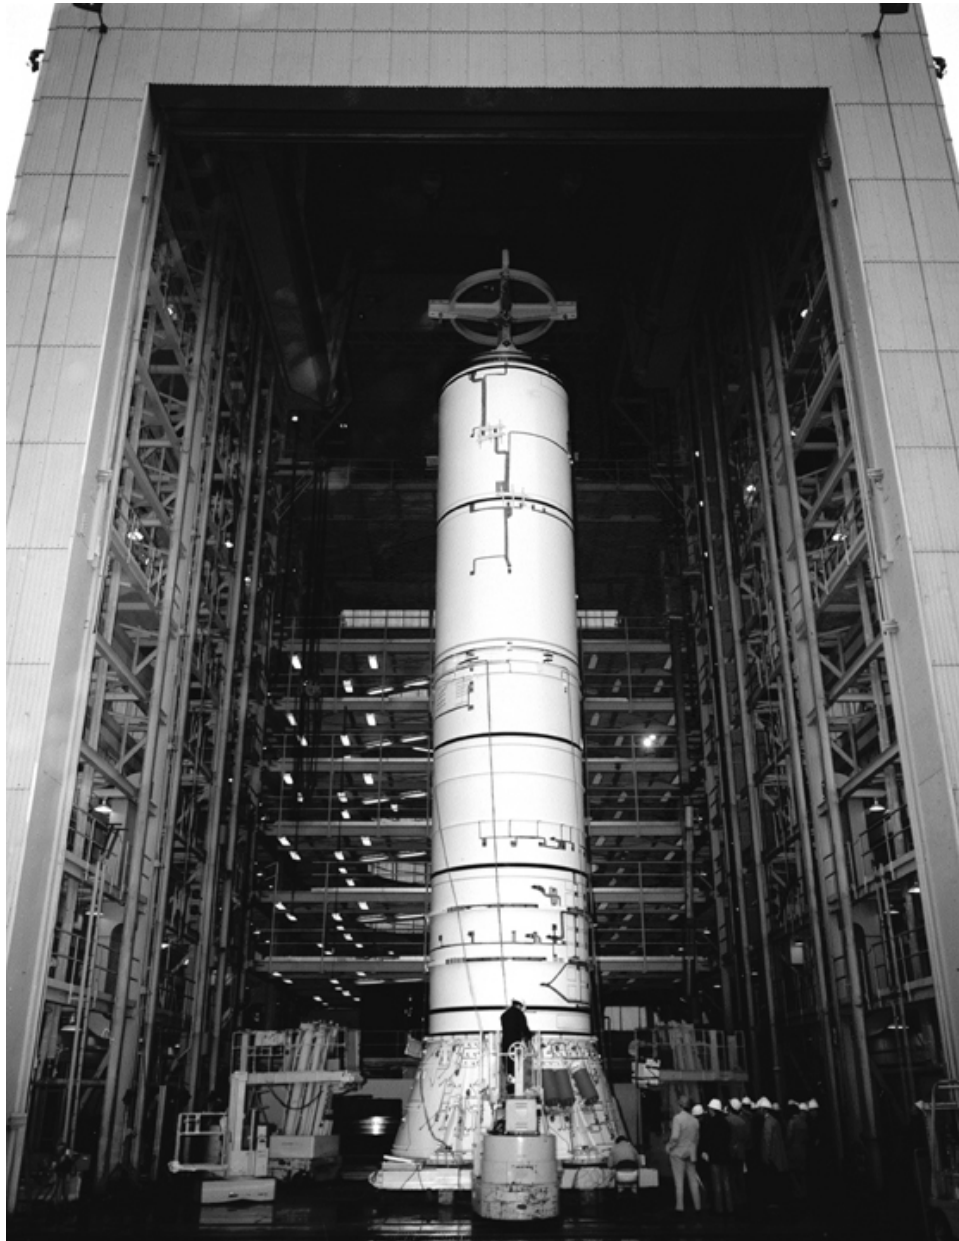
Figure No. E-7. Solid Rocket Booster Structural Test Article at MSFC, November 1, 1978.
Source: NASA Marshall Space Flight Center, MSFC-7884999, accessed at <http://nix.ksc.nasa.gov/>.

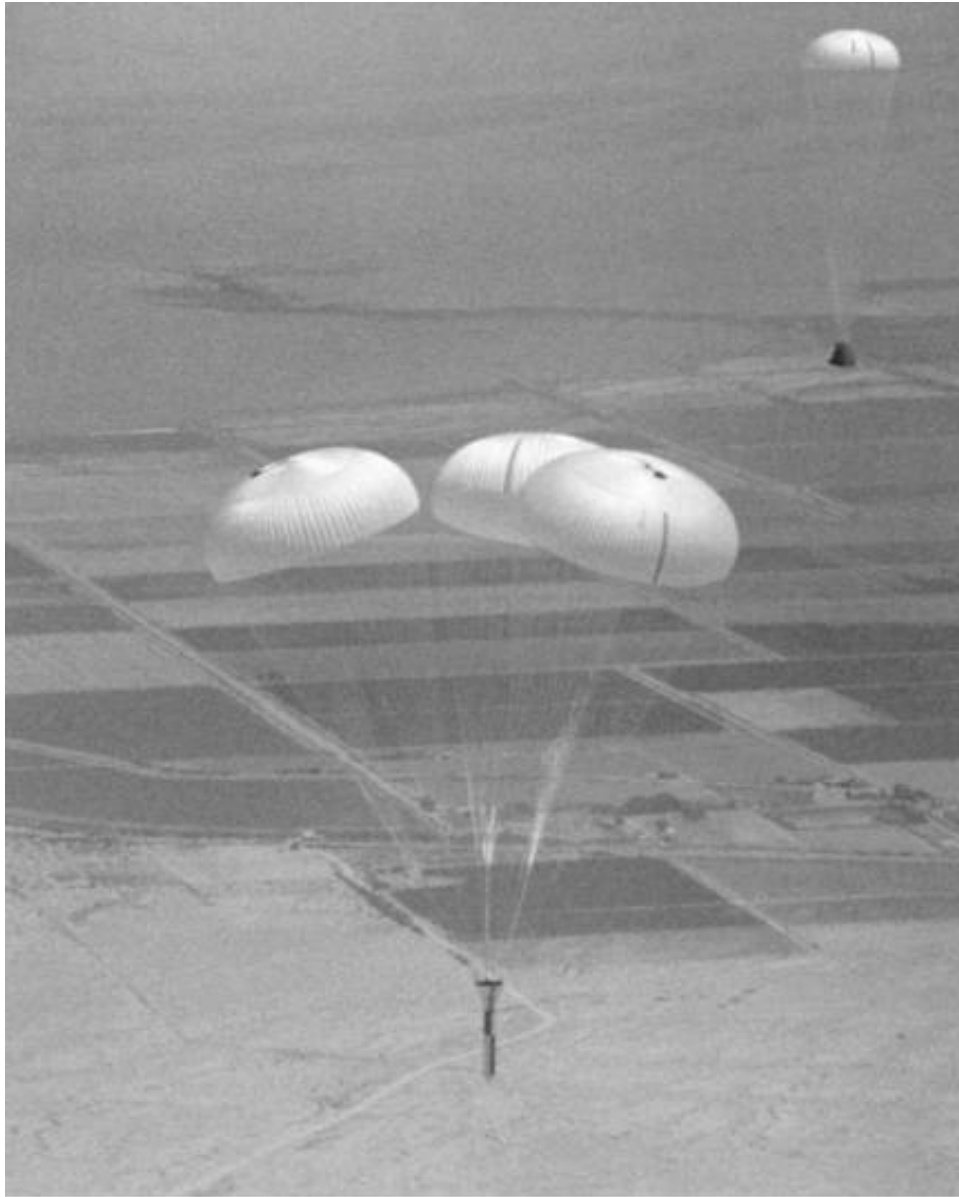
Figure No. E-9. Space Shuttle Solid Rocket Booster Drop Test Vehicle (SRB-DTV) with chutes open after release from NB-52B, January 29, 1979.
Source: NASA Dryden Flight Research Center, NASA Photo: EC79-10168, accessed at <http://www.dfrc.nasa.gov/Gallery/Photo/index.html>.

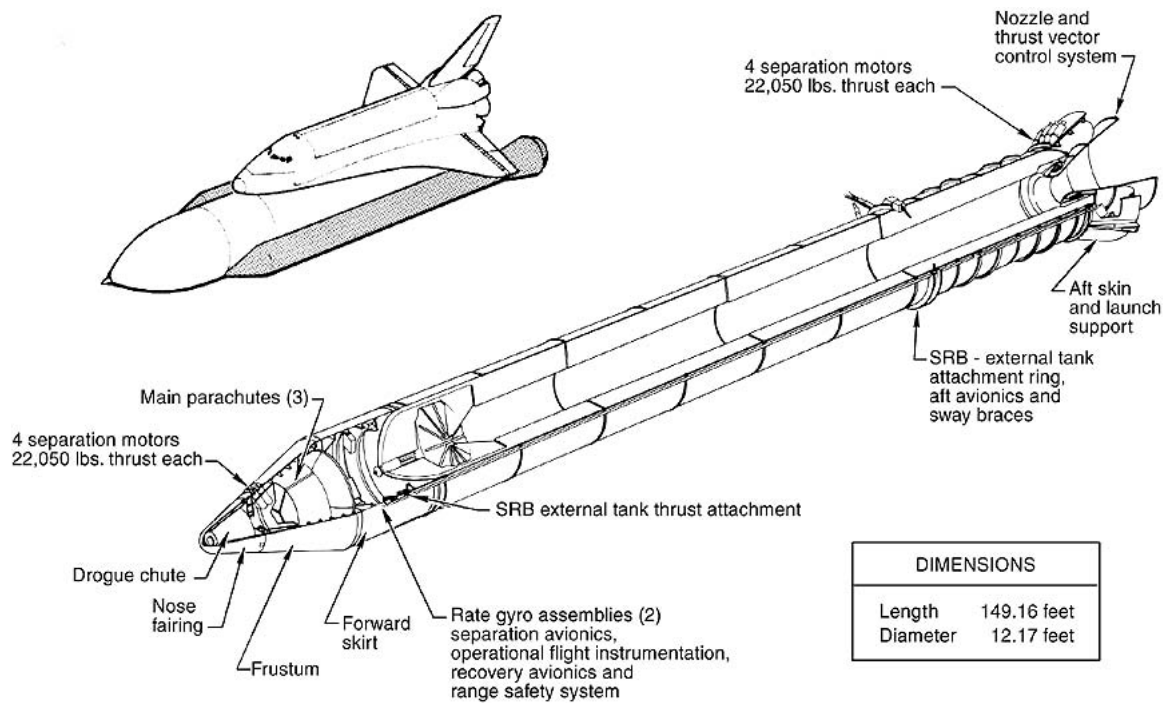
Figure No. E-11. Solid Rocket Booster, general information.
 Source: USA, *Shuttle Crew Operation Manual*, 1.4-1.

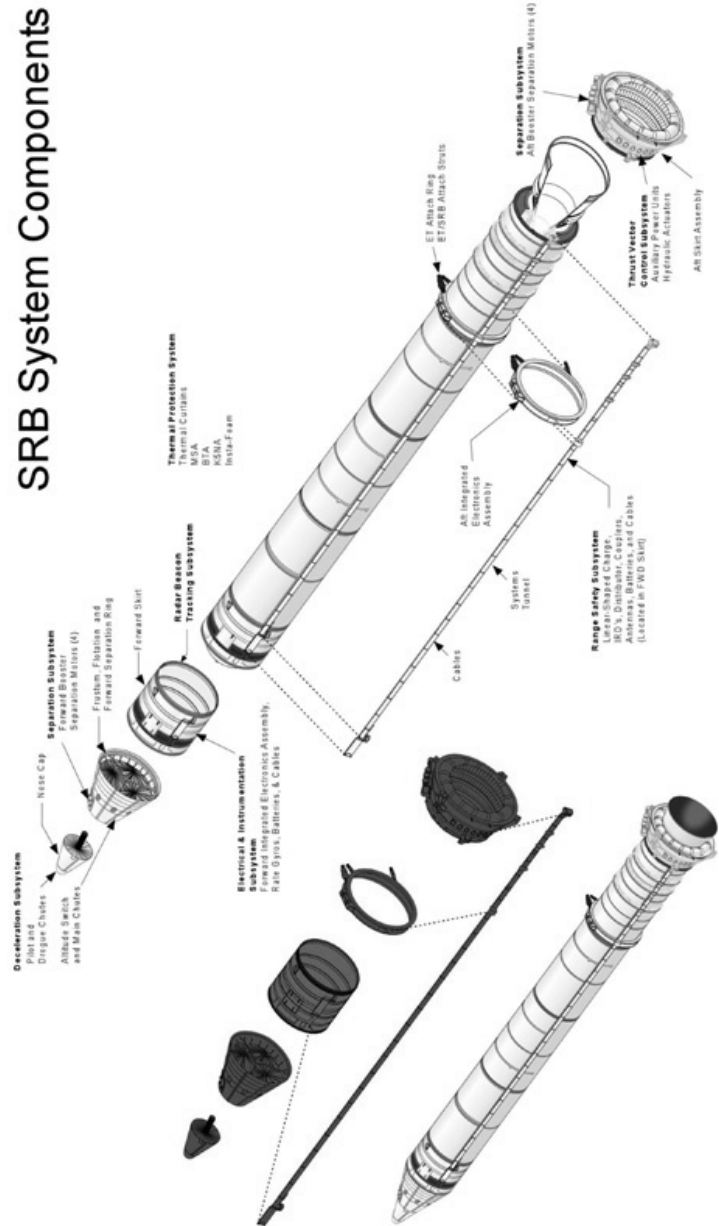
Figure No. E-12. SRB System Components.
 Source: USA, *Solid Rocket Booster Illustrated Systems Manual*, 6.

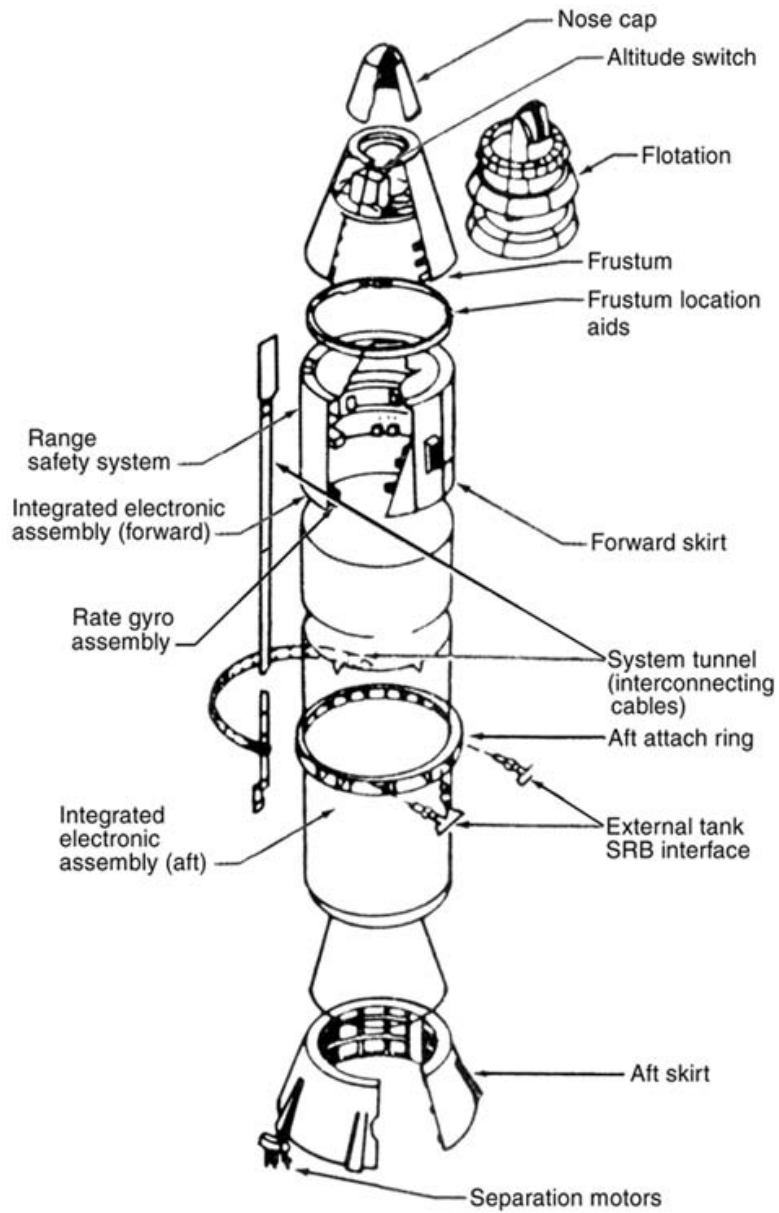
Figure No. E-13. SRB Exploded View.
Source: USA, *Shuttle Crew Operation Manual*, 1.4-4.

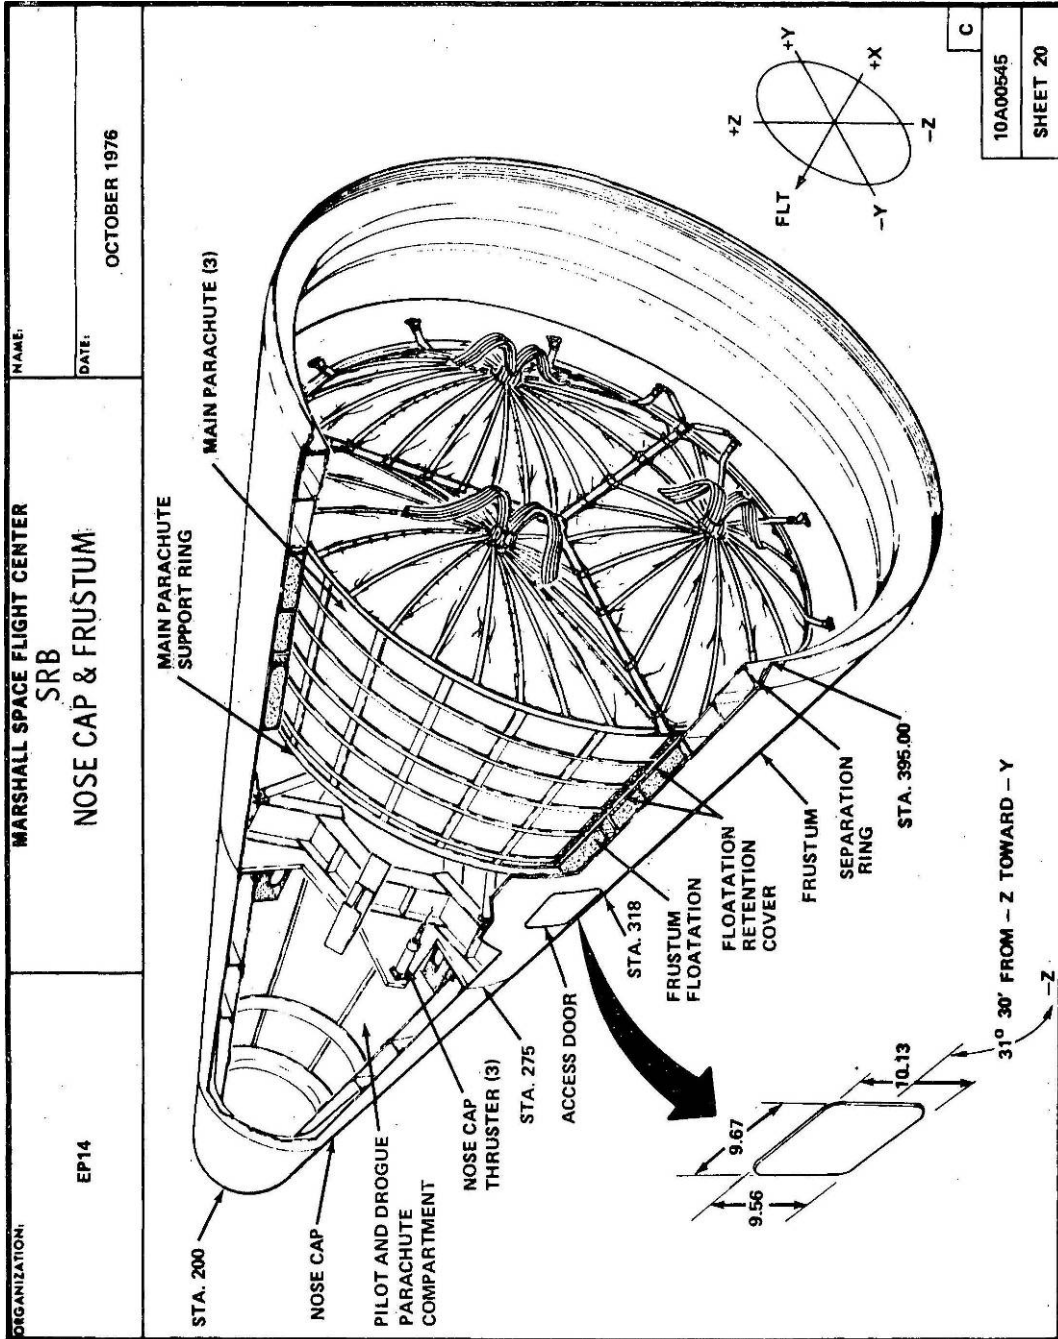
Figure No. E-14. Diagram of SRB nose cap and frustum.

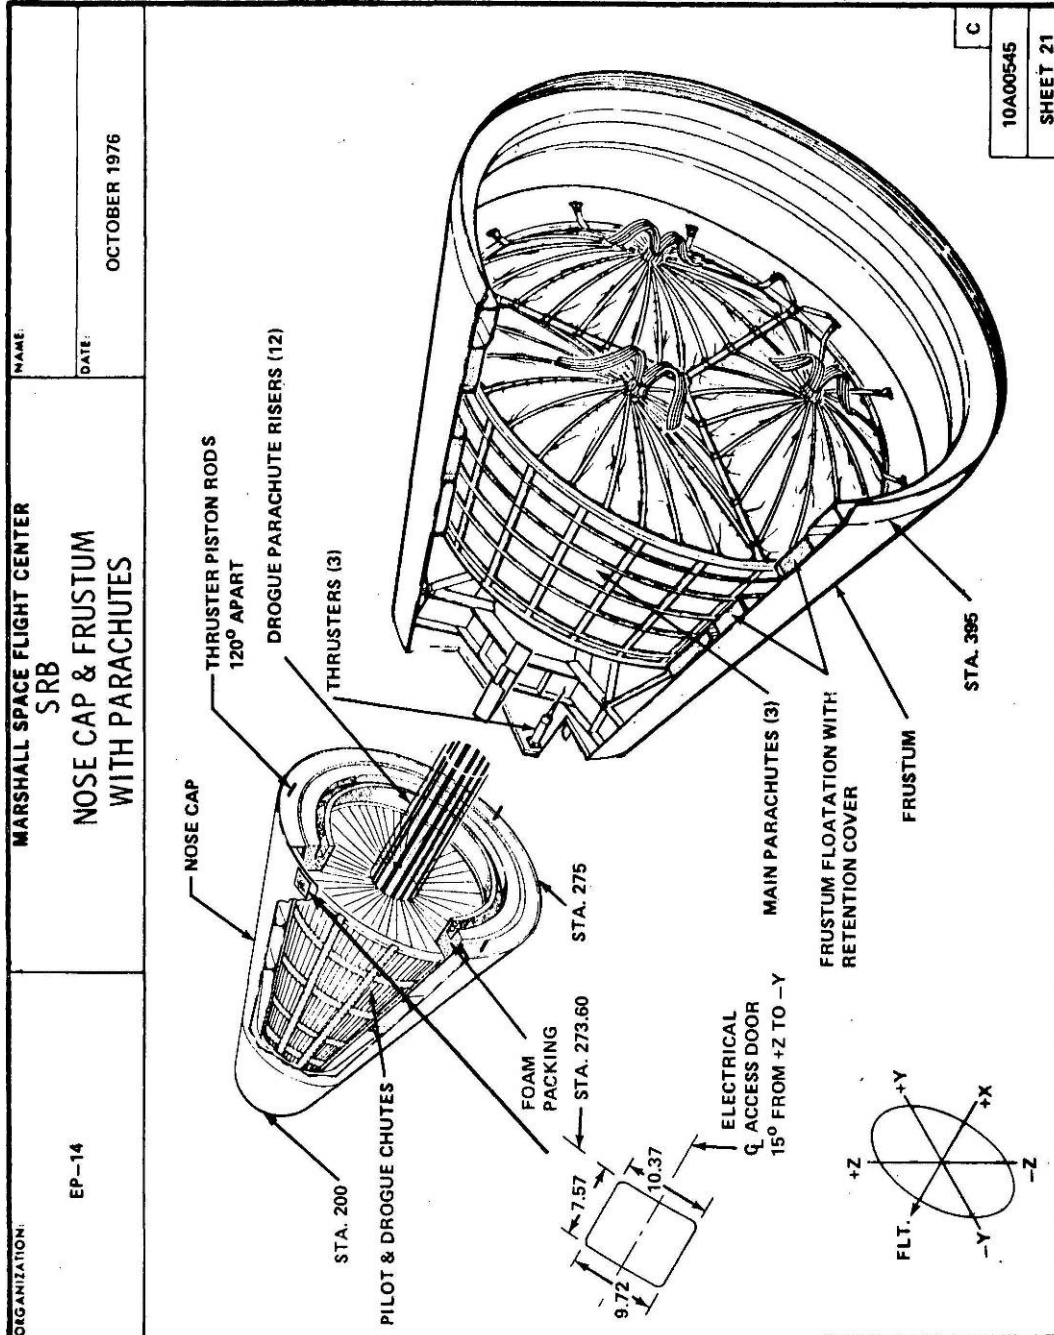
Figure No. E-15. Diagram of SRB nose cap (with parachute) and frustum.
 Source: Griner, et al., *Space Shuttle Solid Rocket Booster Pictorial Representations*, sheet 21.

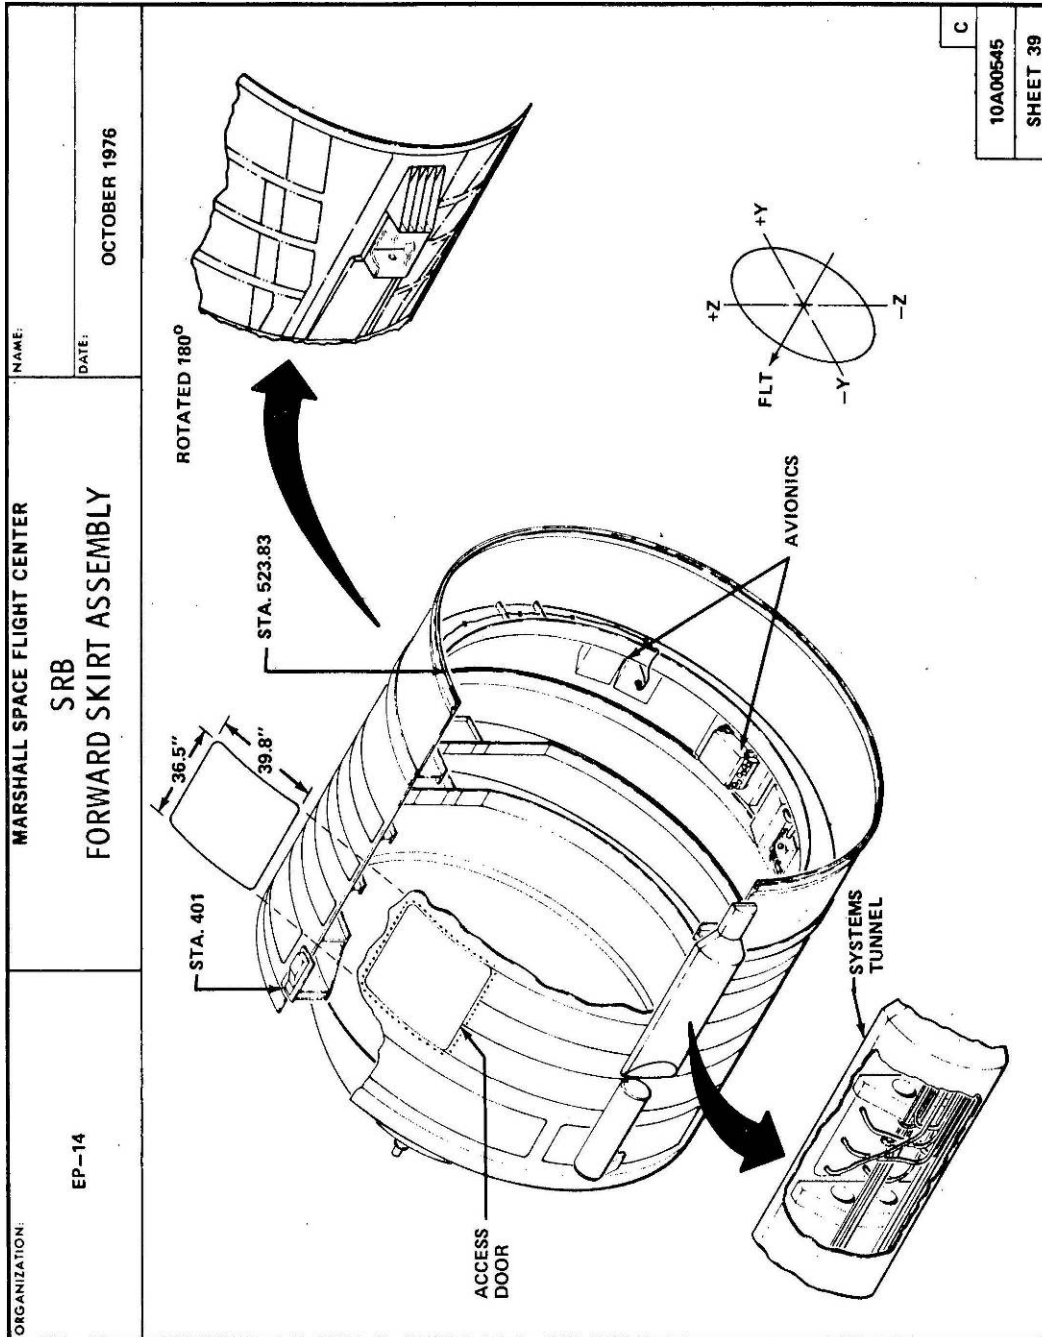
Figure No. E-16. Diagram of SRB forward skirt.
Source: Griner, et al., *Space Shuttle Solid Rocket Booster Pictorial Representations*, sheet 39.

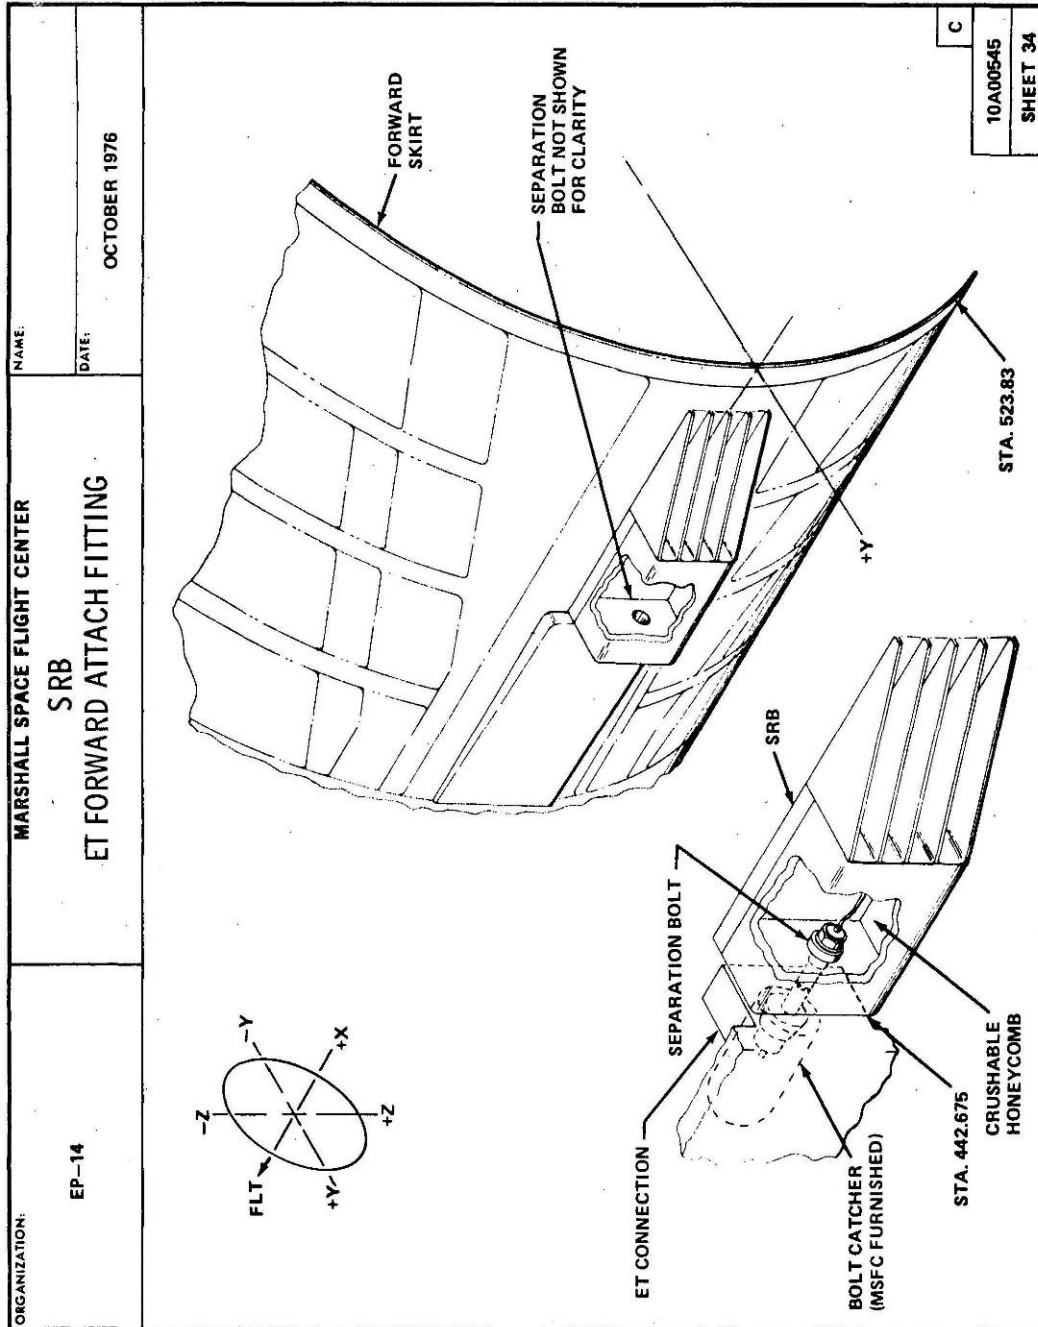
Figure No. E-17. Diagram of SRB/ET forward attach fitting.
Source: Griner, et al., *Space Shuttle Solid Rocket Booster Pictorial Representations*, sheet 34.

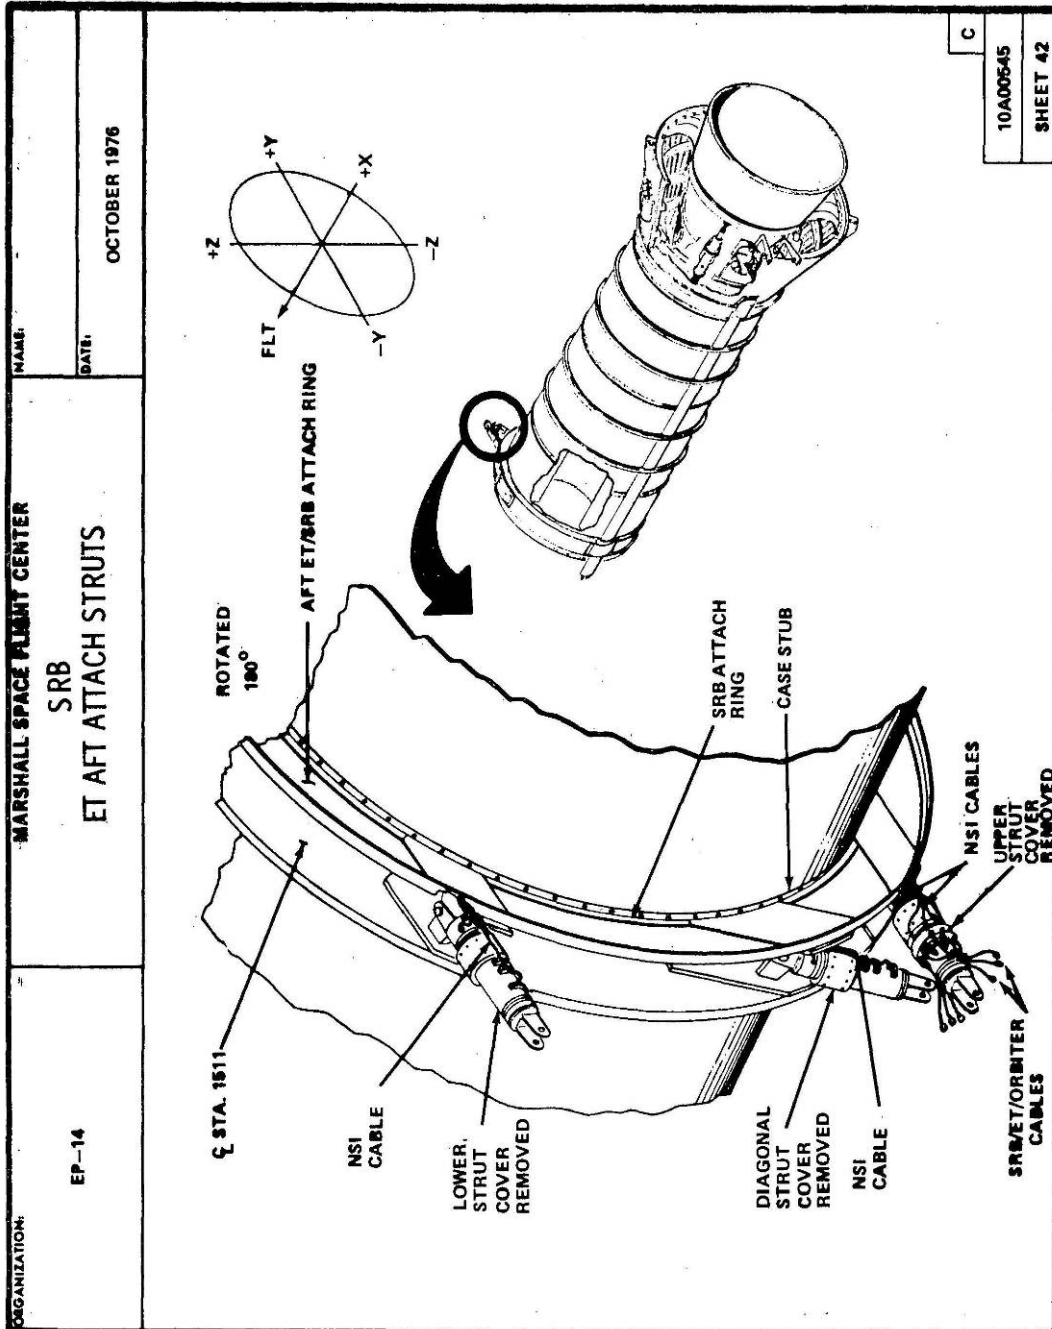
Figure No. E-18. Diagram of SRB/ET aft attach struts.

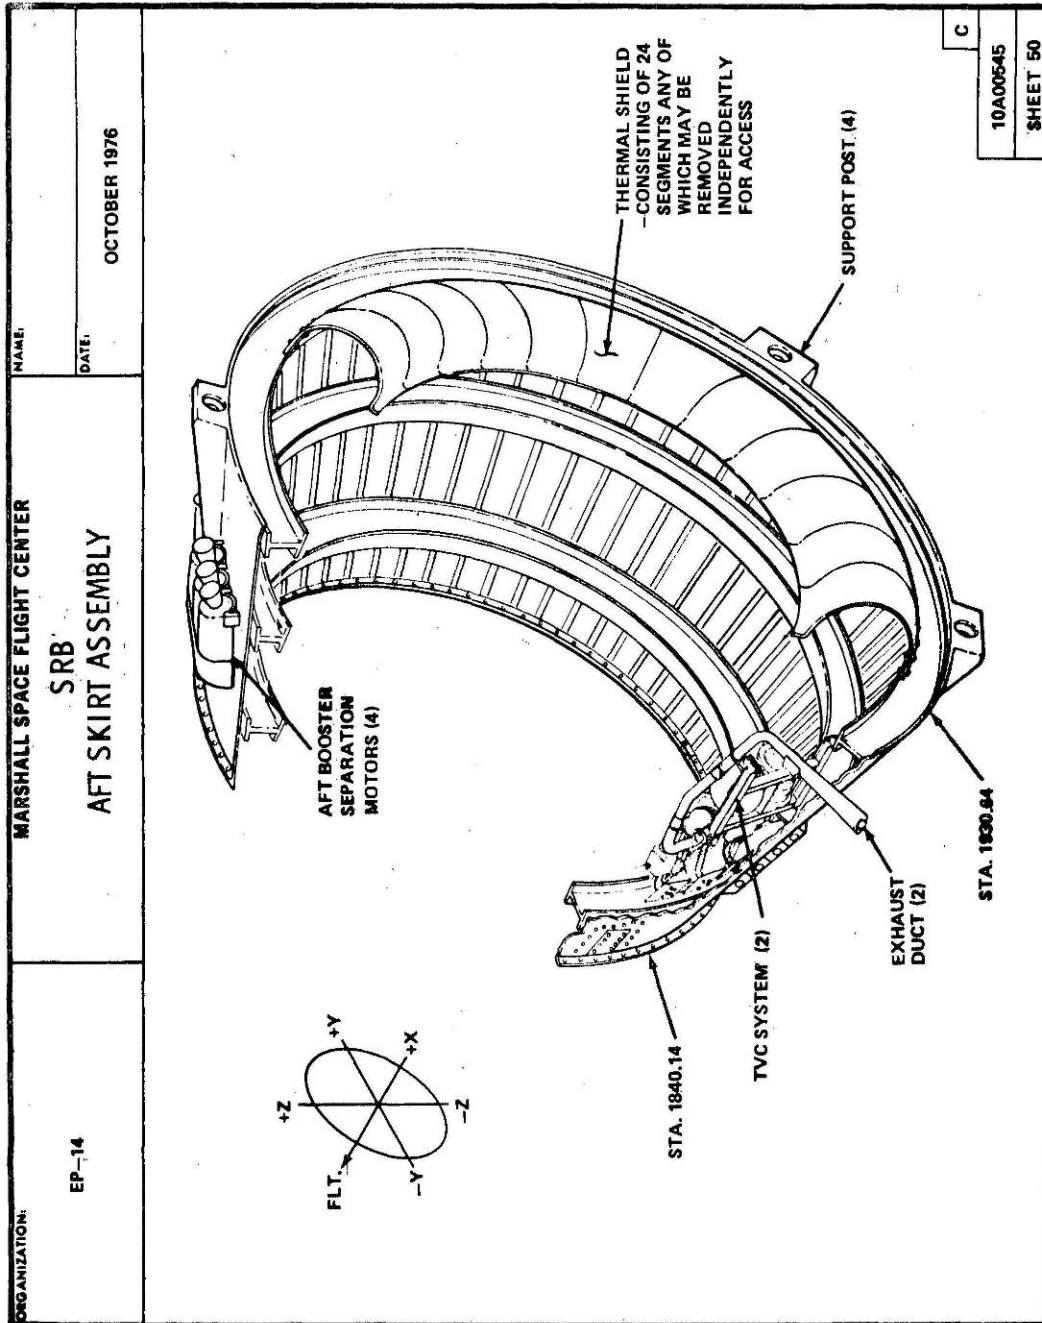
Figure No. E-20. Diagram of SRB aft skirt.

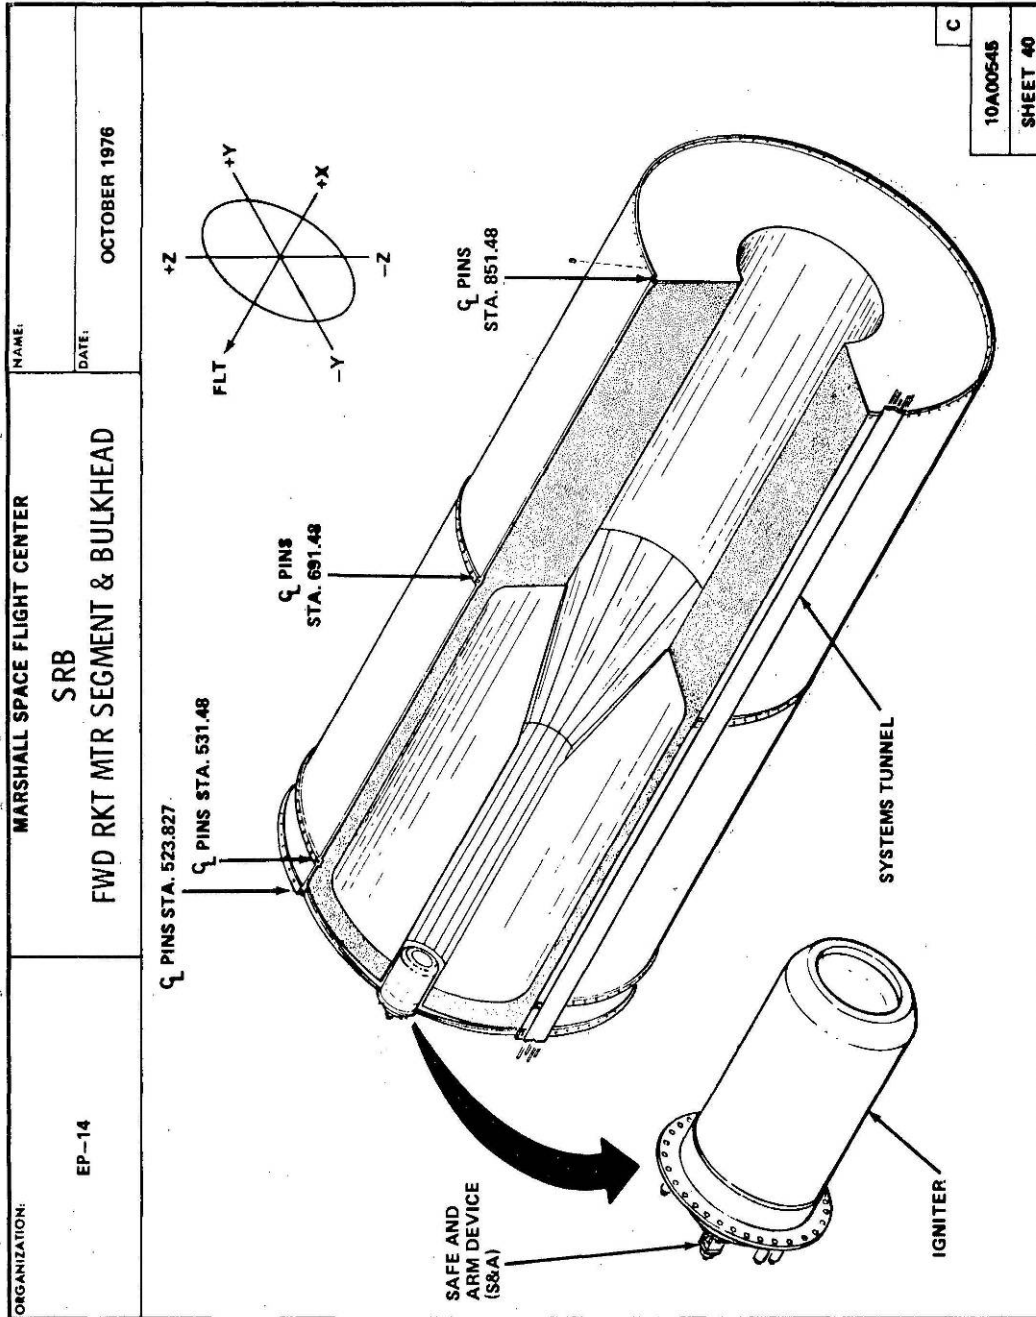
Figure No. E-21. Diagram of SRB forward motor segment.
 Source: Griner, et al., *Space Shuttle Solid Rocket Booster Pictorial Representations*, sheet 40.

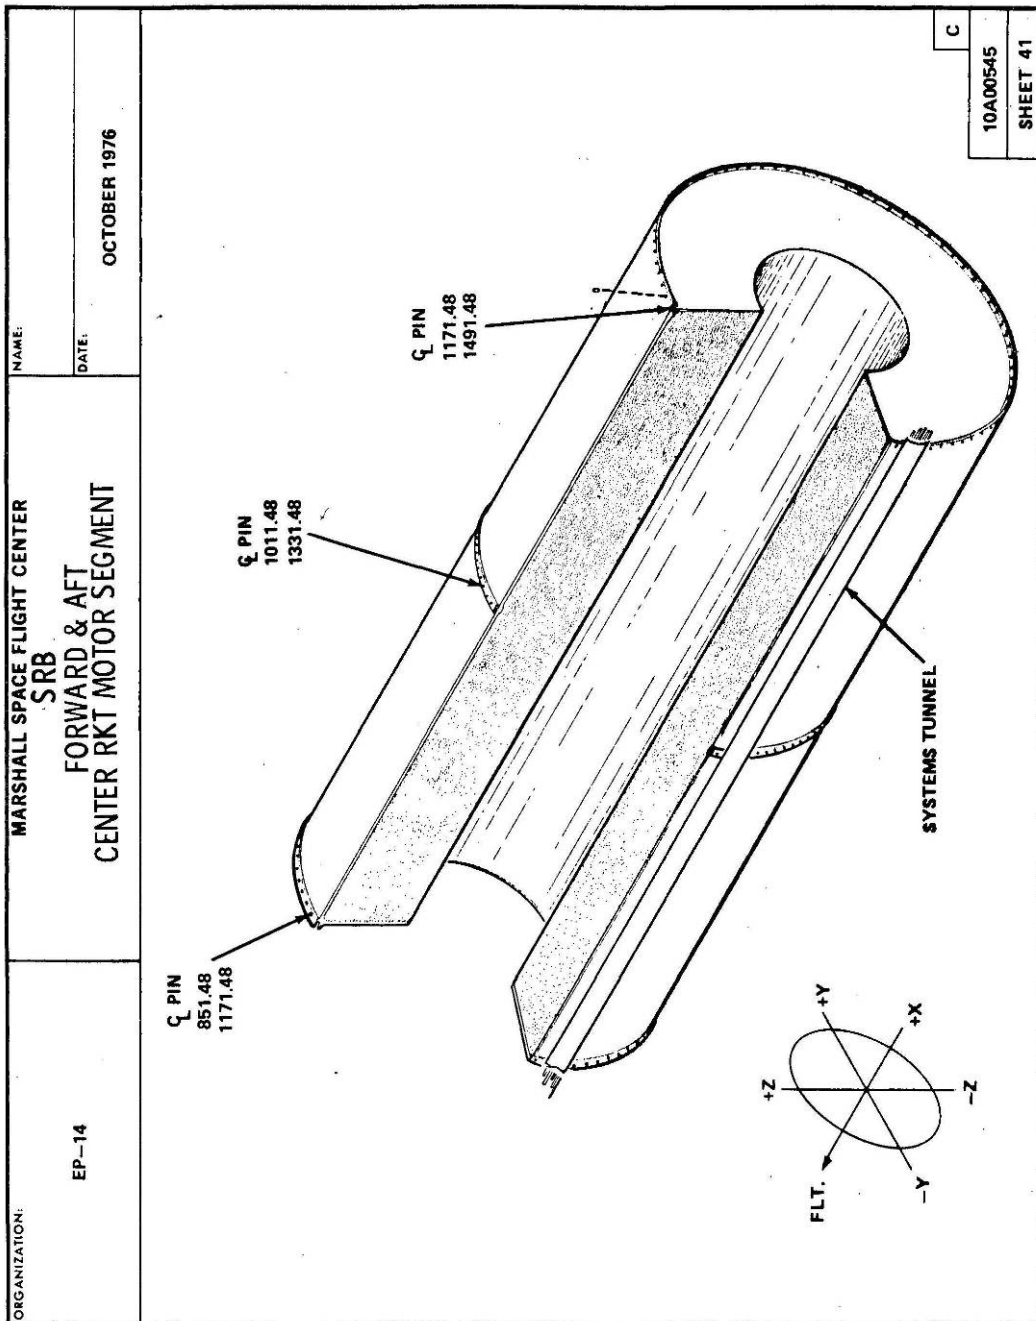
Figure No. E-22. Diagram of SRB center motor segments.
 Source: Griner, et al., *Space Shuttle Solid Rocket Booster Pictorial Representations*, sheet 41.
