Appendix E-SRB/RSRM Figures

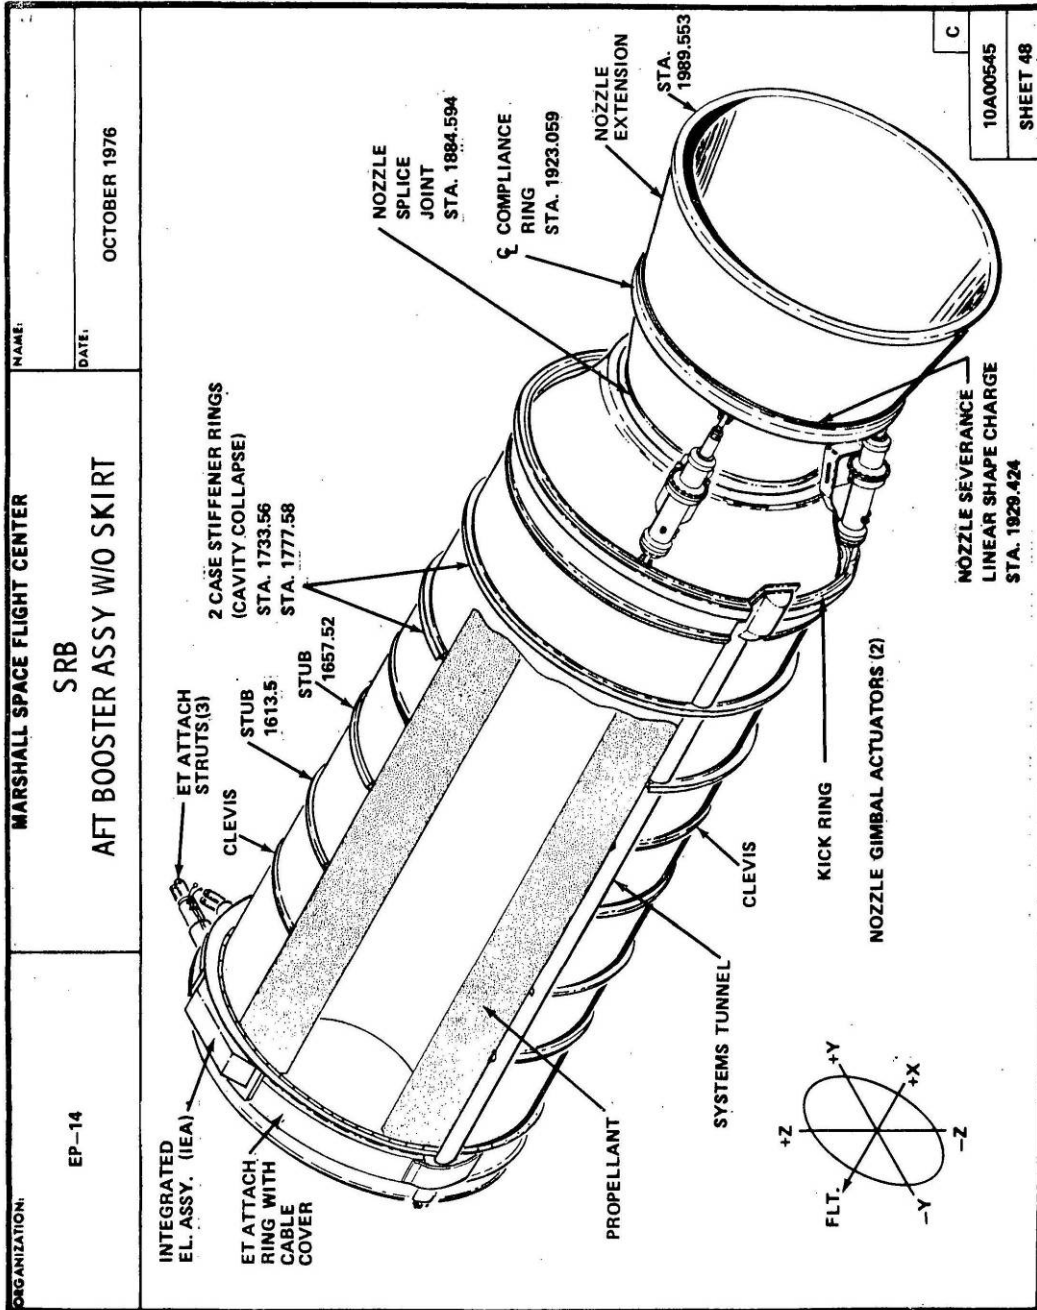
Figure No. E-23. Diagram of SRB aft booster assembly without skirt.
 Source: Griner, et al., *Space Shuttle Solid Rocket Booster Pictorial Representations*, sheet 48.

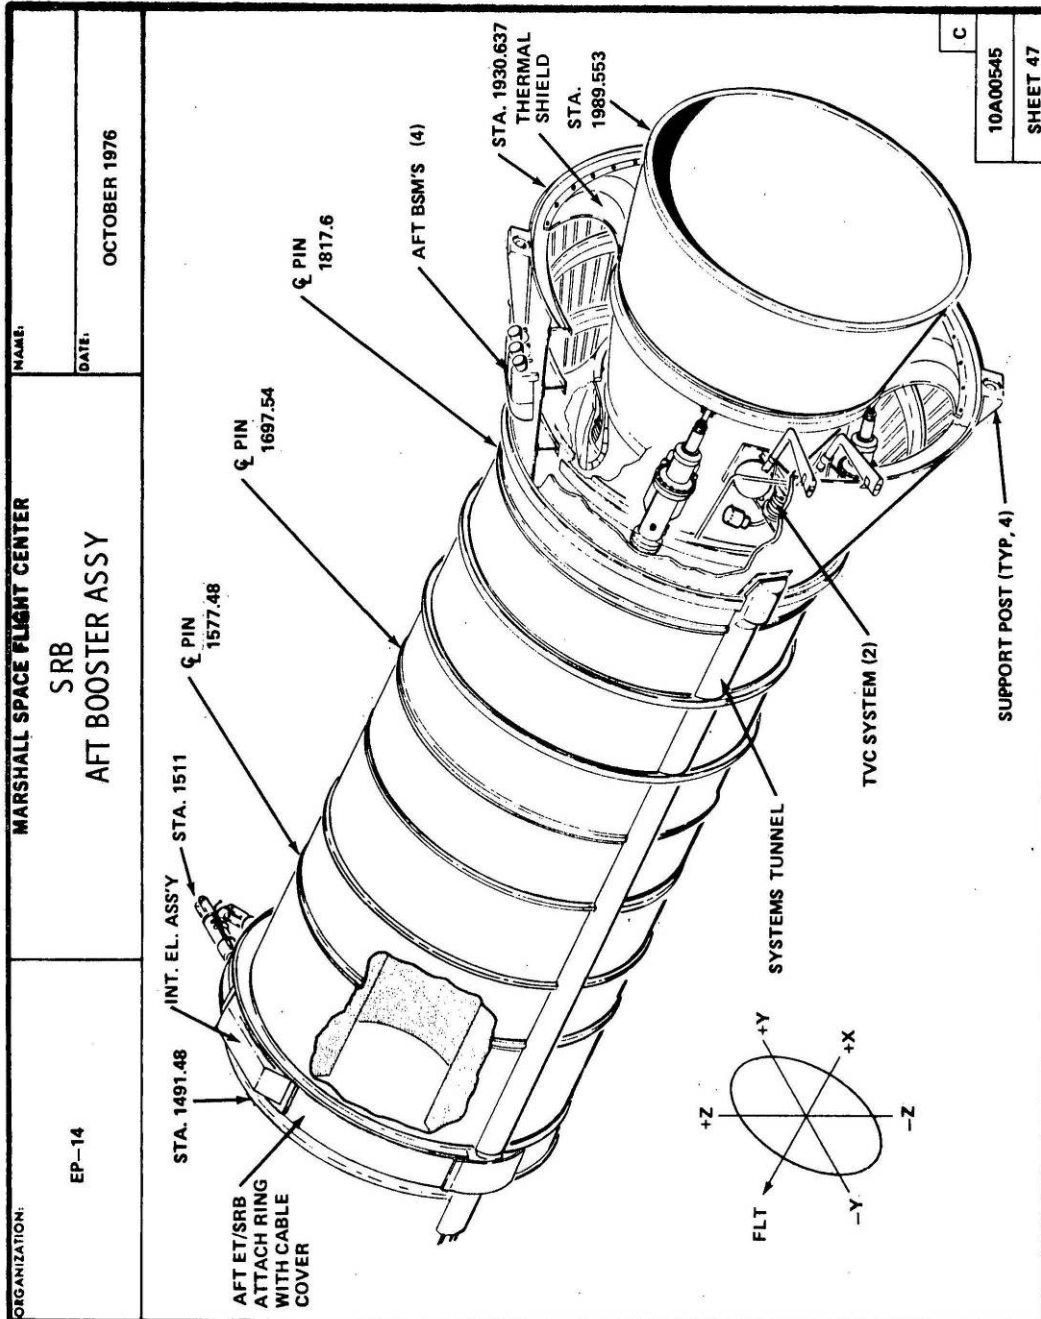
Figure No. E-24. Diagram of SRB aft booster assembly with skirt.
 Source: Griner, et al., *Space Shuttle Solid Rocket Booster Pictorial Representations*, sheet 47.

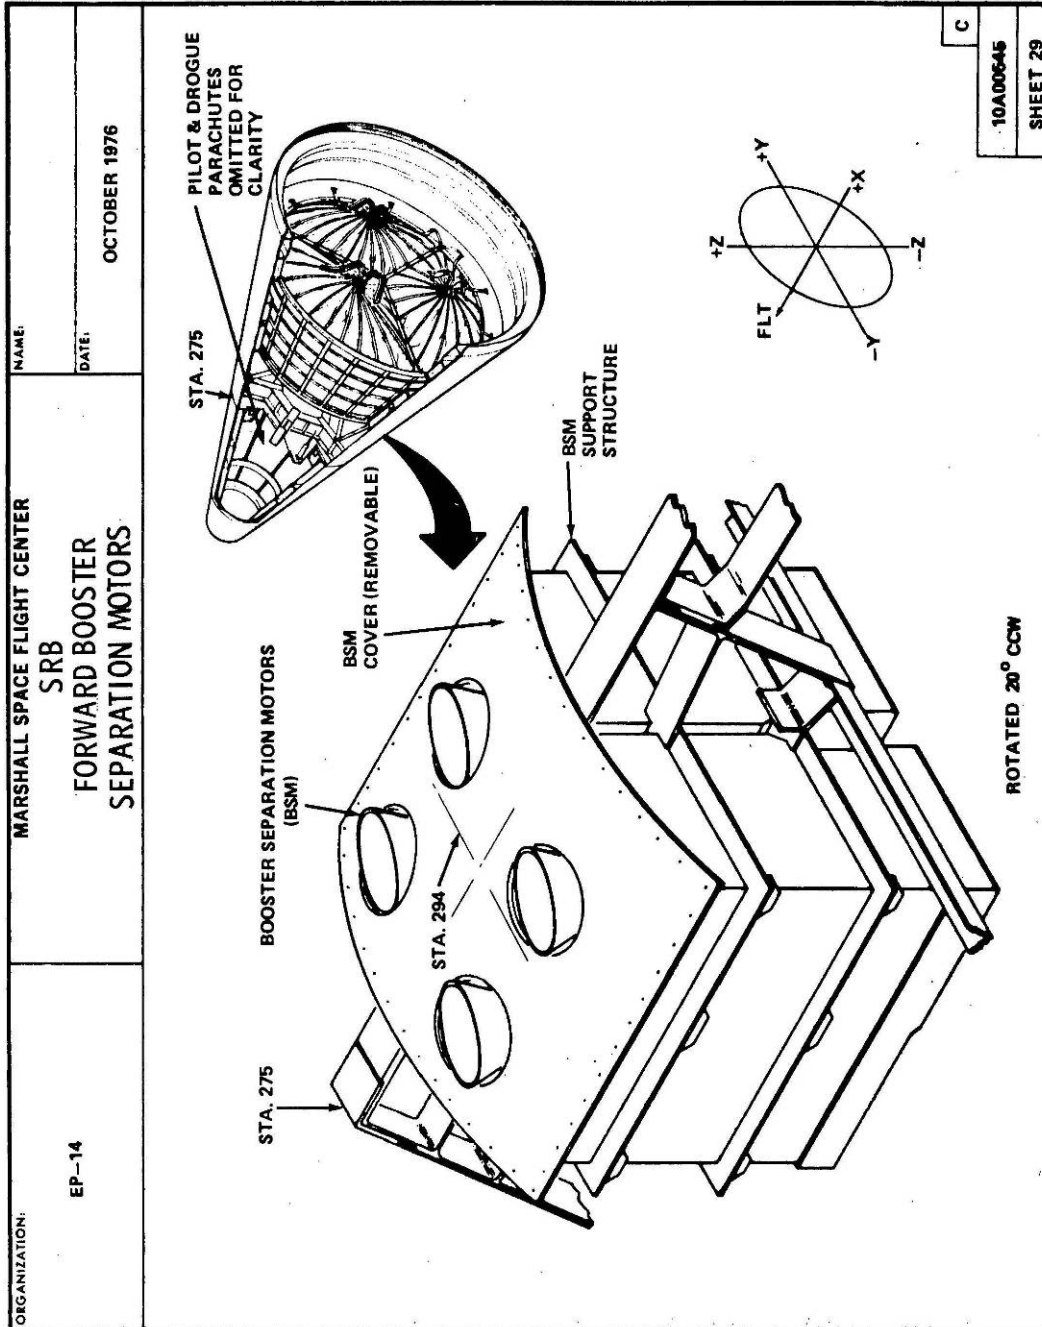
Figure No. E-25. Diagram of SRB forward booster separation motors.
Source: Griner, et al., *Space Shuttle Solid Rocket Booster Pictorial Representations*, sheet 29.

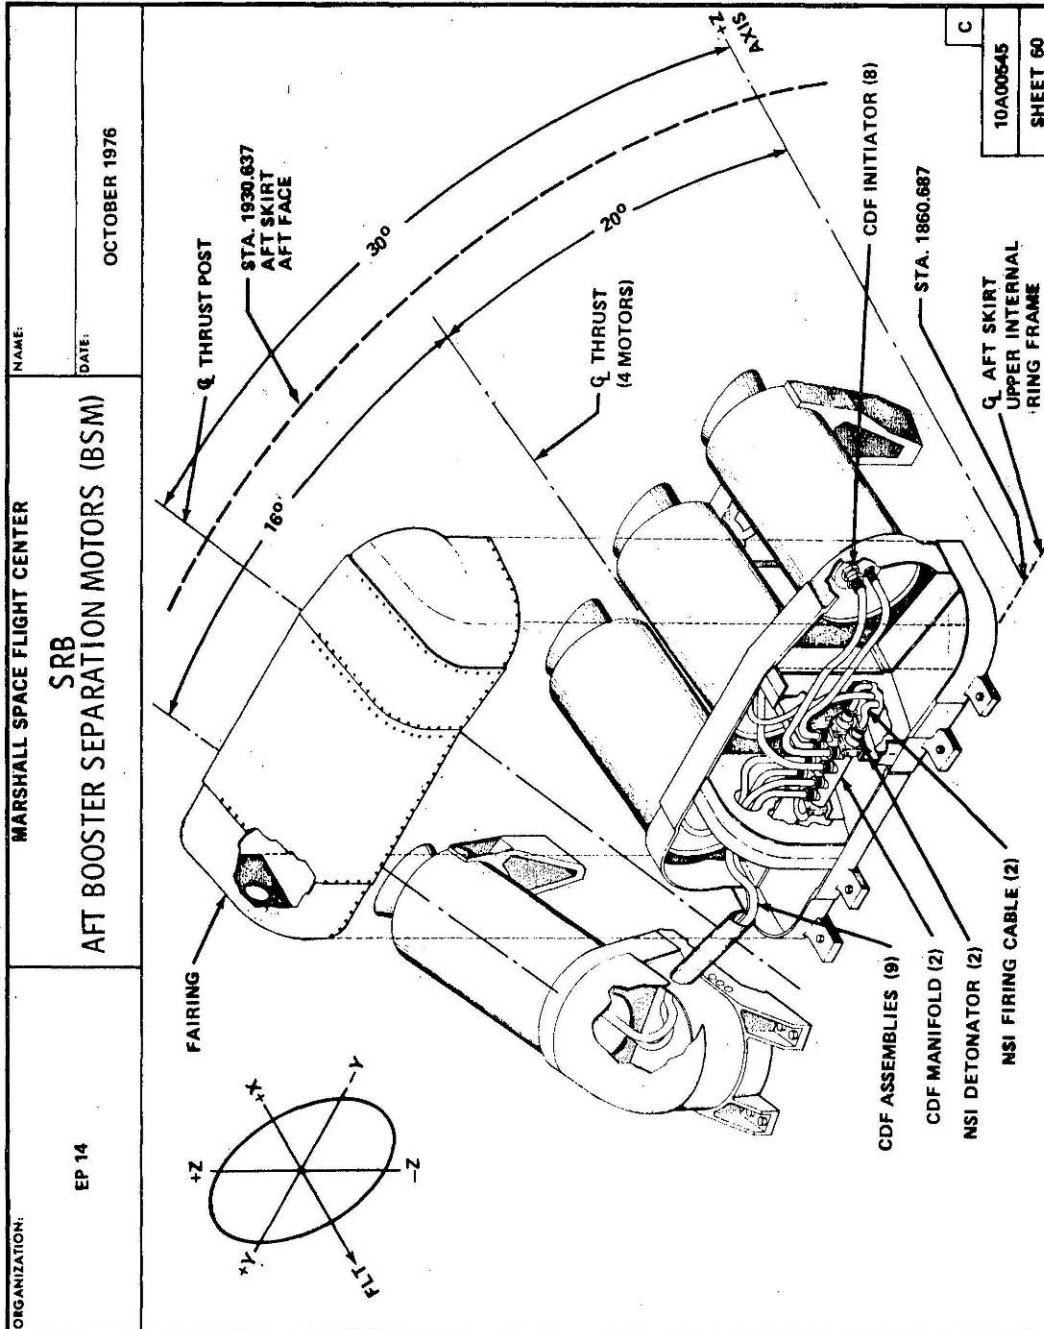
Figure No. E-26. Diagram of SRB aft booster separation motors.
 Source: Griner, et al., *Space Shuttle Solid Rocket Booster Pictorial Representations*, sheet 60.

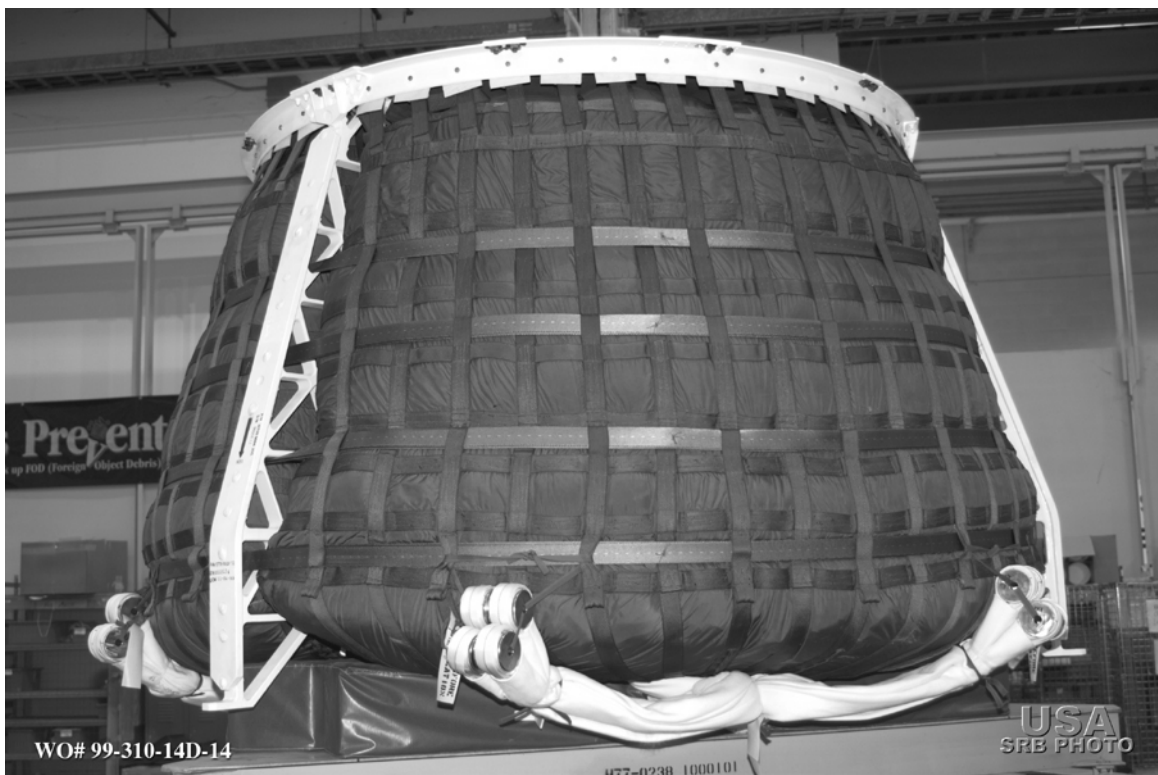
Figure No. E-28. SRB Parachute Assembly.
Source: USA, WO# 99-310-14D-14

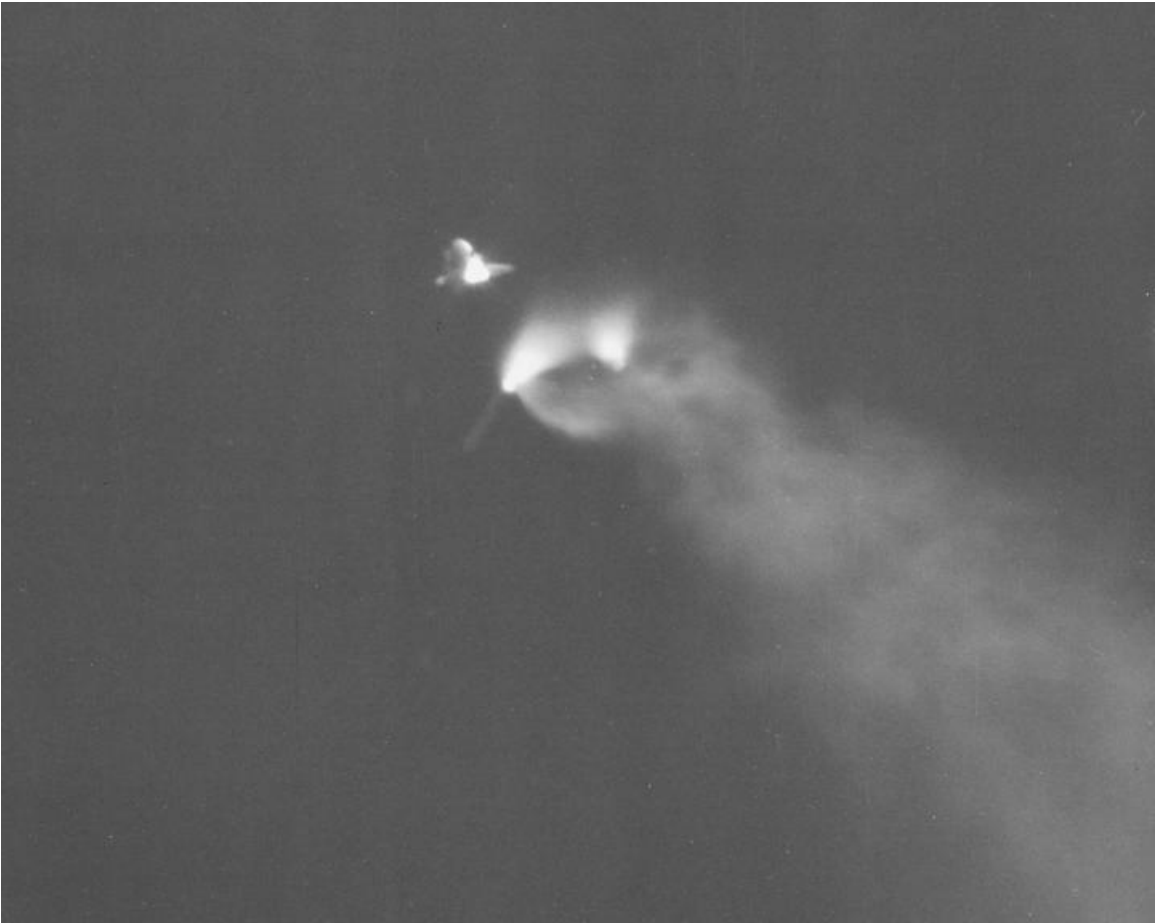
Figure No. E-30. Separation of the SRBs from the Shuttle Columbia, T+2:11, April 12, 1981.
Source: NASA Kennedy Space Center, KSC-81PC-0272, accessed at
<http://mediaarchive.ksc.nasa.gov>.

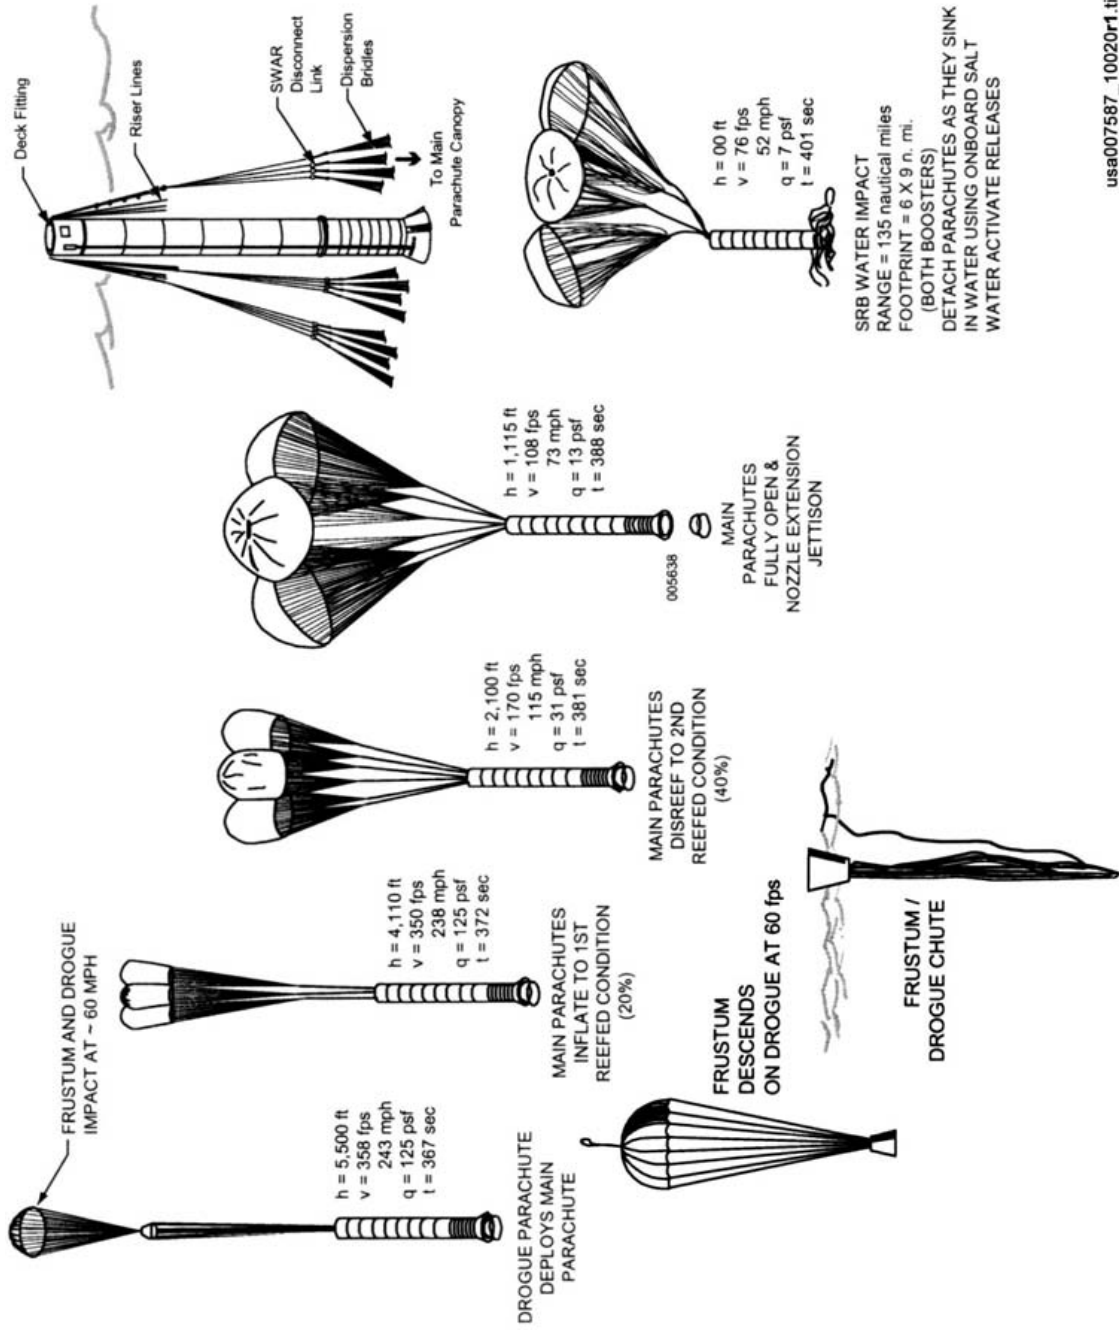
Figure No. E-31. Diagram of SRB Recovery, from main deploy of parachutes through disconnect.

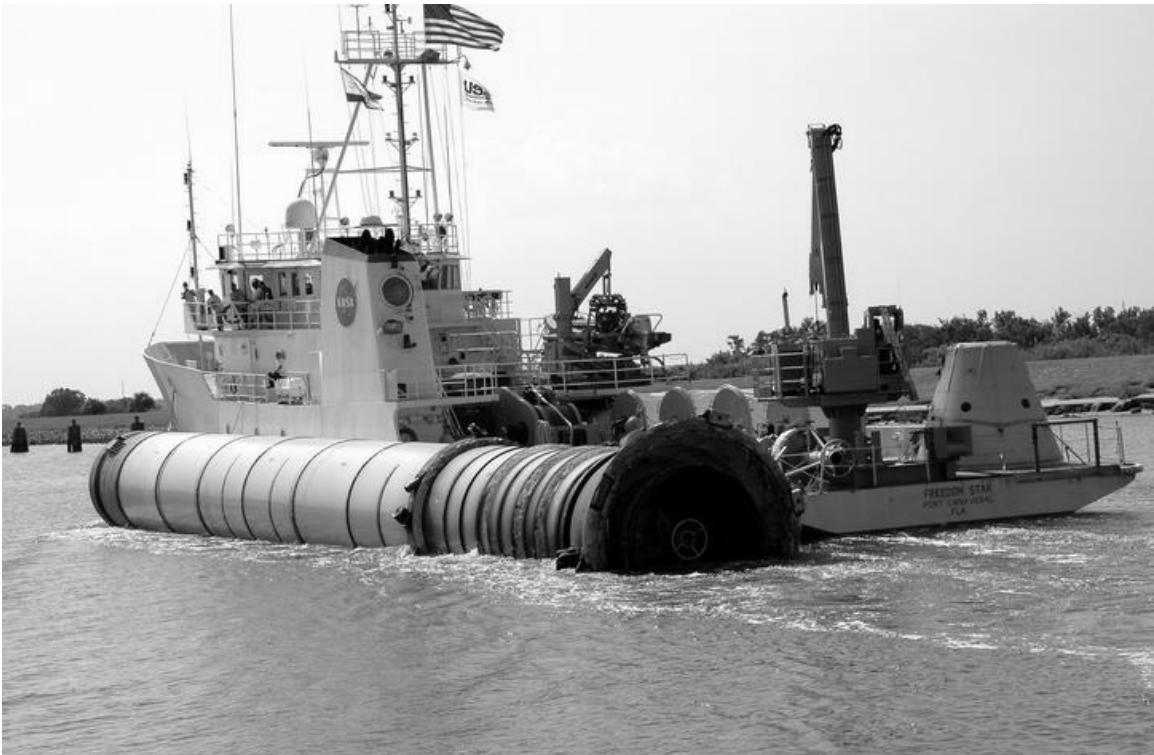
Figure No. E-33. SRB retrieval ship, *Freedom Star*, towing spent SRB from the STS-114 launch, July 27, 2005.

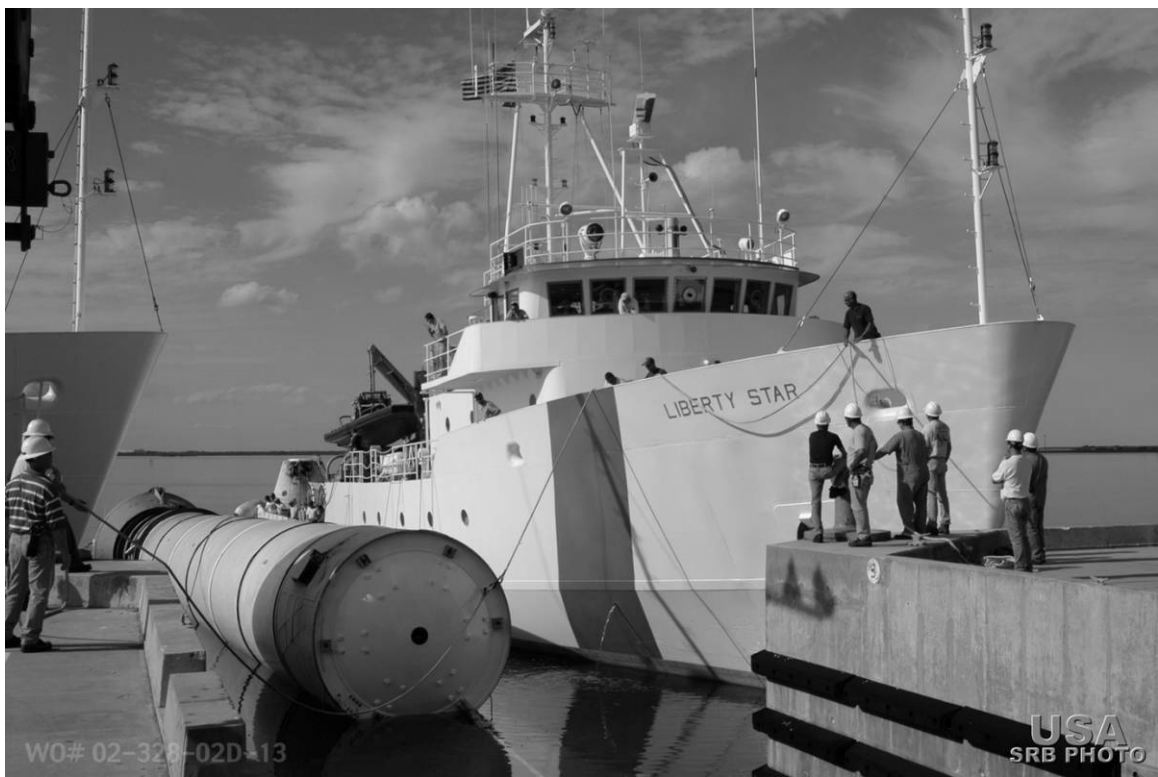
Figure No. E-34. Recovered SRB arrives at Hangar AF Slip.
Source: USA, WO# 02-328-02D-13

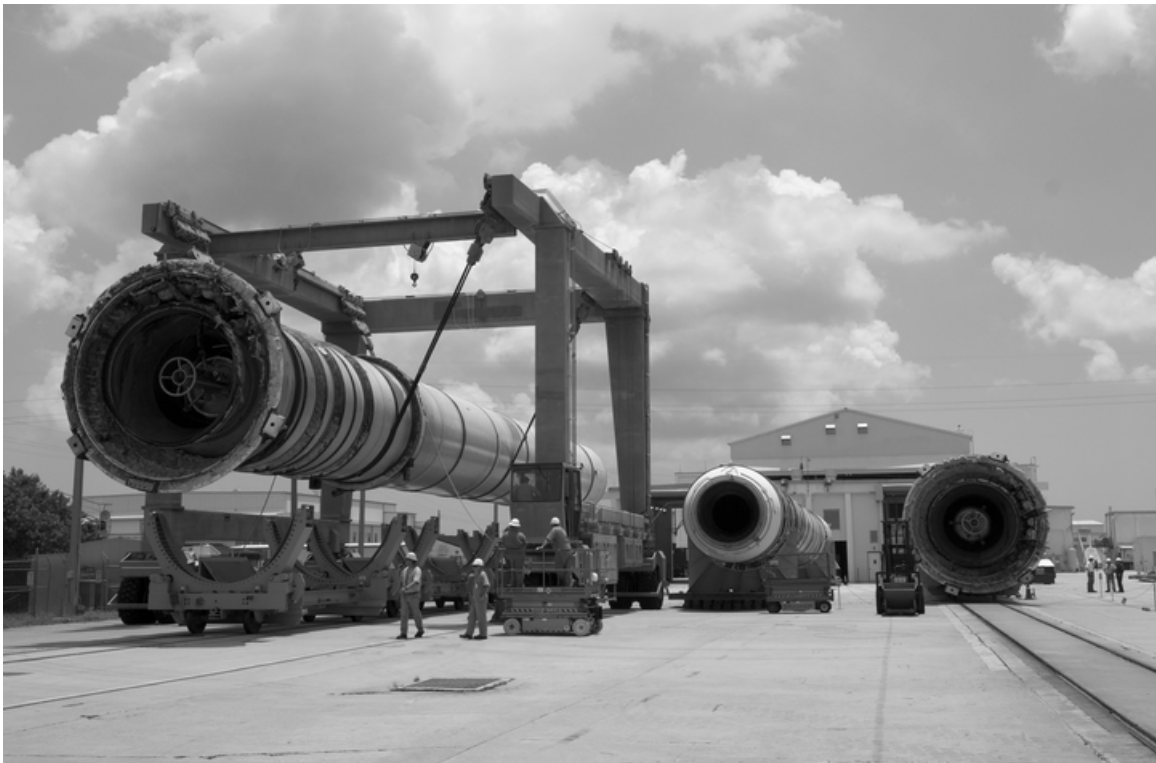
Figure No. E-35. Crane lifts SRB used during *Atlantis*' STS-132 launch onto a tracked dolly at Hangar AF Disassembly Facility, May 18, 2010.

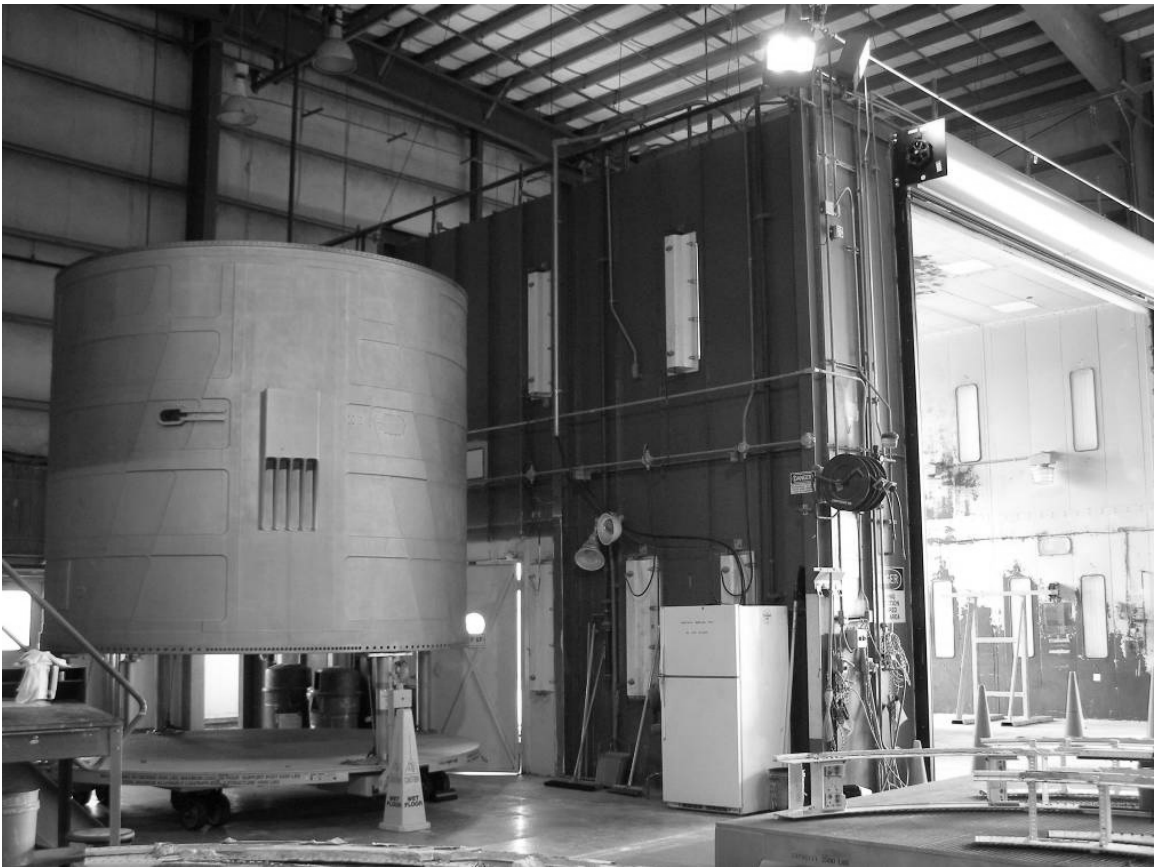
Figure No. E-37. Forward skirt in Hangar AF Robot Wash Building, interior looking south.
Source: Archaeological Consultants, Inc., 2006.

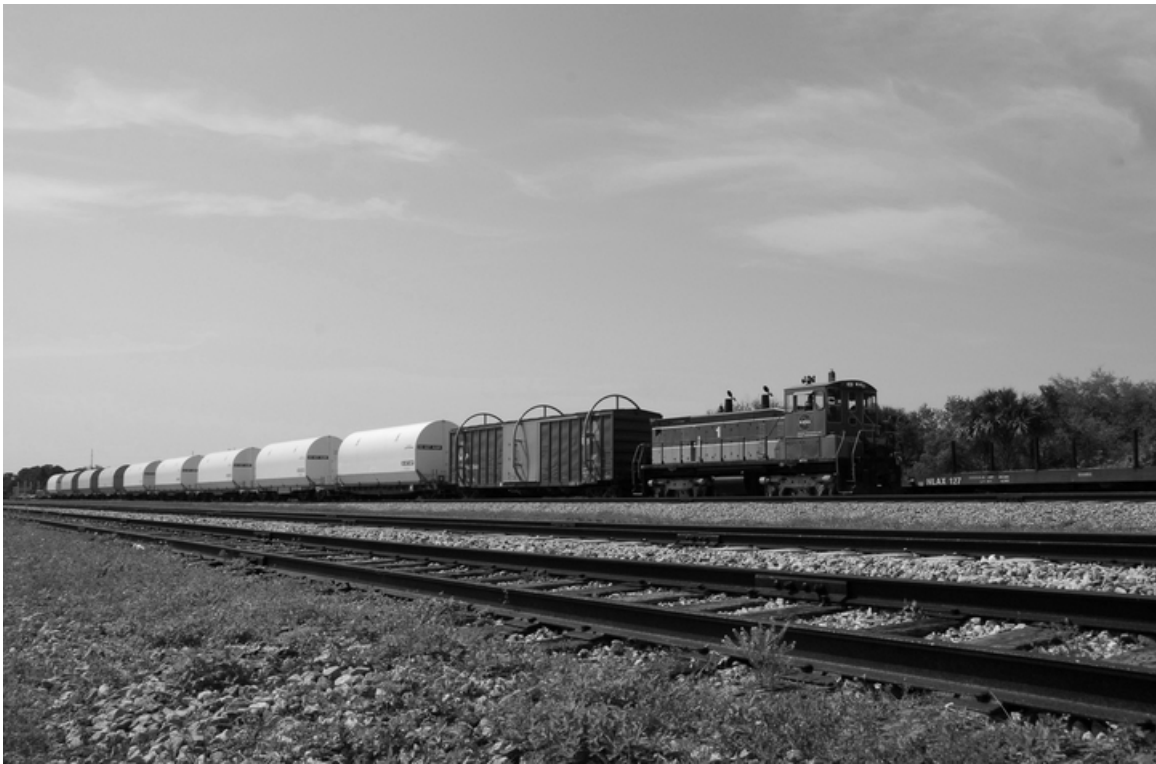
Figure No. E-38. Empty RSRM segments en route to Utah following STS-122, March 5, 2008.
Source: NASA Kennedy Space Center, KSC-08PD-0630, accessed at
<http://mediaarchive.ksc.nasa.gov>.

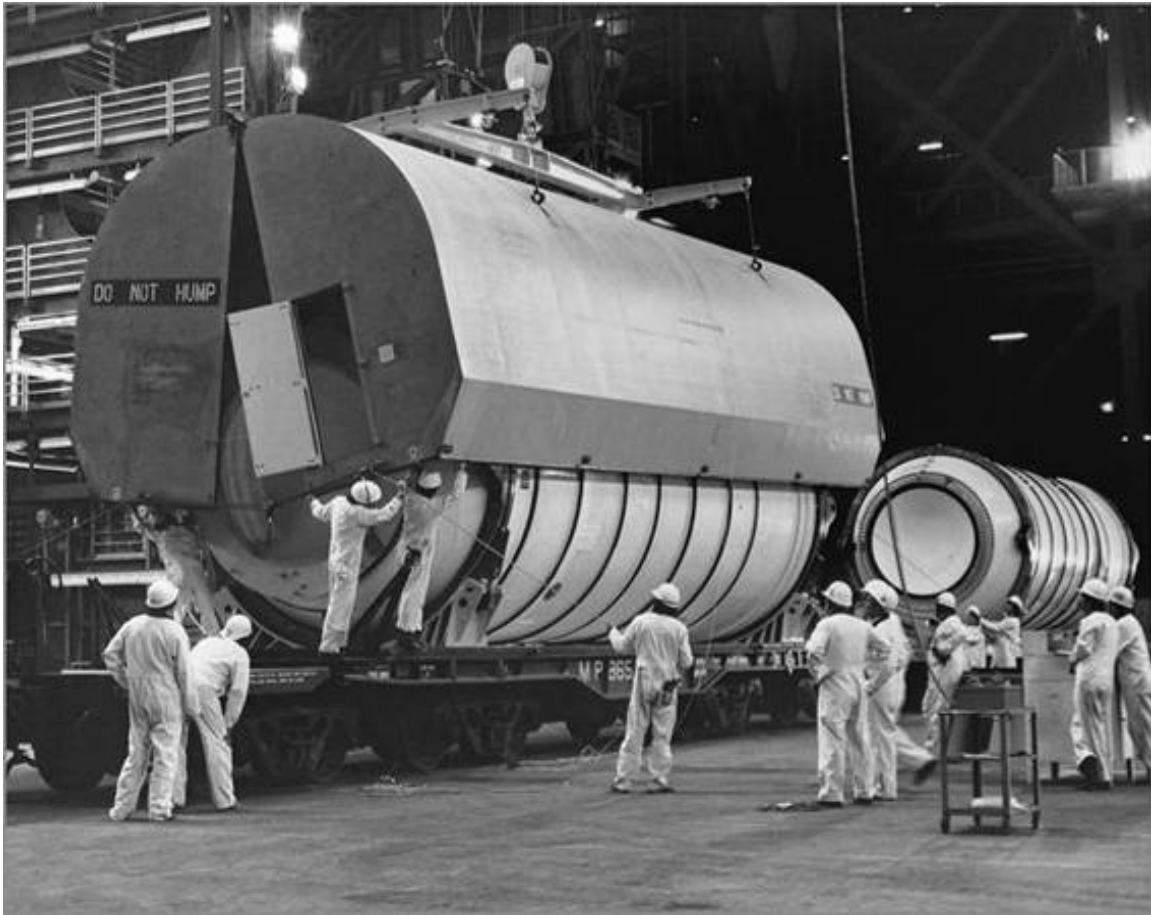
Figure No. E-39. The first solid rocket booster solid motor segments (left and right aft segments) to arrive at KSC, February 2, 1980.

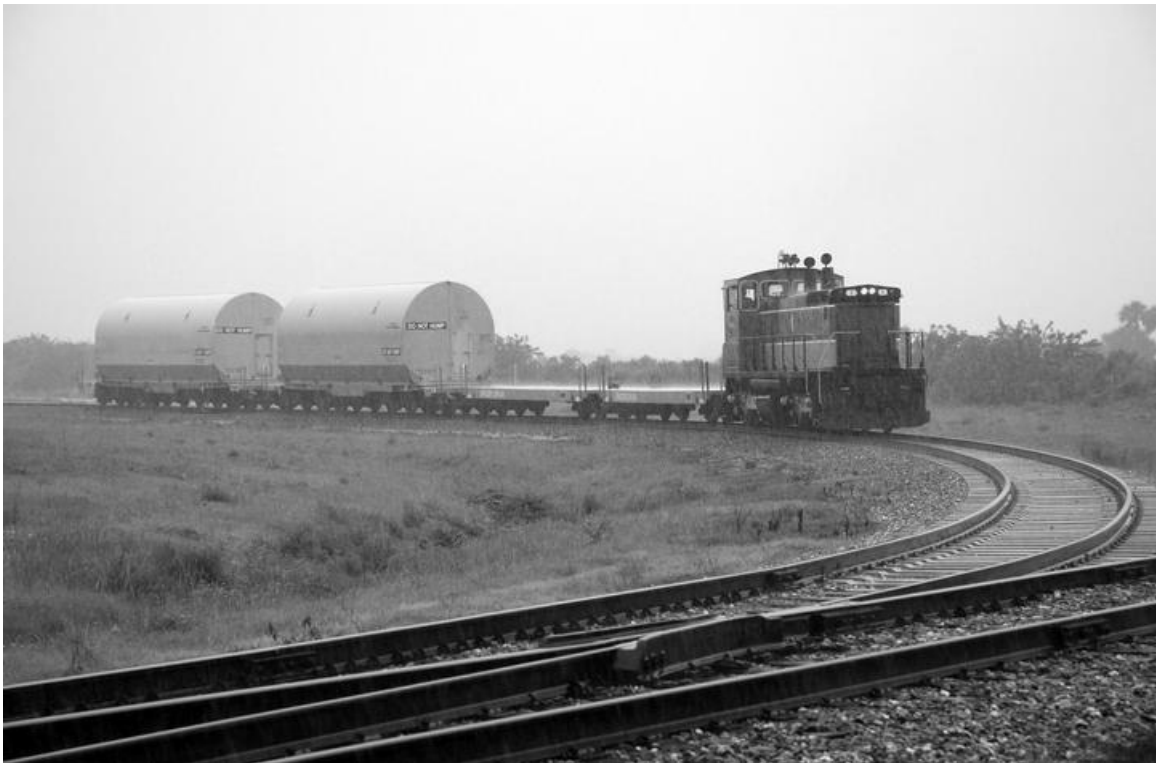
Figure No. E-40. Loaded RSRM segments and two aft exit cone segments en route to the RPSF,
May 14, 2007.

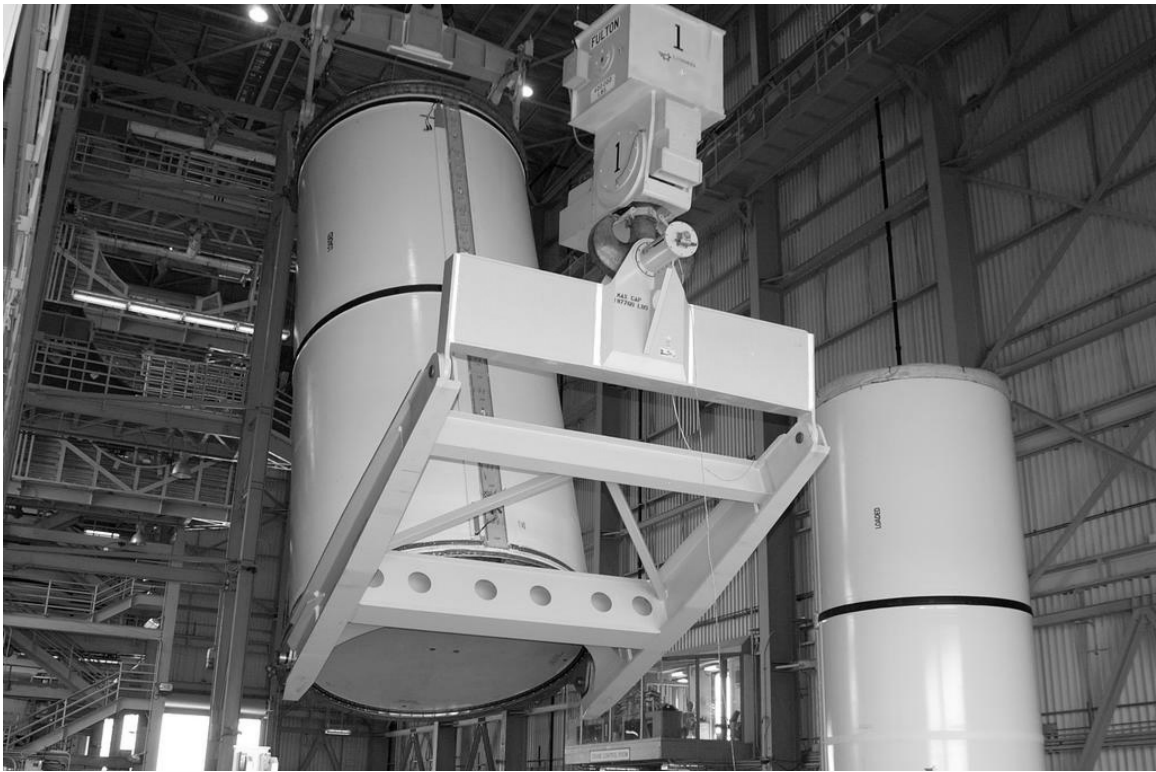
Figure No. E-41. SRB segment being lifted and rotated, 2004.
Source: NASA John F. Kennedy Space Center, KSC-04PD-0058, accessed at
<http://mediaarchive.ksc.nasa.gov/search.cfm>.

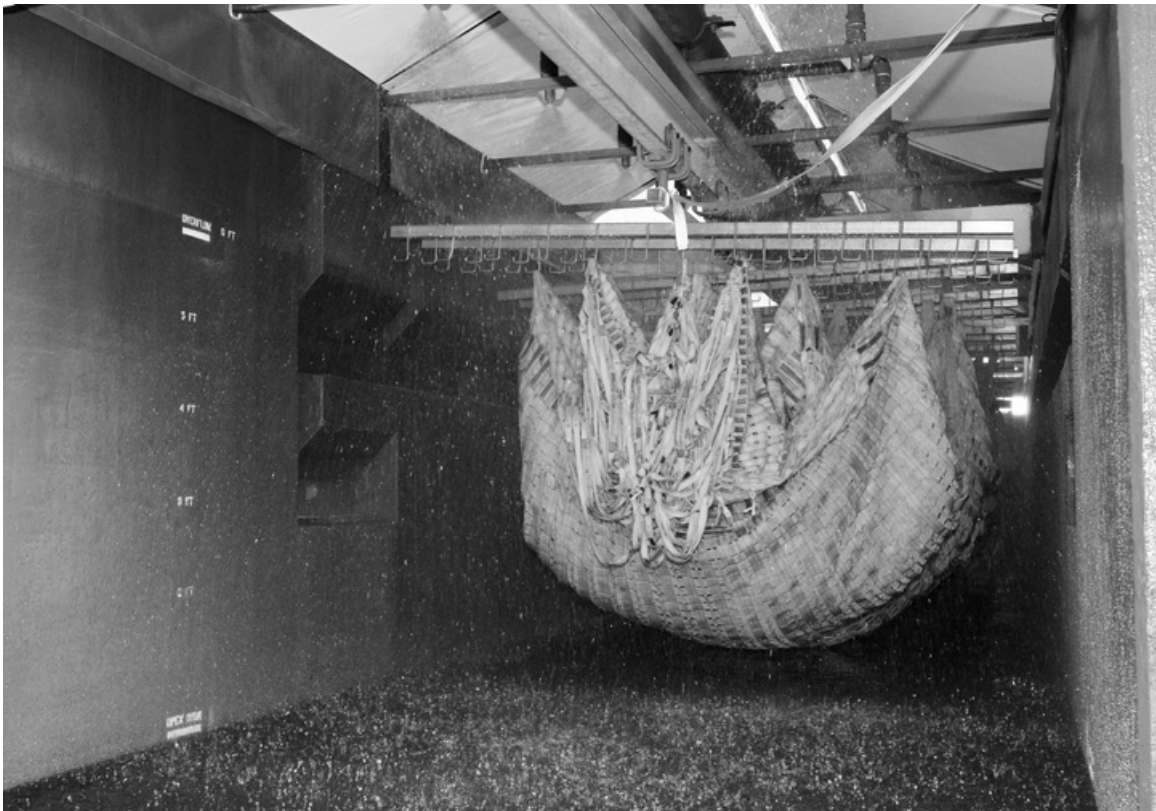
Figure No. E-43. Parachute from *Endeavour's* STS-126 mission is moved through the 30,000 gallon washer, November 19, 2008.

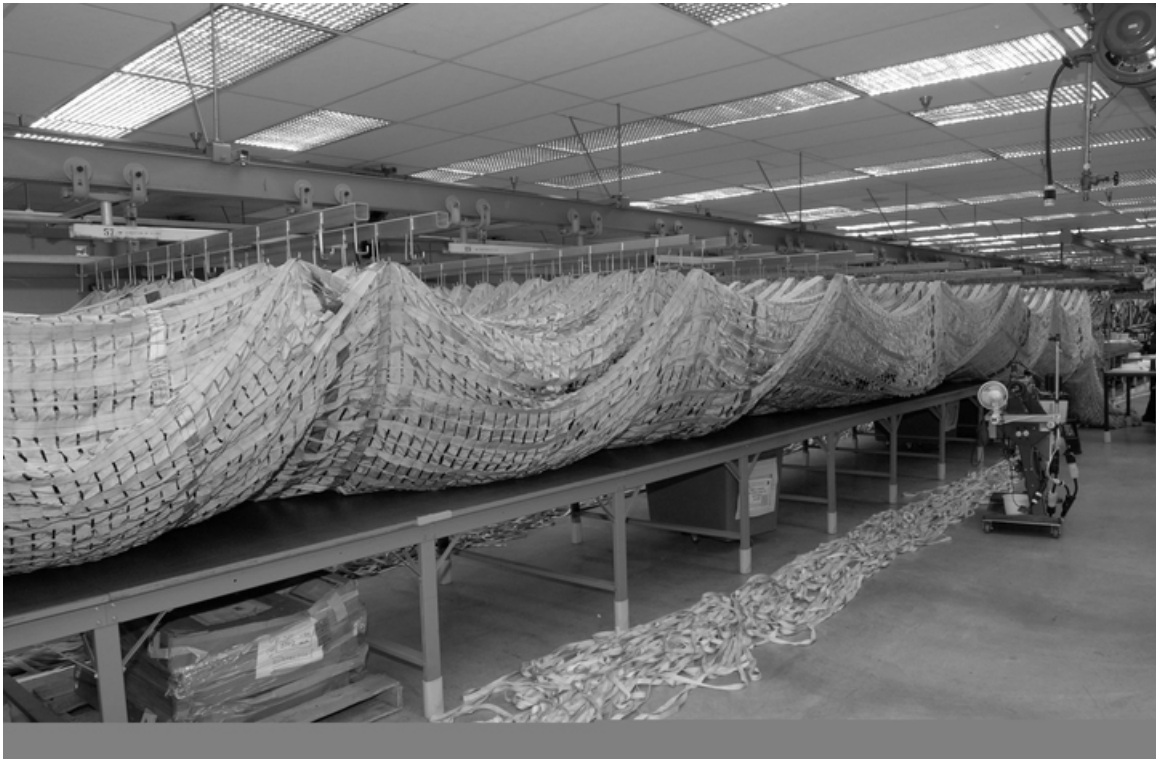
Figure No. E-44. Parachute from *Endeavour's* STS-126 mission is suspended from a hanging monorail system at the KSC Parachute Refurbishment Facility, November 19, 2008.

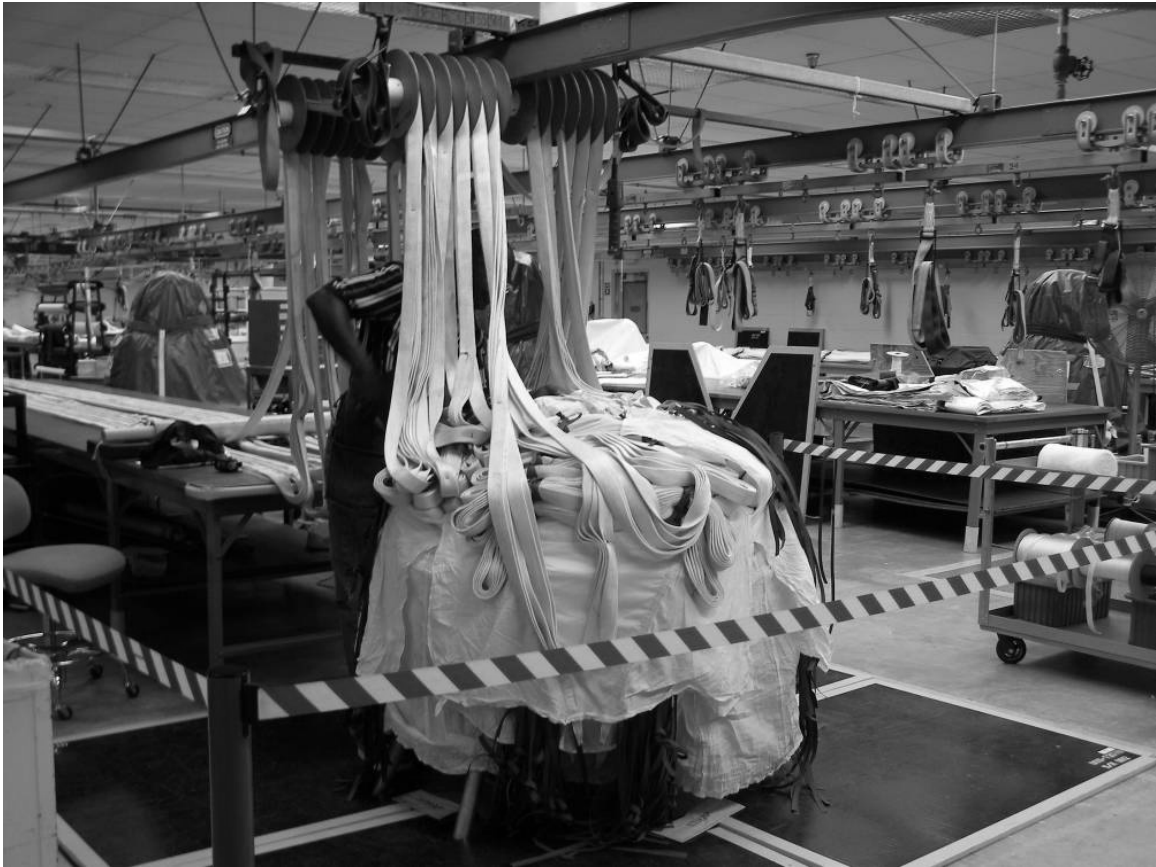
Figure No. E-45. Parachute Refurbishment Facility, packing area.
Source: Archaeological Consultants, Inc., 2006.

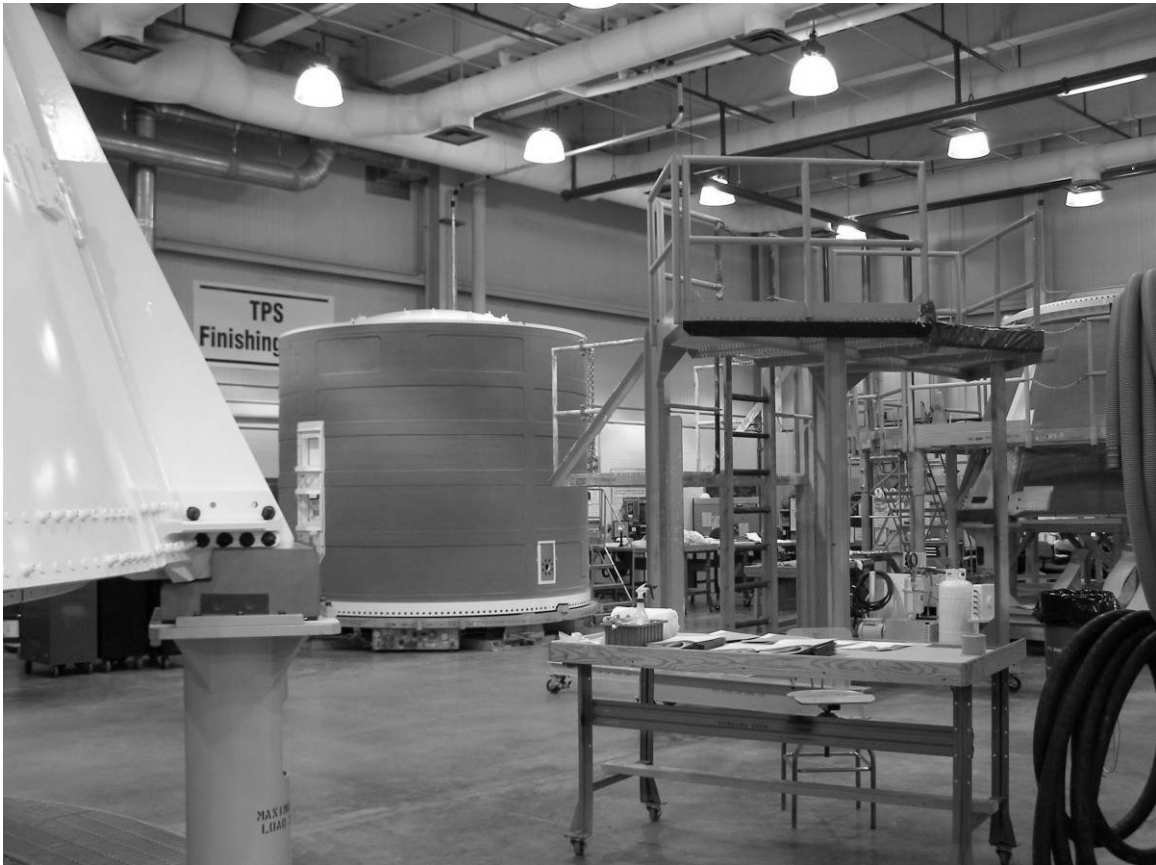
Figure No. E-46. SRB forward skirt in the SRB ARF cure area.
Source: Archaeological Consultants, Inc., 2006.

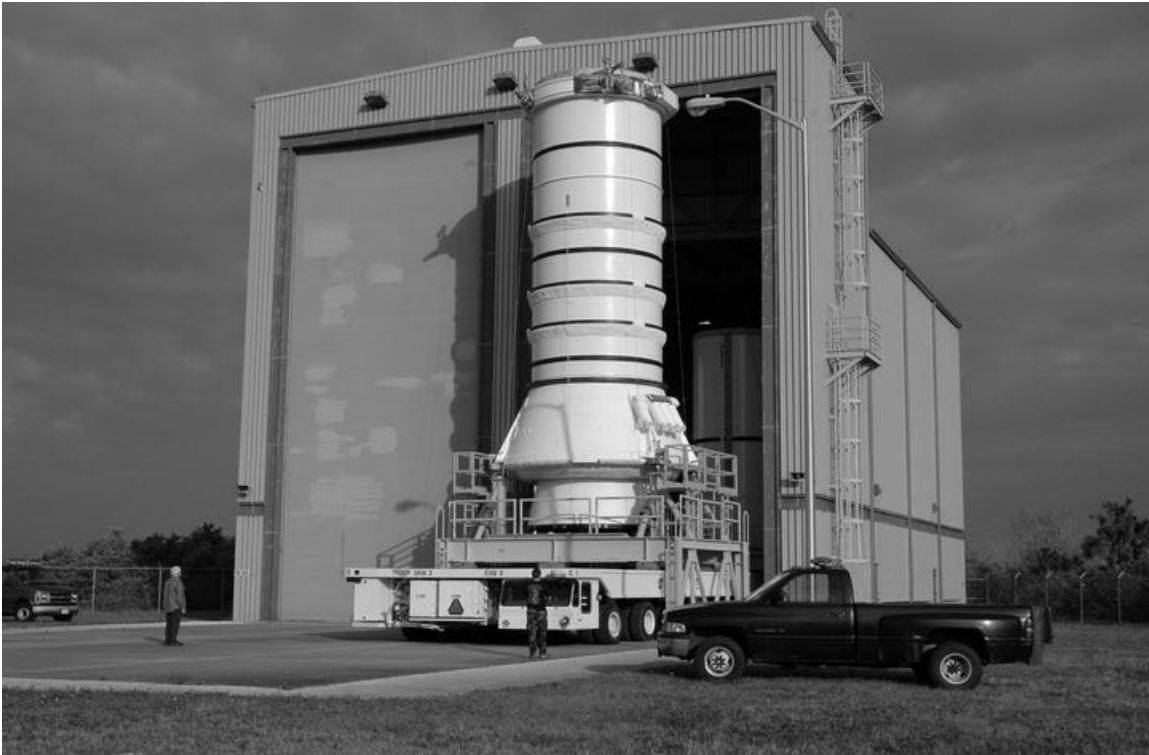
Figure No. E-47. The right aft booster, comprised of the aft skirt and aft motor segment, rolls out of a Surge Building at the RPSF for transfer to the VAB, where it will be stacked for *Discovery*, STS-121, January 23, 2006.

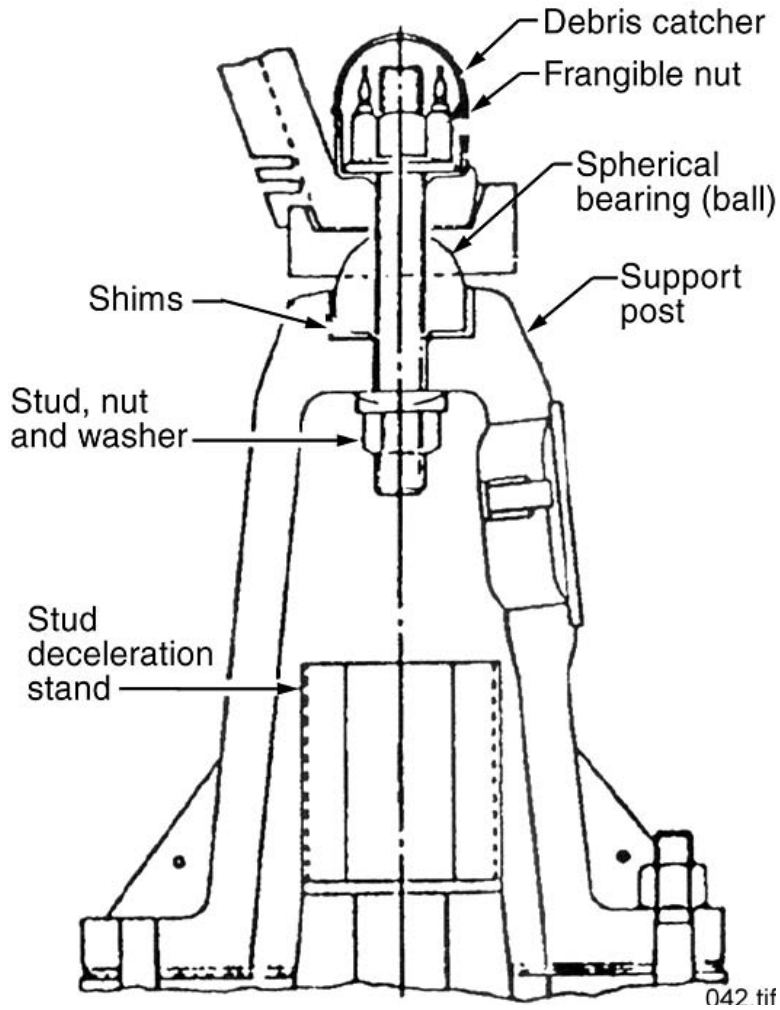
Figure No. E-48. Diagram of SRB Support/Hold-Down Post.
Source: USA, *Shuttle Crew Operation Manual*, 1.4-3.
