Appendix E-SRB/RSRM Figures

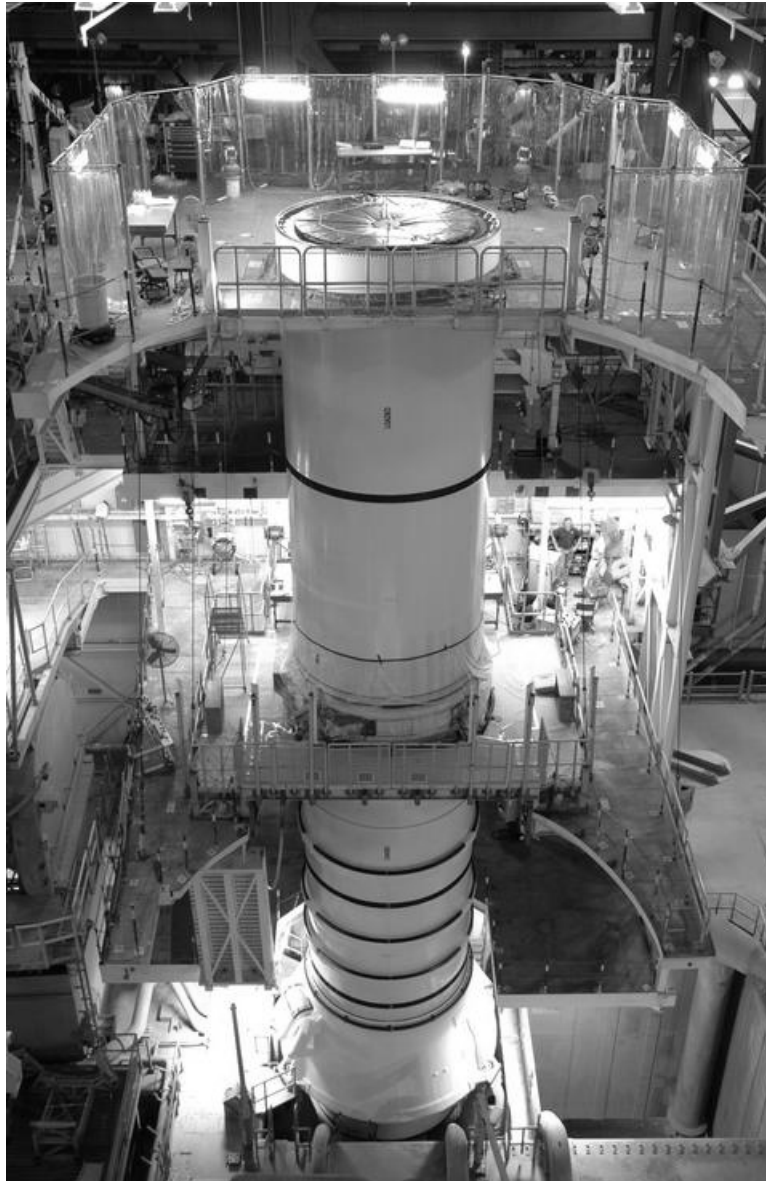
Figure No. E-49. A SRB left aft booster and left aft center segments are stacked in the VAB for STS-120, July 23, 2007.

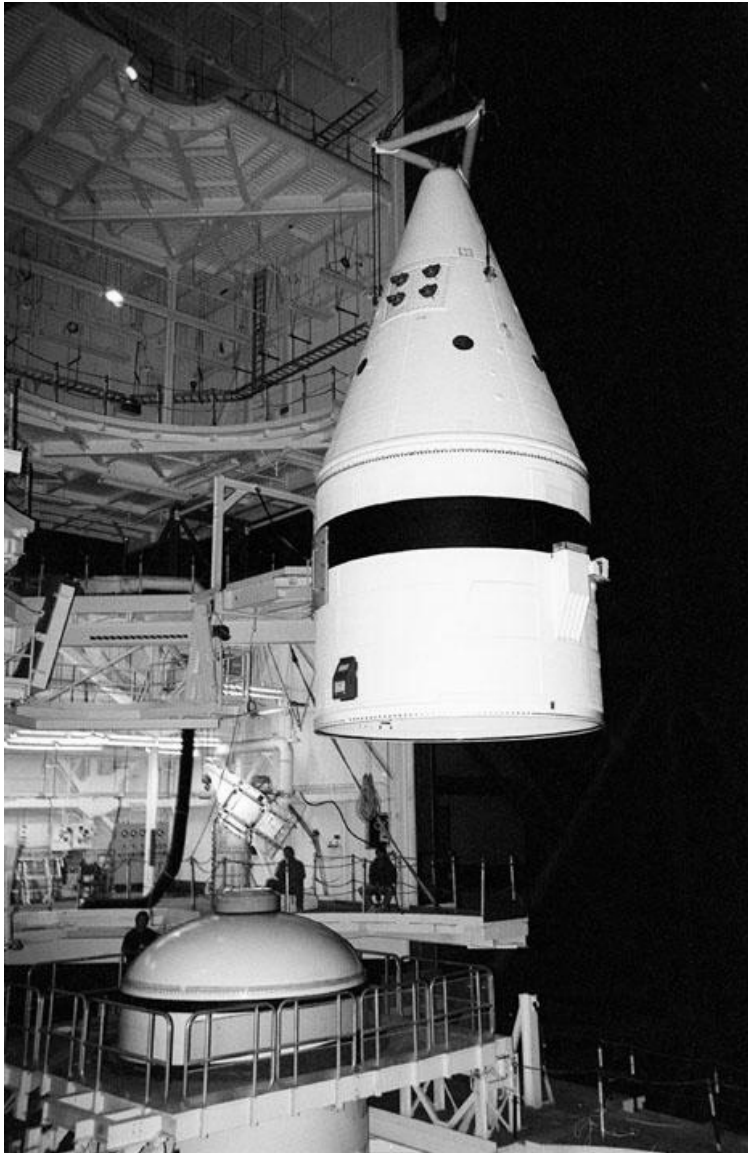
Figure No. E-50. A forward assembly is lifted in the VAB prior to stacking for STS-92,
June 29, 2000.
