Columbia Crew Survival Investigation Report

NASA/SP-2008-565

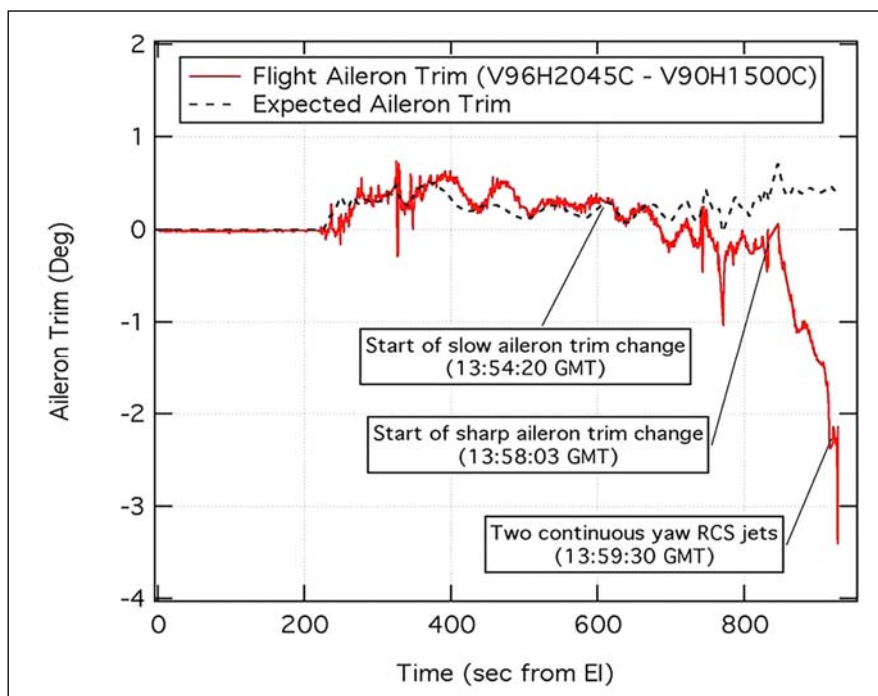
At approximately GMT 13:58:03 (EI+834), the aileron trim begins to diverge sharply from the expected values to counteract the increasing adverse moments due to the left wing damage (figure 1.1-15).

Figure 1.1-15. *Aileron trim discrepancy.*¹⁸

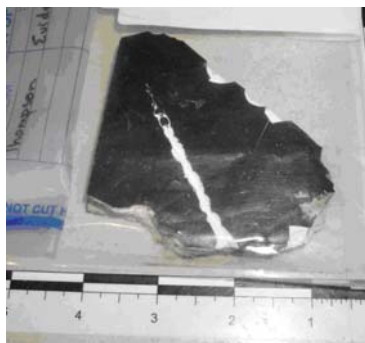
Ballistic analysis indicates that the westernmost piece of recovered *Columbia* debris was released at GMT 13:58:21 (EI+852). This debris, a tile from the left wing upper surface located just inboard of RCC panels 8 and 9, was found in Littlefield, Texas¹⁹ (figure 1.1-16).

Figure 1.1-16. *The Littlefield tile.* [Picture from the *Columbia* Reconstruction Database, debris item no. 14768]

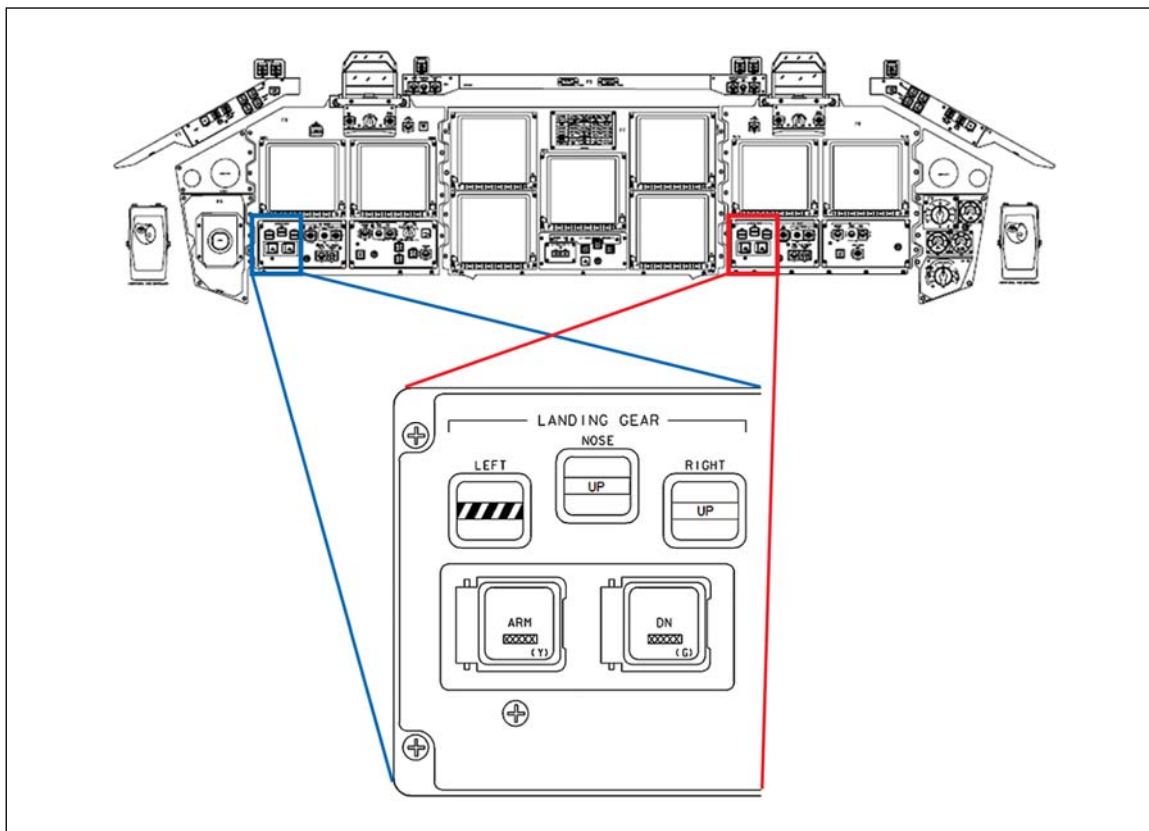
At GMT 13:59:06 (EI+897), 10 seconds after the fourth of four tire pressure fault messages, telemetry indicated the "LEFT MAIN GEAR DOWN" lock sensor transferred to "ON." Other sensors indicated that the landing gear door was still closed and the landing gear was locked in the up (stowed) position. These mixed signals caused the left landing gear position indicator to display a "barber pole" (figure 1.1-17), which indicates an indeterminate landing gear position. Post-accident analysis of the data and recovered debris indicates that the left landing gear was locked in the "up" position and the landing gear door was closed. The signal indicating that the gear was down was a false signal that was likely triggered by damage to the sensor system (sensor, wiring harness, etc.). Based on training experience, the crew was probably attempting to diagnose the situation given that it involved the same landing gear as the tire pressure messages and indicated a potential landing gear deployment problem.

Figure 1.1-17. Landing gear indicator panel, identical on both sides of the flight deck forward display panels. Left indicator showing "barber pole" (indeterminate position). [Adapted from the Space Shuttle Systems Handbook]

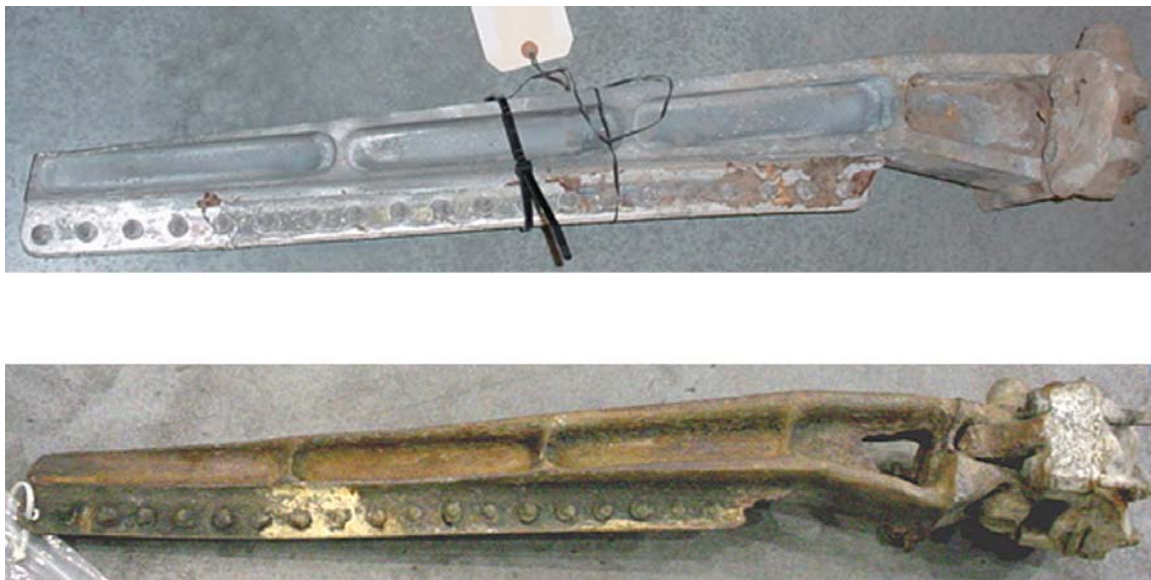
sill, and was likely from a combination of thermal degradation and structural loads. The forebody probably separated from the midbody from starboard to port. Based on structural evidence and the debris field, the crew module remained with the forward fuselage indicating that the links attaching the two structures remained intact. The remaining orbiter structure separated into aft and midbody/right wing segments. See Chapter 2. Figure 1.1-25 shows the recovered x-links.

Figure 1.1-25. Port x-link, debris item no. 1678 (top), and starboard x-link, debris item no. 1765 (bottom), from the Columbia Reconstruction Database.

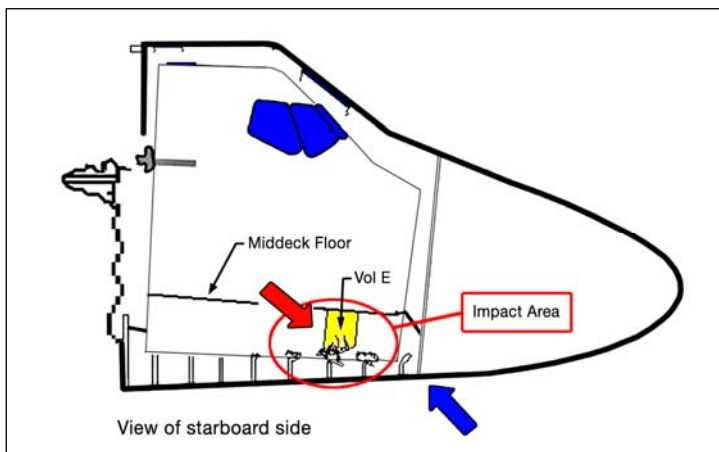
The resulting jerk acting on the crew module attach fittings as the forebody separated from midbody structure caused motion of the crew module within the forward fuselage shell. The crew module pressure vessel impacted the forward fuselage, which apparently resulted in damage to the crew module pressure vessel, internal crew module structure, and forward fuselage structure. Debris evidence shows that internal damage occurred to some volumes and lockers on the middeck in close proximity to the pressure vessel shell. At least one crew module pressure vessel breach occurred in the lower equipment bay or middeck area (figure 1.1-26), probably at or near the time of the CE, but definitely not later than GMT 14:00:35 (EI+986) ±5 sec. This time is based on the ballistic analysis of a recovered mission patch confirmed to have come from inside the crew module from one of the volumes (Volume E) that suffered damage.

Figure 1.1-26. Scenario showing how the crew module pressure vessel could impact the forward fuselage, and the middeck Volume E could impact the crew module pressure vessel, with resultant damage.

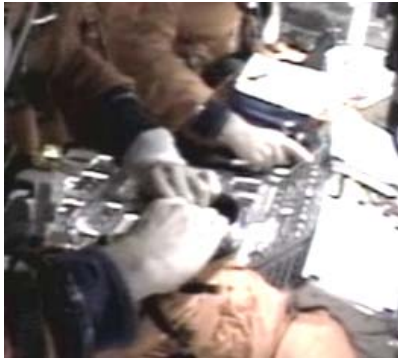
ITEM 27. CDR/Seat 1 manually inputs the ITEM 27 command using the keypad on the C2 panel. This fully recovers the vehicle from the bumped RHC. [From video and telemetry] (figures 1.2-10 and 1.2-11)

Figure 1.2-10. Commander/Seat 1 inputting an ITEM 27.

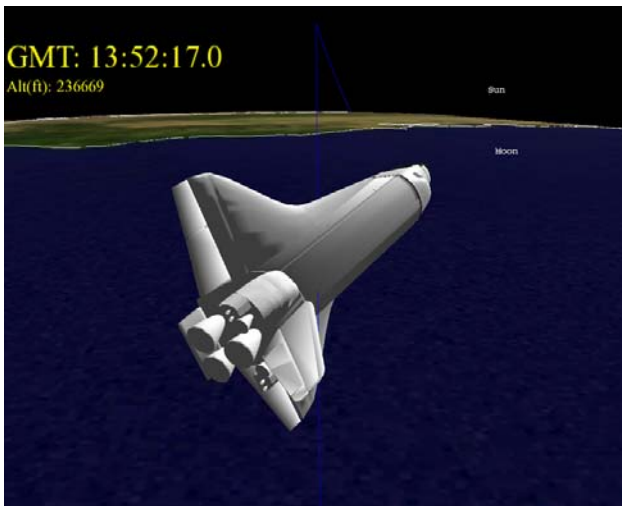
Figure 1.2-21. Columbia approaching the California coastline.

TIME	EVENT
	<p>Approximately 300 miles west of the California coast (figure 1.2-21)</p> <p>Alt = 236,791 feet [<i>Master Timeline, Rev. 15 Baseline</i>]</p> <p>Mach = 23.58 [<i>Master Timeline, Rev. 15 Baseline</i>]</p> <p>Qbar = ~27 psf [modeling]</p>

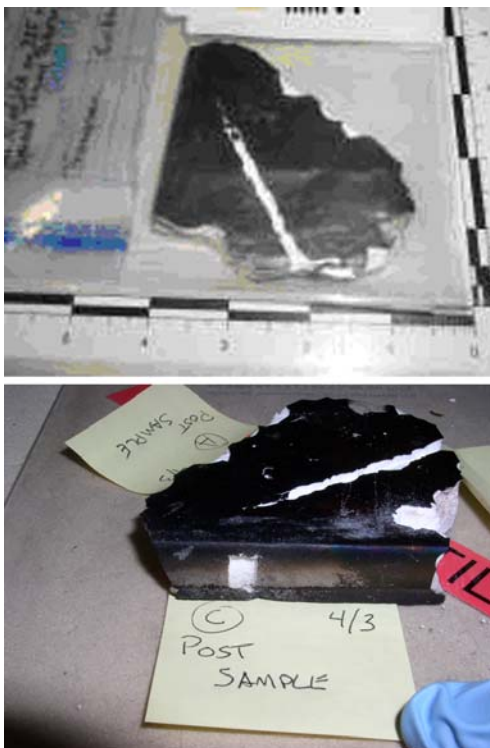
Figure 1.2-35. *The Littlefield tile.* [Picture from the Columbia Reconstruction Database, debris item no. 14768]

<p>Alt = 212,007 feet [Master Timeline, Rev. 15 Baseline] Mach = 19.77 [Master Timeline, Rev. 15 Baseline] Qbar = ~54 psf [modeling]</p>
13:58:12 (EI+843)	<p>End of ground-based video coverage for western portion of entry.</p>
13:58:21(EI+852) ±5 sec	<p>Littlefield Tile Released. This piece of tile was recovered in Littlefield, Texas; it is the westernmost piece of recovered debris (figure 1.2-35).</p>

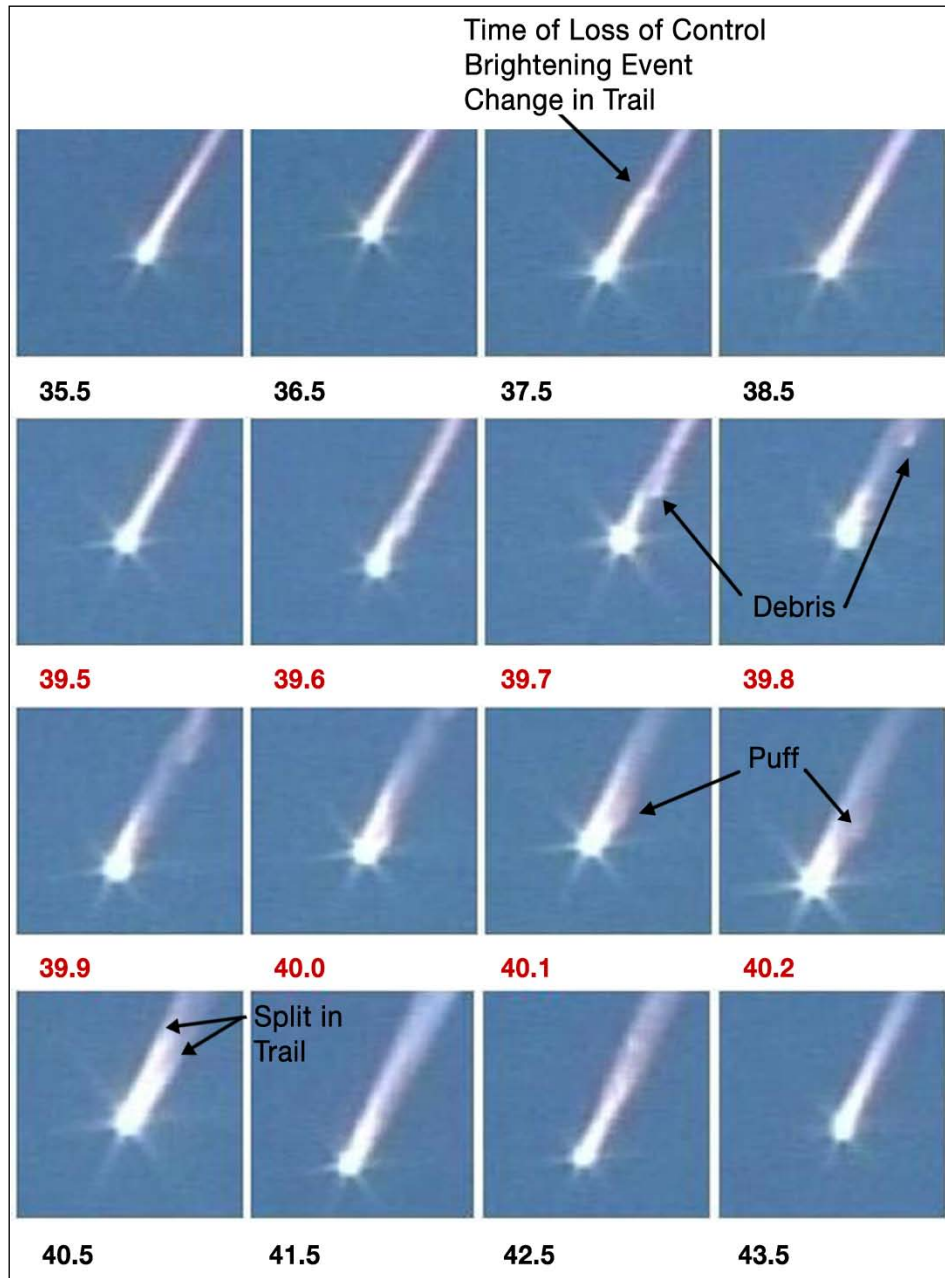
Figure 1.2-41. Video frame captures from ground-based video, beginning at GMT 13:59:35.5 (EI+926.5) and ending at GMT 13:59:43.5 (EI+937.5). The numbers below each frame indicate the seconds after GMT 13:59:00. The frames in the first and last rows are 1 second apart. The frames in the second and third rows are 0.1 second apart.

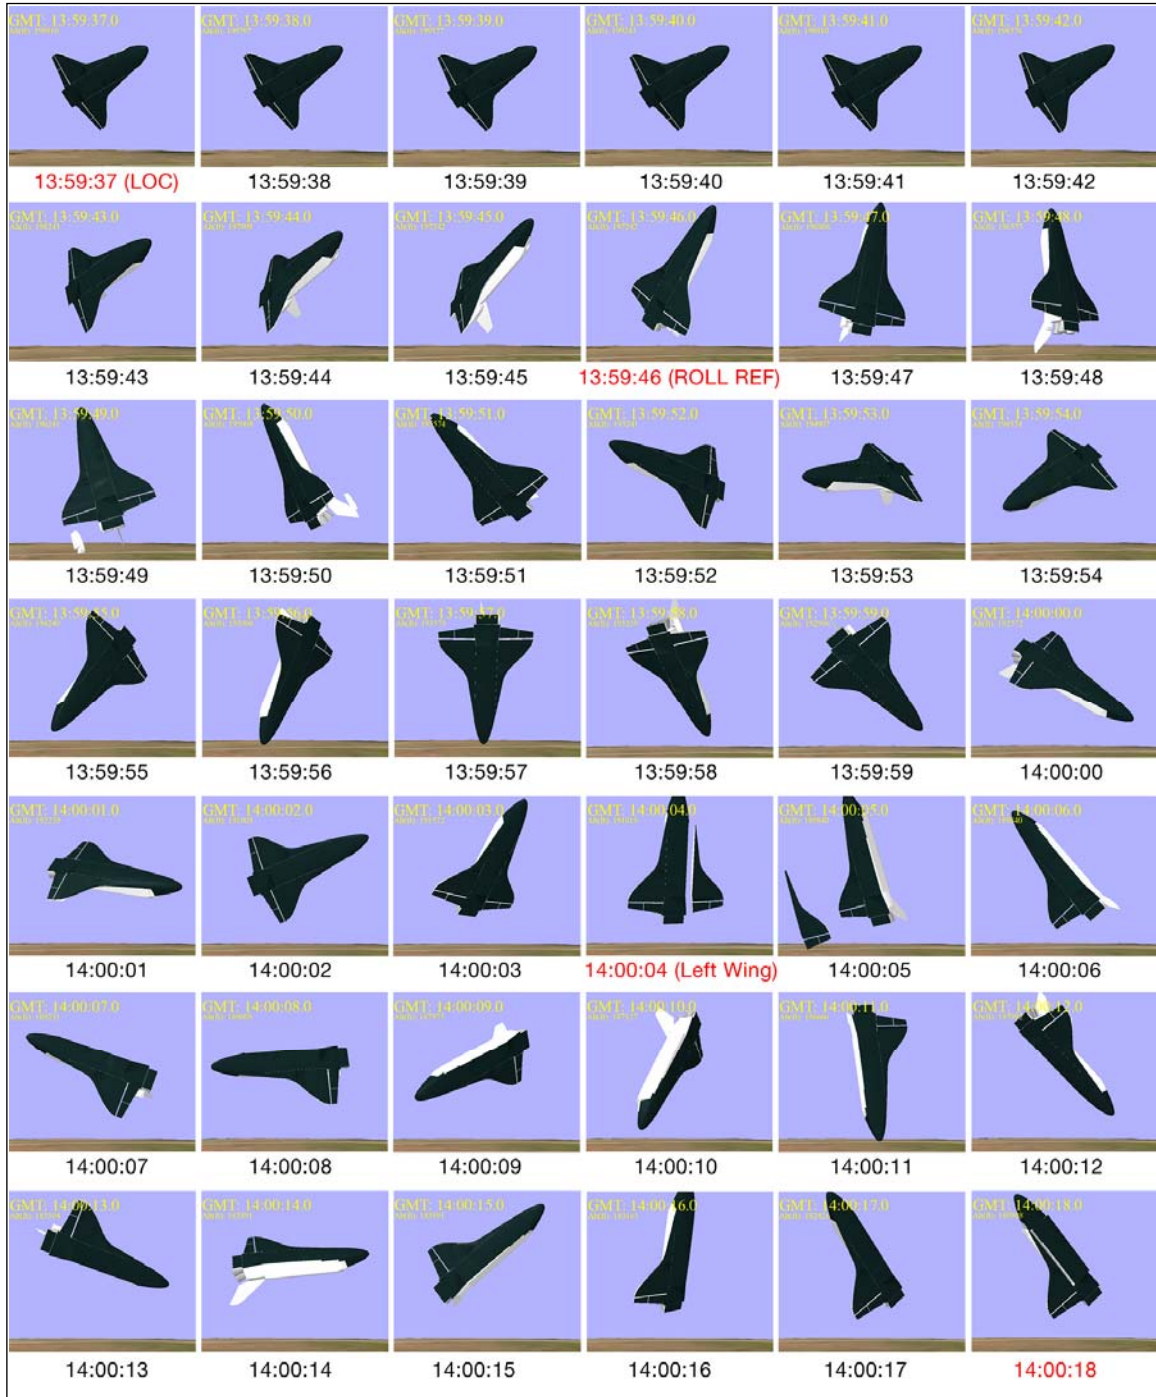
Figure 2.1-13 is a second-by-second graphical depiction of the simulated motion of the orbiter during this period. The sequence begins at the start of the LOC period (GMT 13:59:37) and ends at the CE (GMT 14:00:18). The view is from a point in front of the orbiter’s direction of travel, looking backward along the velocity vector. The snapshot for GMT 14:00:04 shows the left wing departing intact. In reality, the left wing did not come off all at one time but was shedding debris over a period of time.

Figure 2.1-13. Entry simulation snapshot sequence. Times are in Greenwich Mean Time.

With the sequence viewed from a vantage point looking back up the velocity vector, it is apparent that the predominant orientation of the orbiter remained “belly into the wind” with large excursions in pitch, roll, and yaw. This motion can be characterized¹⁰ as a slow (30 to 40 degrees per second), highly oscillatory spin. As the simulation progresses in time, the rates and attitude excursions increase.

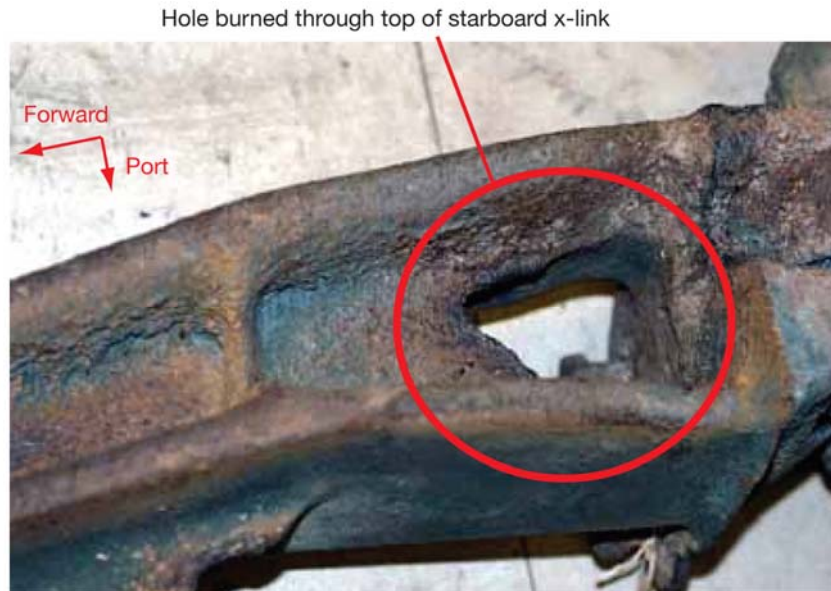
The heating experienced by the starboard x-link was severe enough to melt away the top flange and to burn a hole through the 0.25-in.-thick web. Figure 2.1-48 shows another comparison of the two x-links with a better viewing angle to see the flange damage. Figure 2.1-49 shows a close-up view of the starboard x-link where a hole has been melted through the web.

Figure 2.1-49. Close-up of the hole in the starboard x-link. [Columbia Reconstruction Database, debris item no. 1765]

Knowing the heat of ablation per unit of mass allows a first-order estimate of the required heating that must be applied to cause that burn-through hole in the starboard x-link. The dimensions of the burn-through area are 2 in. by 2 in. and the thickness of the x-link in that area is 0.25 in.

Finding. Thermal analyses predicted that entry aeroheating alone was insufficient by an order of magnitude to produce the observed thermal damage on the x-links. Therefore, the x-links must have experienced other heating mechanism(s) in addition to normal entry heating.

Conclusion A13-2. The heating from a Type IV shock-shock impingement and titanium combustion (in some combination) likely resulted in the damage seen by the forward payload bay door rollers and the x-links.

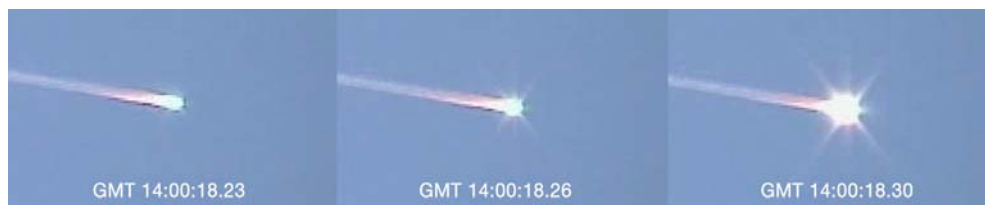
The second significant event that is seen in video is the CE. Figure 2.2-5 shows the CE; there is no change in magnification between frames. The video of the CE is a distinct visual event in which the orbiter envelope brightens significantly and the trail width doubles. Additionally, some color change to orange is evident just prior to the CE. The color change is not readily visible in the still image frames that are taken from the video. In videos of the *Challenger* accident, an orange color was also seen in the videos and was assumed to be hydrazine, the material that is contained in the Orbital Maneuvering System (OMS) pods and RCS tanks. It is unknown whether the orange color seen in *Columbia*'s trail correlates to OMS or RCS tanks, or to some other cause.

Figure 2.2-5. The Catastrophic Event is depicted in these three frames of video that cover 0.1 second. There is no change in the magnification/zoom factor. The third frame represents GMT 14:00:18.3.

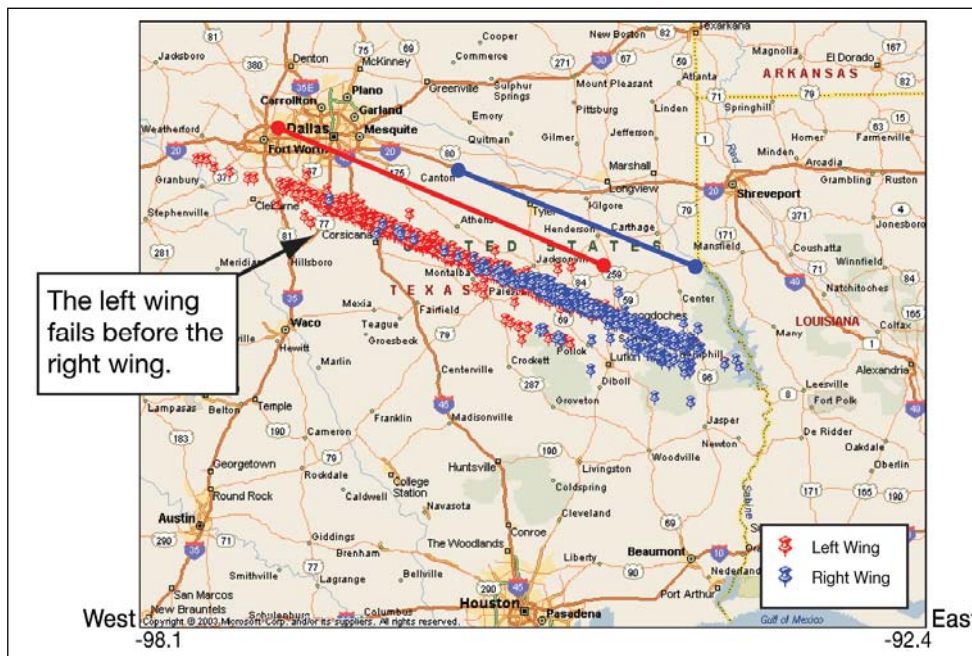
Figure 2.2-13. Debris field of the left and right wings.

Figure 2.2-12 identifies where the wing structure is in relationship to the other orbiter structural components. TPS tile is included in these figures, as some tile adhered to structure and it was not easily possible to separate out individual tiles. Figure 2.2-13 shows a ground debris map that is similar to that produced in the CAIB Report, Volume I, p. 75; however, figure 2.2-13 shows all the debris for the wings whereas the CAIB map shows only the RCC panels. As the CAIB reported, the left wing failed before the right wing. This is implied in figure 2.2-14 as well. Overlay mapping of debris at their correct latitudes and longitudes prevents easy recognition of their actual ground footprints. The bars shown on the map and in later ground debris maps represent the main cluster of the debris. If coverage extends beyond the map shown, an arrow indicates that the footprint continues off the map. The bar shown above each histogram indicates the longitude range covered by the overlay mapping.

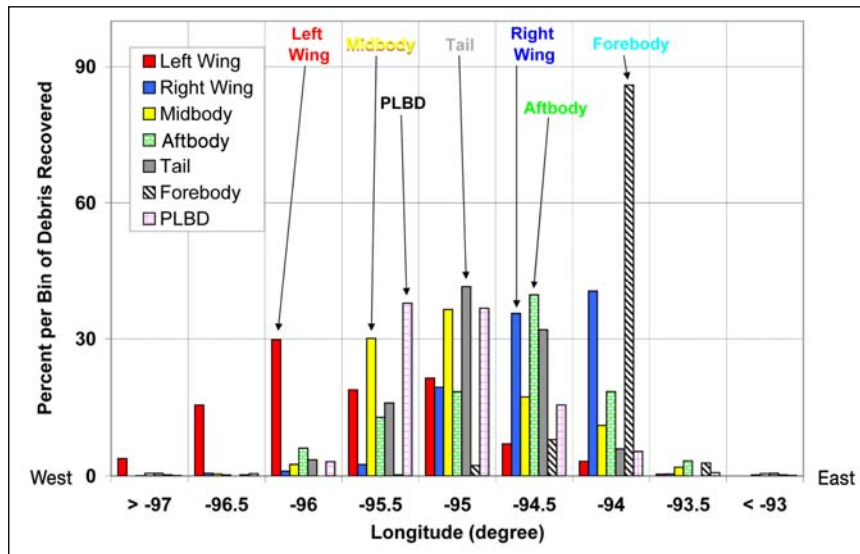
Figure 2.2-21. Histogram of the relative order of the major debris groups recovered.

In summary, figure 2.2-21 shows an overall assessment of debris clusters. The westernmost longitude bin of each group that exceeded 30% of the recovered debris group is referenced with an arrow; the label above the bin identifies the debris group. It was observed that when the number of recovered debris items from one orbiter structural zone reached approximately 30%, the next group began to appear in rapidly increasing numbers. The significance of this observation is not known. It may be an artifact of data processing, or it may be characteristic of a cascade effect of structural breakup. This is a topic that may warrant further research and investigation.

Cluster analyses show that following the left wing, midbody items (predominantly PLBD pieces) departed the vehicle. The tail, the right wing, and the aftbody shed a significant number of pieces, followed by SPACEHAB and the forebody. Table 2.2-5 shows a comparison of sequencing from cluster analysis compared to video and ballistic analyses.

There was no evidence from the ballistic or debris cluster analysis that the forebody suffered any major breach before it separated from the midbody. Figure 2.2-21 (in the debris cluster assessment section) shows that forebody debris does not begin to appear in the debris field until other midbody debris is present in large quantities.

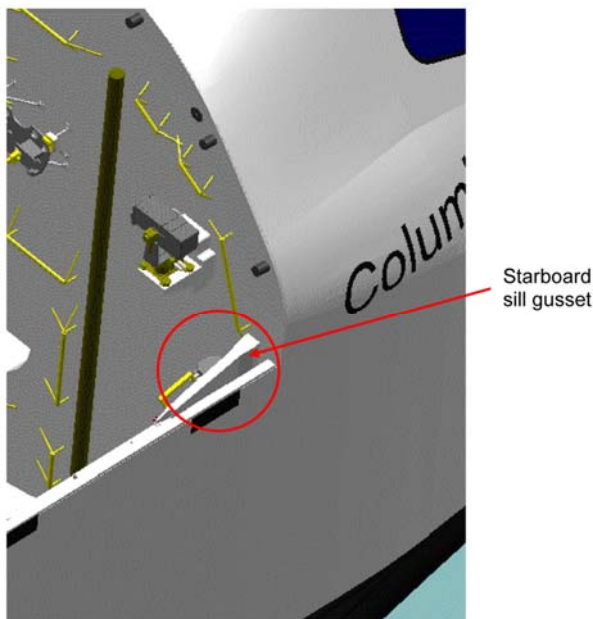
Figure 2.2-31. Close-up of the starboard sill gusset area.

Without the PLBDs, the weak zone between the forebody and the midbody is the sill joint gusset on the aft side of the X_o 582 ring frame bulkhead (figure 2.2-31). This gusset is an offset structural connection that transfers the major X-axis loads from the CM to the midbody sill longeron via the x-links.

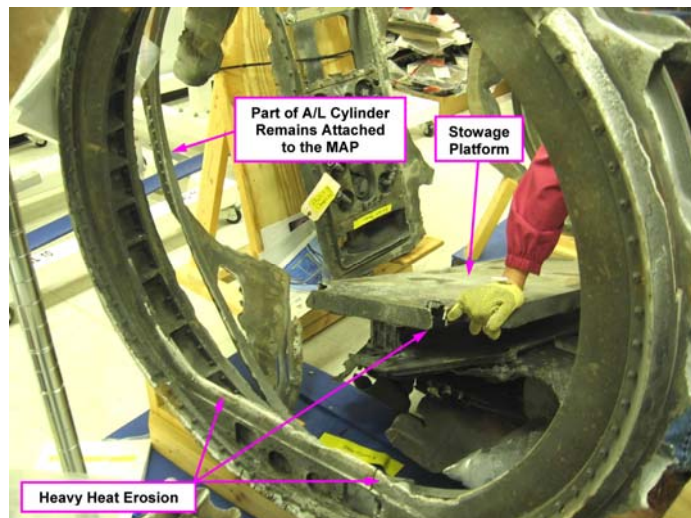
Extreme thermal erosion at the lower edge opening on the MAP where the forward end of the TAA is attached indicates that after the TAA broke away from the MAP, hot gas flowed in over the lower edge of the “B” opening in the MAP. This thermal flow also caused heat erosion to the two aft corners of the stowage platform, which was mounted to the airlock floor (figure 2.2-56). This is consistent with the rotational motion of the forebody post-CE, when such an exposure could have occurred.

Figure 2.2-56. View looking forward at the “B” hatch opening on the X₀ 576 bulkhead.

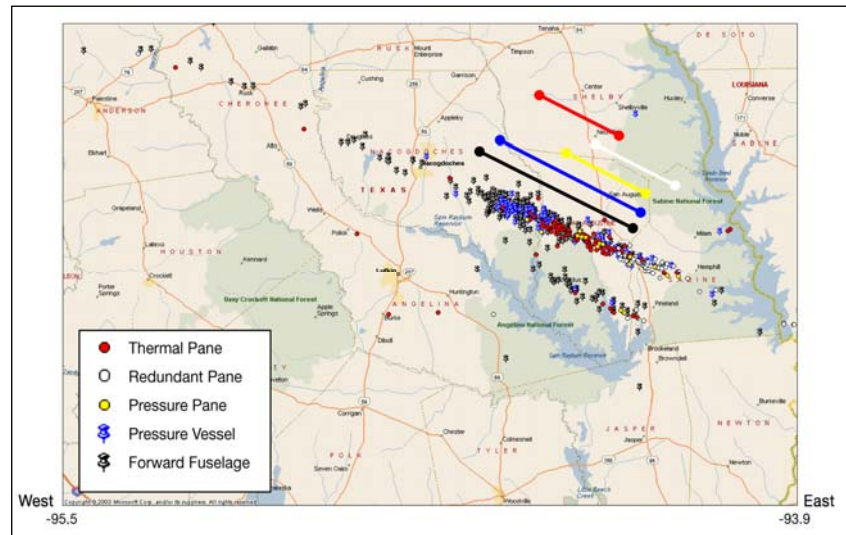
Figure 2.4-9. Debris field of the window panes, forward fuselage, and crew module pressure vessel.

If the source of the cabin depressurization had been a window, both the pressure pane and the redundant pane would have to have failed. However, redundant pane is not seen until the far eastern end in the forebody debris field. Also, in such a case, the pressure from inside the CM would likely blow the entire pane out and result in significant amounts of glass that were not seen west of the main forebody debris field.

Figure 2.4-9 shows that thermal pane debris was recovered east of the beginning of the main forebody debris, suggesting that the windows broke at or after the CMCE. Pressure panes were recovered west of the bulk of the redundant panes, possibly because the redundant panes were extraordinarily thick and heavy and may have traveled farther east because their ballistic number was higher. Determining the failure sequence of the windows based on ground plots alone was somewhat suspect because some of the window frames remained attached to other window frames as a unit, and the shape of the windows can potentially generate lift. Regardless, because the debris field does not contain significant pane debris west of the main CM debris field, it is concluded that the windows were not the source of a CM breach or a part of the initiating event of the forebody breakup.

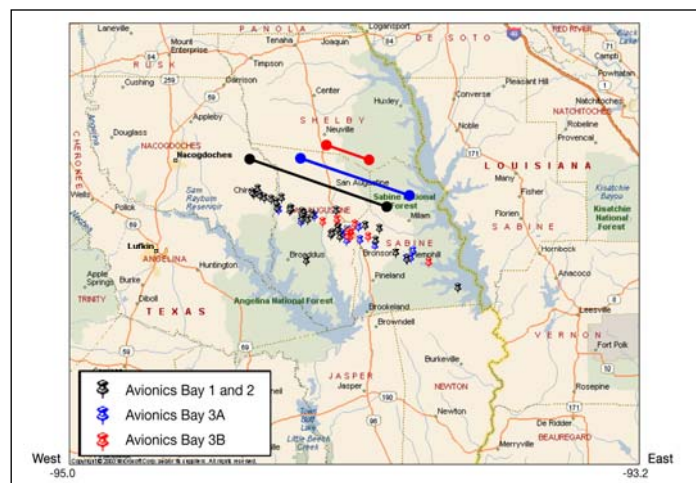
Figure 2.4-21. Debris field of the avionics bays.

Debris from Bays 1 and 2 was recovered west of Bays 3A and 3B. This order matches the CM bulkhead order, supporting that the front ($X_{cm} 200$) bulkhead departed before the aft ($X_o 576$) bulkhead.

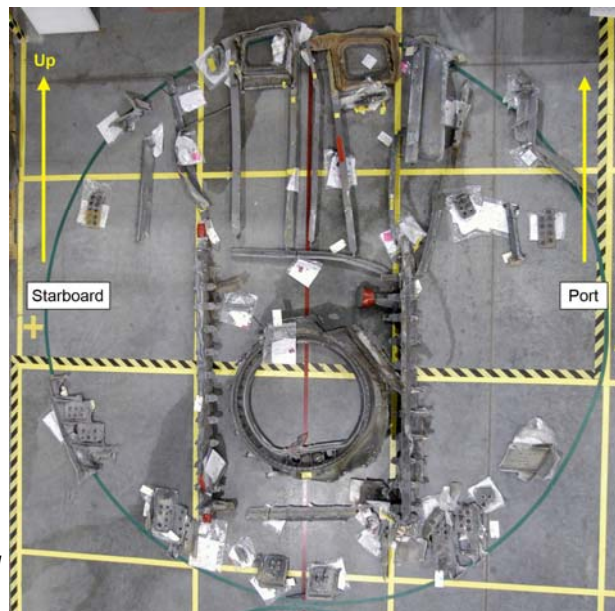
In general, heavy portions of the X_o 576 bulkhead (including the MAP) survived the entry heating (figure 2.4-46). This is possibly due to the high heat absorption property of the aluminum bulkhead.

Some “T”-section stiffeners survived with little heat damage, possibly because of the early departure of these elements before the high thermal event that consumed the bulkhead.

Figure 2.4-46. View looking aft of the recovered X_o 576 bulkhead debris.

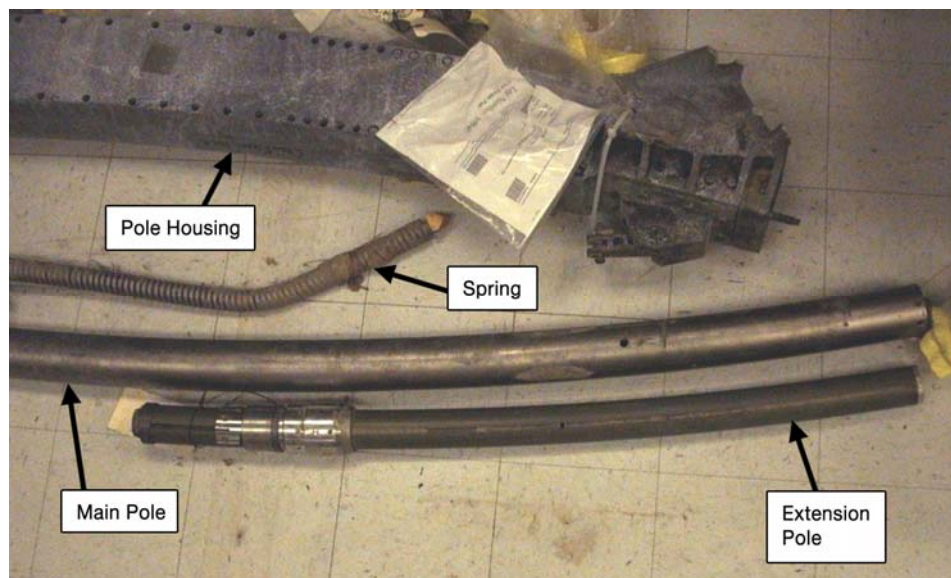
Figure 2.4-53. Port ends of housing, deployment spring, and main and extension poles.

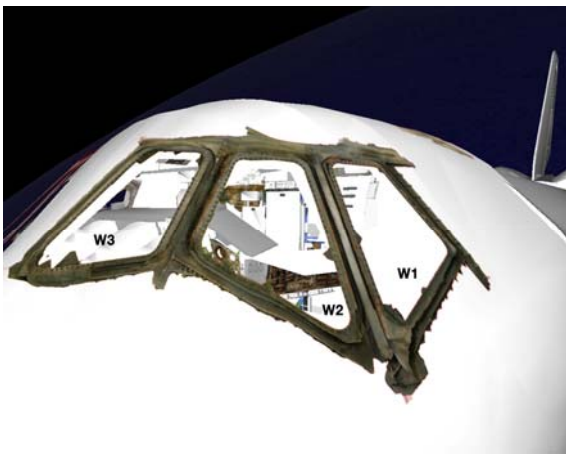
At least one window frame (CM or FF) was recovered from every window. Two large debris assemblies were recovered (figures 2.4-57 and 2.4-58). Each large piece is a complete assembly of three CM forward window frames (Windows 1, 2, and 3 and Windows 4, 5, and 6) with some broken glass pieces still captured in their retainers. Three CM window frames of Windows 7, 9, and 10 were recovered in separate pieces since they were not connected to each other by heavy CM skin structures (figure 2.4-59). Five thermal frames (FF) were also recovered.

Figure 2.4-57. Port view looking aft, recovered Columbia crew module Windows 1, 2, and 3.

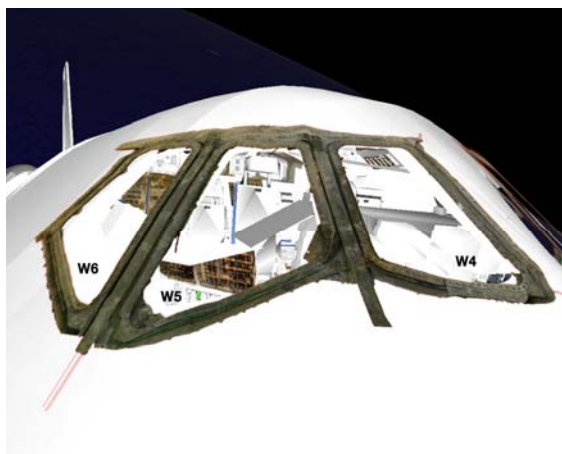
Figure 2.4-58. Starboard view looking aft, recovered Columbia crew module Windows 4, 5, and 6.

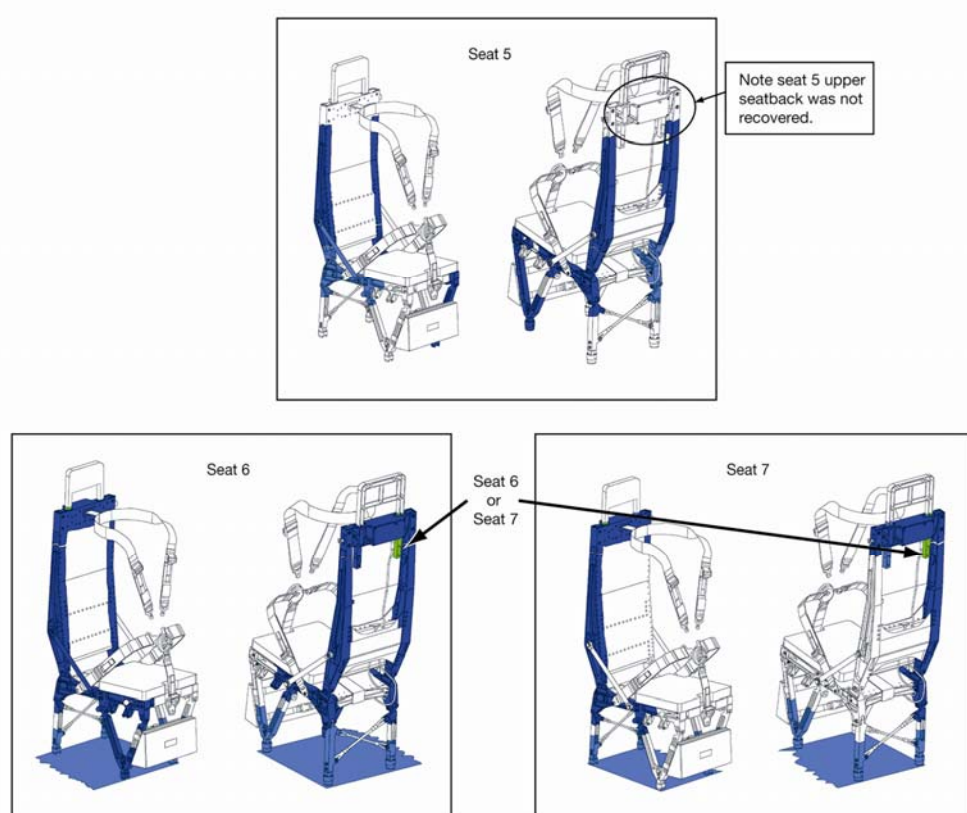
Figure 3.1-7. Identified debris from the middeck seats. [Adapted from the Space Shuttle Systems Handbook]

Figures 3.1-6 and 3.1-7 show seat structure pieces that were identified to each seat location. The blue items in these figures represent items that were positively identified to a seat location. The green items are those items that could be from one of two seats. Figure 3.1-8 shows the major seat structure debris pieces that could not be identified to a specific seat location (the colors in this figure distinguish the different pieces and are otherwise inconsequential). Although represented in figure 3.1-8 on just two seats, the seatback and seat restraint items could be from any of the seven seats. However, the seat pan items could only be from the Mission Specialist seats.

Blue items are positively identified to a specific seat;
green items could be from either one of the two indicated seats.

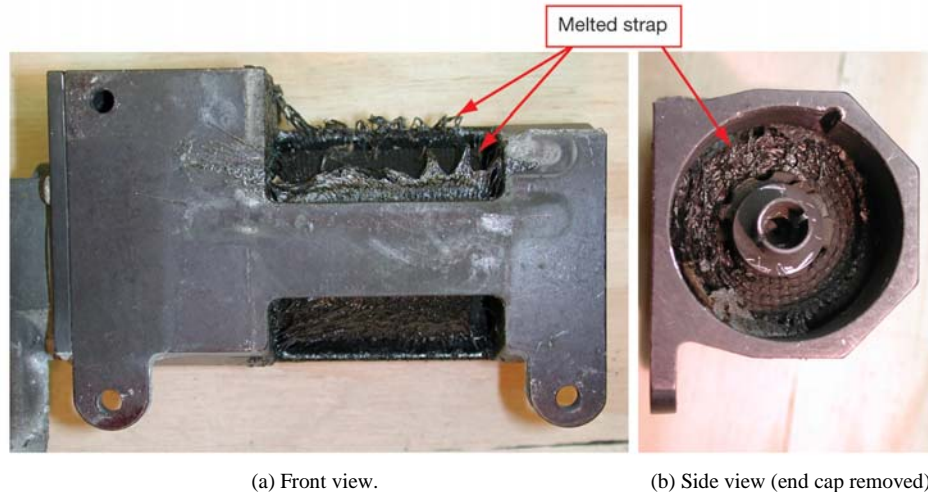
Figure 3.1-23. *Inertial reel melted strap material.*

In all cases, the inertial reel straps were melted only in areas that were immediately adjacent to the strap pass-through openings and along the lateral edges of the strap (figure 3.1-23). The strap material in other areas was not melted and appears normal.

The inertial reel straps failed primarily due to mechanical overload. Limited melting of the straps (and only in distinct areas that were unprotected by the inertial reel housing) indicates that melting was not a significant factor in the inertial reel strap failure. The mechanical overload may have been affected by elevated temperatures that weakened the straps, but these temperatures were not sufficient to cause obvious thermal damage to the strap. Significant strap melting occurred after the inertial reel straps failed and recoiled into the housing. Therefore, the inertial reel straps failed (and the *Columbia* crew members were, at most, partially restrained in their seats) prior to the end of the period of thermal exposure.

Recommendation L2-5. Incorporate features into the pass-through slots on the seats such that the slot will not damage the strap.

Recommendation L2-6. Perform dynamic testing of straps and testing of straps at elevated temperatures to determine load-carrying capabilities under these conditions. Perform testing of strap materials in high-temperature/low-oxygen/low-pressure environments to determine materials properties under these conditions.

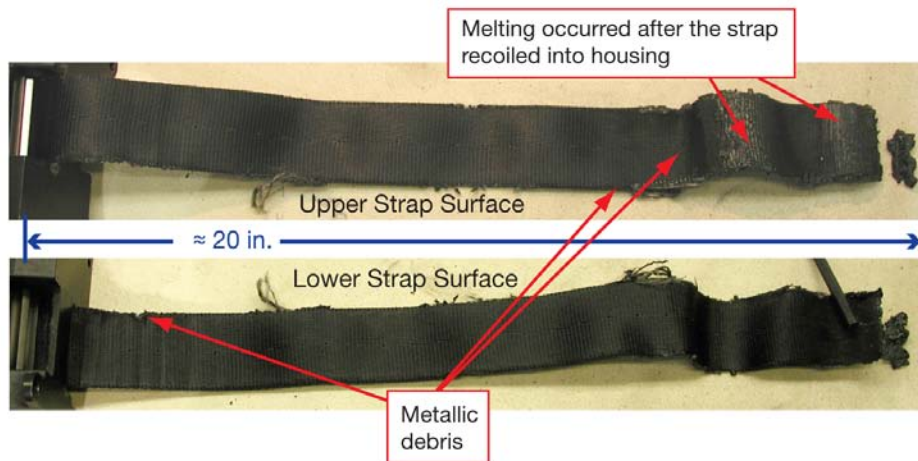
Figure 3.1-30. Seat 6 inertial reel strap.

The seat 6 inertial reel strap (figure 3.1-30) failed at approximately 90% of the extended length (~20 in. away from the inertial reel). Strap failure occurred in close proximity to the shoulder harness y-split attachment (the expected failure point if the strap was not fully extended). No witness marks were observed along the entire strap length. Three pieces of metallic debris were deposited on the strap surfaces: a small ball of melted material (< 1/32-in. dia.) deposited on the upper surface, approximately 16 in. from the reel

attachment (debris came off during inspection); a small fragment of melted material (< 1/32-in. dia.) deposited on the lateral strap edge located approximately 13 in. from the reel attachment; and a small fragment of melted material (< 1/32 in. dia.), which was deposited on the lateral strap edge located approximately 1.75 in. from the reel attachment. The strap was melted completely through one layer near the strap pass-through opening.

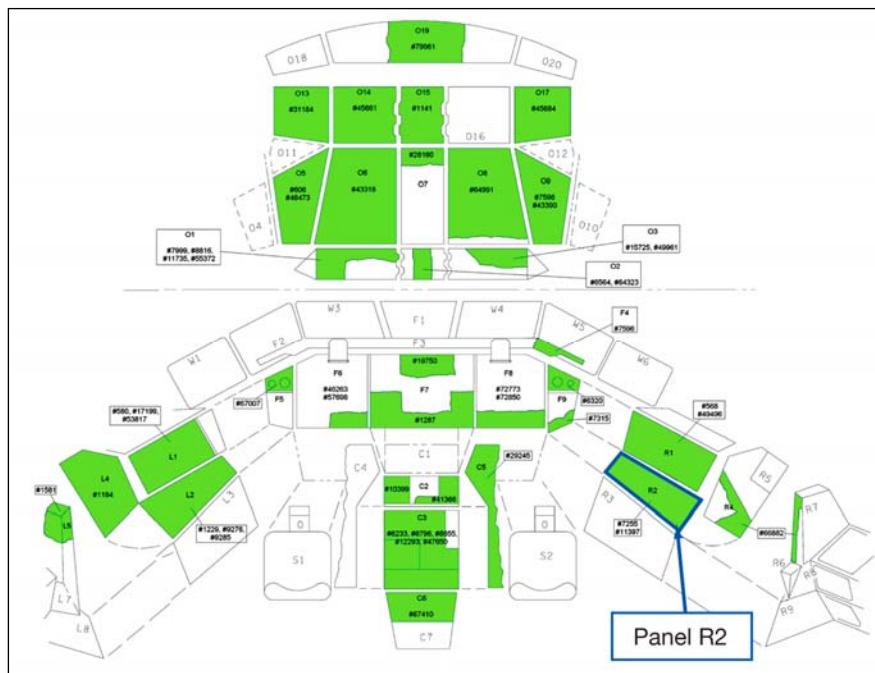
Following the 1986 loss of *Challenger*, a review of the recovered equipment showed that the crew took a few actions after the breakup and prior to losing consciousness.⁴ During the *Columbia* CM reconstruction, the switch panels were examined to determine whether any switches were out of the expected positions. Of the recovered flight deck panels (highlighted green in figure 3.3-2), an estimated 10% to 15% of the switches were found out of position with respect to the expected positions for the entry timeframe.

Figure 3.3-2. Columbia recovered flight deck forward panels (highlighted in green).

No further analysis was performed at that time as it was not possible to know whether the switch positions were due to crew action, the mishap, or handling during debris recovery. However, the R2 panel, to the immediate right of the PLT on the flight deck (figure 3.3-2), warranted further investigation. This panel contains the primary controls for the auxiliary power units (APUs). The APUs drive the hydraulic pumps that provide hydraulic pressure to the flight control surface actuators. During entry, these surfaces become increasingly important to vehicle control, and loss of hydraulic pressure can have catastrophic results. Reconstructed general purpose computer (RGPC)-2 data revealed that the hydraulic systems failed prior to GMT 14:00:03 while the crew was conscious and capable of taking action.
