Report of Findings

X-43A Mishap

By the
X-43A
Mishap Investigation Board

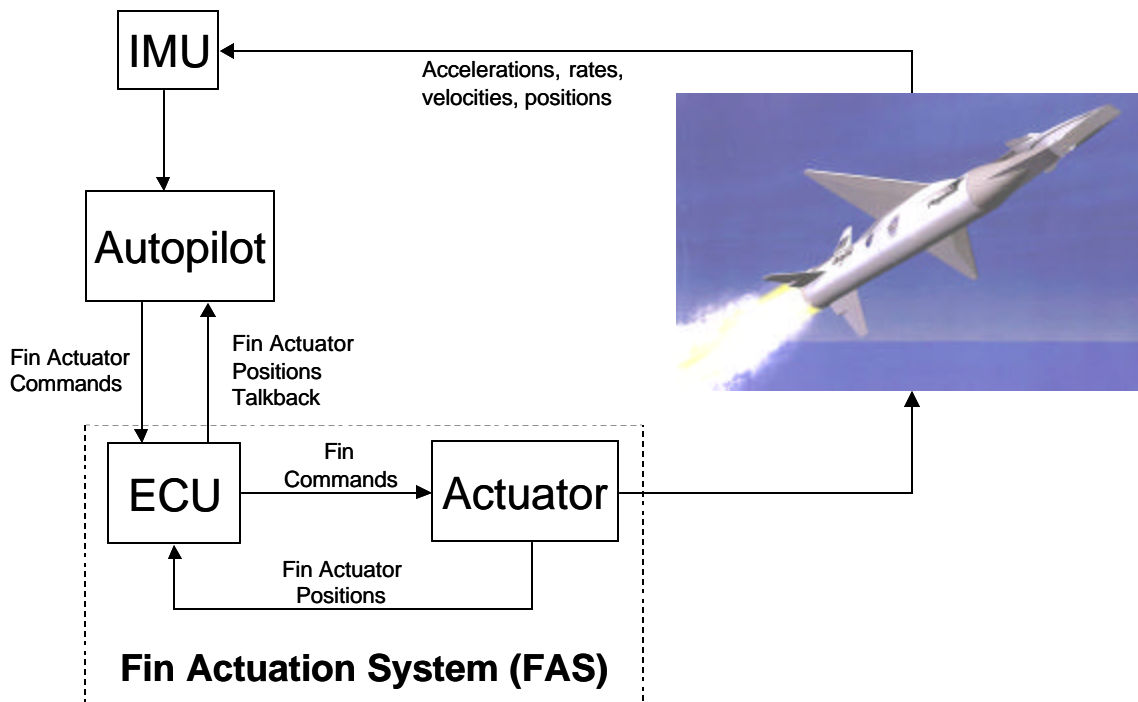
Figure 6-6. HXLV Control System Diagram

The HXLV control system was a closed-loop feedback system (Figure 6-6). The HXLV control system consisted of an inertial measurement unit (IMU) that sensed the X-43A stack accelerations and rates; an autopilot that translated the output from the IMU into steering commands; an electronic control unit (ECU) that translated the autopilot commands into fin (elevons and rudder) position commands; and an electromechanical actuator (EMA) that rotated the fins to the commanded positions. A sensor measured fin actuator position that the ECU used as feedback for servo control. The ECU also filtered the sensed actuator position and transmitted it to the autopilot (talkback). The ECU and the EMA comprised the Fin Actuation System (FAS).

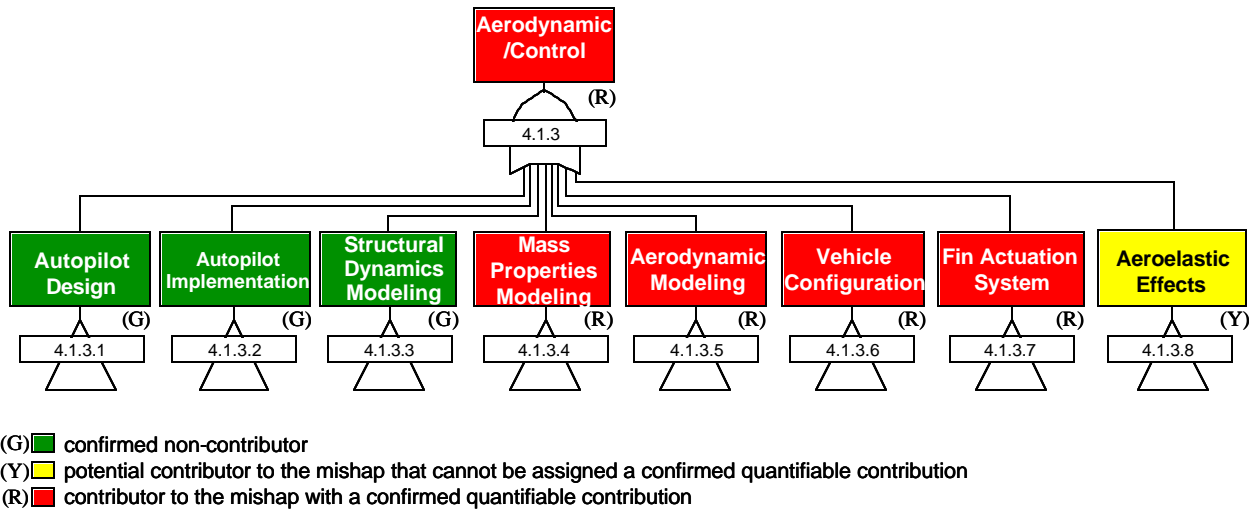
Figure 8-3. Critical Fault Tree Branch

The critical branch of the fault tree is shown in Figure 8-3.
