Condition Assessment and Rehabilitation Plan Hangar One

for NASA Headquarters and
Ames Research Center, California

Volume 1
Condition Assessment

1.0 Executive Summary – Condition Assessment and Rehabilitation Plan

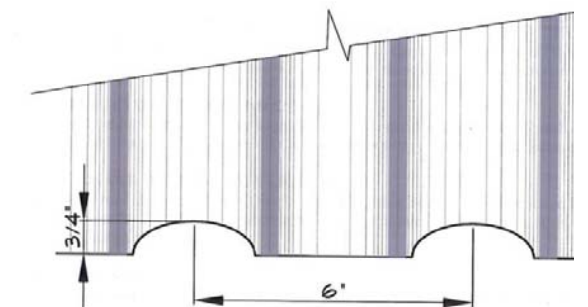
Figure 2.4

The upper portion of metal wall panel (or the area historically referred to as the Mansard Siding) has a different profile than the V-Beam shape with convex ribs. These Mansard Siding panels are currently covered with a black, fluid-applied bituminous coating but were originally a silver colored panel to match the V-Beam panels below. The black coating was added to help create a higher surface temperature which in

turn works to reduce the potential for condensation to develop on the interior of the hangar roof surfaces.

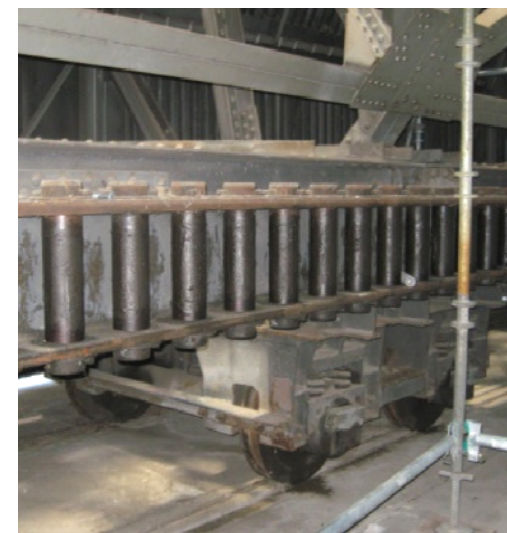
Figure 2.13

Each hangar door leaf sits on nine trucks (see figure 2.13) that consist of support for the door leaf and a series of wheels that roll on tracks that are mounted within the concrete hangar floor slab. These tracks extend beyond the building enclosure and allow the hangar door leaves to roll into their fully open position. At the end of each set of tracks is a door stop that would protect the hangar from the doors opening too far. The wheel and trucks appear to be in relatively decent shape based on visual inspection but because they have not been operational for many years they would require maintenance and cleaning in order to bring them to a fully functional state of operations. These motors may need electrical components replaced as well in order to meet current regulations.

As part of the Navy’s removal action they will be draining oil from the trucks and providing overall thorough cleaning of all mechanisms. Some items may not be able to be thoroughly cleaned due to inability to completely disassemble some pieces or difficult locations of equipment. A site

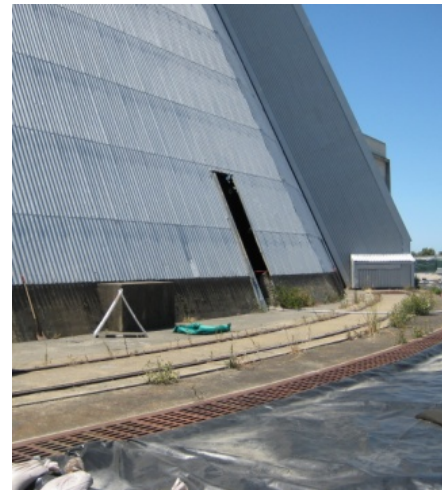
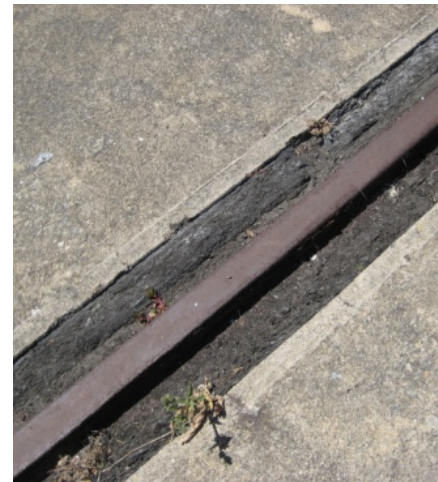
Figure 2.14

The hangar door tracks consist of standard gauge railroad tracks that are attached directly to the concrete below with steel brackets. Composite material filler members have been installed around the tracks (see figures 2.14 and 2.15) as a safety precaution to fill the leftover large gaps and to allow for carts or other objects to be rolled over the tracks. It has recently been identified that these composite

filler members contain asbestos and will be removed as part of the ongoing Navy removal action. The steel rails will be left in place. Although not considered historic these filler members may need to be replaced for future use as a safety precaution.

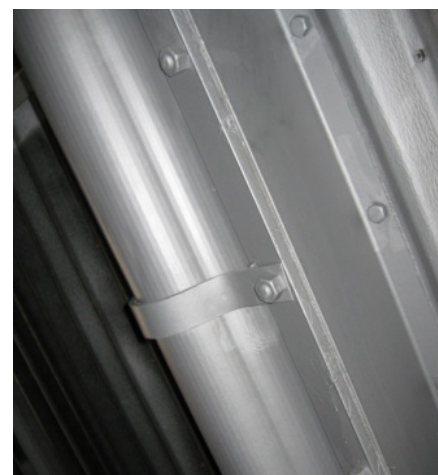
Figure 2.17

At the center of each hangar door where the two door leafs come together there are a pair of rubber seals that are covered on the exterior with a set of flat steel cover plates and on the interior with a half-round copper/steel backing plate (see figure 2.17).

tops of the hangar doors there are large pivot components within the door enclosure that can be accessed by the previously mentioned north and south roof dog houses. Both of these pins, or pivot points, is leaking oil and will require repairs to make them operational. As part of the Navy’s action removal these mechanisms will be drained and thoroughly cleaned.

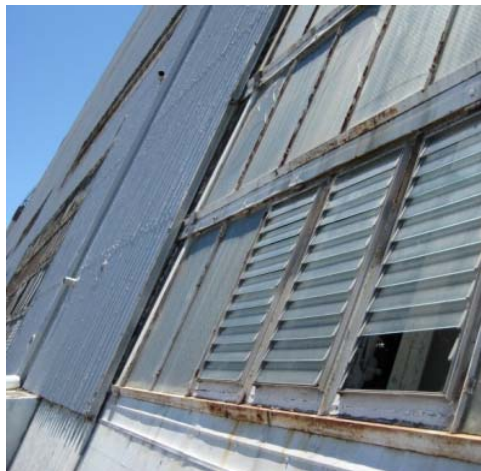
Figure 2.18

The existing windows are mostly intact but are in fairly poor condition. Many of the lowest sets of windows are damaged and have been broken over time. The corrugated glass is also cracked and broken in many places. It was the original intent to salvage and re-install the windows as part of the rehabilitation of the hangar. However, the full extent of window damage is too great to support salvage and repair of the existing window systems (frames and glazing). Therefore, the Rehabilitation Plan calls for all windows and frames to be replaced as part of the rehabilitation process.

The flat glass profile occurs at the lower two sets of horizontally oriented windows on the east and west facades of the hangar and on the lower set of windows at the hangar doors. Some of the windows in the lowest set on the east and west facades are louvered and or hinged for operability (see figures 2.18 and 2.19).

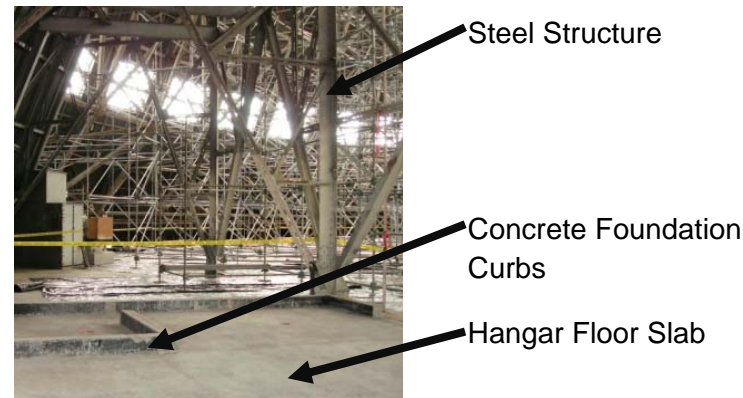
Figure 2.32

Based on interior construction and structures that were added for the various occupants of the hangar there are concrete foundation curbs at various locations in the hangar (see figure 2.32). The removal of these curbs is not presently part of the Navy removal action but the curbs would have to be removed as part of any future improvements. Refer also to the structural condition assessment for additional concrete slab information. Two locations of concrete slab within the hangar have been noted during the Navy removal action where the concrete is deteriorating. One location existed prior to the removal action. A third area within the hangar was identified as a potential void space beneath the concrete slab that may have been created during a water main break. The water main break was repaired by NASA and occurred prior to the removal action.

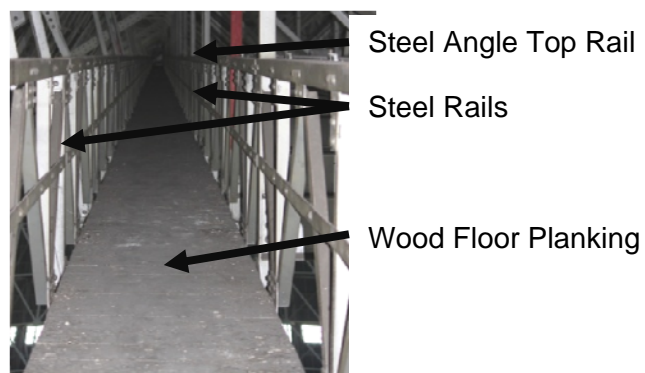
Figure 2.33

A series of stairs, ladders and catwalks provides access between the hangar ground floor and the upper portion of the hangar interior, including access to the outer portions of the roof. The current configuration of railings, specifically the height and/or shape of railings does not comply with OSHA requirements. The stair railings are

As part of the ongoing Navy removal action the wood floor planking of the catwalks is being removed as it has absorbed contaminants. The steel components will be left in place and future use will dictate the replacement requirements.

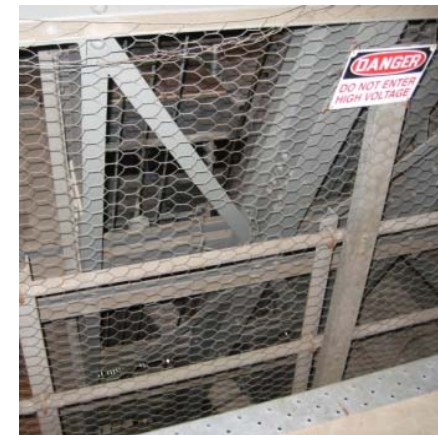
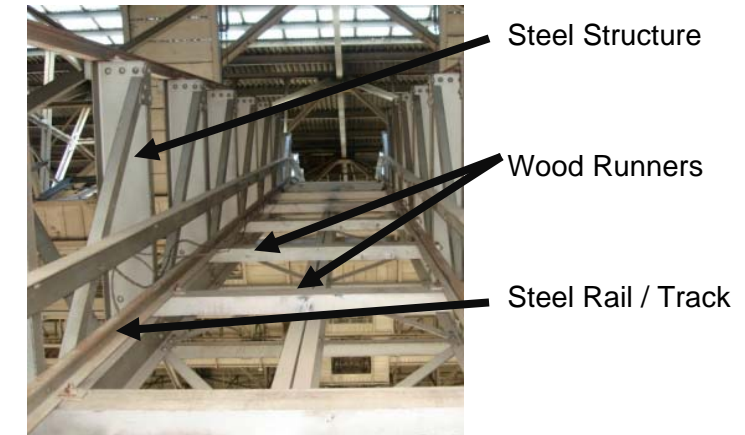
The steel elevator rails are welded to steel angles which are in turn welded to the steel hangar superstructure. There are wood runners spaced periodically (see figures 2.34 and 2.35) that have similar contaminants as the metal panels. These wood runners are being removed as a part of the ongoing Navy removal action. An engineering analysis by Will Design in April 2011 has verified that removal of these wood runners would not adversely impact the steel rail connection to the hangar structure from a vertical load standpoint.

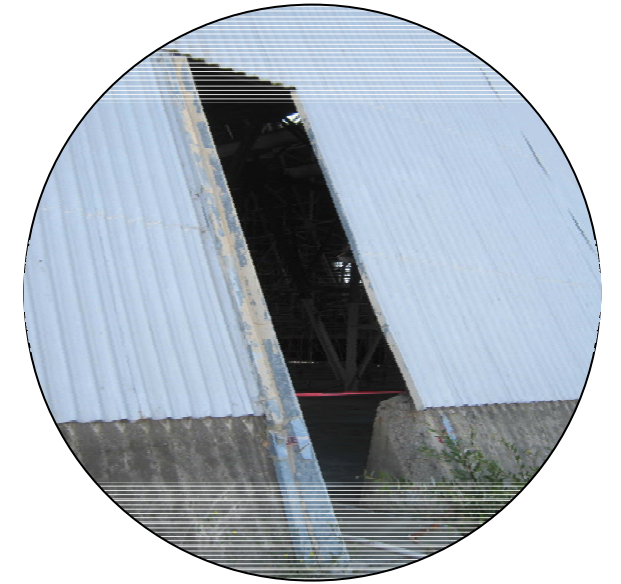
Figure 3-17: New Opening

The concrete perimeter walls also appear to be in good condition. No concrete decay was noted during the site visit. The new doors in the hangar wall were saw cut through the concrete. The saw cut portion may need to be replaced for historical reasons.

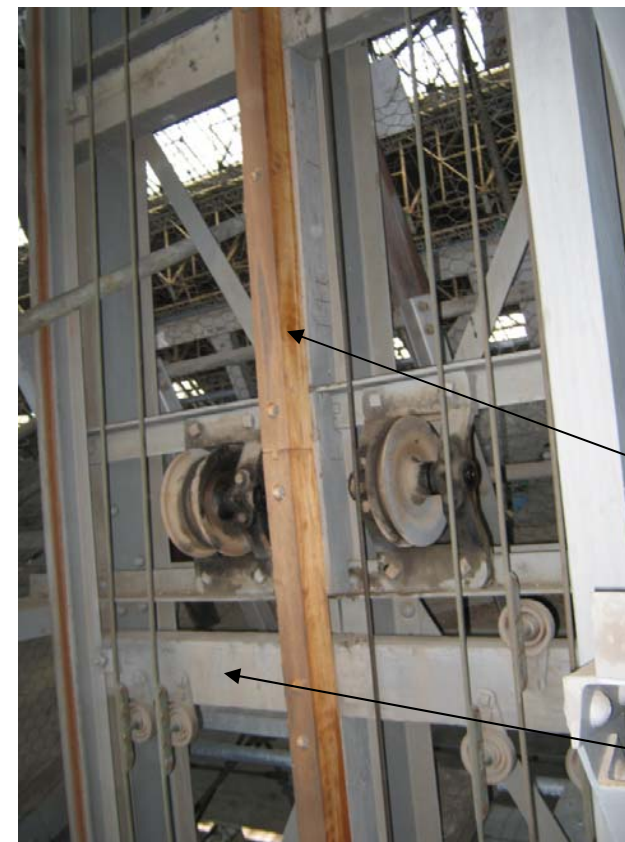
The elevator system uses redwood ties to support the rails and a redwood center rail that apparently guides the elevator cab. The wood members at the elevators would need to be replaced if the elevators are to be made functional again.

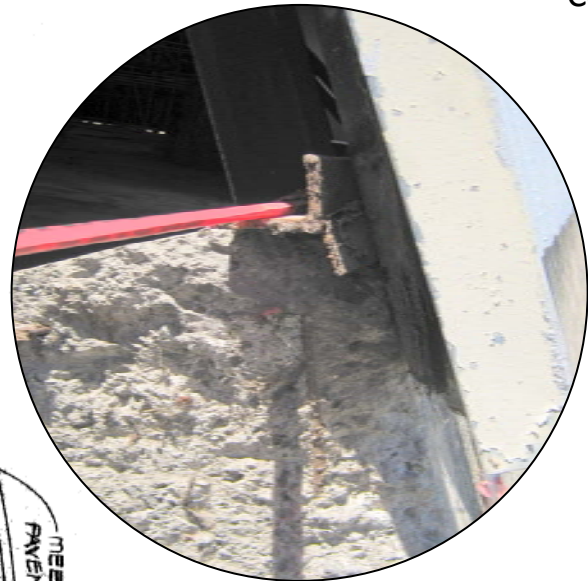
Figure 3-27: Saw Cut Concrete Wall at New Opening in Hangar

The one tall new opening in the east side of the hangar will need to be repaired. At this location, a wind girt was completely severed to accommodate the new opening. That wind girt will need to be replaced with a modern steel member similar to the original member. The location of the girt is shown in Figure 3-27. The figure shows the steel member at the top of concrete wall which was cut and will need to be replaced. The girt is directly above the opening shown in the figure.

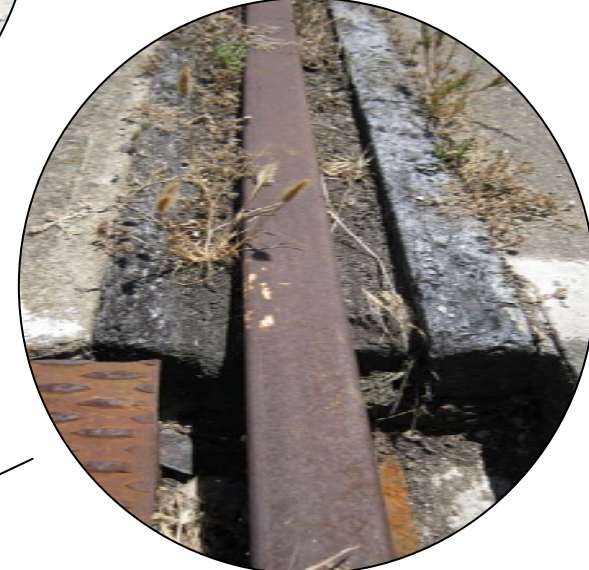
Figure 3-29: Railroad Tracks

There are railroad tracks down the center of the hangar as well as along the sides of the hangar and around the ends of the hangar doors. The railroad tracks at the hangar doors are surrounded by a contaminated material which will be removed as part of the Navy’s removal action. The railroad tracks at the center of the hangar are surrounded by an asphalt material which will be left in place.

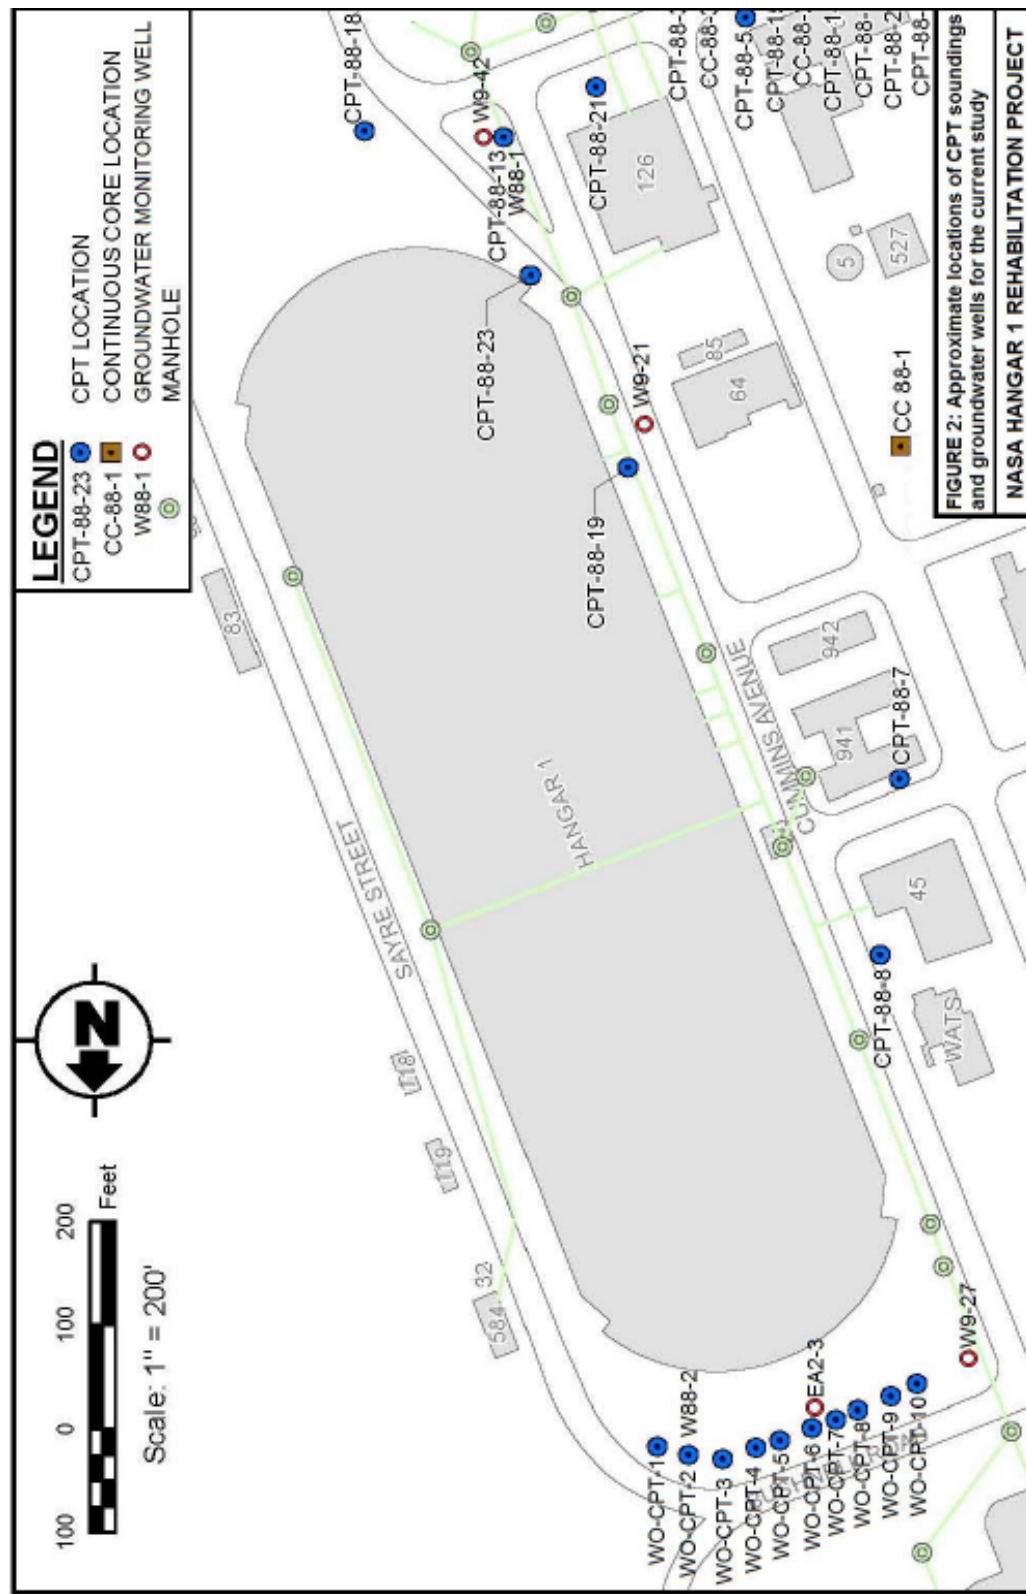
FIGURE 2: APPROXIMATE LOCATIONS OF CPT SOUNDINGS AND GROUNDWATER WELLS FOR THE CURRENT STUDY

Based on the limited field data, groundwater was encountered within 20 feet bgs during the field investigations. However, as mentioned previously, published shallow groundwater maps indicate a shallow groundwater depth of less than 5 feet bgs in the project area (CGS, 2006). Groundwater variation can be expected due to seasonal variation, influenced from the tidal fluctuations in the Bay and human activities.

No subsurface information was made available to us at the time of this study for areas inside and along the eastern side of the building. We assume that similar subsurface conditions are present throughout the building site. Because the soil and groundwater conditions were interpreted using limited data and only to the maximum depth explored, subsurface conditions between borings/soundings may differ significantly from those shown on the logs.

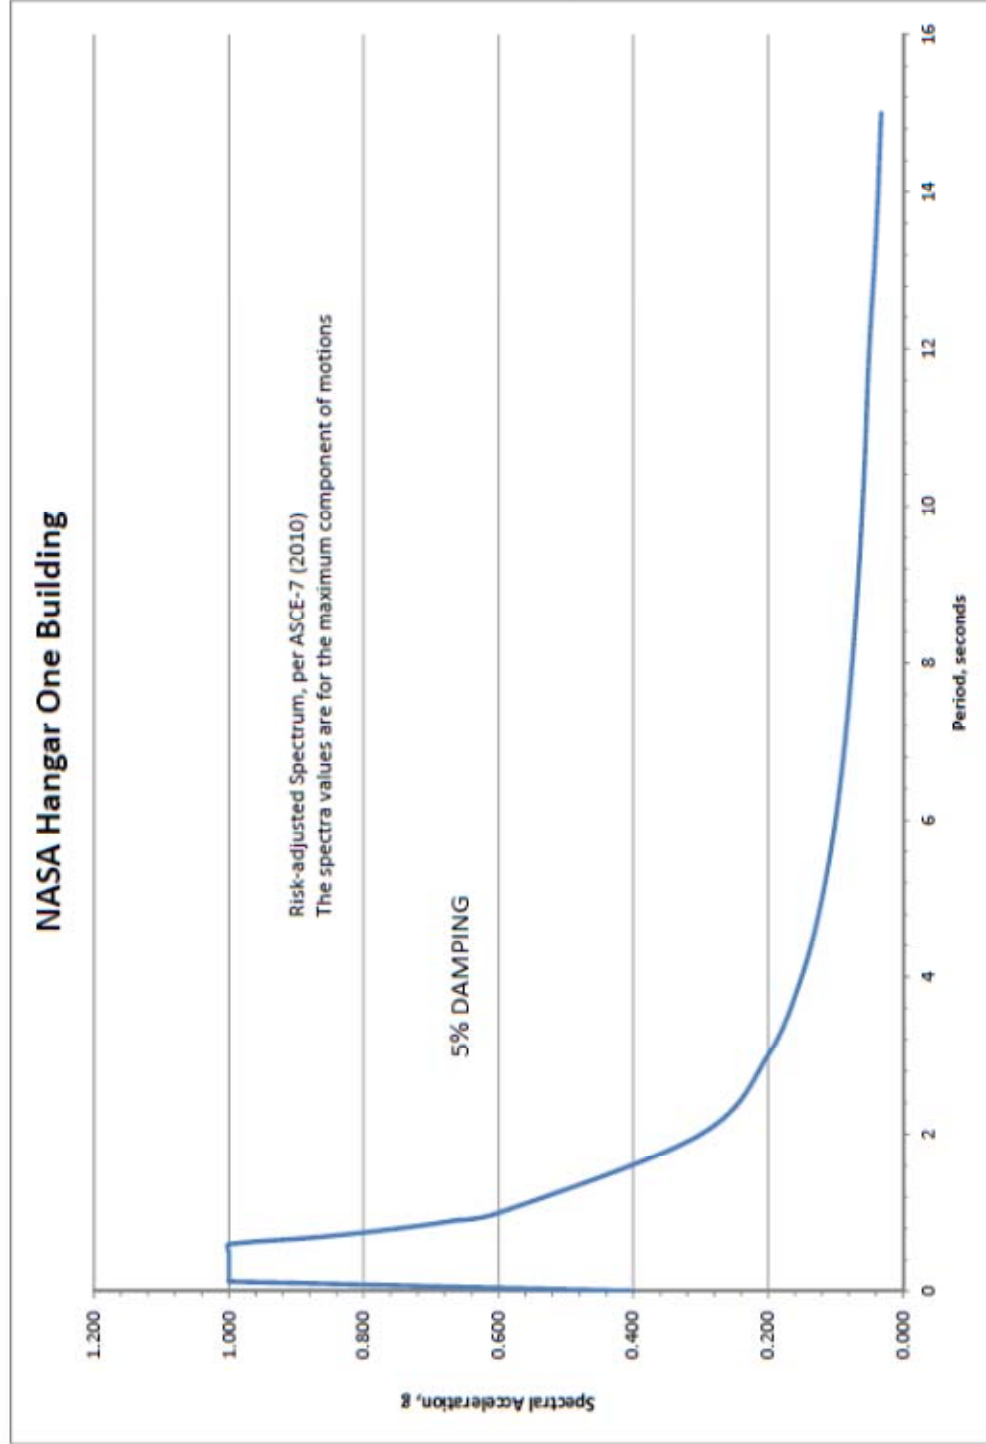
FIGURE 5-3
5%-damped Acceleration Response Spectrum (ASCE-7, 2010)

CH2M HILL reviewed these new standards, and estimated the design seismic parameters using their seismic requirements. Figures 5-3 and 5-4 show the 5%-damped ARS curves developed in accordance with the 2010 ASCE-7 and 2008 USGS seismic data. For the 2008 USGS data, ground motions associated with the following return periods were developed: 72 years, 224 years, 475 years and 2,475 years (corresponding to 50%, 20%, 10% and 2% probabilities of being exceeded in 50 years, respectively). Because the building is located at about 14.5 km from the San Andreas Fault, the near-fault effects on long-period motions (periods greater than 0.5 seconds) were included in the figures for considerations.

Note that the ARS curves and PGA values developed above are for a Seismic Site Class D (a stiff soil site), with an average shear-wave velocity in the upper 100 feet of the site soils of 275 m/sec (or 900 feet/sec). As discussed in Section 5D below, the cohesionless soil underlying the hangar site is susceptible to liquefaction under the design earthquakes. Per the building codes, a site with liquefiable soil should be classified as Seismic Site Class F for ground motion characterization. Furthermore, the codes

require that a site-specific response analysis be performed for Site Class F to evaluate the effects of liquefied soil on earthquake ground motion. However, if the liquefiable soil is mitigated, as recommended in Section 5D.4 below, the site can be classified as Seismic Site Class D; a Site Class for which the seismic design parameters presented herein have been developed for. Failure to mitigate soil liquefaction will result in different seismic design parameters than those presented in this section.

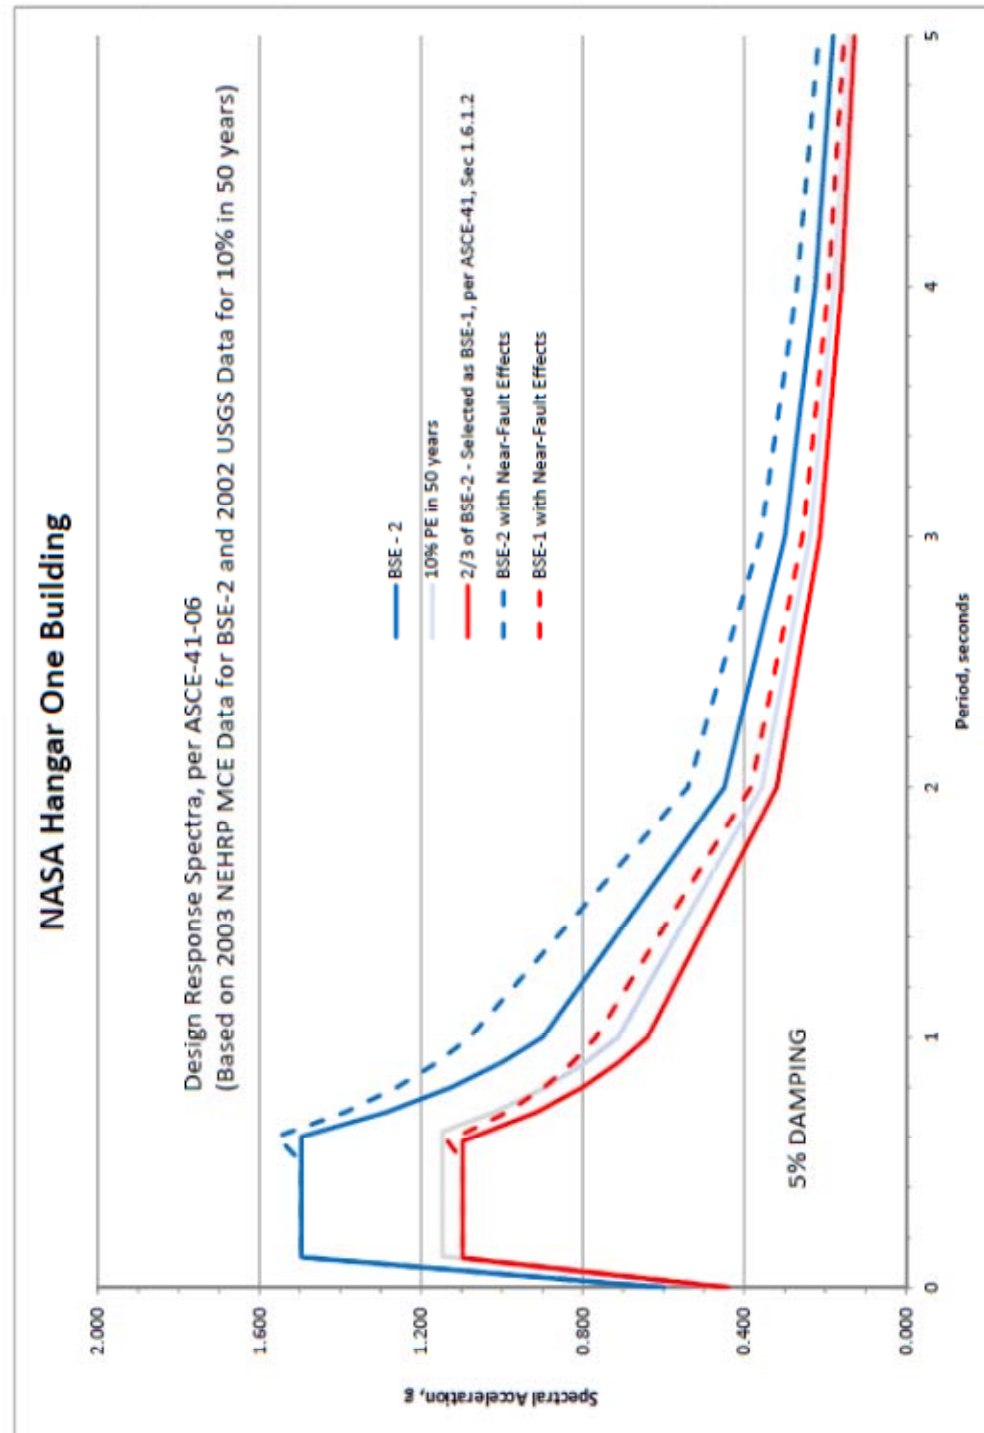
Figure 5-5
5%-damped Acceleration Response Spectrum (ASCE-41-06)

We understand that the current study also considers the ASCE-41 (2006) as the basis for the structural analysis. This standard considers two level design earthquakes (BSE-1 and BSE-2 earthquakes) for structural performance evaluation during earthquakes. Figure 5-5 presents the calculated 5%-damped BSE-1 and BSE-2ARS curves developed using the guidelines of ASCE-41 (2006).

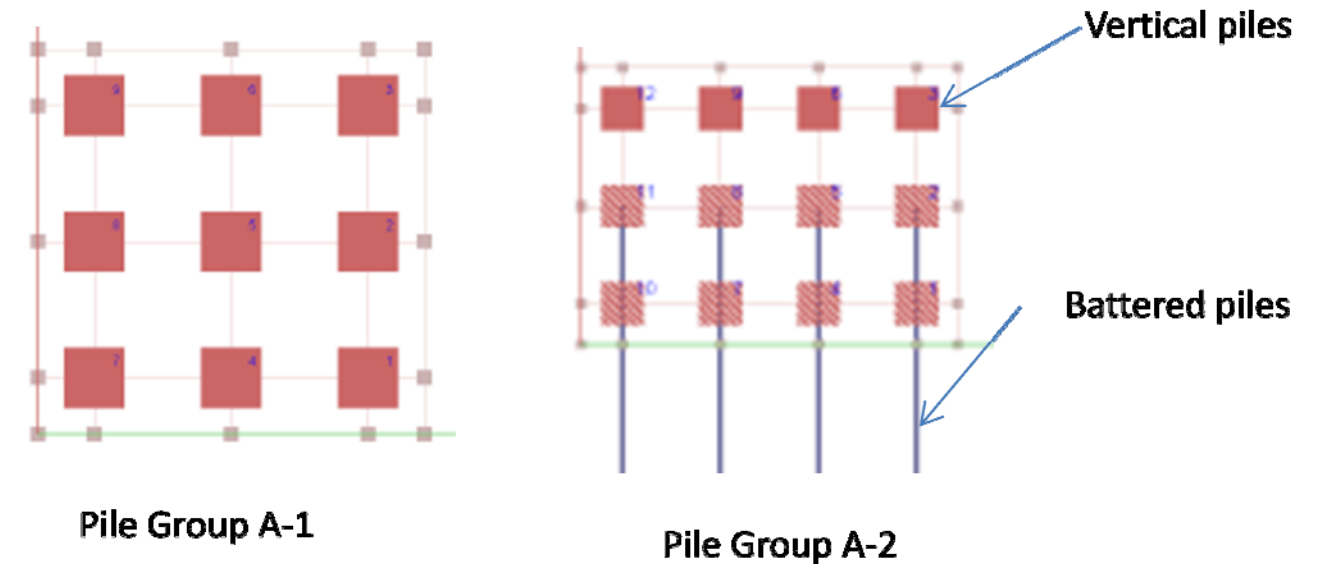
FIGURE 5-6 SCHEMATIC DRAWINGS OF PILE GROUPS A-1 AND A-2

For this study, we developed the relations for the two pile groups that support Arch #6: Pile Groups A-1 and A-2. Pile Group A-1 is an 8.5-feet by 8.5-feet, 4-foot thick, square pile cap supported by 9 vertical piles. Pile Group A-2 consists of an 8.5-feet by 11.5-ft, 4 feet thick, rectangular pile cap supported by 4 vertical piles and 8 battered piles. Figure 5-6 shows the schematic drawings of these two pile groups.

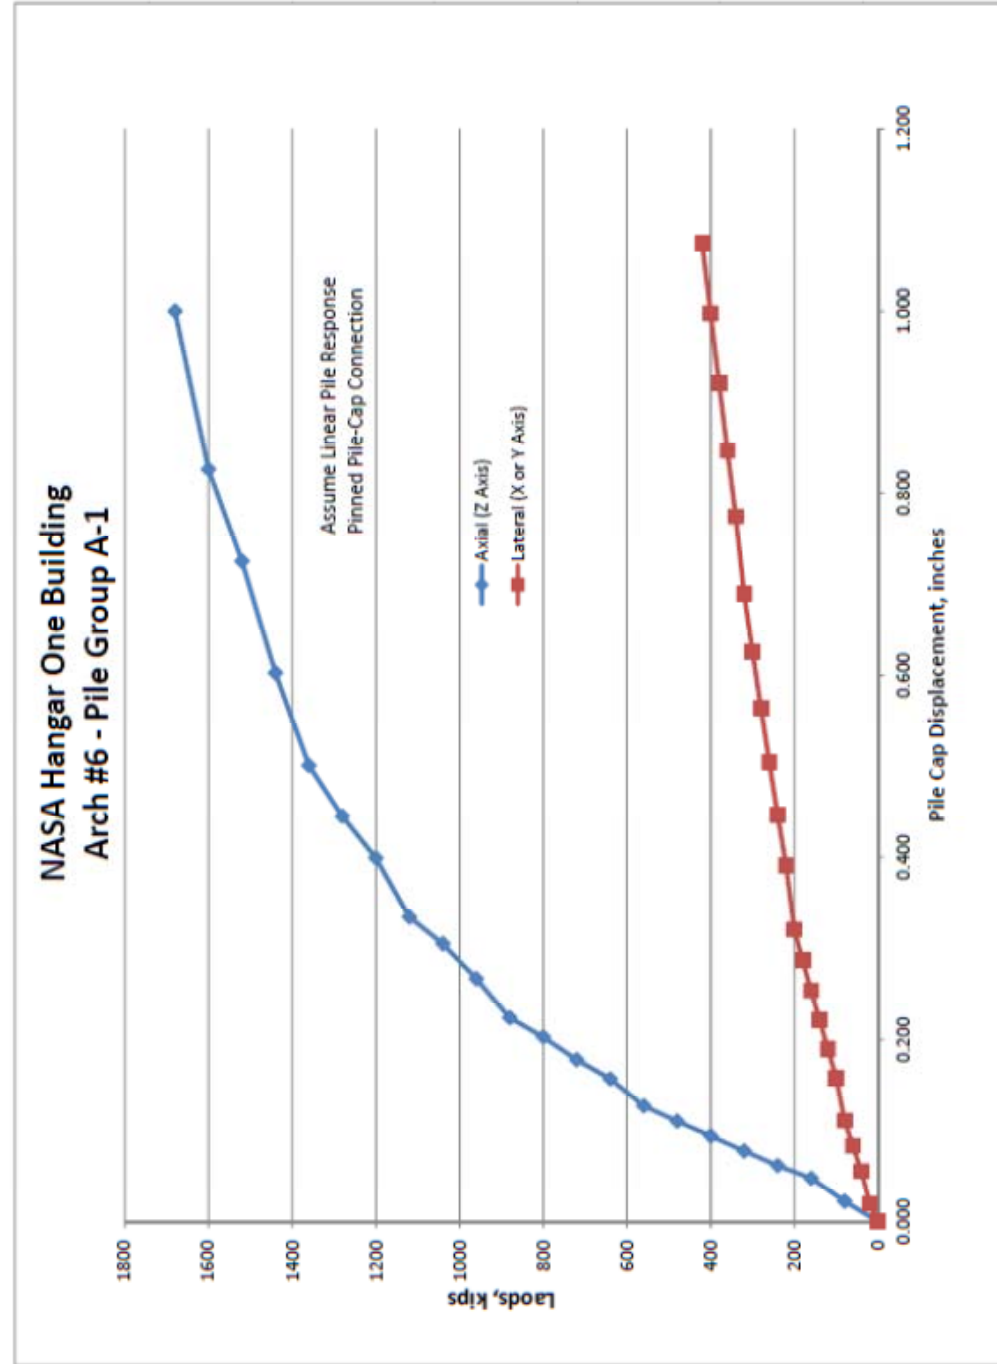
FIGURE 5-7
Load-Displacement Relationship for Pile Group A-1 (Axial and Lateral Axis)
(x-axis: building's transverse direction, y-axis: building's longitudinal direction)

We used the computer programs FB-Multiplier (version 4, Florida Bridge Software Institute, 2000) to calculate the load-displacement relationships of a pile group. In the analysis, the pile and pile cap elastic cross sectional properties were used, the loads were applied individually (separately) in each direction, and a pile-to-pile cap pinned connection was assumed. Figures 5-7 through 5-10 depict the calculated load-displacement relationships of these two pile groups.

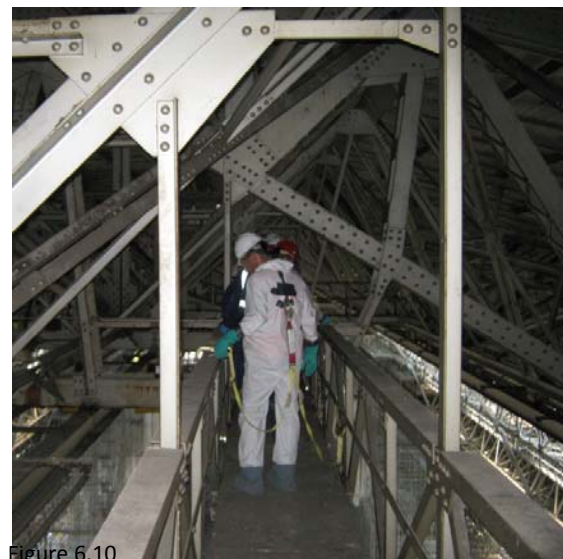
Figure 6.10

The catwalk guardrails, as originally designed, were installed at a height of 38" above the deck elevation. Current code requires a guardrail height of 42". This four inch height increase must be achieved either by retrofitting a new (visually different) guardrail extension to the top angle, or by lowering the deck

elevation. As noted above, by utilizing a low profile, lay-in grating system to re-floor the catwalk, a guardrail height increase of approximately 4" may be achieved. The configuration of the existing supporting angle may also serve as the code required toe plate. If additional height is required at the toe plate, a visually distinct steel plate extension can be attached to the edges of the lay-in grating sections.

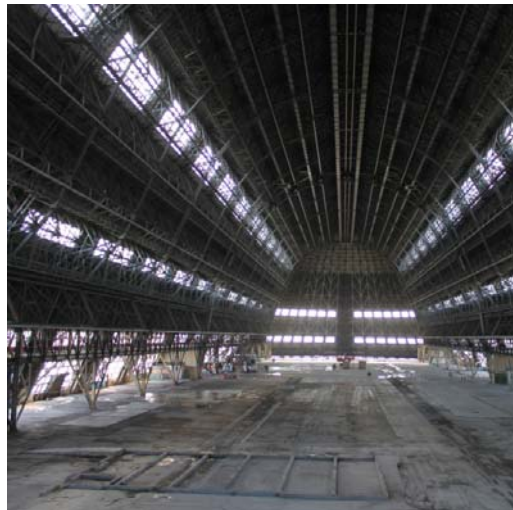
Figure 6.11

The existing hangar floor slab is less than ideally smooth. It is rough, and uneven in various locations that will make it an area of future modifications, depending on future tenants requirements. The floor slab also contains multiple locations of existing concrete curbs that served as foundations for previous interior construction that has since been removed from the facility as part of the Navy demolition contract. These curbs will require future removal to facilitate re-use of the interior of the hangar. There also are small areas of topping slabs that previously provided smooth floor slabs within various interior spaces. These topping slabs will likely need to be removed to meet future tenant needs. Additionally, the existing 8" deep hangar slab was originally designed for use with a 'lighter than air' aircraft. Because of this, the floor slab load capacity might not be suitable for heavy loading and traffic.

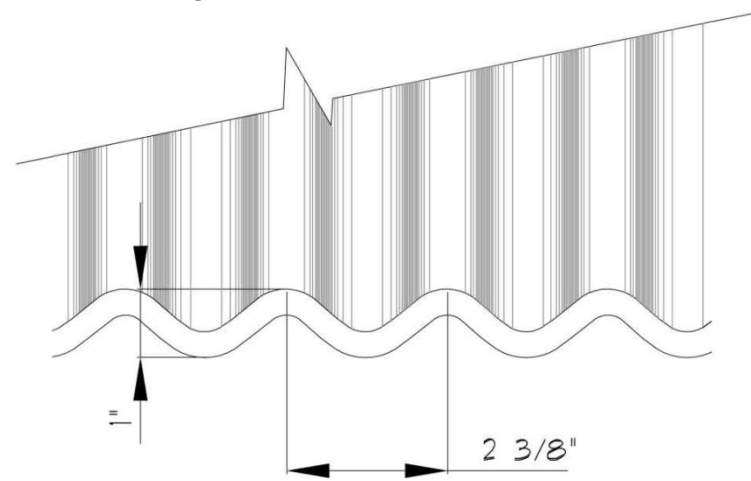
Figure 6.15

The existing windows, in particular the corrugated glass, are an important historic preservation feature of the existing hangar. Ideally the existing windows and frames would be salvaged and re-used. However, due to the poor existing state of the glazing and steel frames they are being removed as part of the Navy's removal action. Left in place are the steel support members that connect between the steel structure and the window frames. As part of the re-skinning project of the hangar new steel window frames and glazing will need to be provided to the requirements noted herein.

Existing 1/2" thick Historic Corrugated Window

The most simple, preferable and recommended replacement for the windows is to replace the frames and glazing, in-kind, to match the detailing and attachment of the original construction. Readily available wired, corrugated glass to match the existing construction is difficult to find in the United States and difficult to find

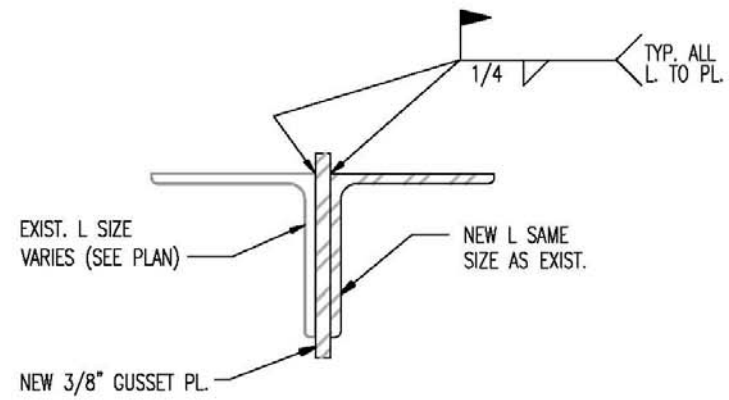
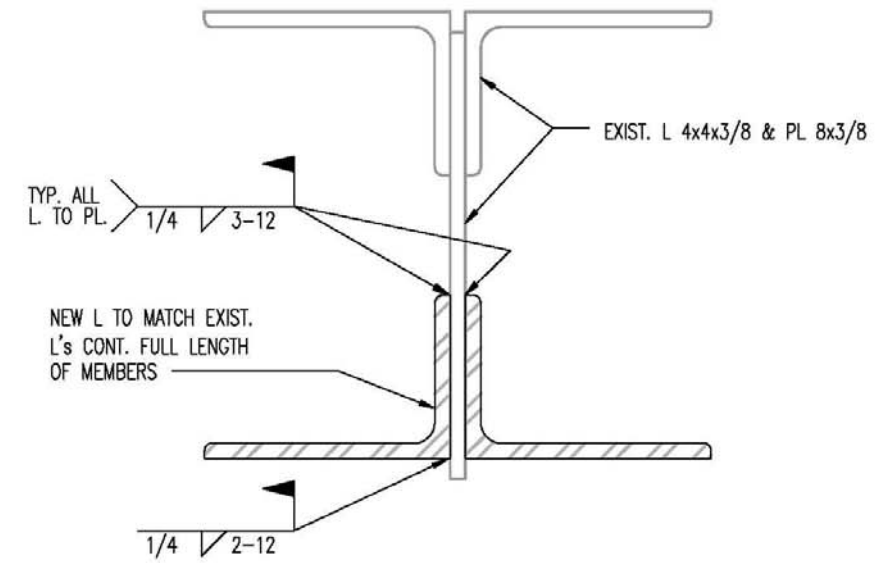
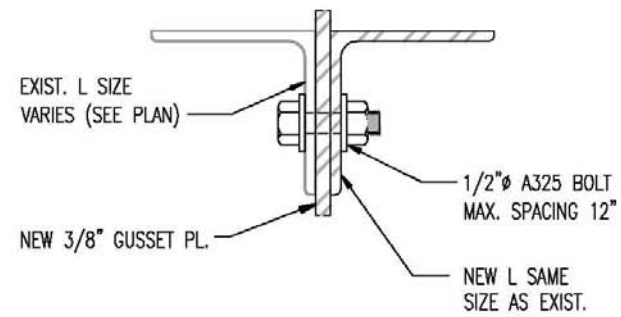
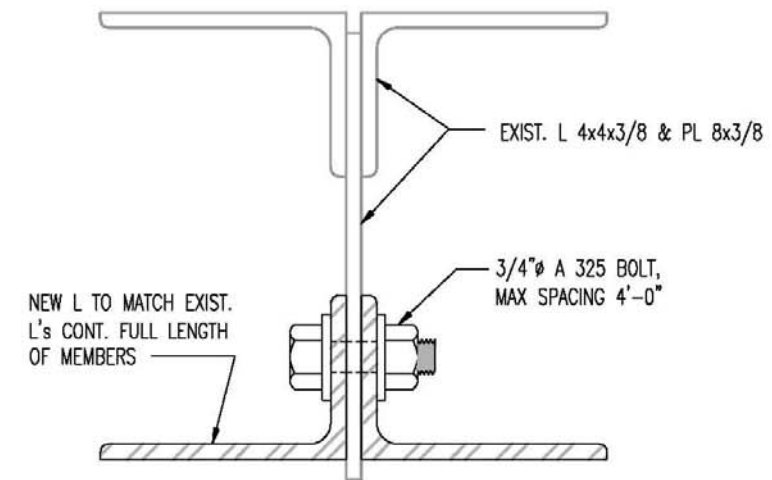
Figure 7-1 Retrofit Details

- In Type I retrofit (required mostly in bracing members), single angle members are proposed to be retrofitted by providing another angle of the same size angle and a gusset plate between the two angles as shown in Figure 7-1.
- Type II (Not Used)
- In Type III retrofits (required mostly in A frame members), two single angles in + configuration with a gusset plate between them are proposed to be supplemented with two more smaller single angles as shown in Figure 7-2.
- Type IV retrofit involves a double channel built-up section with an “I” beam in the middle. This section is mostly found in arch members. The section is proposed to be retrofitted by providing channel sections on each side of the “I” beam web and bolting them together as shown in Figure 7-2.

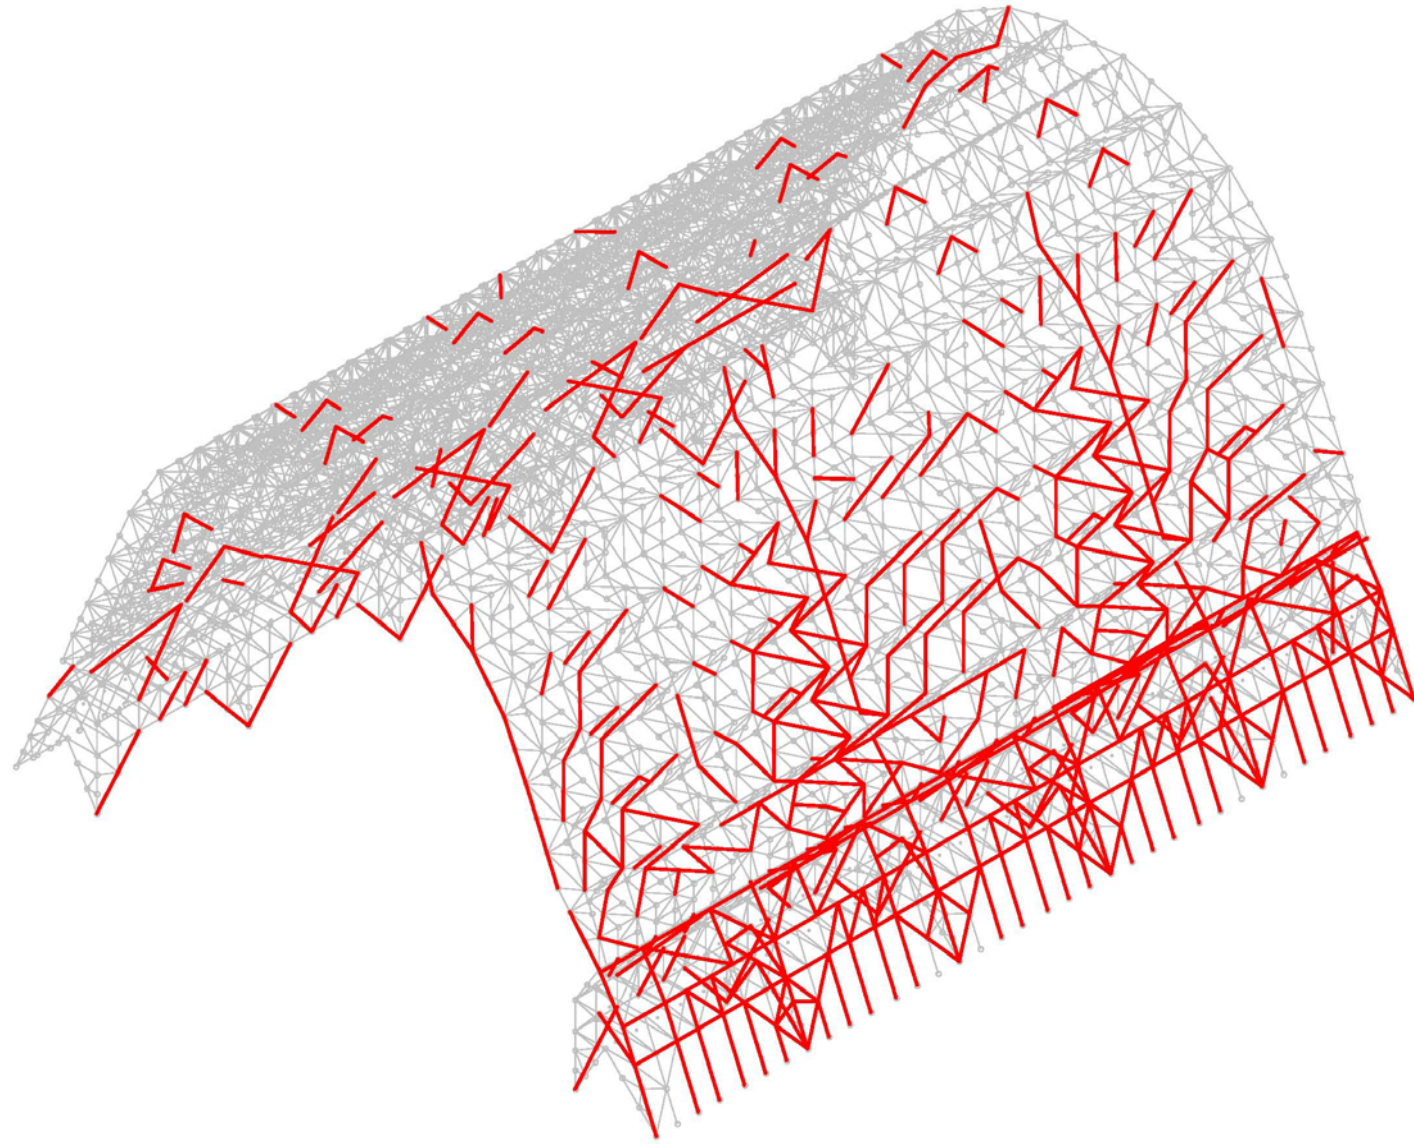
Figure 7-3

Overstressed members considering an assumed differential settlement. Note: The differential settlement is for comparison purposes only.

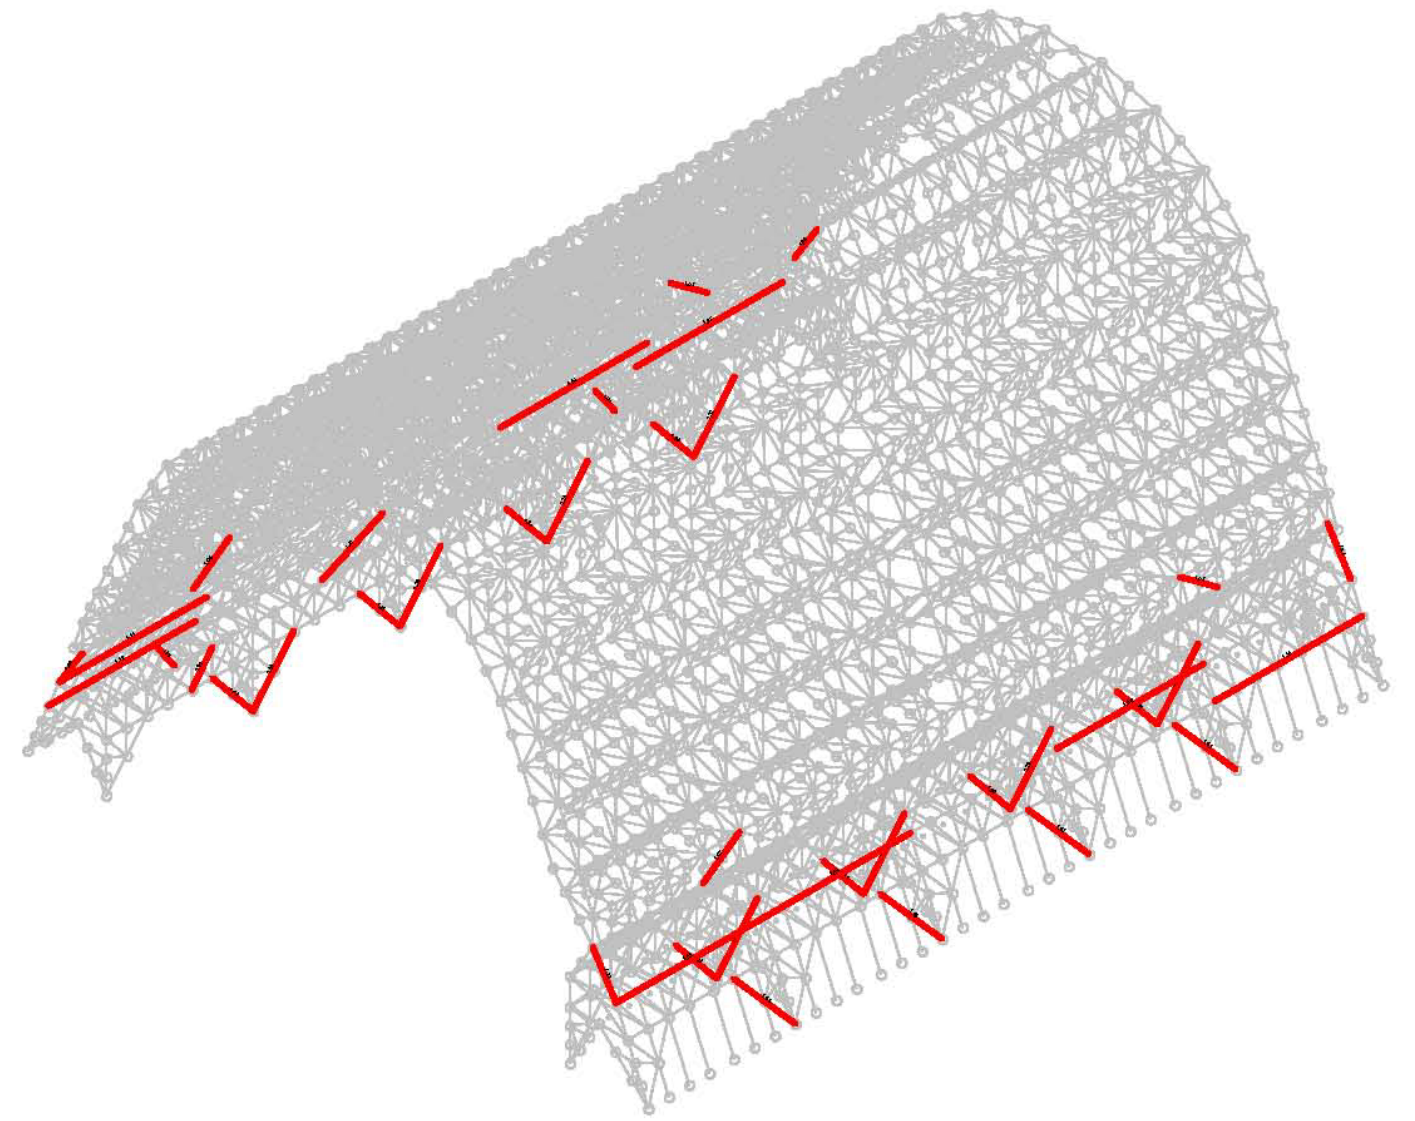
Overstressed members considering only lateral seismic forces without differential settlement.
