International Space Station (ISS) EVA Suit Water Intrusion

High Visibility Close Call

IRIS Case Number: S-2013-199-00005

Date of Mishap: July 16, 2013

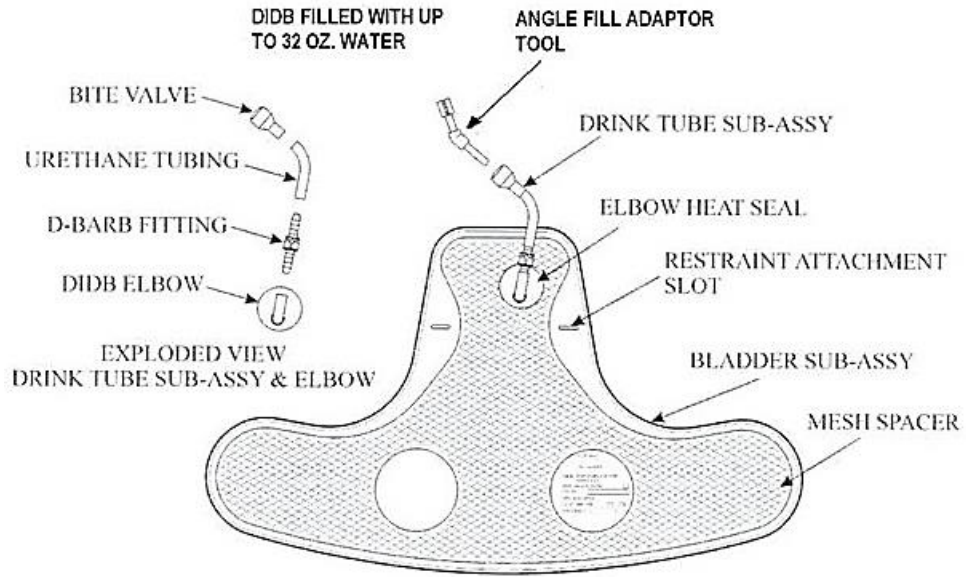
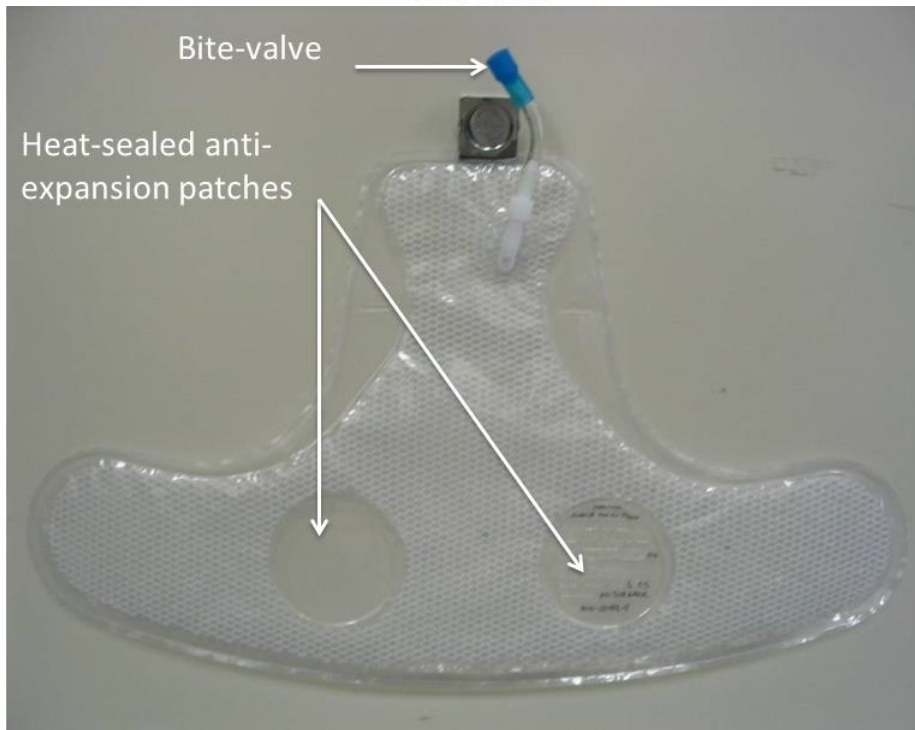
Figure 3-16. Disposable In-suit Drink Bag (DIDB)

The ISS Investigation Team determined that there are several potential sources which could result in water entering the ventilation circuit. The Disposable In-suit Drink Bag (DIDB) (Figure 3-16) is an obvious candidate, since it contains up to 32 ounces of water and is in the proximity of the helmet. Another potential source is the waste collection pull-up absorbent garment. A third possibility is leakage from the cooling water side to the ventilating gas stream side of the sublimator heat rejection component (Figure 3-9). A fourth potential leak source is the LCVG connector or the tubing itself (Figure 3-17). Leakage of the cooling water transfer lines through the HUT is a fifth potential source (Figure 3-6).

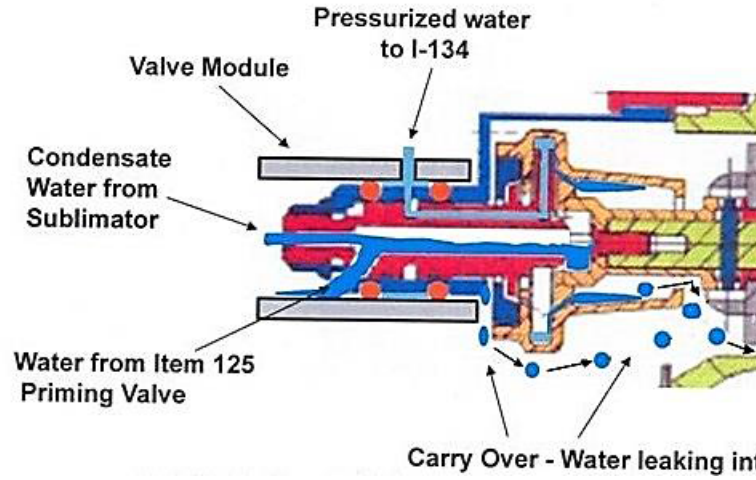
Figure 3-18. Water Separator Spinning Drum and Pitot Components

A seventh possible source is the water separator circuit, which consists of the spinning drum-and-pitot components (Figure 3-18– showing the path of water leaking into the ventilation loop via the fan inlet), the Item 134 check valve and filter (Figure 3-19), the Item 125 pump priming valve (Figure 3-20), the Item 141 gas trap (Figure 3-12) and the water flow passages linking the various elements of the circuit.

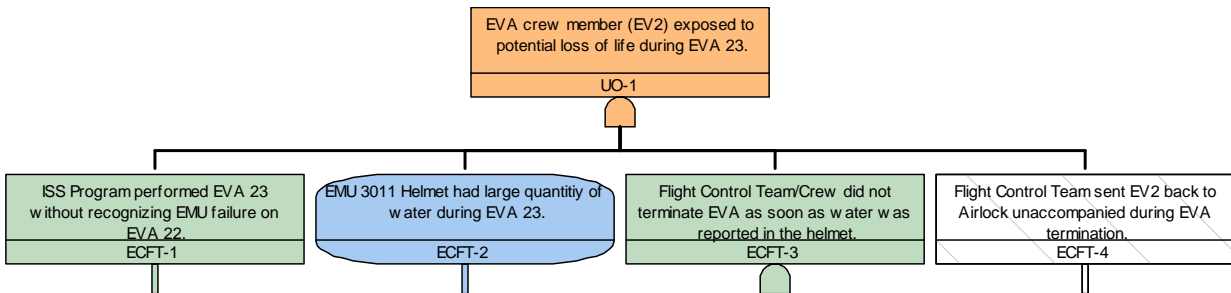
Figure 3-43. ECFT Proximate Causes

The MIB defined the three Proximate Causes and one contributing factor (Figure 3-43), which led to the PUO and are discussed in the following sections.

ECFT-1 – ISS Program performed EVA 23 without recognizing EMU failure on EVA 22. (Proximate Cause 1) (Figure 3-44)

ECFT-2 – EMU 3011 Helmet had large quantity of water during EVA 23. (Proximate Cause 2)(Figure 3-45)

ECFT-3 – Flight Control Team/Crew did not terminate EVA 23 as soon as water was reported in the helmet. (Proximate Cause 3)(Figure 3-46 through Figure 3-67)

ECFT-4 – Flight Control Team sent EV2 back to Airlock unaccompanied during EVA termination. (Contributing Factor 1)(Figure 3-68)

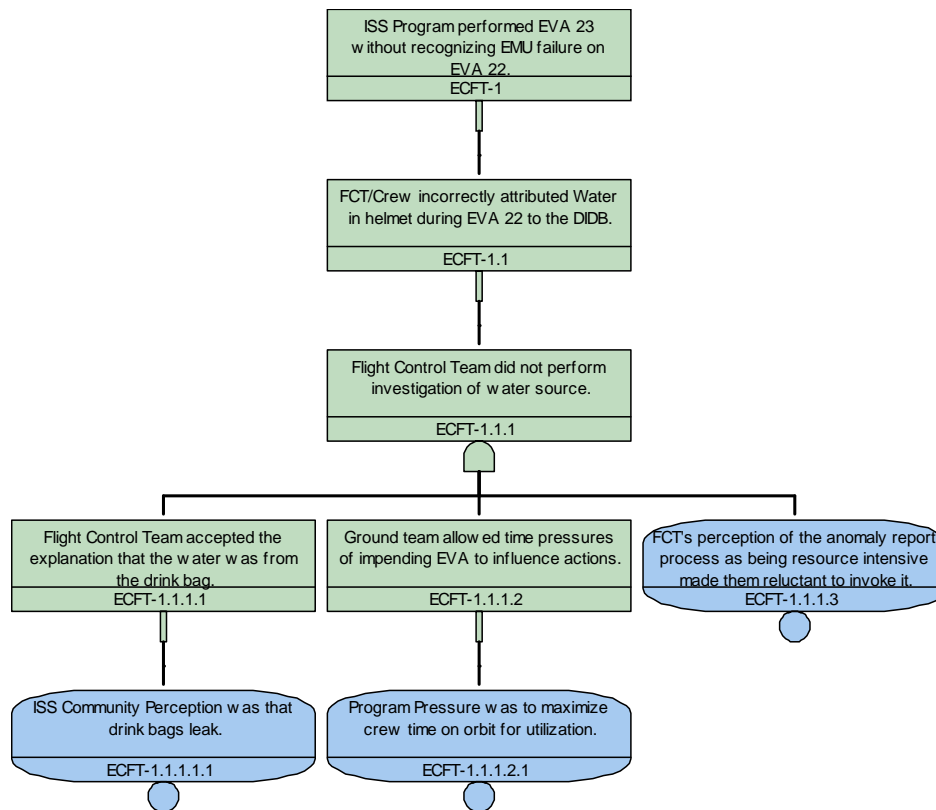
Figure 3-44 Intermediate and Root Causes under ECFT-1

ECFT-1.1 Flight Control Team and Crew incorrectly attributed the water in the helmet during EVA 22 to the drink bag. (Intermediate Cause 1)

Supporting Evidence: MIB determined from EVA debrief and crew member interviews that EV2 had indicated that he saw some water escape past his bite valve during EVA 22 repress. This might have happened because his chin was resting on the bite valve while he was in a tucked position. Audio logs and interview transcripts revealed that the ground team accepted the crew's determination of cause for the EVA 22 water leak. The team perceived that additional investigation of the water leak was not necessary, because the source had already been identified and agreed upon. They also considered that a lengthy investigation could impede preparations for EVA 23 for a reason likely would likely turn out to be inconsequential.

ECFT-1.1.1 Flight Control Team did not perform investigation of the water source following EVA 22. (Intermediate Cause 2)

Supporting Evidence: After the conclusion of EVA 22, the team perceived that the water in EV2's helmet probably came from EV2's drink bag and that the solution was to provide a new drink bag prior to the next EVA, per routine. The team also perceived that lengthy investigations were unnecessary and could impede preparations for EVA 23, which was scheduled for the following week. Audio logs and interview transcripts revealed that the team, as a whole, did not perform a thorough real-time risk assessment; instead, the crew's determination of cause for the EVA 22 water leak was accepted by the ground team (Engineering, Safety, Operations). The Human Factors Analysis (Appendix A) findings support the fact that the team was predisposed to determine the drink bag was the cause of the water and that further investigation would be time-consuming and unproductive. See Appendix A.1.1 PC 214 Response Set for more detail.

ECFT-1.1.1.1.1 ISS Community Perception was that drink bags leak. (Root Cause 2)

Supporting Evidence: After EVA 22 ended, the crew concluded that the water which collected in EV2's helmet had likely leaked from his drink bag inadvertently. Based on MIB interviews, it was determined that one reason that ground team members did not challenge the crew's conclusion was the perception that drink bags leak. Additionally, the way in which the drink bag was supposed to have leaked made sense, according to the ground team's understanding of its design. However, the MIB found no recorded evidence of a drink bag leak during an actual EVA other than small amounts of water (droplets) introduced into the helmet due to inadvertent actuation of the bite valve. The MIB has concluded that the

perception that drink bags leak, especially as a frequent occurrence, is false. The MIB further found that this “drink bag failure” conclusion was not questioned by any of the other ground teams, supporting the contention that a drink bag leak was considered a normal event that could be corrected by simply replacing the failed drink bag.

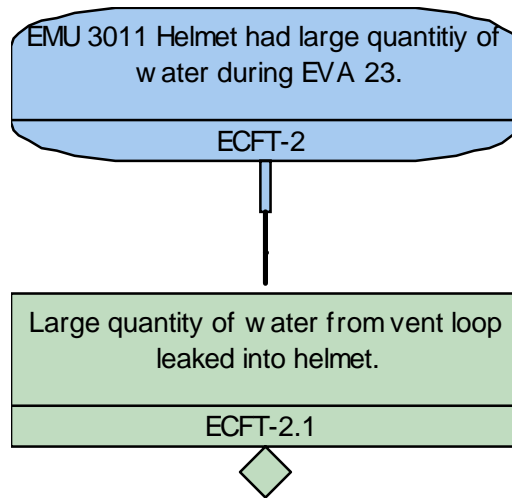
Figure 3-45 Intermediate Cause Directly Under ECFT-2

ECFT-2.1 Large quantity of water from vent loop leaked into helmet during EVA 23. (Intermediate Cause 5)

The MIB in conjunction with the ISS Investigation Team evaluated multiple sources of water in the suit. A significant effort was put into developing a detailed Fault Tree for the hardware failure (see Appendix G). This fault tree was developed and controlled by the ISS Investigation Team, but the MIB participated with the ISS Investigation Team and concurred with its accuracy and sufficiency. Investigations are continuing to resolve the cause(s) of the water in the vent loop. Additional root causes will be found.

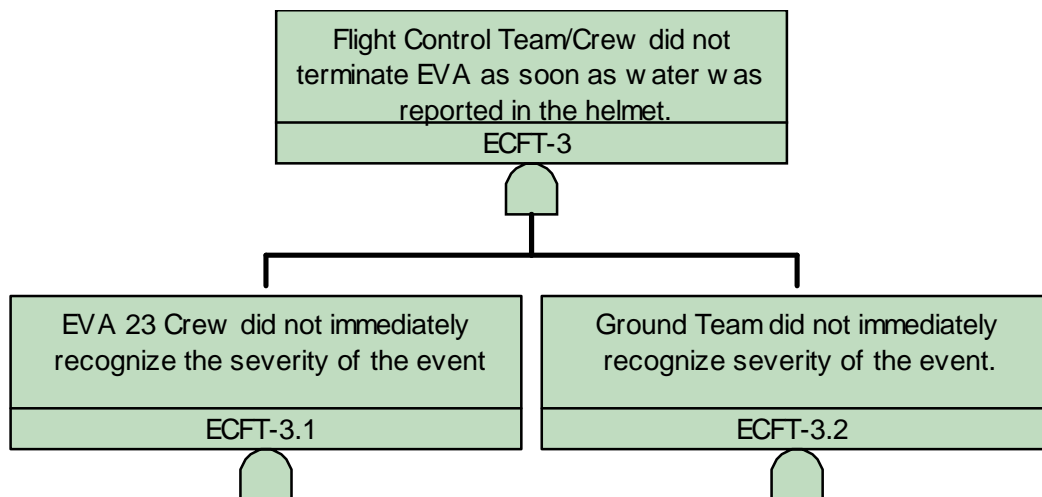
Figure 3-46 Intermediate Causes Directly Under ECFT-3

ECFT-3.1 – EVA 23 Crew did not immediately recognize the severity of the event. (Intermediate Cause 6)

Supporting Evidence: The MIB learned through discussions captured on audio loops between the ground control teams and the EVA crew members that neither of the EVA 23 crew initially recognized the severity of the water pooling at the back of EV2's head. EV2 did not indicate a sense of urgency with

respect to the water in his helmet. EV1 recognized the fact that water pooling in the helmet was not a nominal behavior of the EMU and participated in the questioning of EV2 about the source. The EVA 23 crew concurred with the ground team's initial recommendation to continue the EVA since they believed the source of the water was not increasing. Prior to getting a direct visual on EV2, EV1 only had the information coming to him via the loop communications and his own experience with the behavior of the EMU. By GMT 12:51 (10 minutes after first call of water), EV1 had a direct visual of EV2's face and saw water pooling on the side of EV2's head. At this time, EV2 also expressed concern about the quantity of water in his helmet and, within minutes, the decision was made to terminate the EVA. The terminate decision is a less rapid response than an "abort" call and EV1 concurred with the decision to terminate. EV1 was concerned about EV2's condition as he watched EV2 navigate towards the airlock and started suspecting that the condition of EV2 with respect to the water in his helmet was more severe than first believed.

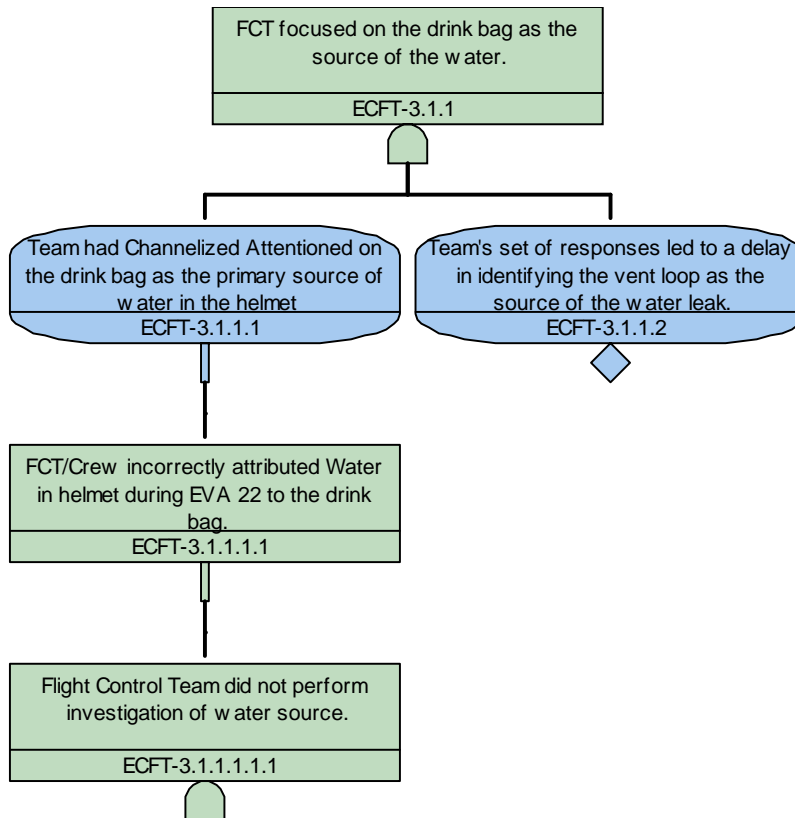
Figure 3-48 Causes Under ECFT 3.1.1

ECFT-3.1.1 – Flight Control Team focused on the drink bag as the source of the EVA 23 water. (Intermediate Cause 8)

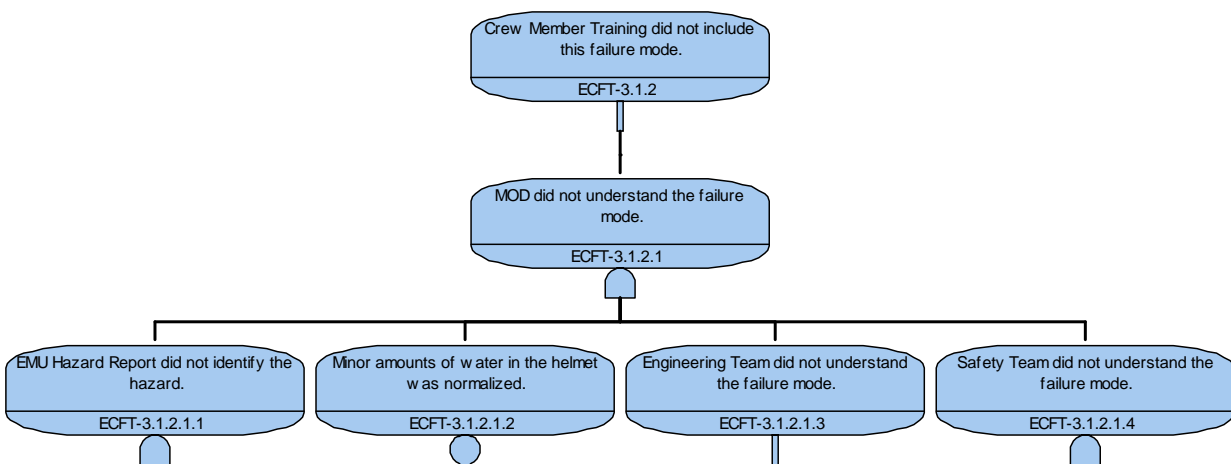
Figure 3-49 Intermediate Causes Under ECFT-3.1.2

ECFT-3.1.2 – Crew Member Training did not include this failure mode. (Intermediate Cause 7)

ECFT-3.1.2.1 – MOD did not understand the failure mode. (Intermediate Cause 11)

Supporting Evidence: MOD is responsible for writing procedures and conducting crewmember training. The MIB learned through interview and discussions with EVA crew members, crew trainers, and flight controllers that MOD relies on a variety of resources to learn about the functionality of the ISS subsystems including the EMU and Airlock. This knowledge and collaboration with the Engineering and Safety communities forms the basis for flight rules, procedures and training materials. Fundamentally, four factors led to MOD not understanding this failure mode to the extent necessary to identify its severity. These factors included the hazard reports did not address the hazard of water in the helmet to the extent experienced, water in the helmet had been normalized over time, and neither did the engineering nor safety communities understand the failure.

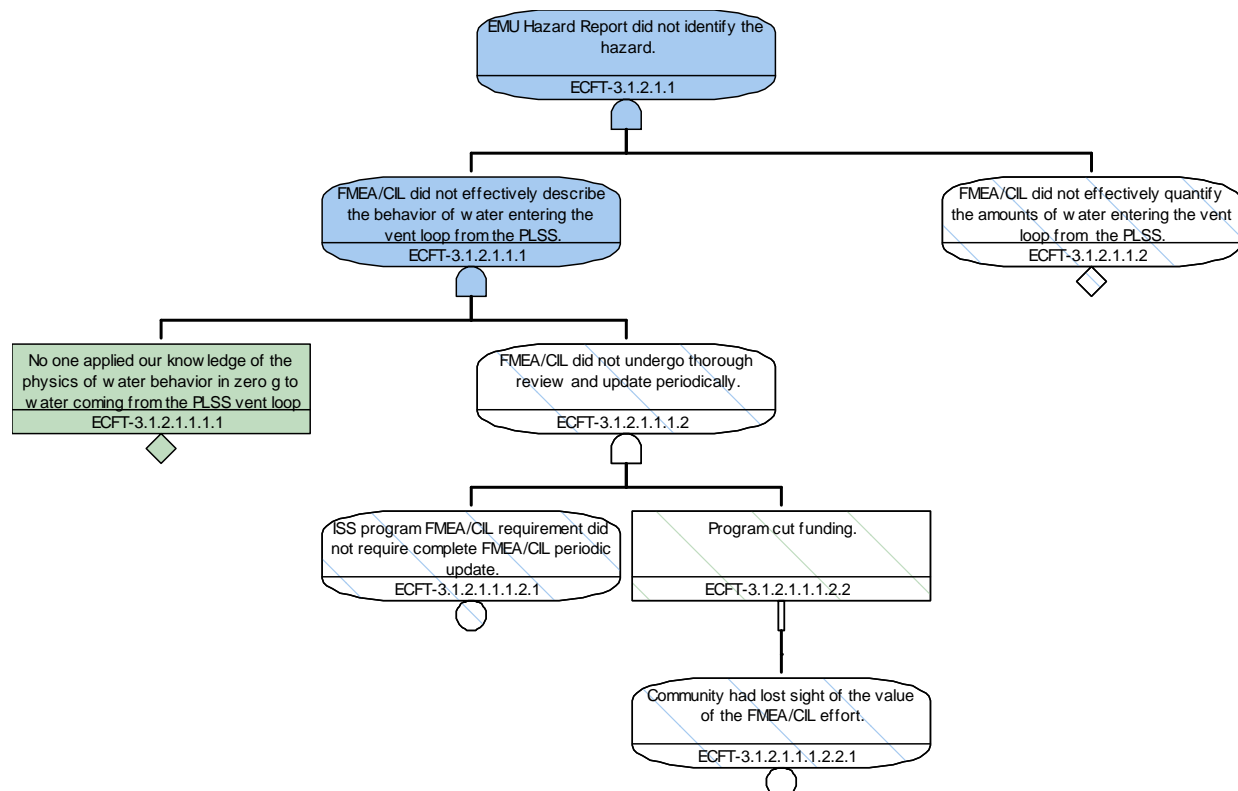
Figure 3-50 Causes and Contributing Factors under ECFT 3.1.2.1.1

ECFT-3.1.2.1.1 – EMU Hazard Report did not identify the hazard. (Intermediate Cause 16)

ECFT-3.1.2.1.1.2 – FMEA/CIL did not effectively quantify the amounts of water entering the vent loop from the PLSS. (Contributing Factor 7)

Supporting Evidence: As discussed in ECFT 3.1.2.1.1.1, PLSS water in the vent loop is discussed in the FMEA but does not directly address the quantity of water reaching the helmet.

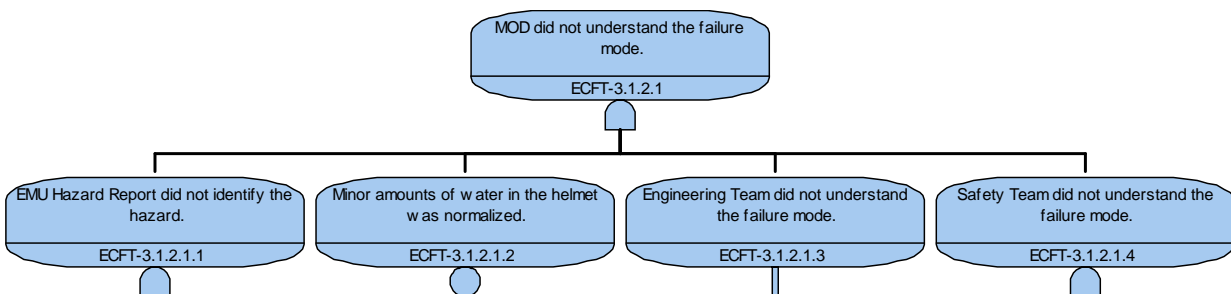
Figure 3-51. Causes and Contributing Factors under ECFT 3.1.2.1 for reference

ECFT-3.1.2.1.2 – Minor amounts of water in the helmet was normalized. (Root Cause 5)

Recommendation R-6: The ISS Program should ensure that all instances of free water and contamination in the EMU are documented and investigated, with corrective action taken, if appropriate.

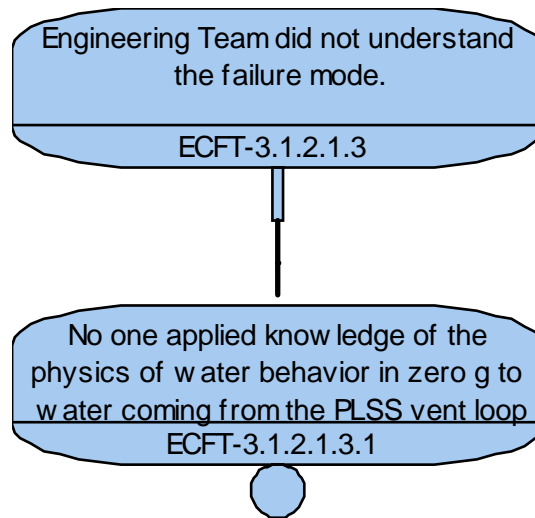
Figure 3-52 Cause under ECFT 3.1.2.1.3

ECFT-3.1.2.1.3 – Engineering Team did not understand the failure mode. (Intermediate Cause 17)

ECFT-3.1.2.1.3.1 – No one applied knowledge of the physics of water behavior in zero-g to water coming from the PLSS vent loop. (Root Cause 4)

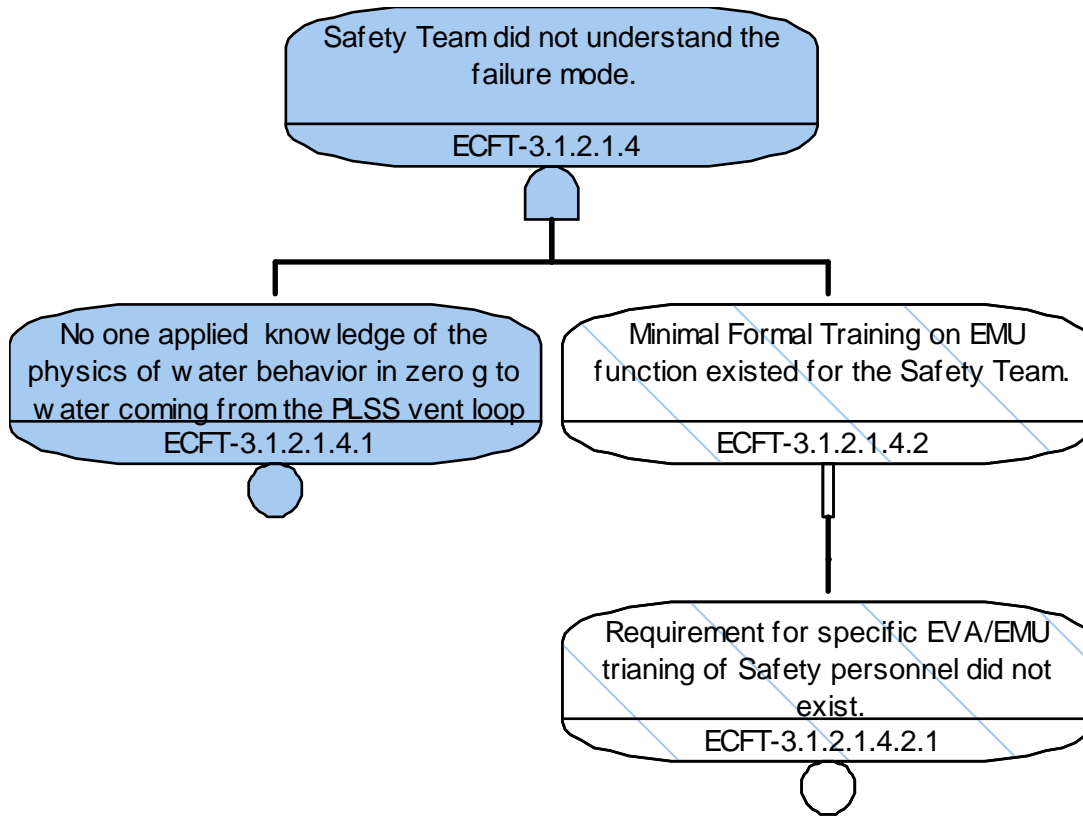
Figure 3-53 Root Cause and Contributing Factors under ECFT 3.1.2.1.4

ECFT-3.1.2.1.4 – Safety Team did not understand the failure mode. (Intermediate Cause 18)

ECFT-3.1.2.1.4.2.1 – Requirement for specific EVA/EMU training of Safety personnel did not exist. (Contributing Factor 10)

Supporting Evidence: Interviews with Safety and Mission Assurance management and personnel as well as a review of relevant documentation indicated that there are no requirements for formal systems training set forth by S&MA. The S&MA organization depends largely on the existing skill and knowledge base of the personnel hired into the organization from other jobs such as in Engineering or Mission Operations for their systems knowledge. See Observation 26 in Section 3.7 for more discussion.

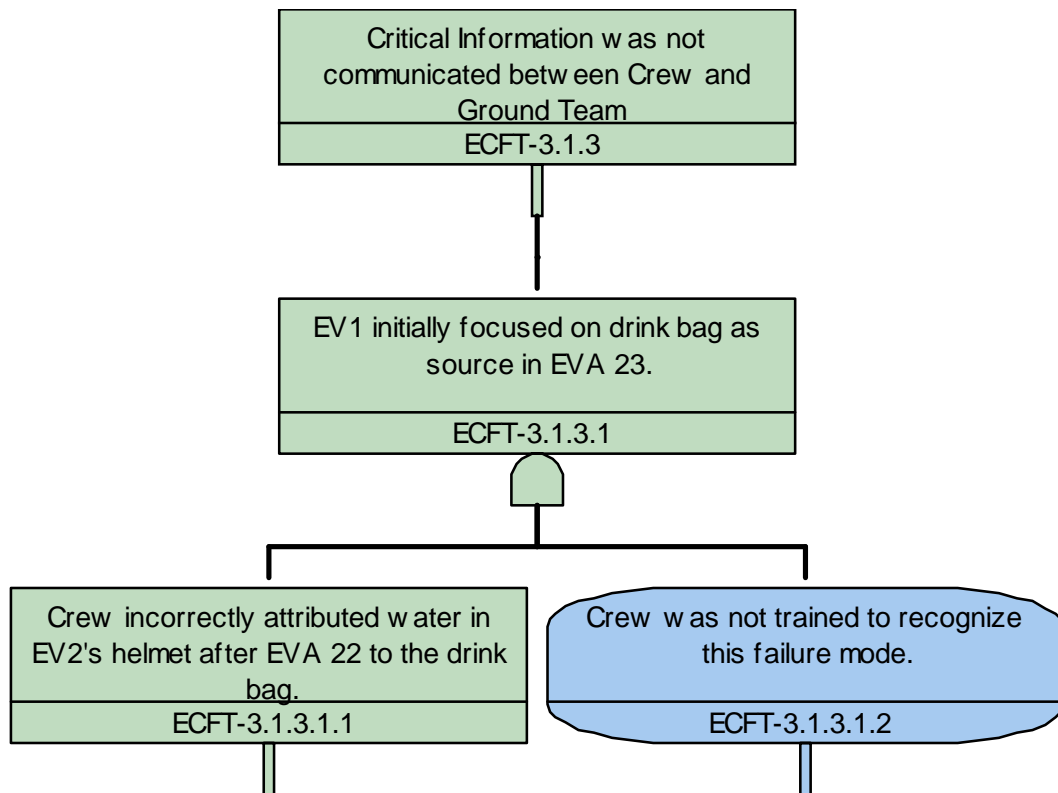
Figure 3-54 Causes under ECFT 3.1.3

ECFT-3.1.3 – Critical Information was not communicated between Crew and Ground Team. (Intermediate Cause 9)

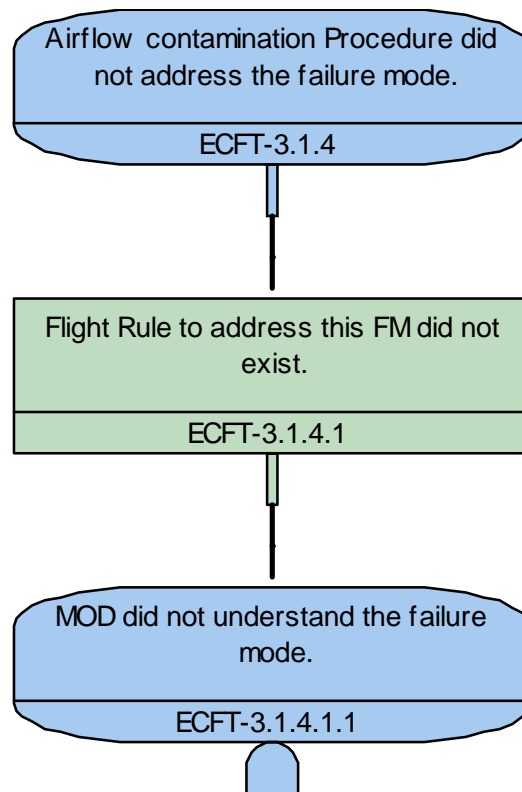
Figure 3-55 Causes under ECFT 3.1.4

ECFT-3.1.4 – Airflow contamination procedure did not address the failure mode. (Intermediate Cause 10)

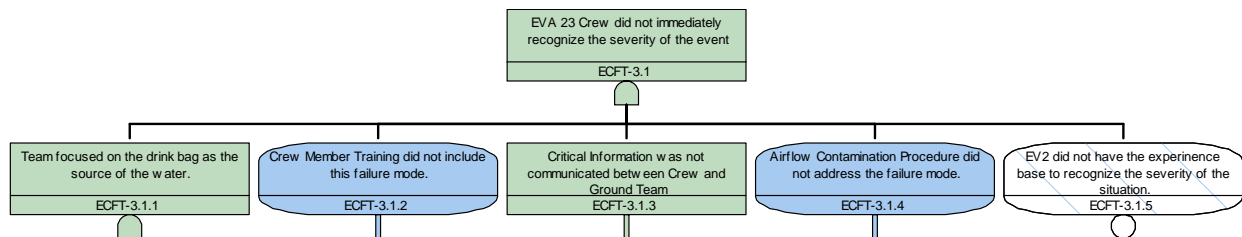
Figure 3-56 Causes and Contributing Factors under ECFT 3.1 for reference

ECFT-3.1.5 – EV2 did not have the experience base to immediately recognize the severity of the situation. (Contributing Factor 2)

Supporting Evidence: From EVA historical documentation and interviews, the MIB found that this was EV2's second EVA. His first EVA was EVA 22 which occurred just one week prior to EVA 23. Prior to spaceflight, EV2 had conducted one vacuum chamber run in an EMU on the ground. His chamber run was uneventful but his first EVA resulted in water in his helmet. The water in his helmet during EVA 22 started appearing at the end of the spacewalk during Airlock re-pressurization. Since it was EV2's first EVA, he assumed that water droplets and fog on his visor were normal Airlock re-pressurization phenomena that no one had told him about in advance. When EV2's helmet was removed, EV1 saw what he considered "a lot" of water (estimated at one-half to one liter) and asked EV2 where it all had come from. In discussing it between themselves and with the ground team, the water was attributed to sweat and water from the drink bag. EV2 didn't have the experience base or training to determine if this was a serious issue or not and didn't want to cause the EVA to be terminated for a non-issue.

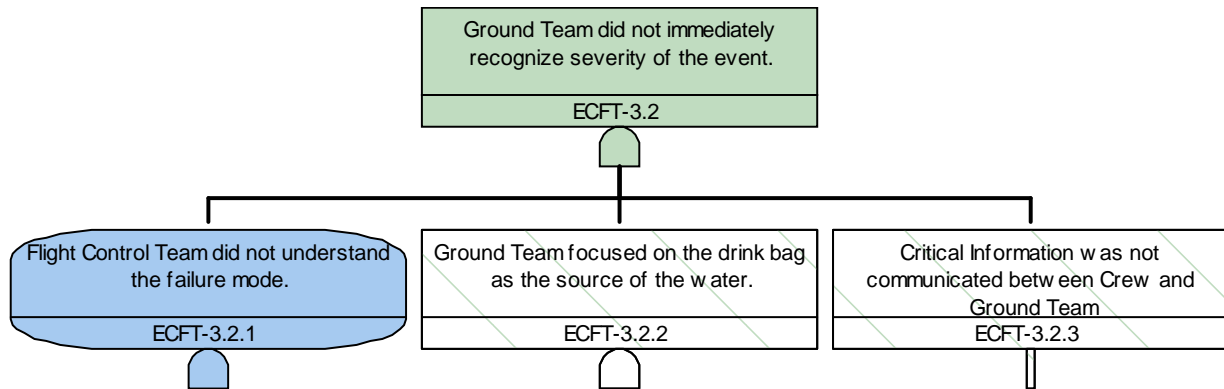
Figure 3-57 Causes and Contributing Factors under ECFT 3.2

ECFT-3.2 – Ground Team did not immediately recognize the severity of the event. (Intermediate Cause 6)

Supporting Evidence: It is clear through discussions captured on audio loops between the ground control teams and the EV crew that the Ground Team did not initially recognize the severity of the water pooling at the back of EV2's head. The Ground Team did recognize the fact that water pooling in the helmet was not a nominal behavior of the EMU and participated in the questioning of EV2 (through the CAPCOM) about the source. The ground team's initial recommendation was to continue the EVA since they believed the amount of the water was not increasing. Prior to getting a direct visual on EV2 by EV1, the Ground Team only had the information coming to them via the loop communications and their own experience with the behavior of the EMU. By GMT 12:51, EV1 had a direct visual of EV2's face and saw water pooling on the side of EV2's head. At this time, EV2 also expressed concern about the quantity of water in his helmet and within minutes the Ground Team made the decision to terminate the EVA for EV2.

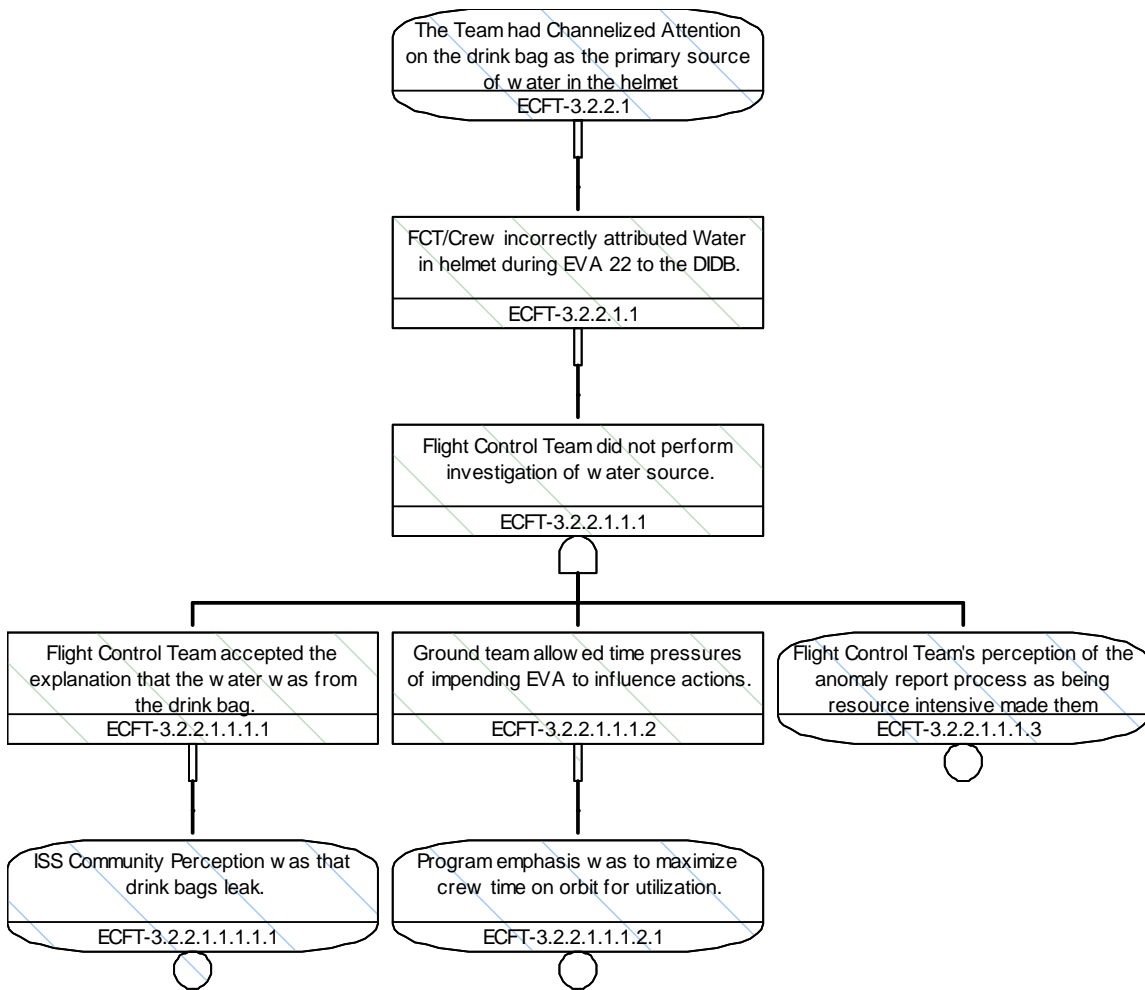
Figure 3-64. Contributing Factors under ECFT 3.2.2.1

ECFT-3.2.2.1 – The Team had Channelized Attention on the drink bag as the primary source of water in the helmet. (Intermediate Cause 12)

ECFT-3.2.2.1.1.3 Flight Control Team’s perception of the anomaly report process as being resource intensive made them reluctant to invoke it. (Root Cause 3)

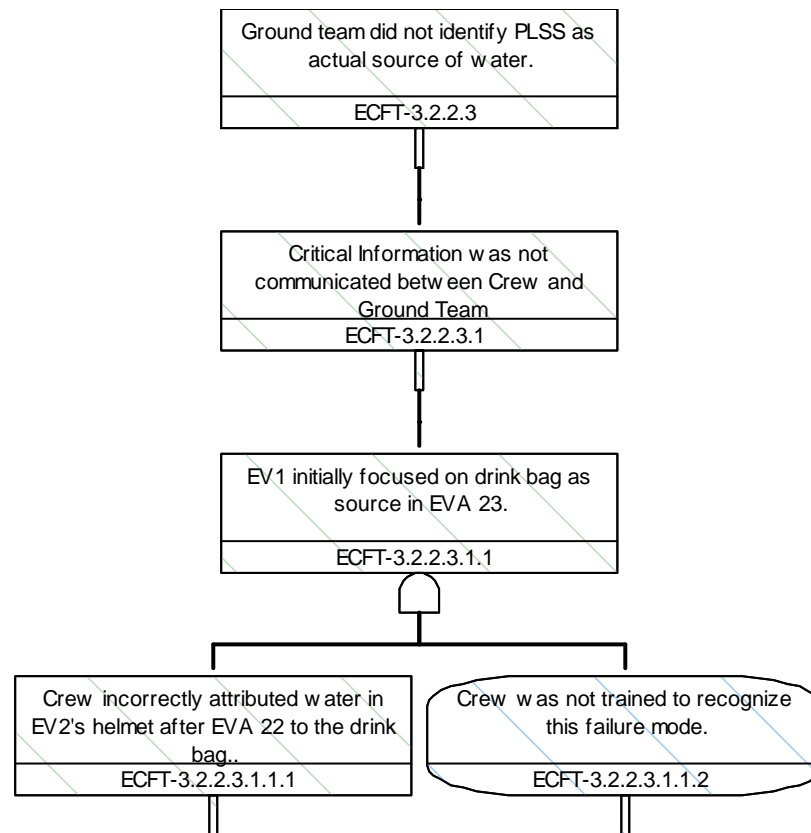
Figure 3-66 Contributing Factors under ECFT 3.2.2.3

ECFT-3.2.2.3 – Ground team did not identify PLSS as actual source of water. (Contributing Factor 4)

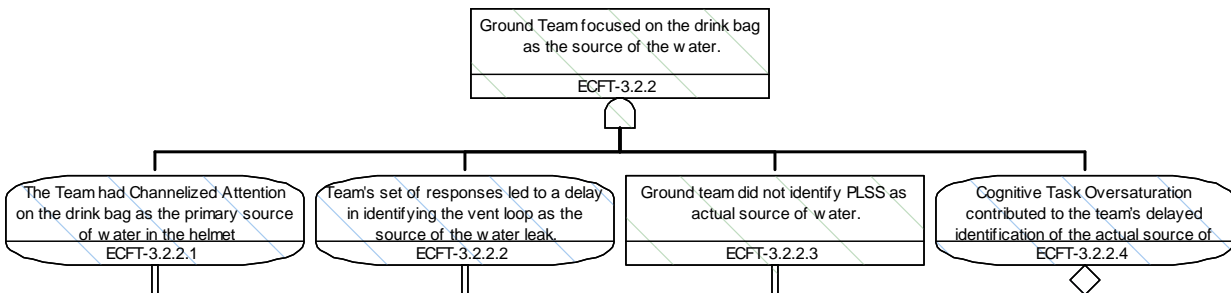
Figure 3-67. Contributing Factors under ECFT 3.2.2 for reference

ECFT-3.2.2.4 Cognitive Task Oversaturation contributed to the team's delayed identification of the actual source of the water leak. (Contributing Factor 5)

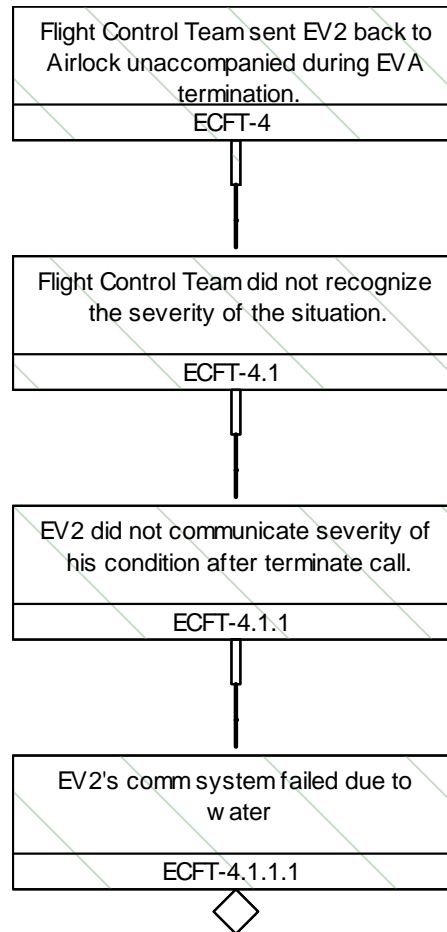
Figure 3-68. Contributing Factors under ECFT 4 for reference

ECFT-4.1 Flight Control Team did not understand the severity of the situation. (Intermediate Cause 6)

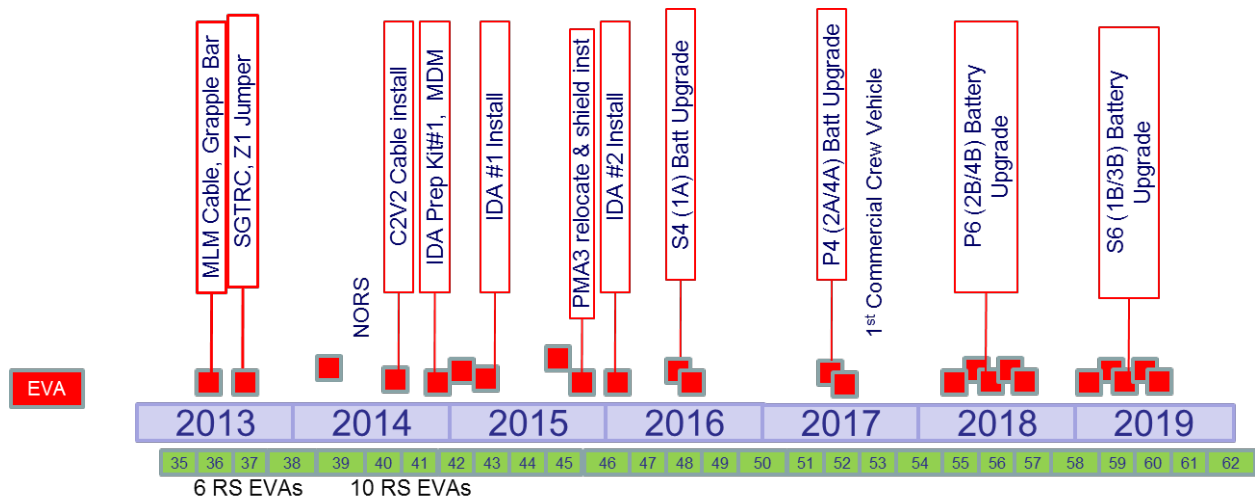
Figure 3-69 Projected Future Maintenance EVAs

EVA community resources also do not seem adequate for long term support of the increased frequency of EVAs needed for ISS planned maintenance as seen in Figure 3-69 combined with the expectation that there may be a need for an increased number of CCEs per year through 2020.

Recommendation R-41: ISS Program should augment, at least temporarily, MOD EVA personnel to allow the existing backlog of work to be completed in a fairly short order by bringing on, through rotational opportunities, personnel that can provide valuable technical assistance that will not add to the training and certification burden already faced by the organization.
