REPORT OF APOLLO 13 REVIEW BOARD

NATIONAL AERONAUTICS AND SPACE ADMINISTRATION

APOLLO 13 REVIEW BOARD

June 15, 1970

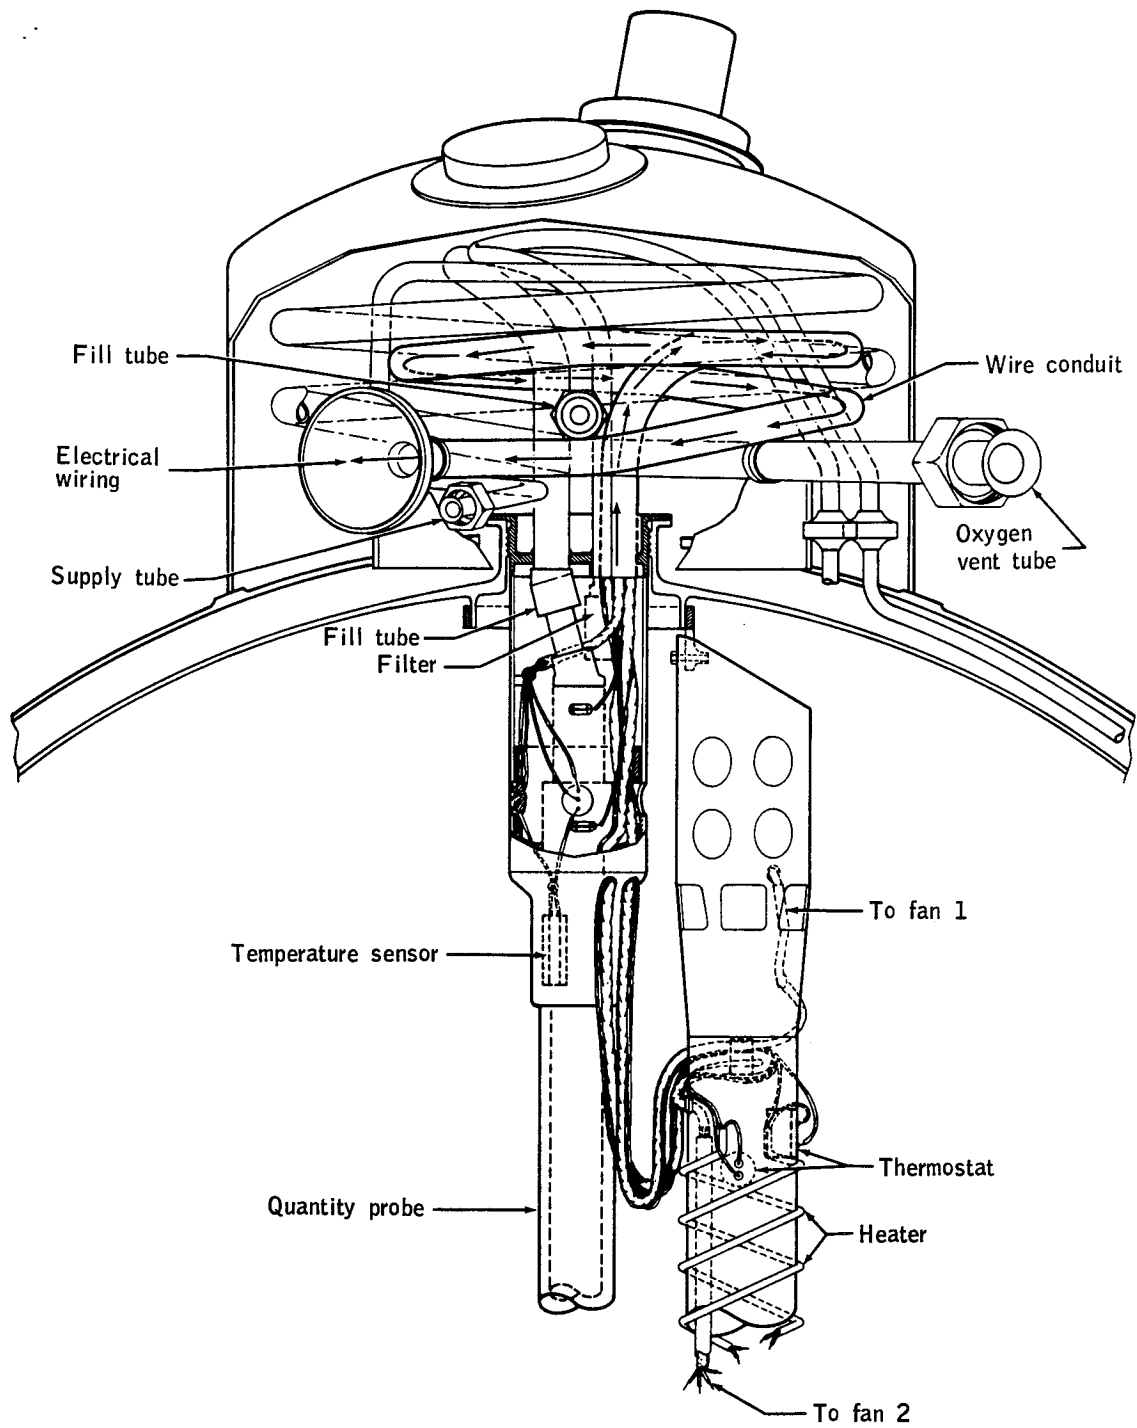
Figure 4-2.- Oxygen tank wiring and lines.

After the helium proof test, the tank was filled with liquid oxygen and pressurized to a proof pressure of 1335 psi by use of the tank heaters powered by 65 V ac. Extensive heat-leak tests were run at 900 psi for 25 to 30 hours over a range of ambient conditions and out-flow rates. At the conclusion of the heat-leak tests, about 100 pounds of oxygen remained in the tank. About three-fourths of this was released by venting the tank at a controlled rate through the supply line to about 20 psi. The tank was then emptied by applying warm gas at about 30 psi to the vent line to force the liquid oxygen (LOX) in the tank out the fill line (see fig. 4-2). No difficulties were recorded in this detanking operation.

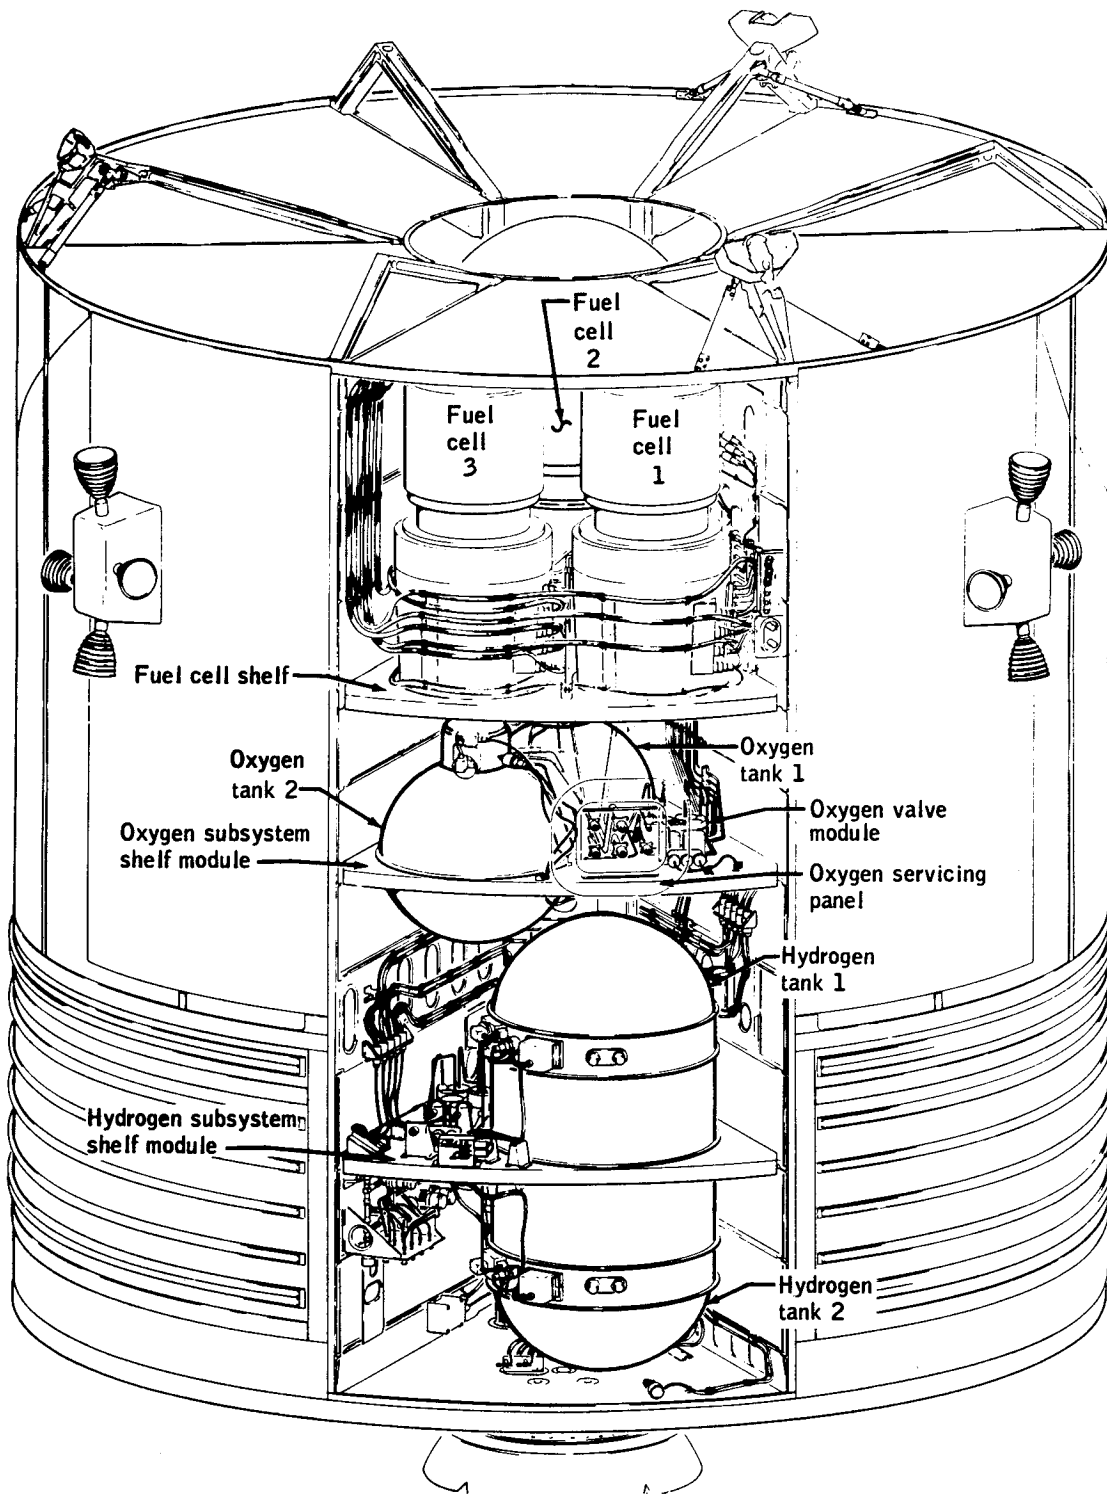
Figure 4-4.- Arrangement of fuel cells and cryogenic systems in bay 4.

Two oxygen tanks are mounted on a shelf in bay 4 of the SM, as shown in figure 4-4. Figures 4-5 through 4-8 are photographs of portions

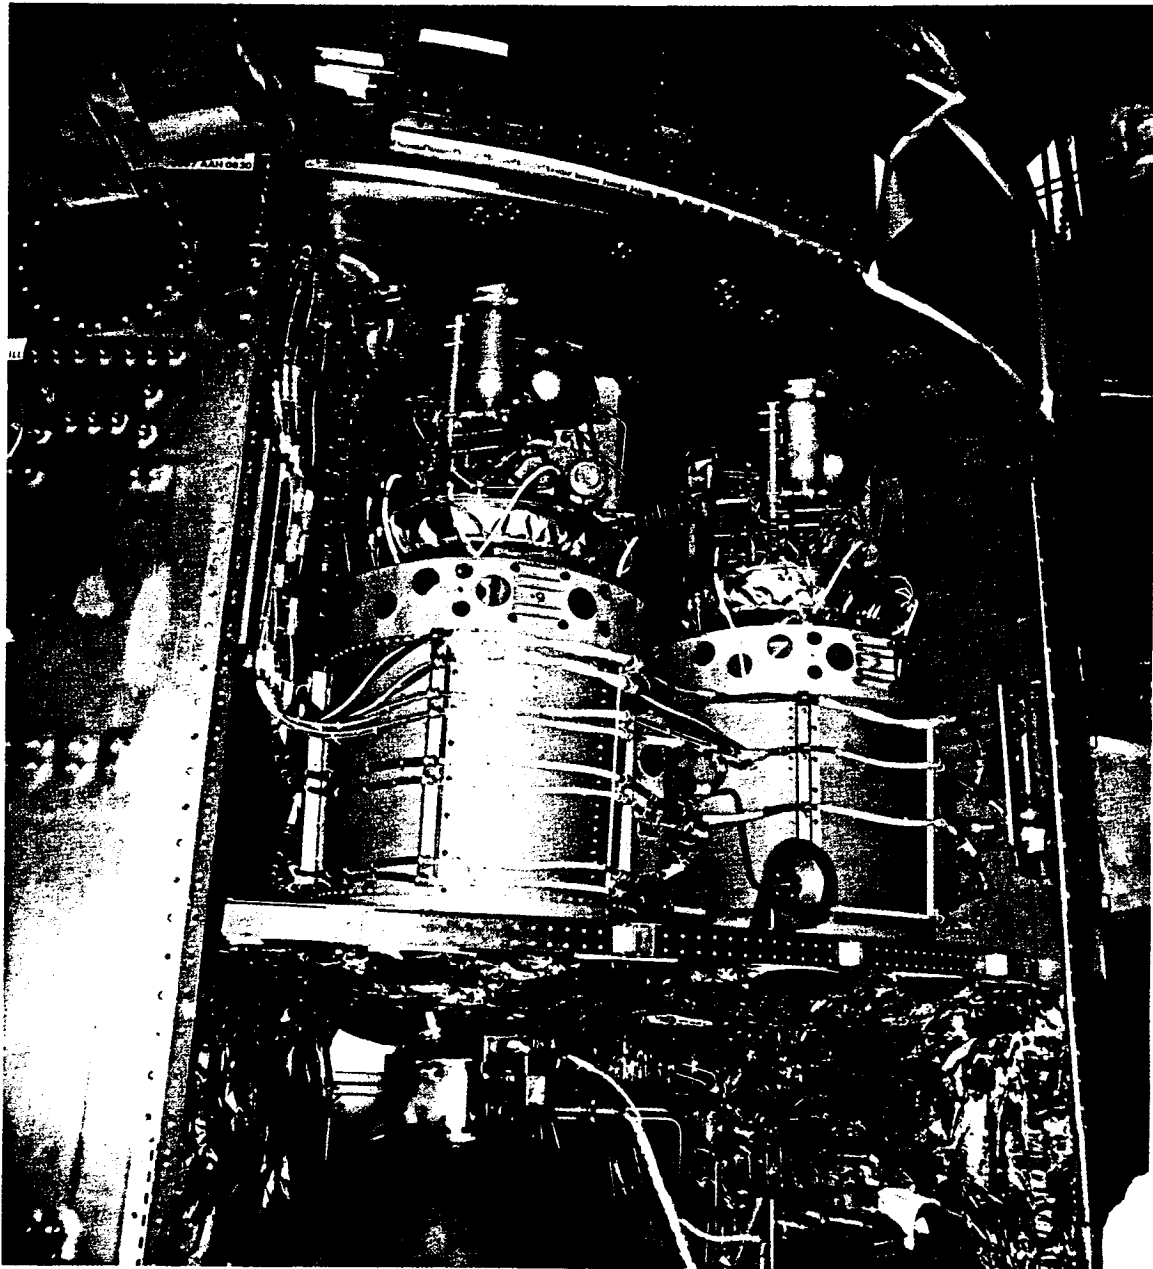
Figure 4-5.- Fuel cells shelf.

of the Apollo 13 service module (SM 109) at the North American Rockwell plant prior to shipment to KSC. Figure 4-5 shows the fuel cell shelf, with fuel cell 1 on the right, fuel cell 3 on the left, and fuel cell 2 behind cells 1 and 3. The top of oxygen tank no. 2 can be seen at the lower left. Figure 4-6 shows the oxygen tank shelf, with oxygen tank no. 2 at left center. Figure 4-7 shows the hydrogen tank shelf with hydrogen tank no. 1 on top and hydrogen tank no. 2 below. The bottom of the oxygen shelf shows some of the oxygen system instrumentation and wiring, largely covered by insulation. Figure 4-8 is a photograph of the bay 4 panel, which was missing from the service module after the accident.

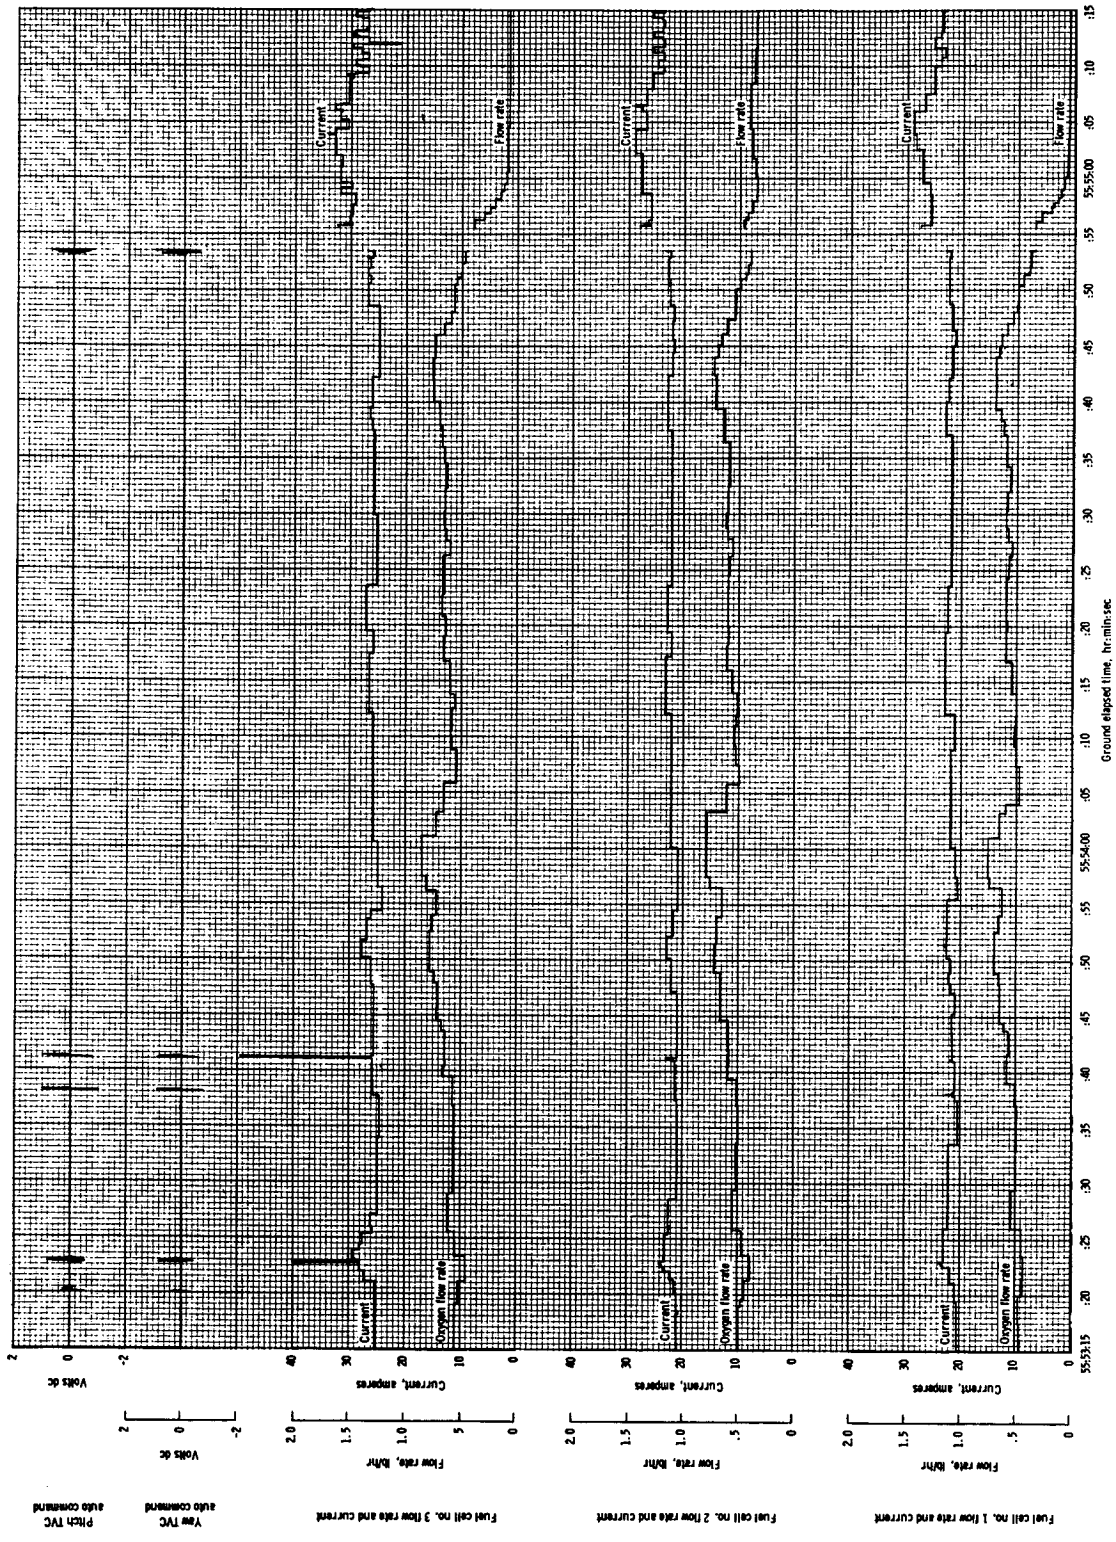
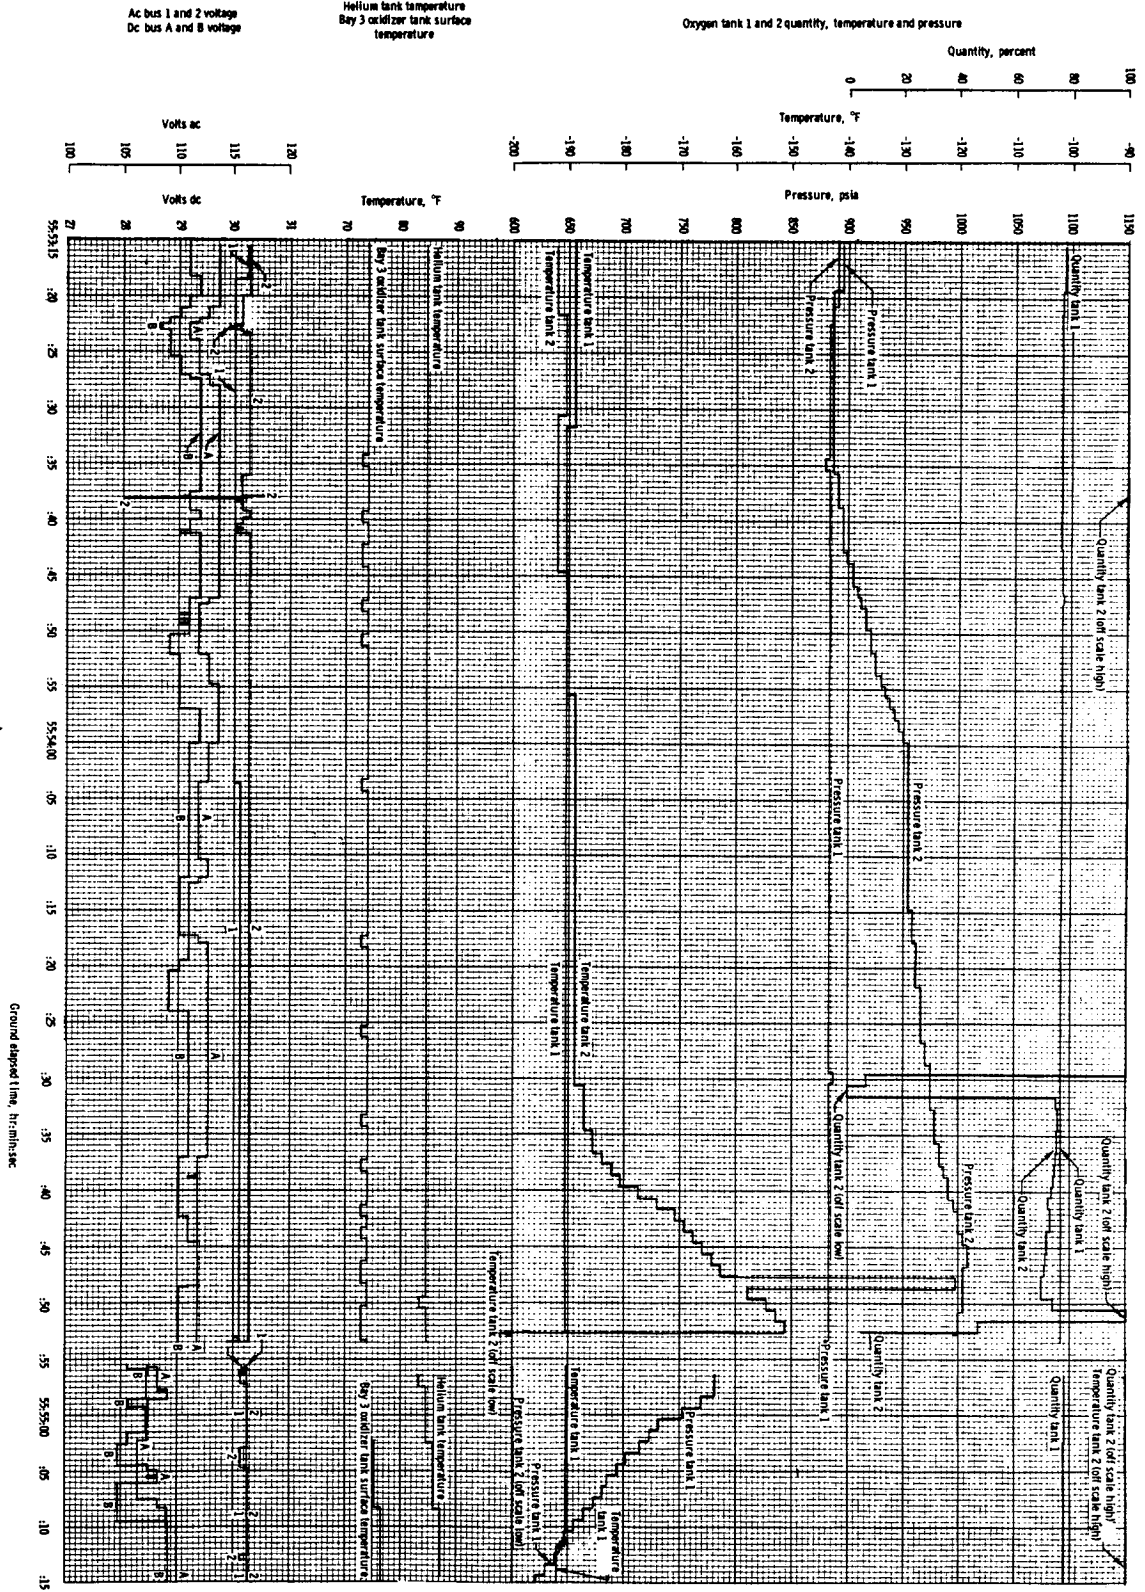
Figure 4-10.- Telemetry record.

The various telemetered parameters of primary interest are shown in figure 4-10 and listed in table 4-11.

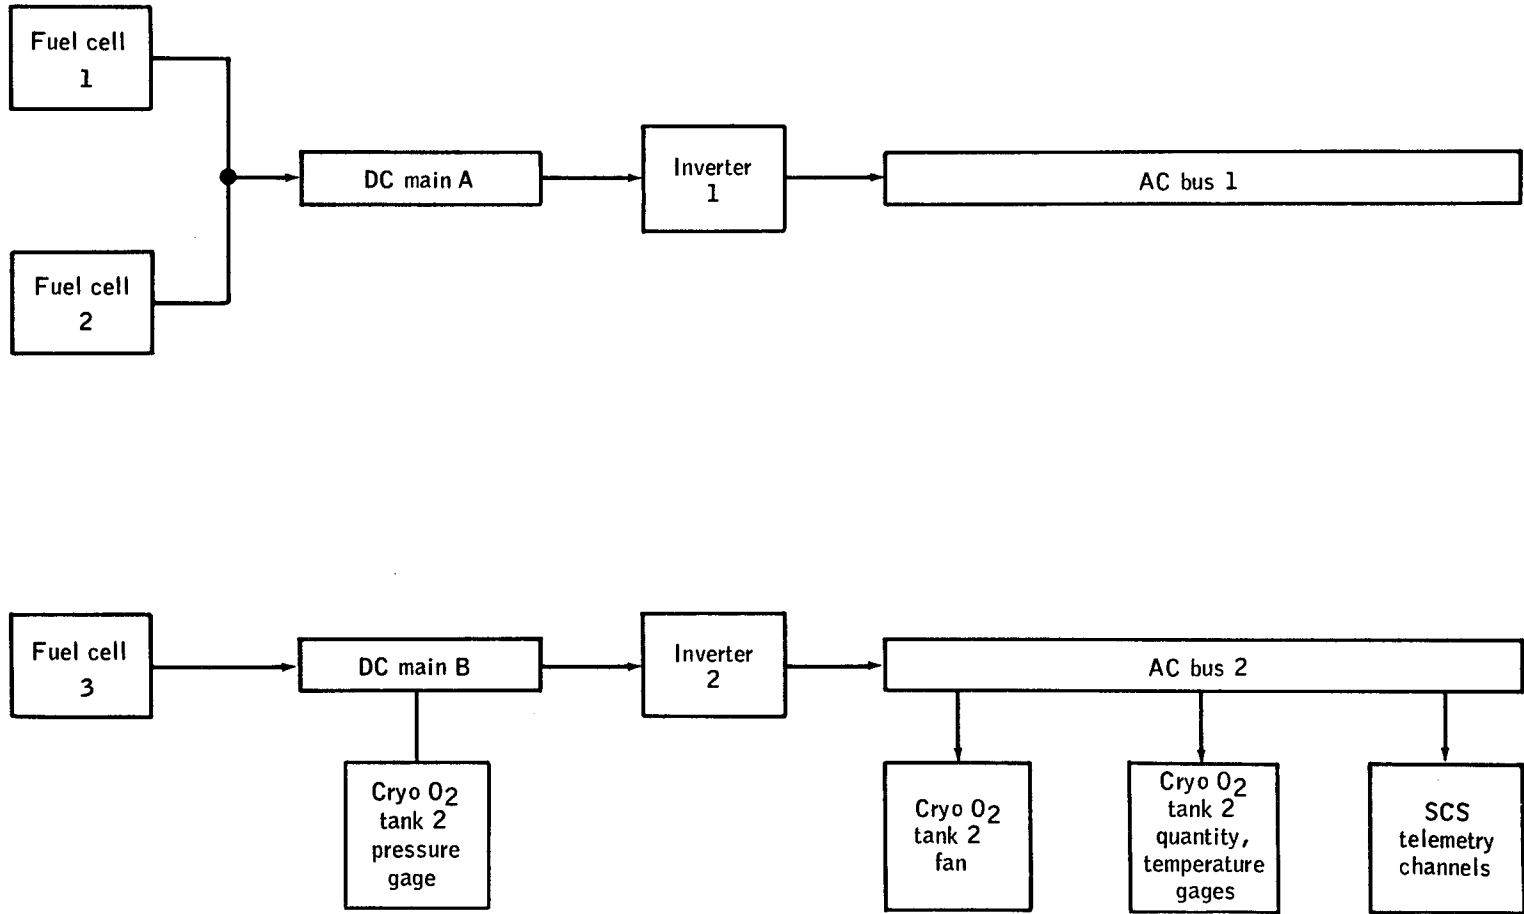
Figure 4-12.- Electrical configuration at 55:54:53 g.e.t.

The failure of oxygen tank no. 2 and consequent removal of the bay 4 panel produced a shock which closed valves in the oxygen supply lines to fuel cells 1 and 3. These fuel cells ceased to provide power in about 3 minutes, when the supply of oxygen between the closed valves and the cells was depleted. Fuel cell 2 continued to power ac bus 1 through dc main bus A, but the failure of fuel cell 3 left dc main bus B and ac bus 2 unpowered (see fig. 4-12). The oxygen tank no. 2 temperature and quantity gages were connected to ac bus 2 at the time of the accident. Thus, these parameters could not be read once fuel cell 3 failed at 55:57:44 until power was applied to ac bus 2 from main bus A.

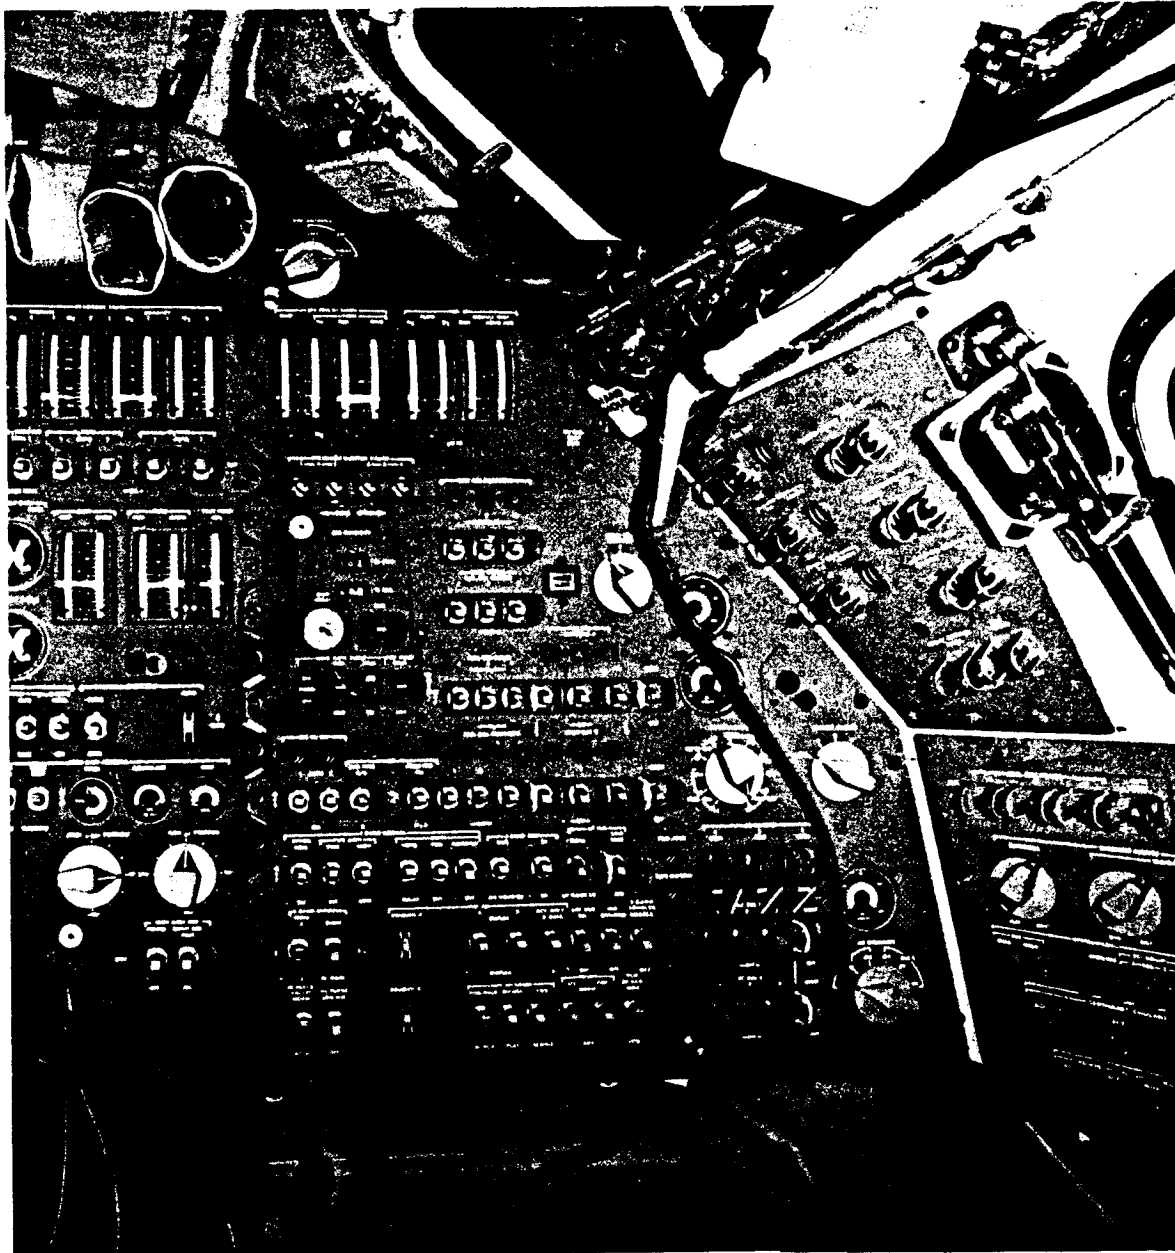
Figure 4-13.- Main display panel.

The Lunar Module Pilot was in the tunnel between the CSM and the LM, returning to the CSM. The Command Module Pilot was in the left-hand couch, monitoring spacecraft performance. Because of the master alarm indicating low voltage, the CMP moved across to the right-hand couch where CSM voltages can be observed. He reported that voltages were "looking good" at 55:56:10. At this time, main bus B had recovered and fuel cell 3 did not fail for another 1-1/2 minutes. He also reported fluctuations in the oxygen tank no. 2 quantity, followed by a return to the off-scale high position. (See fig. 4-13 for CM panel arrangement).
