MSC-00171

APOLLO 11 MISSION REPORT

MANNED SPACECRAFT CENTER
HOUSTON, TEXAS
NOVEMBER 1969

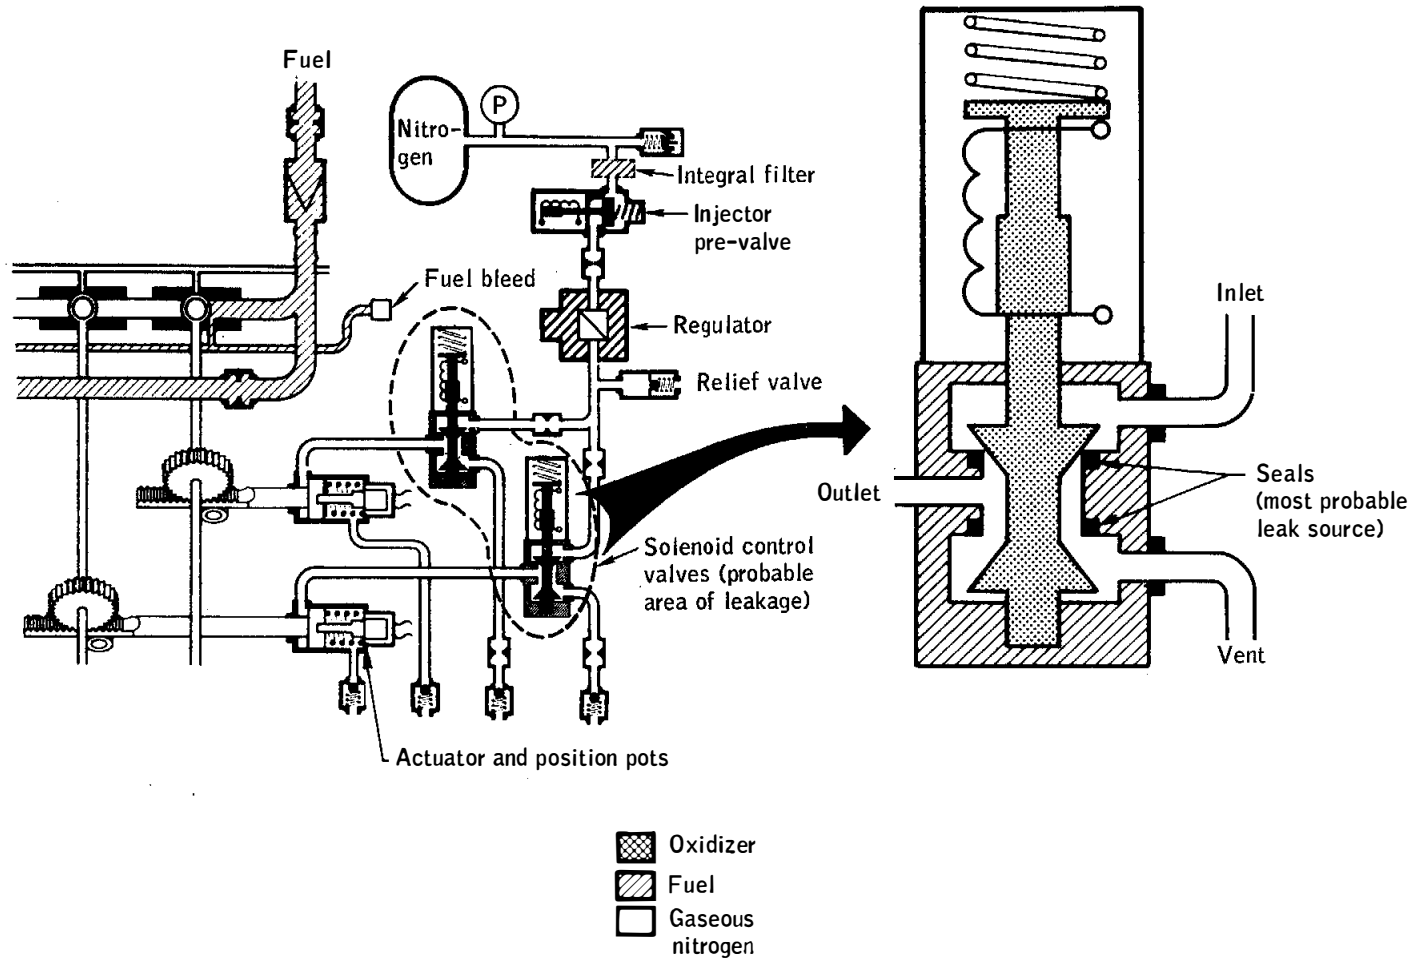
The fuel and oxidizer valves are controlled by actuators driven by nitrogen pressure. Figure 16-2 is representative of both nitrogen control systems. When power is applied to the service propulsion system in preparation for a maneuver, the injector pre-valve is opened; however, pressure is not applied to the actuators because the solenoid control valves are closed. When the engine is commanded on, the solenoid control valves are opened, pressure is applied to the actuator, and the rack on the actuator shaft drives a pinion gear to open the fuel and oxidizer valves. When the engine is commanded off, the solenoid control valve vents the actuator and closes the fuel and oxidizer valves.

It is concluded that the leakage was due to a contamination-induced failure of a solenoid control valve. The source of contamination is unknown; however, it was apparently removed from the sealing surface during the valve closure for the first lunar orbit insertion maneuver (fig. 16-2). A highly suspect source is a contaminated facility manifold at the vendor's plant. Although an investigation of the prior failure indicated the flight valve was not contaminated, the facility manifold is still considered a possible source of the contaminants.

Figure 16-2.- Control for service propulsion propellants.

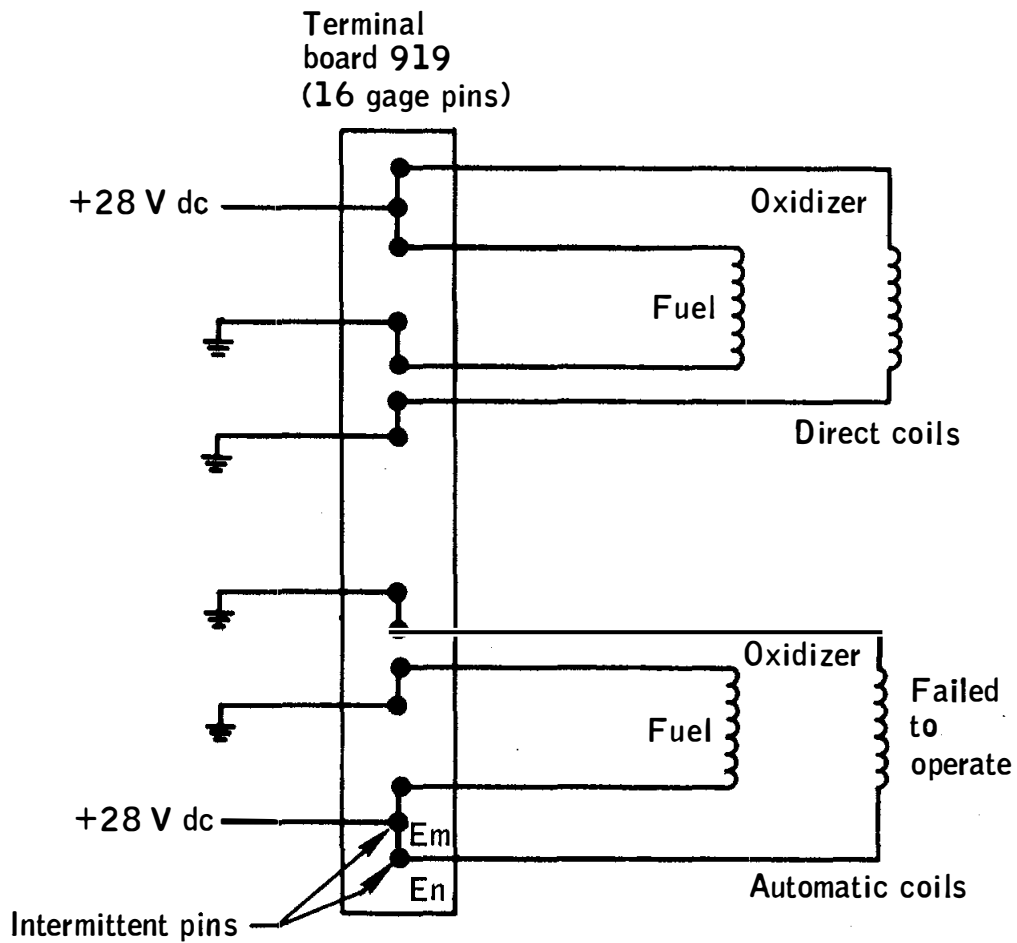
Postflight tests showed that two pins in the terminal board (fig. 16-3) were loose and caused intermittent continuity to the automatic coils of the engine valve. This type failure has previously been noted on terminal boards manufactured prior to November 1967. This board was manufactured in 1966.

Figure 16-3.- Terminal board schematic for minus-yaw engine, command module reaction control system 1.

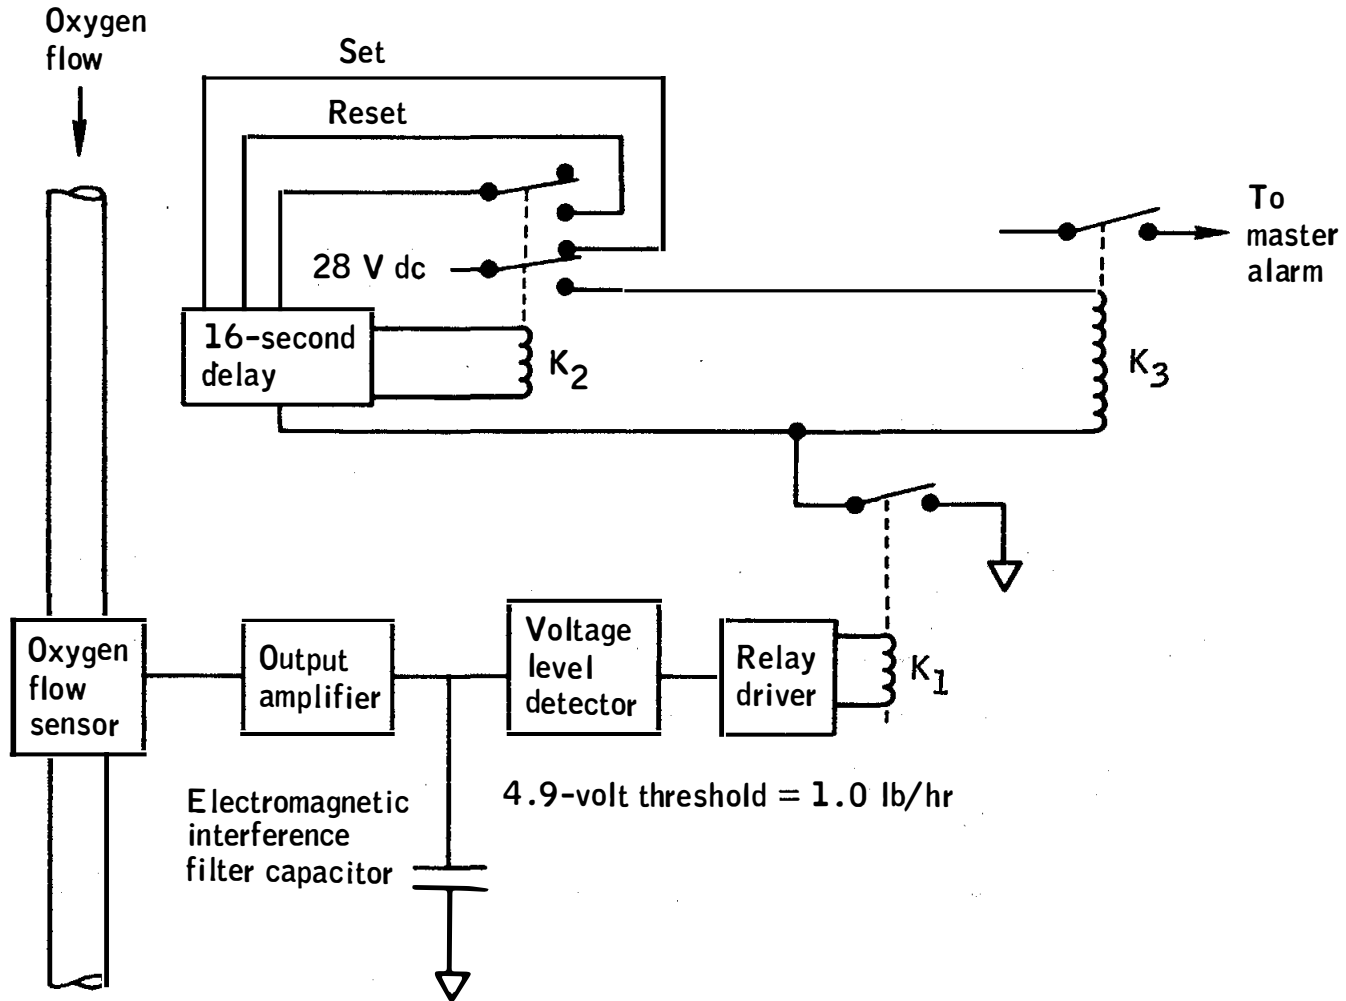
During the initial lunar module pressurization, two master alarms were activated when the oxygen flow rate was decreasing from full-scale. The same condition had been observed several times during altitude-chamber tests and during subsequent troubleshooting. The cause of the problem could not be identified before launch, but the only consequence of the alarms was the nuisance factor. Figure 16-4 shows the basic elements of the oxygen flow sensing circuit.

Note in figure 16-4 that in order for a master alarm to occur, relay K1 must hold in for 16 seconds, after which time relays K2 and K3 will close, activating a master alarm.

Figure 16-4.- Oxygen flow sensing circuit.

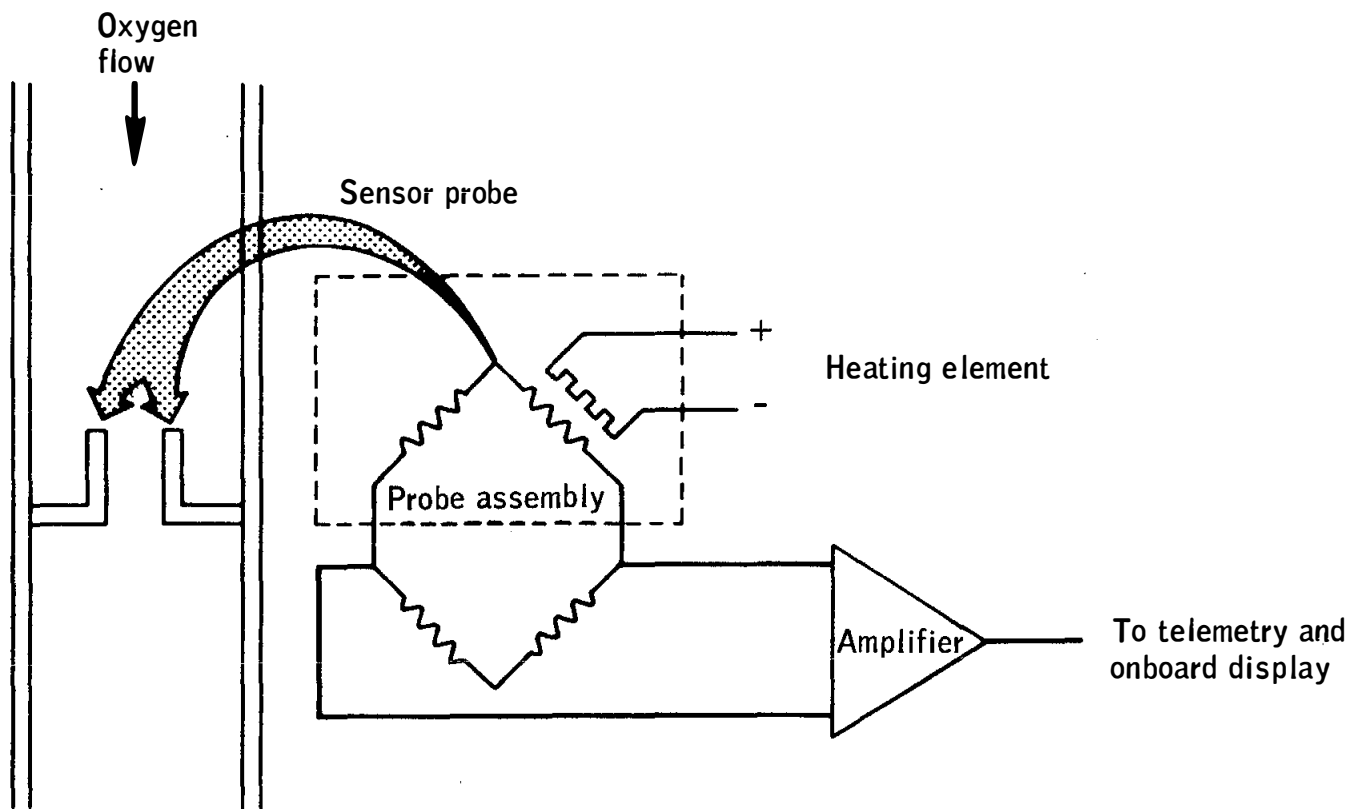
Analysis of associated data indicated that the oxygen flow was normal, but that the indicated flow rate was negatively biased by approximately 1.5 lb/hr. Postflight tests of the transducer confirmed this bias, and the cause was associated with a change in the heater winding resistance within the flow sensor bridge (fig. 16-5). The resistance of the heater had increased from 1000 ohms to 1600 ohms, changing the temperature of the hot wire element which supplies the reference voltage for the balance of the bridge. Further testing to determine the cause of the resistance change is not practical because of the minute size of the potted resistive element. Depotting of the element would destroy available evidence of the cause of failure. Normally, heater resistance changes have occurred early in the 100-hour burn-in period when heater stability is achieved.

Figure 16-5.- Oxygen flow sensor.

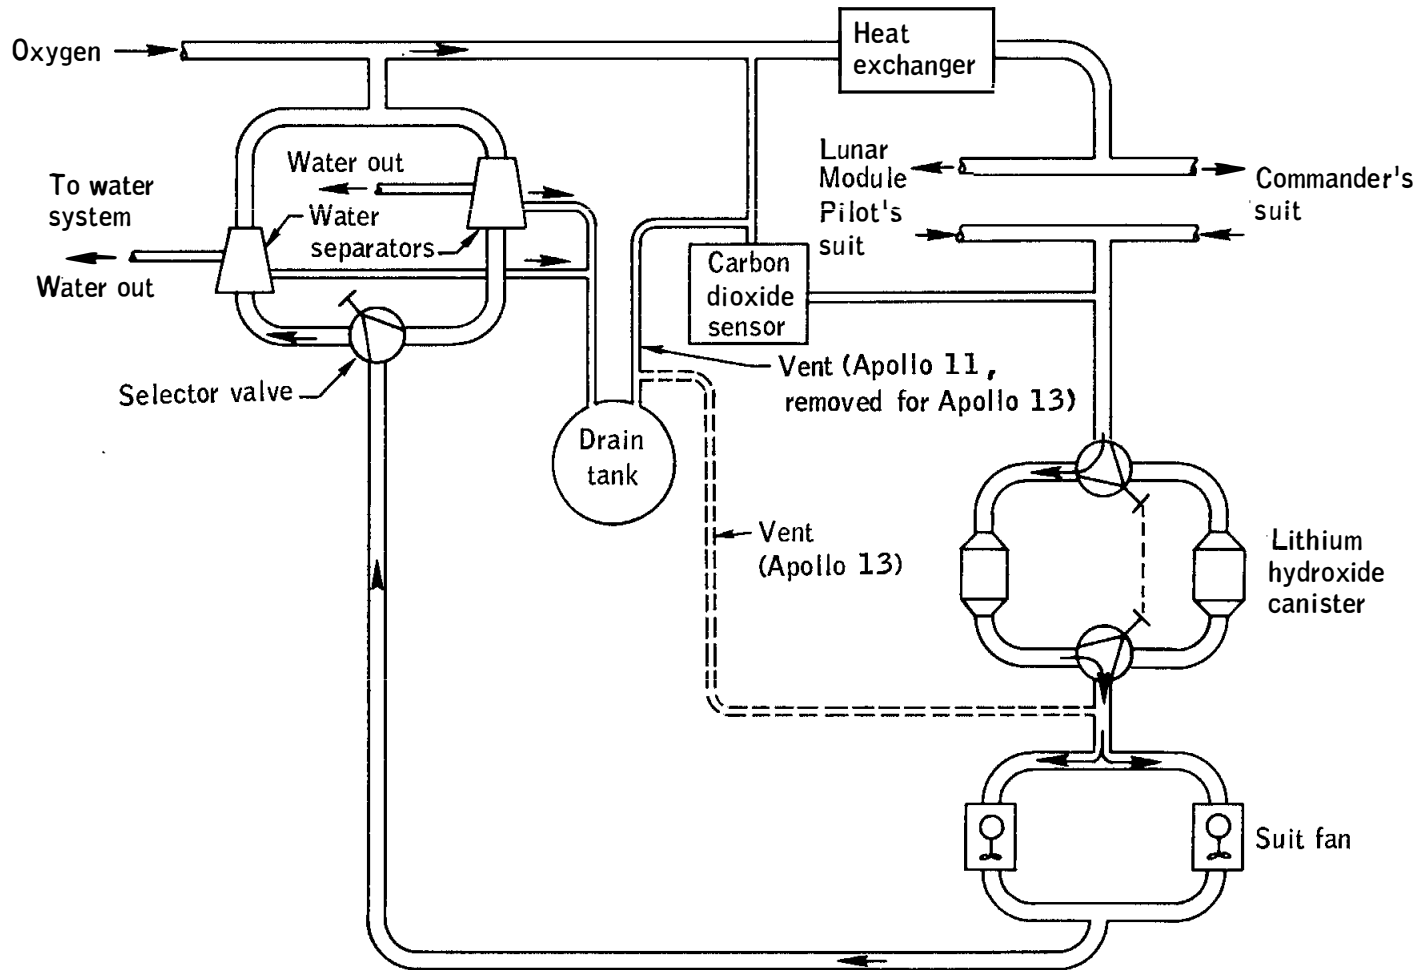
The possible sources of free water in the suit loop are the water separator drain tank, an inoperative water separator, local condensation in the suit loop, and leakage through the water separator selector valve. (see fig. 16-11). An evaluation of each of these possible sources indicated that leakage through the water separator selector valve was the most probable source of the free water.

Figure 16-11.- Simplified suit loop schematic.

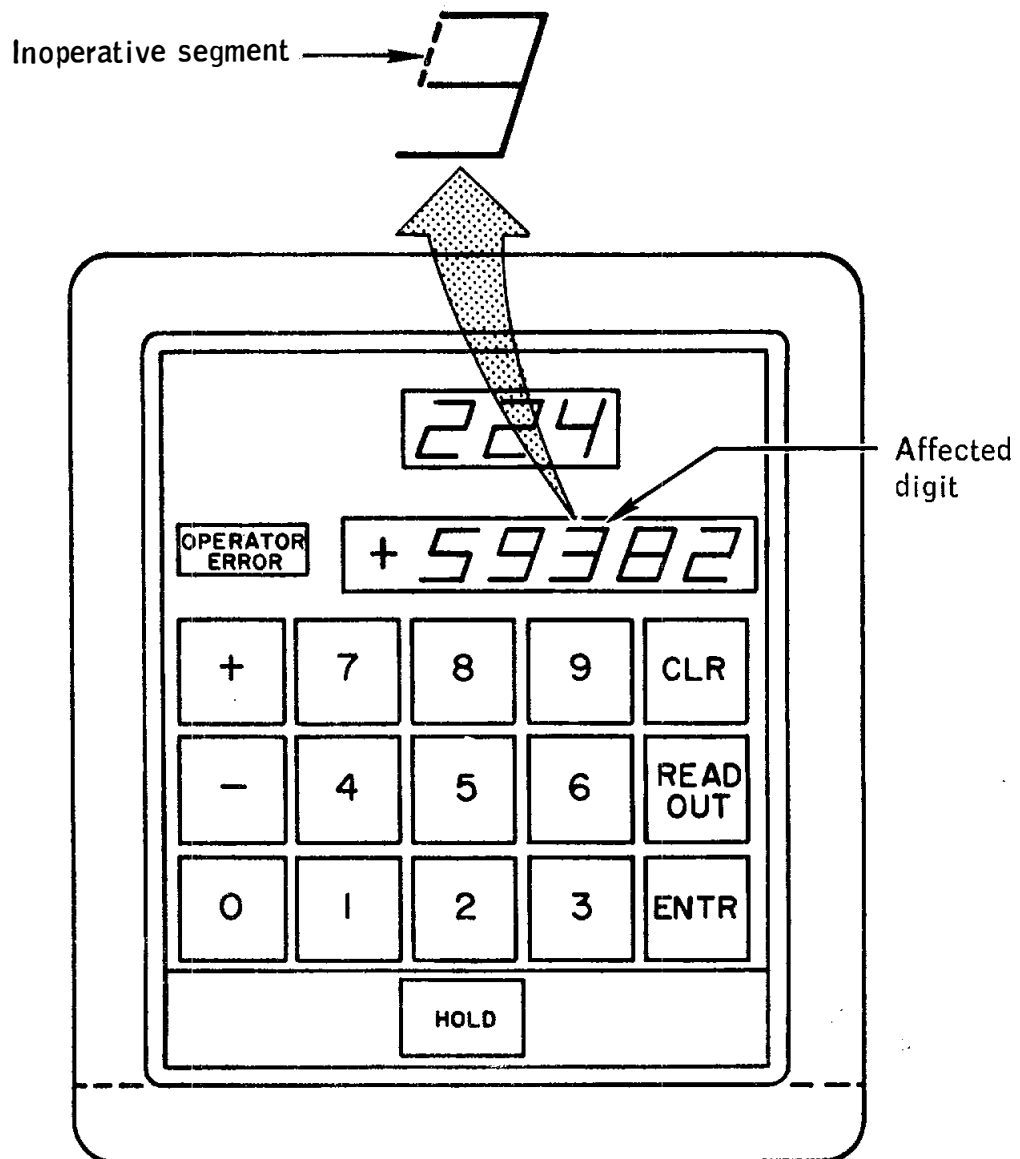
Figure 16-15.- Inoperative segment in one digit of data entry and display assembly.

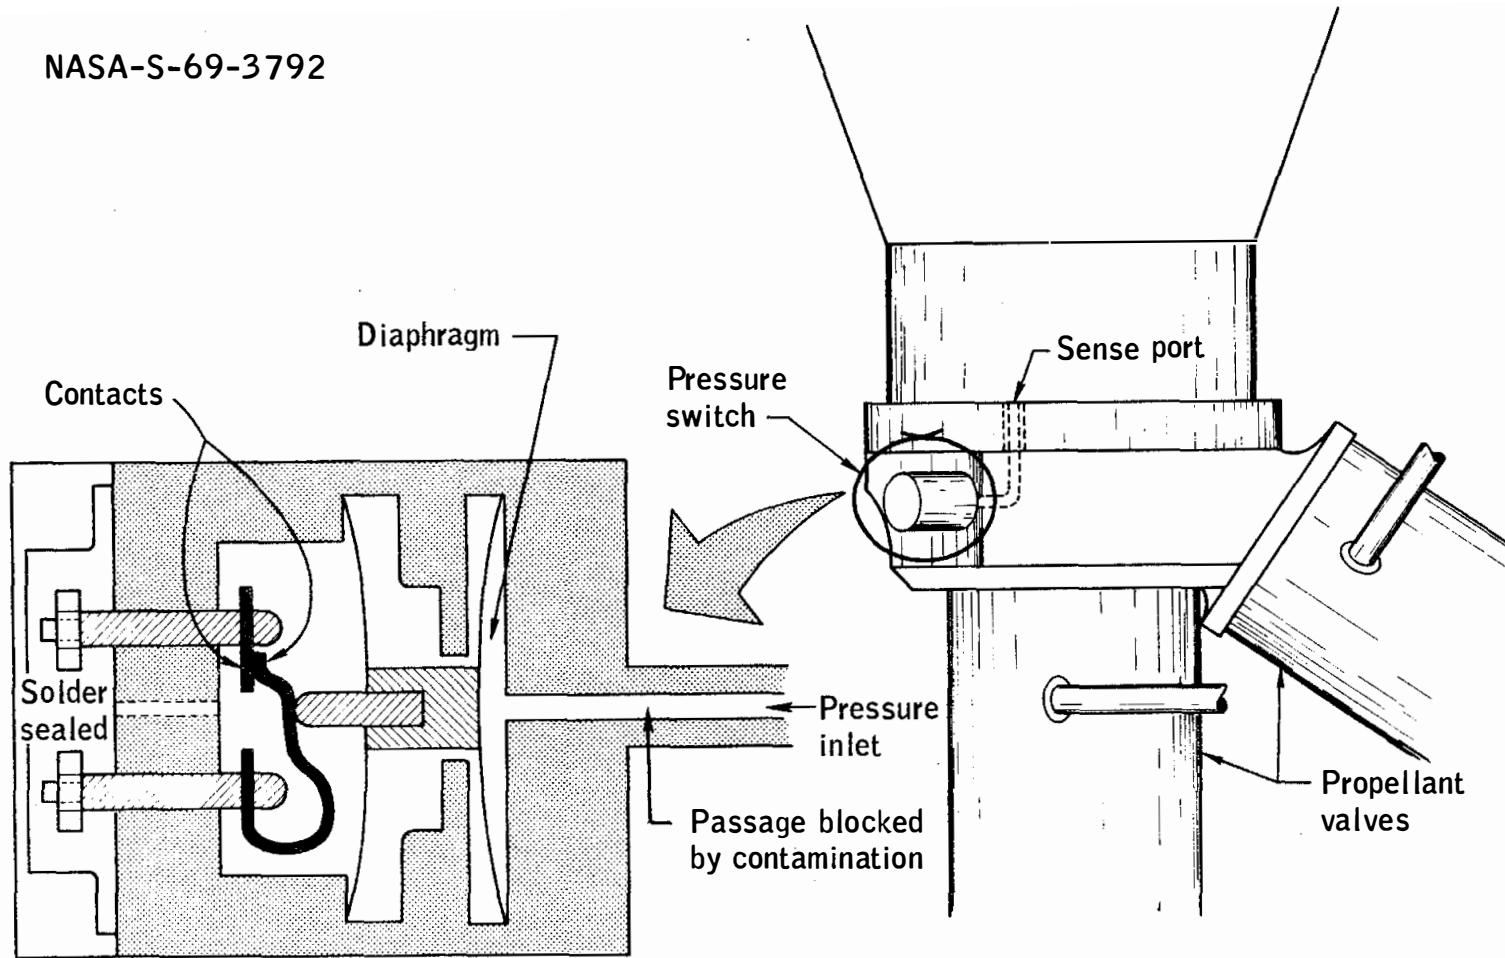
Figure 16-18.- Chamber pressure switch.

The switch used to monitor the quad 2 aft-firing engine (A2A) exhibited slow response to jet driver commands during most of the mission. During an 18-minute period just prior to terminal phase initiation, the switch failed to respond to seven consecutive minimum impulse commands. This resulted in a master alarm and a thruster warning flag, which were reset by the crew. The engine operated normally, and the switch failure had no effect on the mission. The crew did not attempt any investigative procedures to determine whether the engine had actually failed. A section drawing of the switch is shown in figure 16-18.

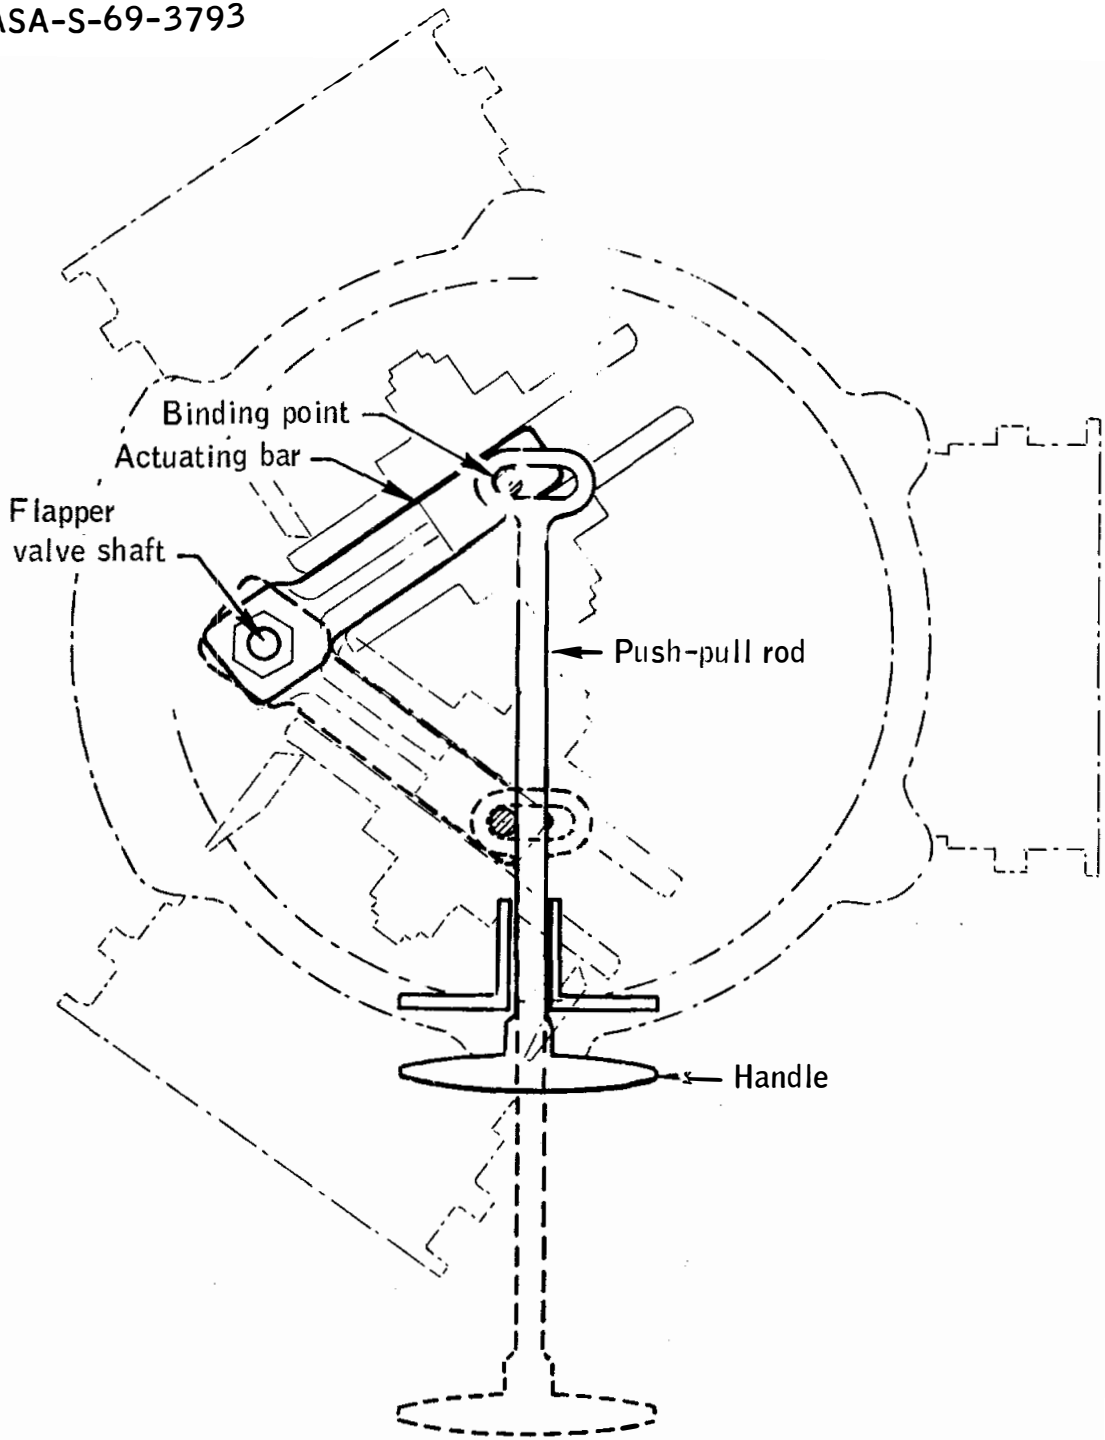
Figure 16-19.- Water separator selector valve.

The flapper type valve is located in a Y-duct arrangement and is used to select one of two water separators. Leakage of this valve would allow free water to bypass through the idle water separator and subsequently enter the suit hose. This leakage most probably resulted from a misalignment and binding in the slot of the selector valve actuation linkage (see fig. 16-19). The allowable actuation force after linkage rigging was 15 pounds. The usual actuation forces have been 7 to 8 pounds, but 12.5 pounds was required on Apollo 11. The allowable actuation force has been lowered to 10 pounds, and inspections for linkage binding have been incorporated into procedures at the factory and the launch site.

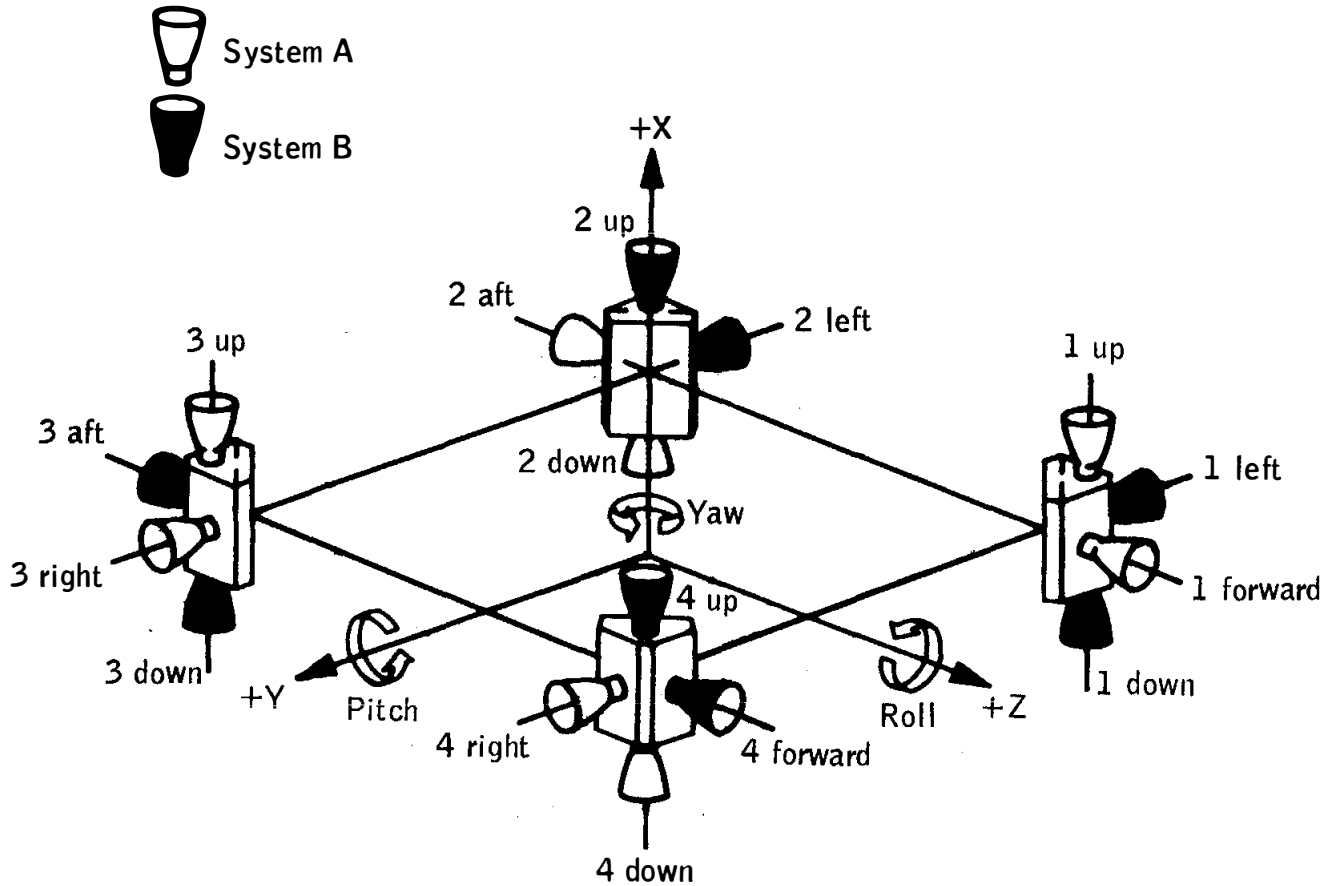
Figure 16-21.- Reaction control system geometry.

If +X translation were commanded (fig. 16-21), the down-firing engines in quads 2 and 4 of system A could fire, giving flags 2A and 4A. A subsequent minus X rotation could fire the forward-firing thruster in quad 4 of system B and the aft-firing thruster in quad 2 of system A, giving flag 4B. The aft-firing engine in quad 2 of system A (A2A) is not monitored by one of the ten buffers postulated failed. The failure then could have cleared itself. The response of the vehicle to thruster firings would have been normal under these conditions. There is no history of similar failures either at package or module level in the signal conditioner electronics assembly. No corrective action will be taken.

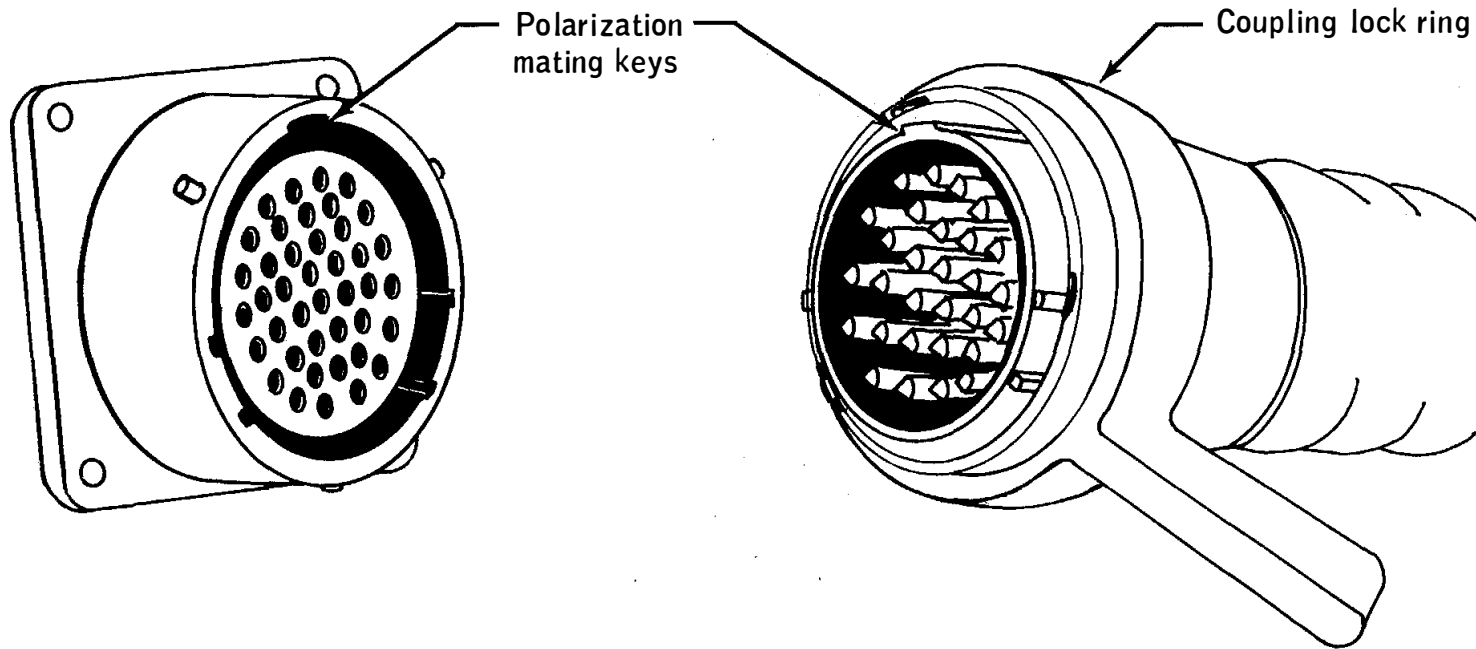
Figure 16-22.- Connector between remote control unit and portable life support system.

During preparation for extravehicular activity, the crew experienced considerable difficulty in mating the electrical connectors from the remote control unit to the portable life support system. For rotational polarization alignment, it was necessary to grasp the cable insulation because the coupling lock ring was free for unlimited rotation on the connector shell (see fig. 16-22).
